Jordan Elementary School

Date: 12/15/2020 Score 63% Average

Educational Suitability Summary Report

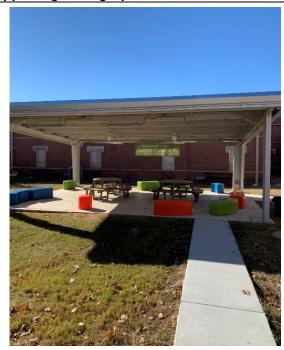
Outdoor Learning: Generous covered outdoor library space provides a great opportunity for students to read and learn outside.

The covered outdoor library appears to be relatively new and provides a great opportunity for outdoor teaching. It is centrally located but is the only outdoor teaching area on campus. A covered basketball court is located near the portables and playground as well, providing another potential area for outdoor teacher activities.

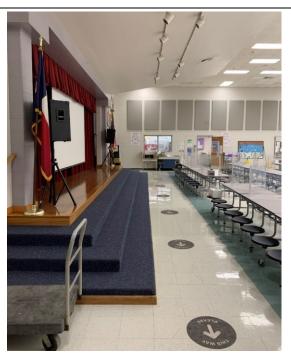
Cafetorium: Works well to hold district meetings but a separate auditorium space for larger events/performances was requested during the interview.

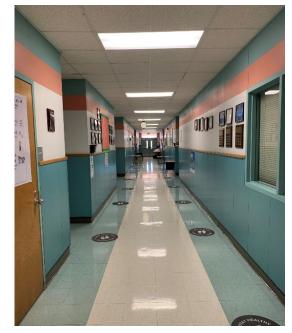
General: Most corridors are undersized and with low visibility. Little opportunity for collaboration or informal interaction.

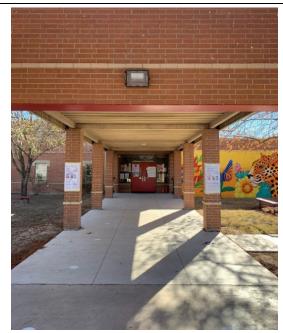
Front Entry: Main entrance is difficult to identify when approaching the building. Added wayfinding or signage could improve visibility.

When approaching the building from the parking lot, it can be difficult to tell where the entrance is located, and signage is limited. Vehicular traffic and bus traffic are separated, however there are not enough stack spaces available before the pickup/drop-off traffic begins to impede the roadway.

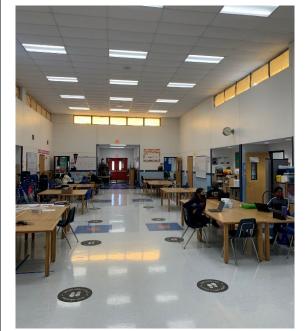
General: Central multipurpose space in new annex for fourth grade serves many functions but it would be preferable to have a dedicated space for a Maker/STEM lab.

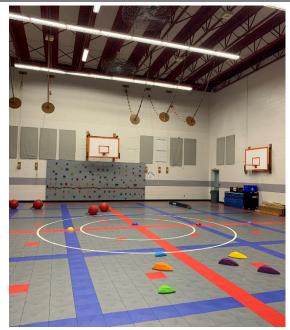
PE and Wellness: The gym connects to the cafeteria with an operable wall. The space is in good condition but aged.

The campus has two covered playgrounds and a covered basketball court to support physical education. A large play field provides ample space for outdoor activities, however most of it is exposed to the elements and may not be usable year-round. The gym is adjacent to the cafeteria and can open up with a movable partition to create a larger gathering space if needed. The gym itself is in good condition but aged.

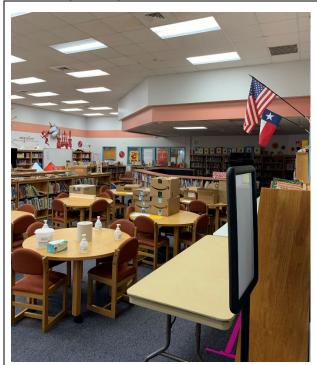
Media Resources: Furniture supports large group gatherings but is bulky and difficult to move. Individual quiet study spaces are not present.

The library is centrally located on the campus with some access to the exterior for after-hours functions. It does not adequately support quiet study but does provide opportunity for social interaction and large groups. Small collaborative groups can be supported as well but space is limited as they spread out.

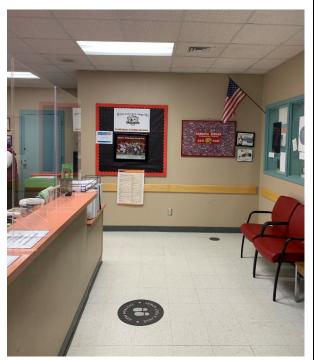
Administration: The reception area is small with limiting waiting room and the office spaces have limited privacy.

Administration area is small with limited seating for visitors are adequate with doors closed; however, space is cramped so privacy is limited. There are no conference rooms for parent or public use.
