Educational Suitability Summary Report

Kocurek Elementary School

Date: 01/28/2021

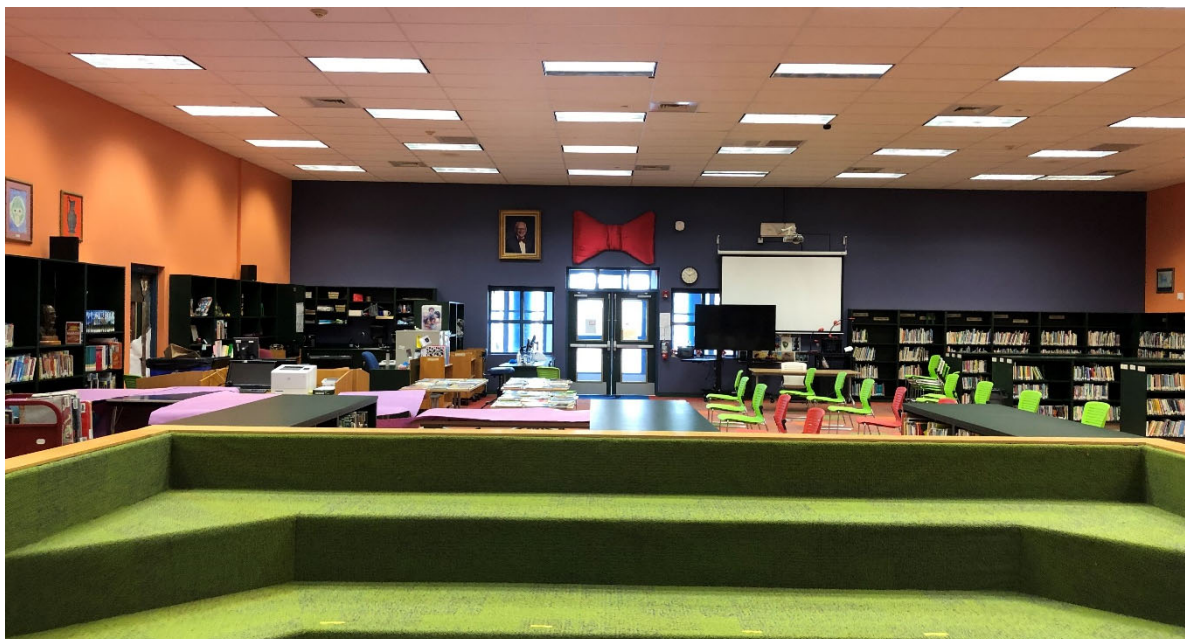
Library outfitted with flexible furniture, including tables with wheels for ease of reconfiguration but does not have a variety of furniture. The library is the space used for most meetings.

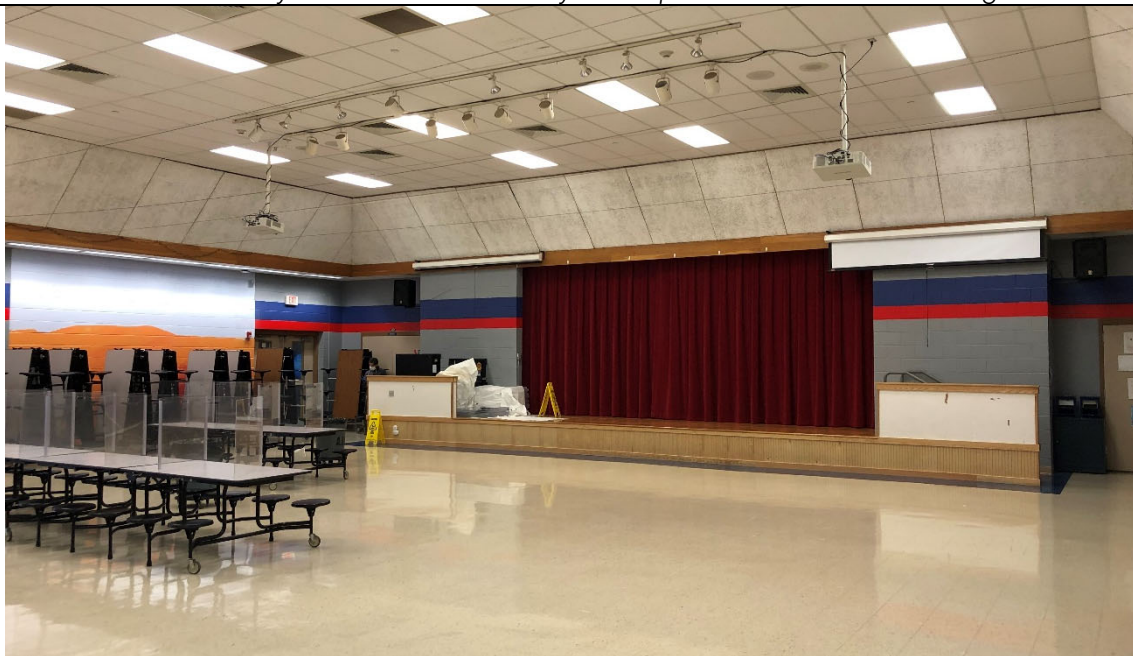
Cafeteria stage has two donated projectors that are dated but does not have a central screen for projection. There are some acoustic panels, but more are needed to reduce noise levels.

13.4	Is there adequate AV for presentations spaces – cafeteria and gym?			3				Comments	1.00 3.00	
1	Very unsatisfactory - AV not present in one or more space							No overhead projector. No outlets on stage for devices.		
2	Unsatisfactory - AV undersized for room, poor condition									
3	Average - Adequately sized / poor condition OR AV undersized / adequate condition									
4	Satisfactory - Good size, good condition									
5	Very Satisfactory - Generous sized, excellent condition									
N/A	Does not apply

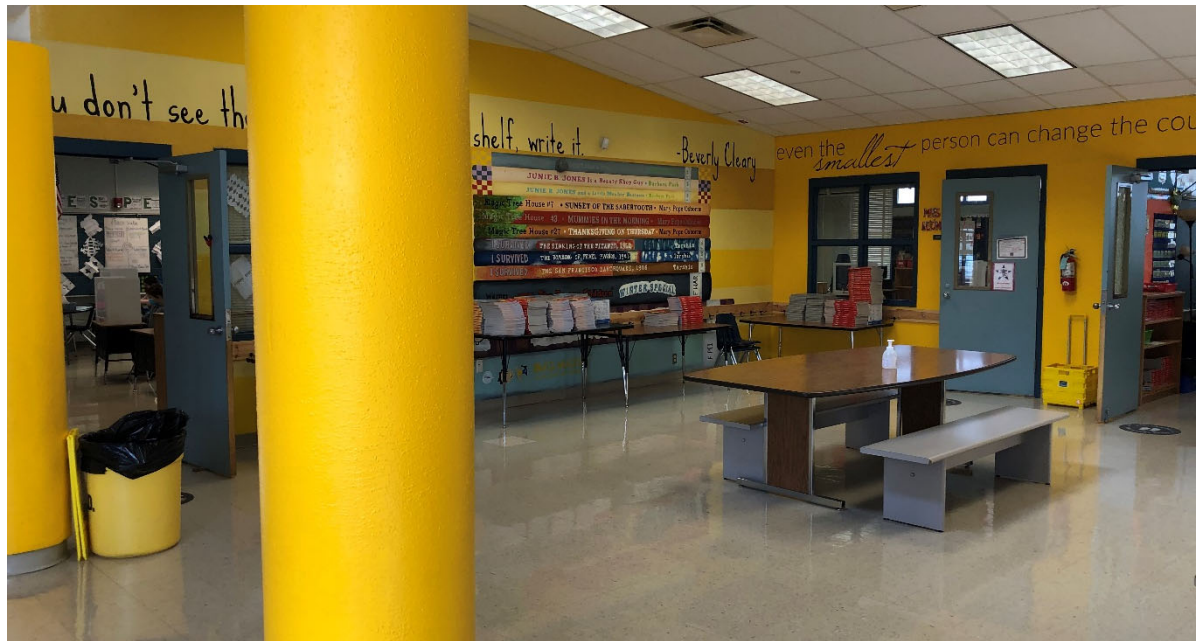
Shared common/collaboration space arranged with four studios. Spaces are in good condition and provide ample space to add technology and more learning space.

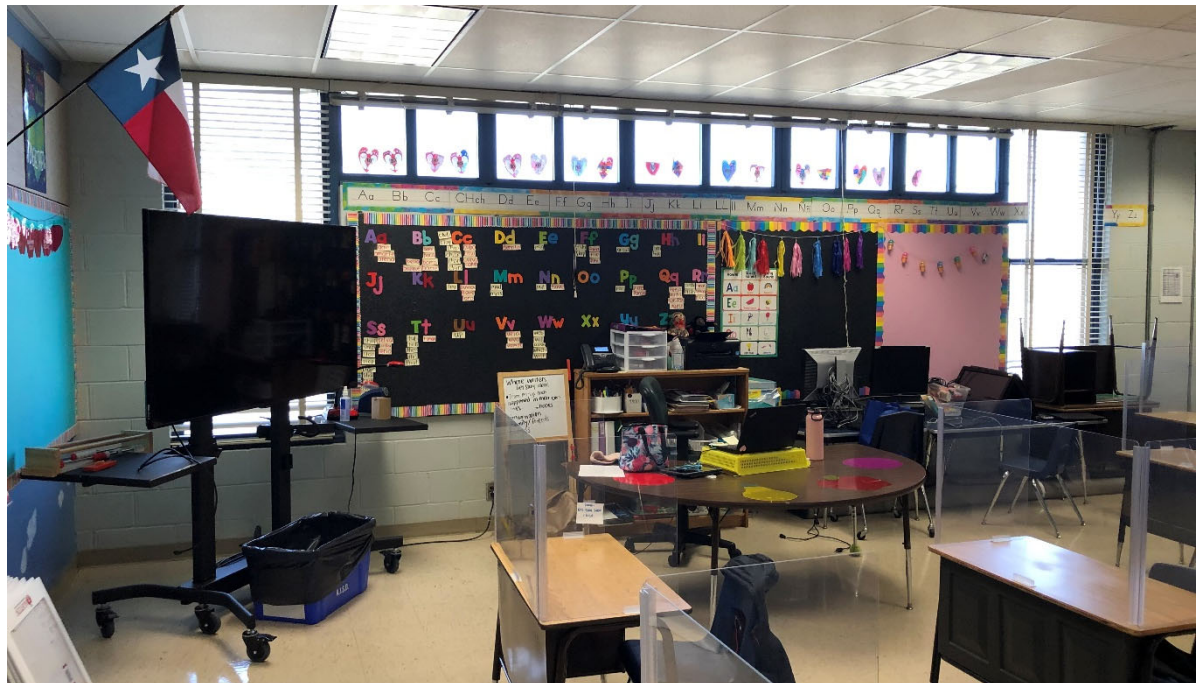
Studios in main building with a good amount of access to natural light. Blinds are old but in working condition. Furniture is in good shape but lacks flexibility and is somewhat cumbersome to reconfigure.

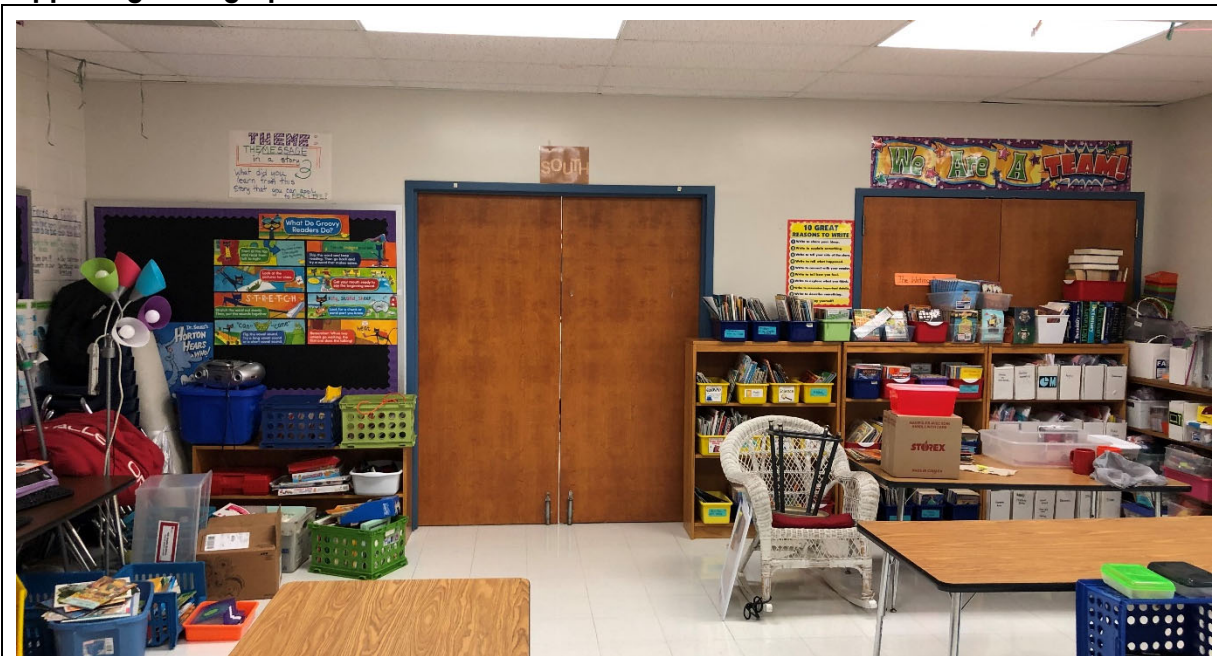
Newer studio addition building with studios that are connected, which allows sound to transmit easily between spaces.

The studios in the addition are connected via a bathroom corridor, but also have two double doors connecting the rooms that allow more sound to transmit between the spaces. This building lacks common spaces for collaboration and breakout areas for students.

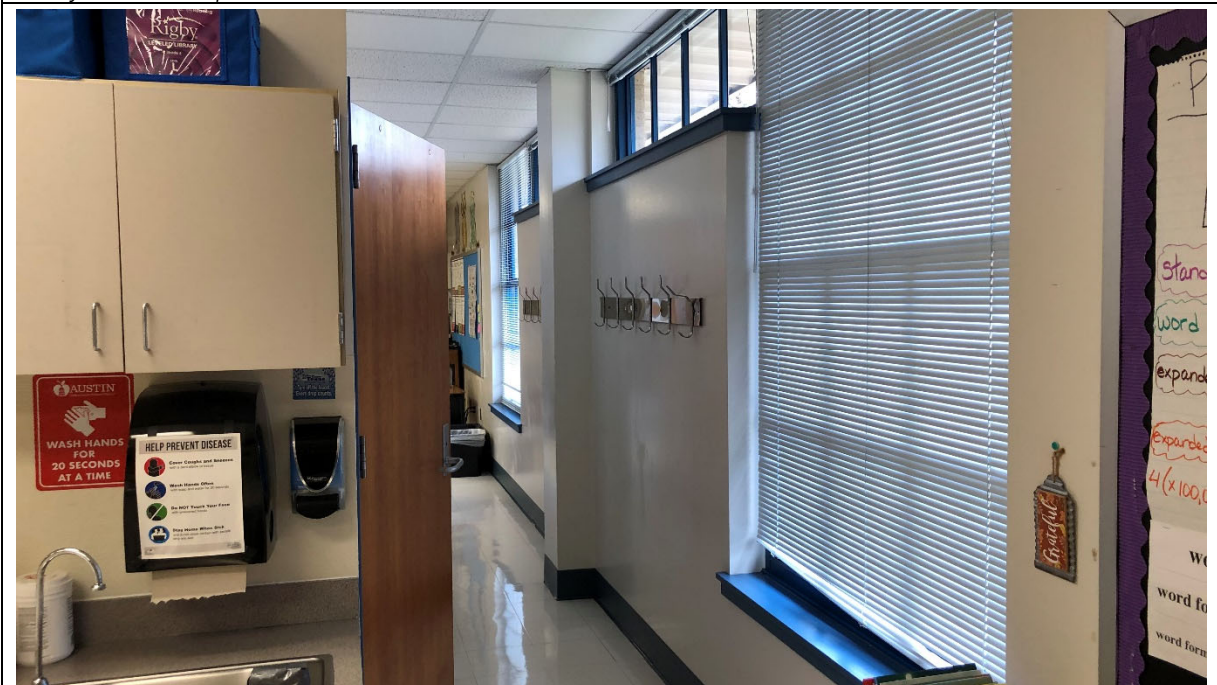
Natural light access to newer studio addition limited to the connected restroom corridor.

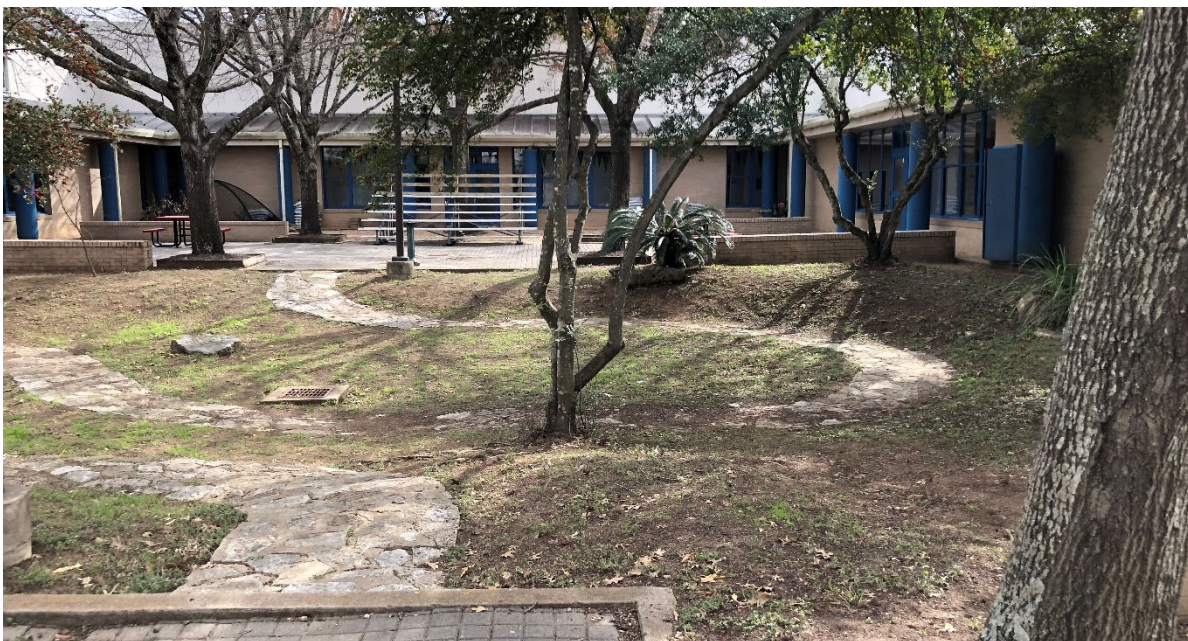
Interior courtyard space used for outdoor learning. Space is underdeveloped and needs updates.

The central courtyard space needs maintenance to replace uneven walking surfaces. This area is readily accessible to the learning neighborhoods but is difficult to use with limited seating.

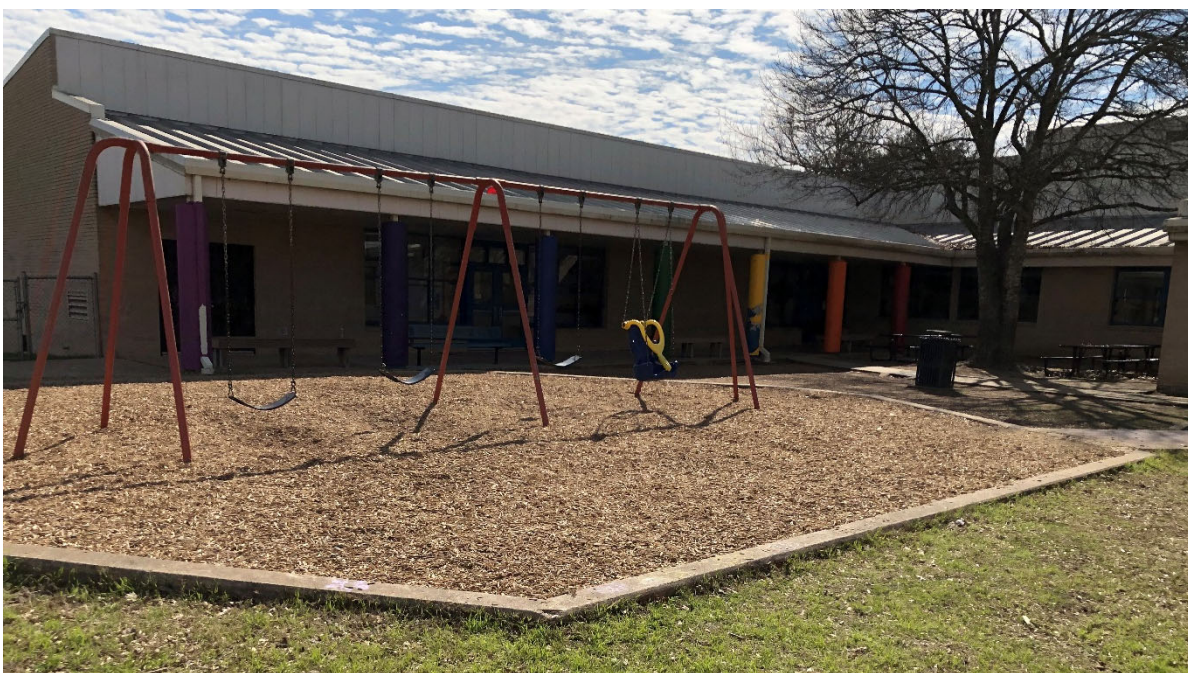
Kindergarten wing of building configured with covered area and direct access to a dedicated playground.

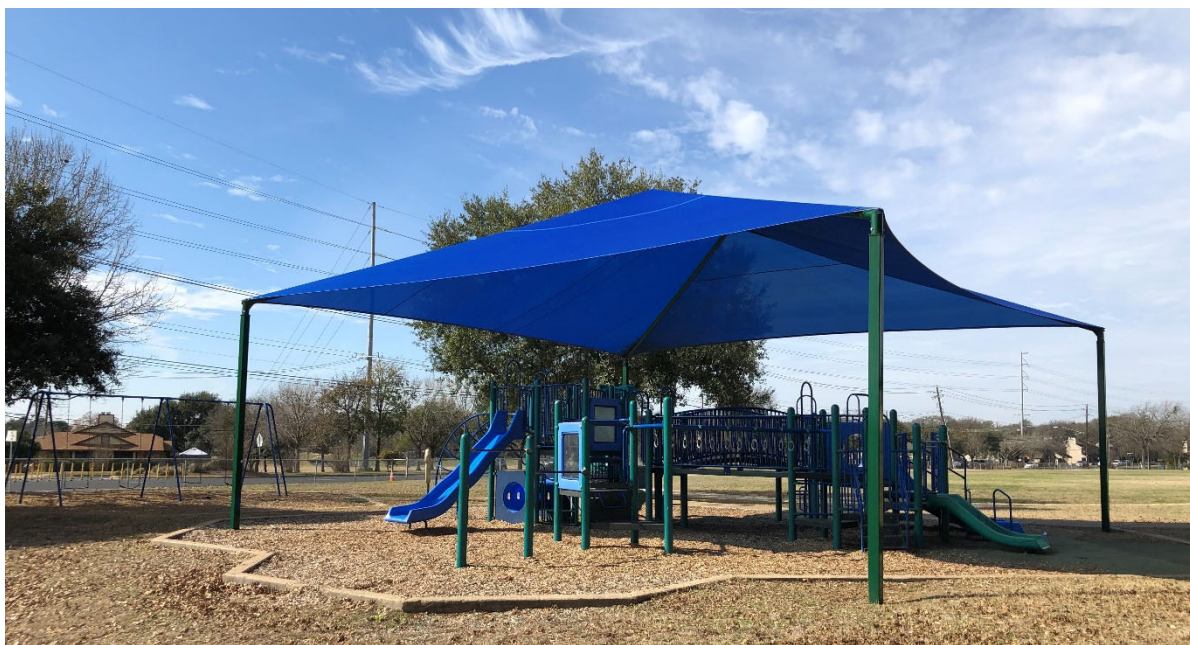
Playground space is shaded and equipment in good condition.

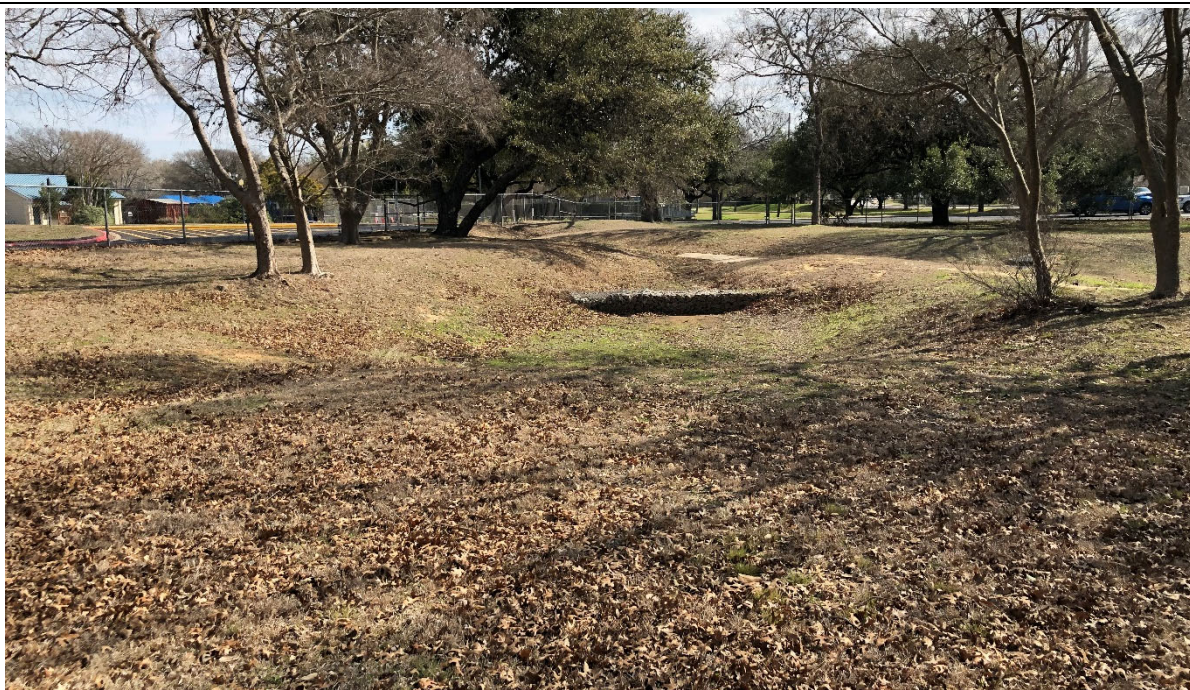
Depressed areas for water retention near playground

Playground faces a busy street.
