Educational Suitability Summary Report

Langford Elementary School

Date: 02/01/2021

Score 57% Average

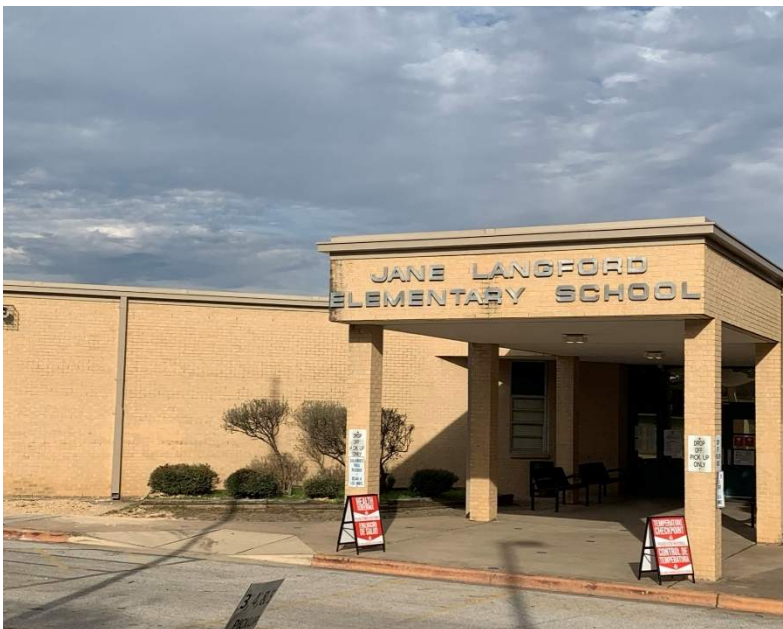
No separate marquee or directional signage around entrance; side fences are damaged.

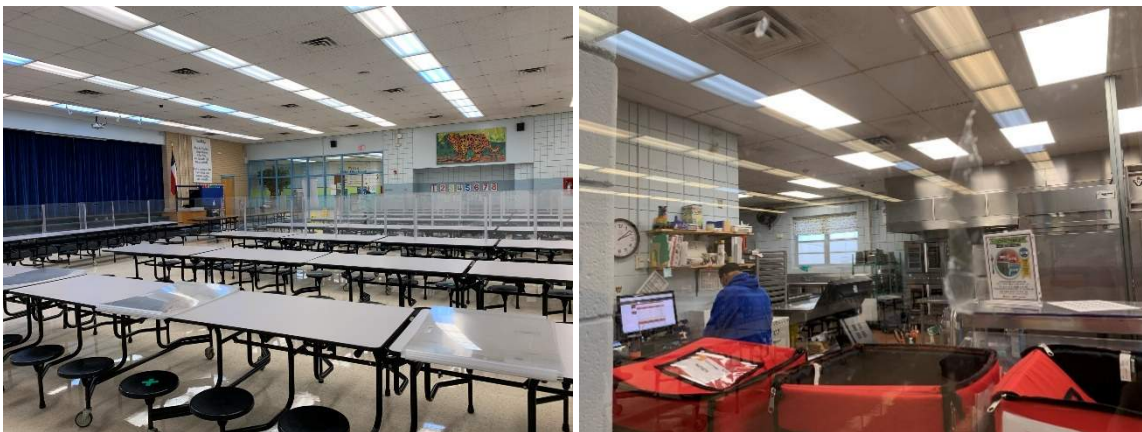
Cafeteria is undersized based on campus capacity. There is no access to outdoor dining and finishes and furniture are in average condition. The kitchen is adequately sized. Stage is adequate but lacks dedicated storage.

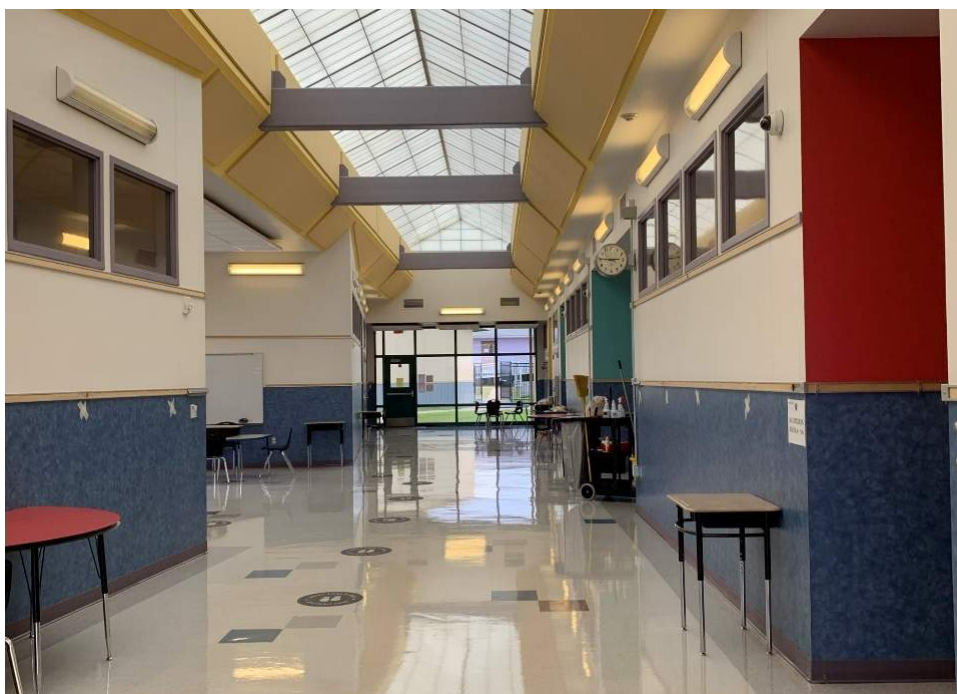
Collaboration areas and circulation space in annex building have ample daylight. Whiteboards and furniture are provided to accommodate small groups.

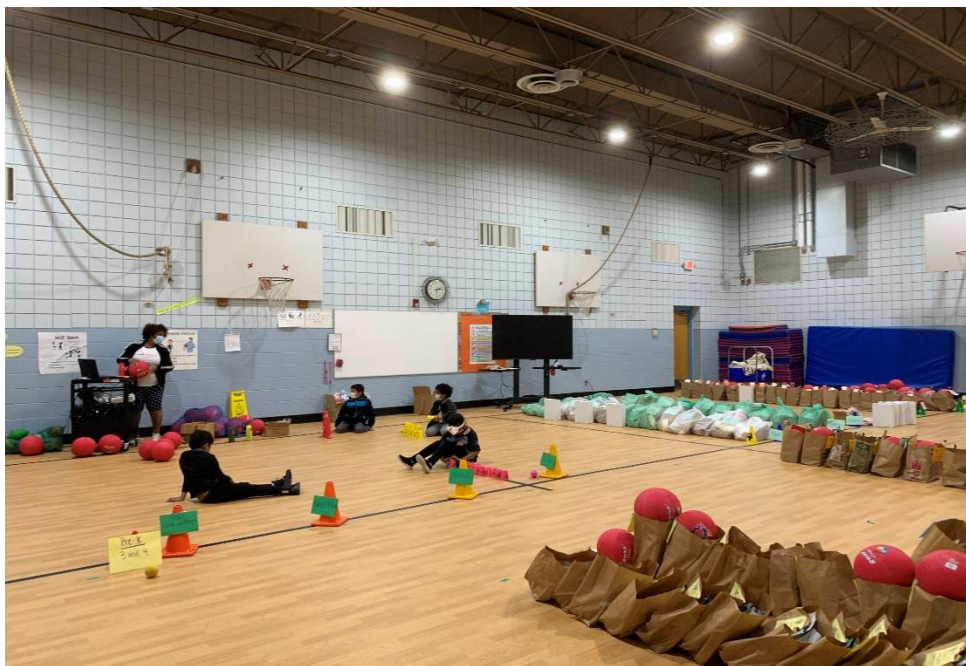
Gym is undersized and does not have sufficient storage space.

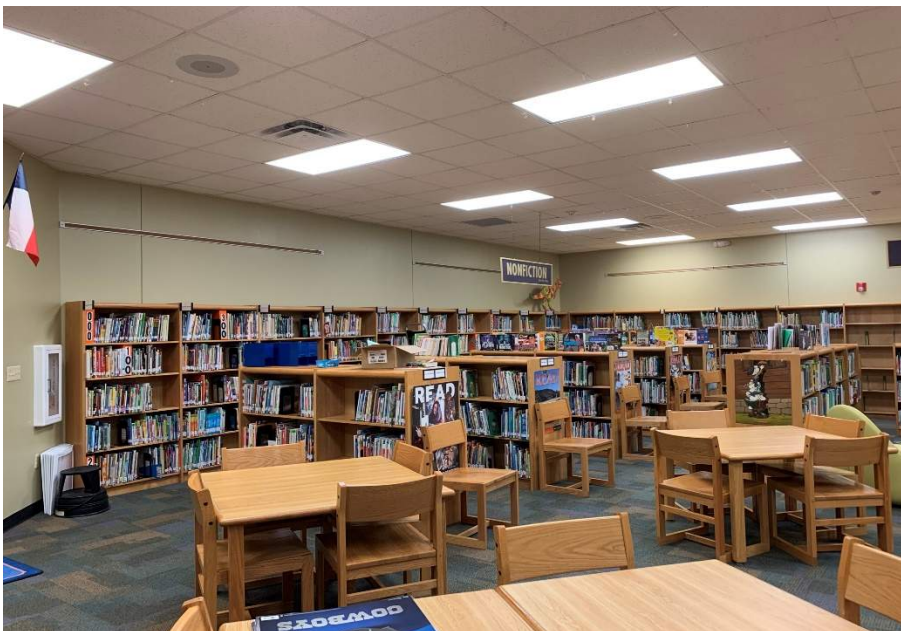
Media Center: Library is in average condition and can support group or individualized study, but most furniture is not easily movable.

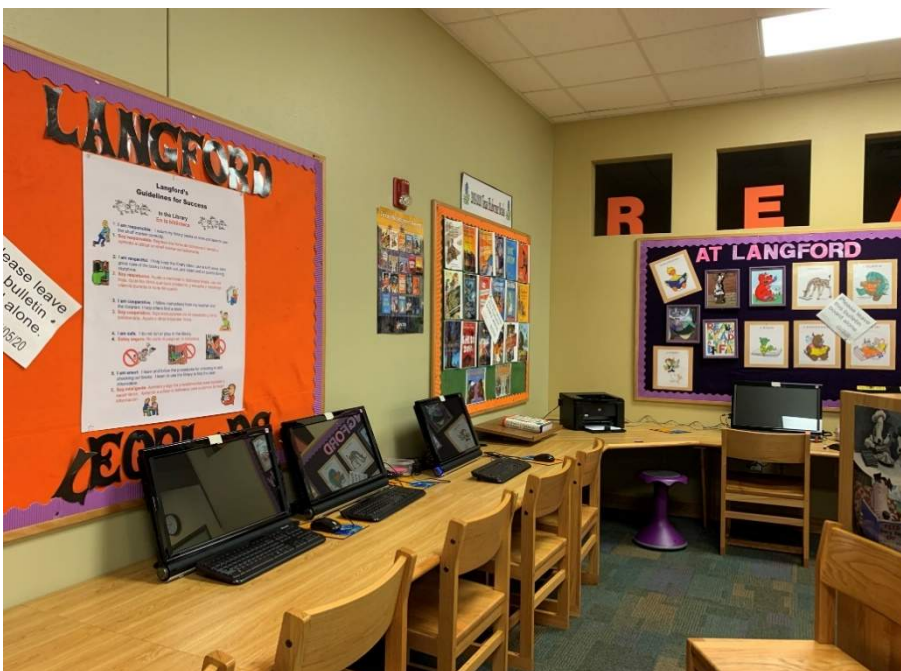
Media Center: Technology is well equipped, but more outlets are needed.

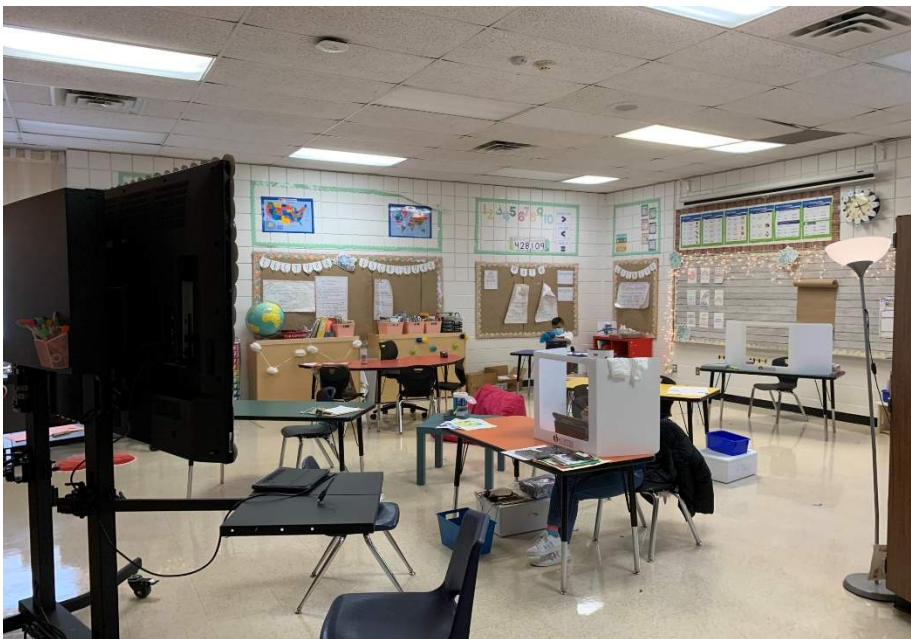
Studios are adequately sized; no natural daylight in approximately 25% of the studios; acoustic condition is good; technology devices are well equipped in most studios.

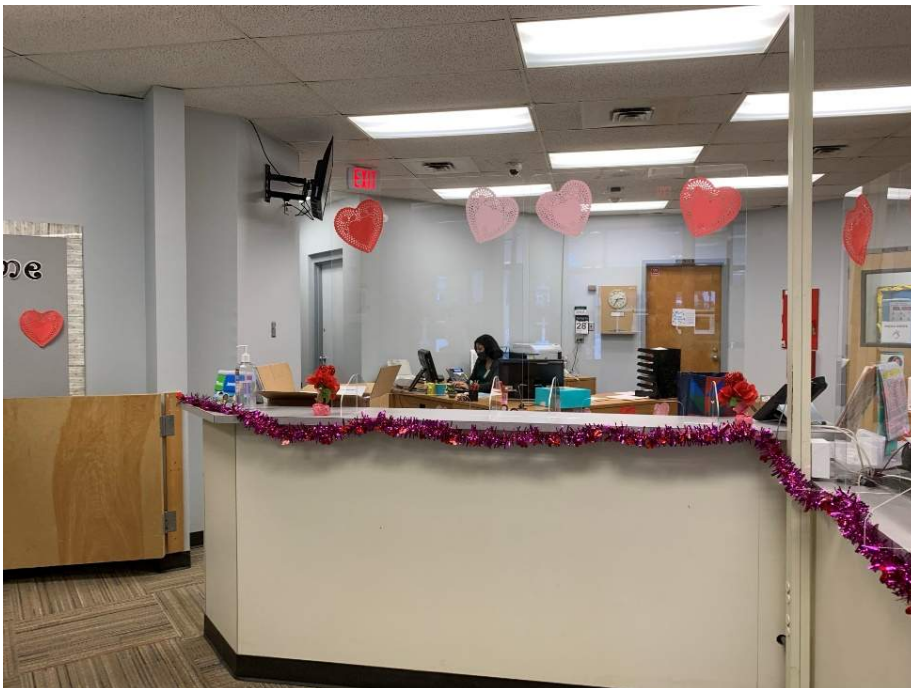
Administration: Reception area requires updates to feel more welcoming.

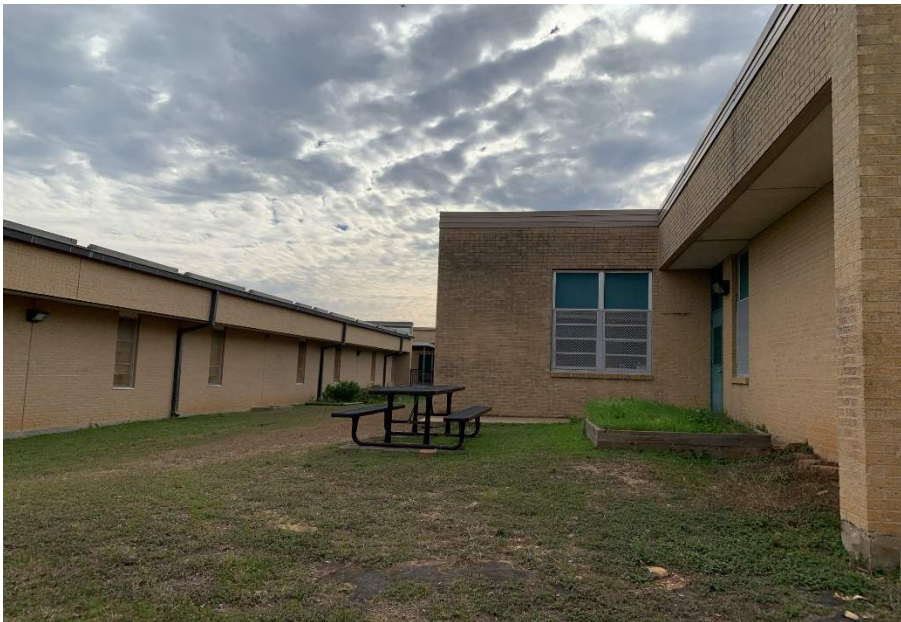
School does not support outdoor studios. [REDACTED] no furniture for students is provided; maintenance and updates are needed.

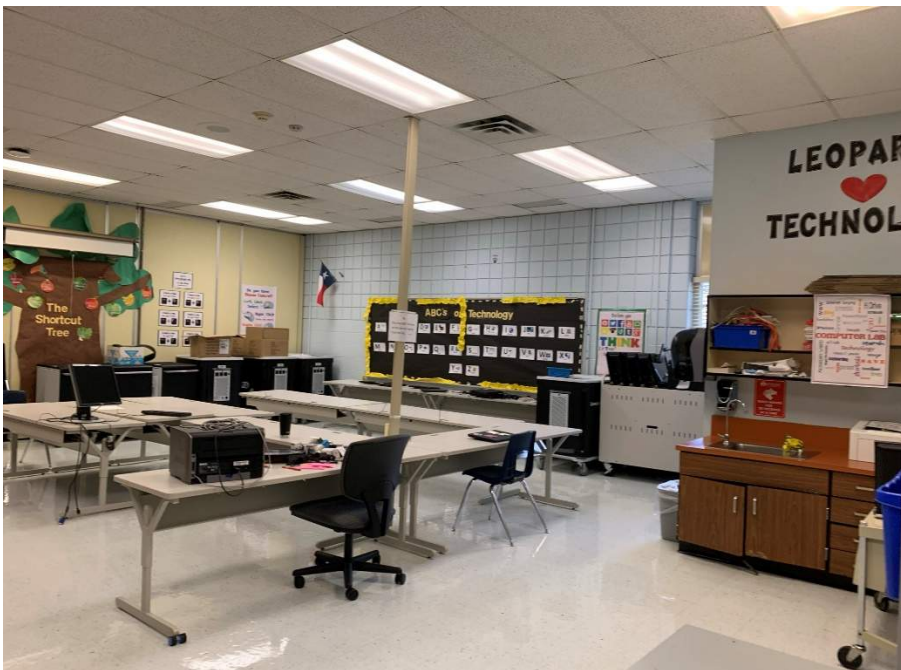
Computer Lab: Access to power outlets is unsatisfactory.
