## Educational Suitability Summary Report

Linder Elementary School

Date: 12/22/2020

**Score 51% Average**

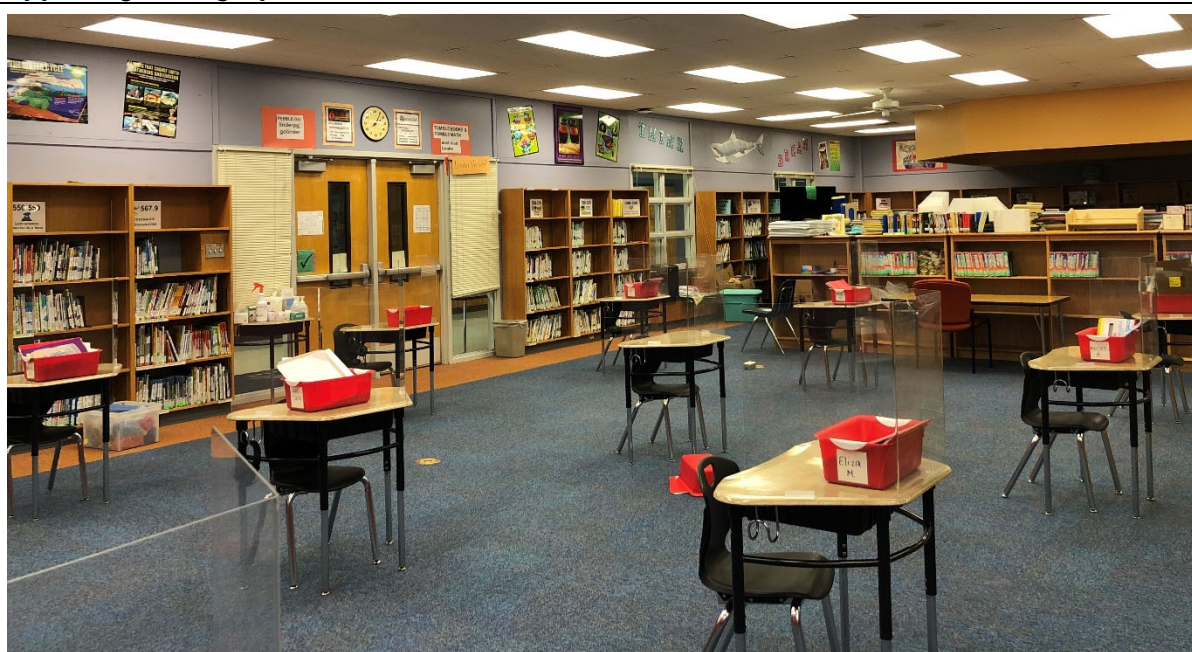
*Library is undersized with limited space for larger groups and no private study spaces. Needs updates to function well.*

No quiet study rooms are available in the library, and the furniture is not flexible. Small reading space can limit number of students occupying the library at the same time. There are no markerboards, but there is a projection screen and projector for teaching.

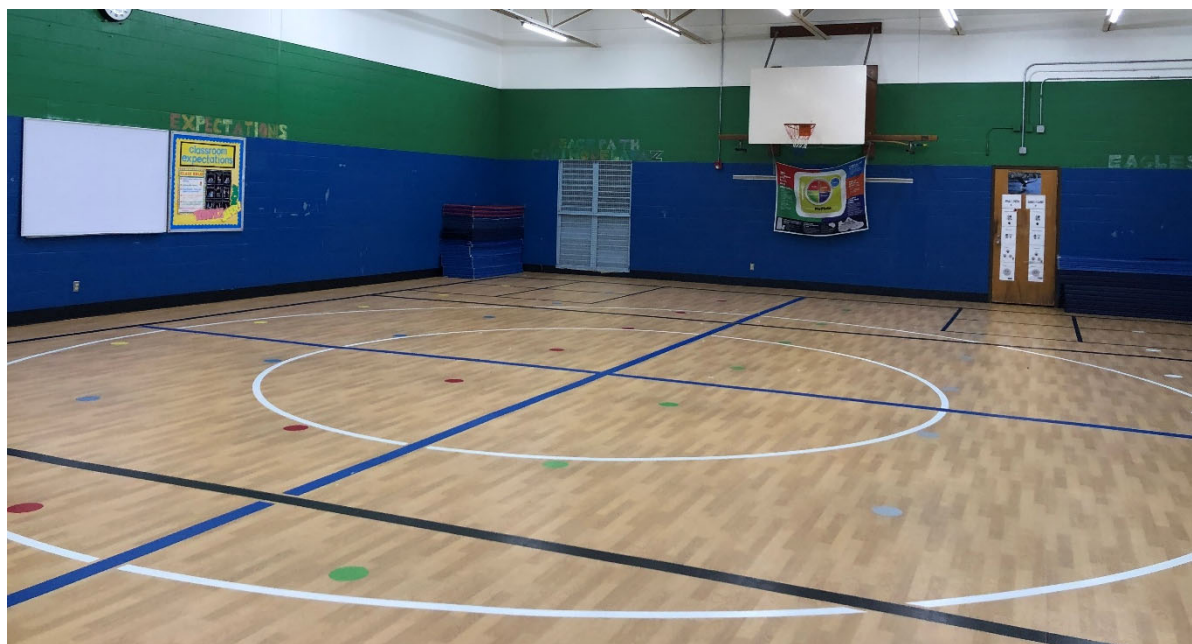
*Gym is connected to the cafeteria with an operable partition. The floor appears to be new and is in excellent condition, but paint on walls is chipping or peeling in many places.*

Flooring in gym seems new. The gym wall paint is chipping and peeling on the walls. There is a movable partition that opens to the cafeteria.

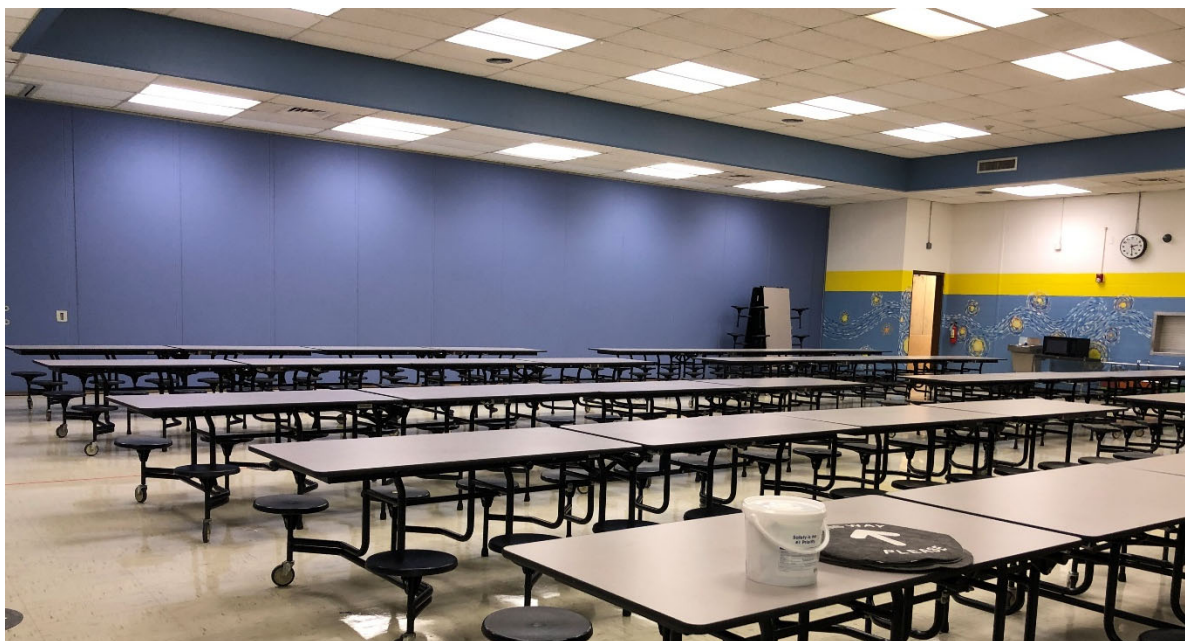
*Cafeteria has only one option for seating and is slightly undersized with limited circulation space.*

There is a lack of furniture variety in the dining area. Outdoor seating option is away from cafeteria. Storage is limited and kitchen is small overall.

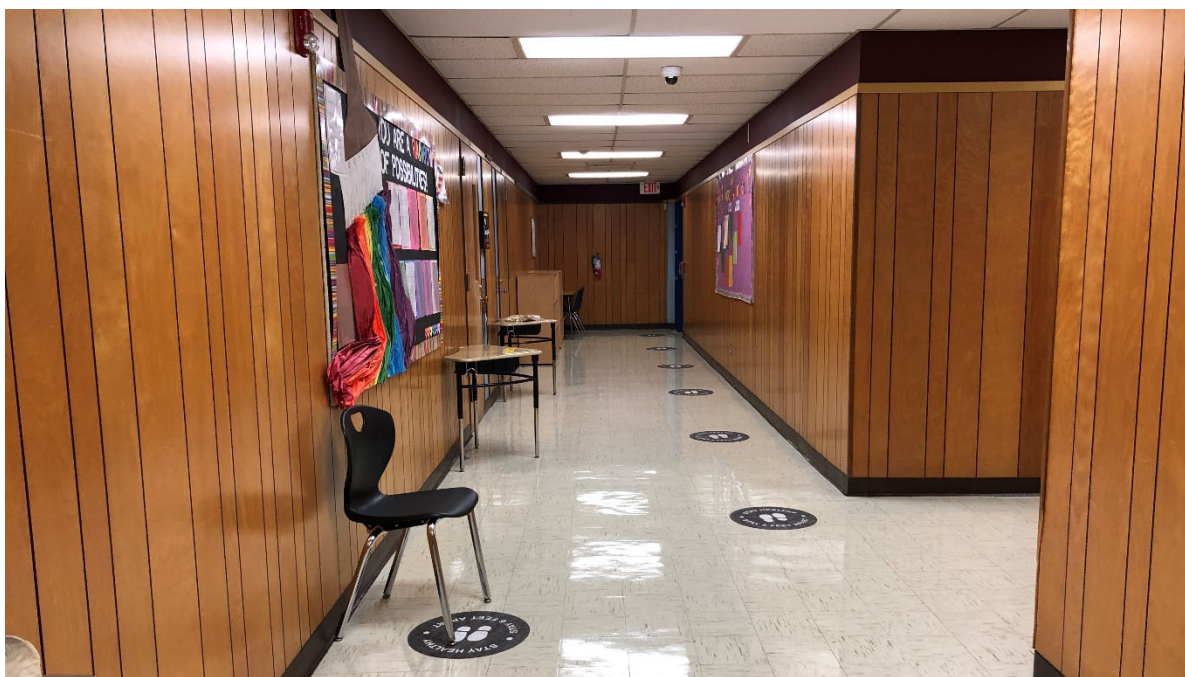
*Corridors are narrow and maze-like, and lack of wayfinding makes it difficult to navigate.*

8.11	Does the building provide opportunities for informal interaction?		2					Comments	1.00 <b>2.00</b>	
1	Very unsatisfactory - No space								Corridors are narrow and confusing; double-loaded with limited opportunity for informal interaction	
2	Unsatisfactory - Too small, poor condition, layout and furnishings do not support informal interaction well									
3	Average - Adequate size and condition, needs updates or renovations to function well.									
4	Satisfactory - Good size, good condition, layout and furnishings support informal interactions									
5	Very Satisfactory - Generous size, excellent condition, layout and furnishings support informal interactions									
N/A	Does not apply

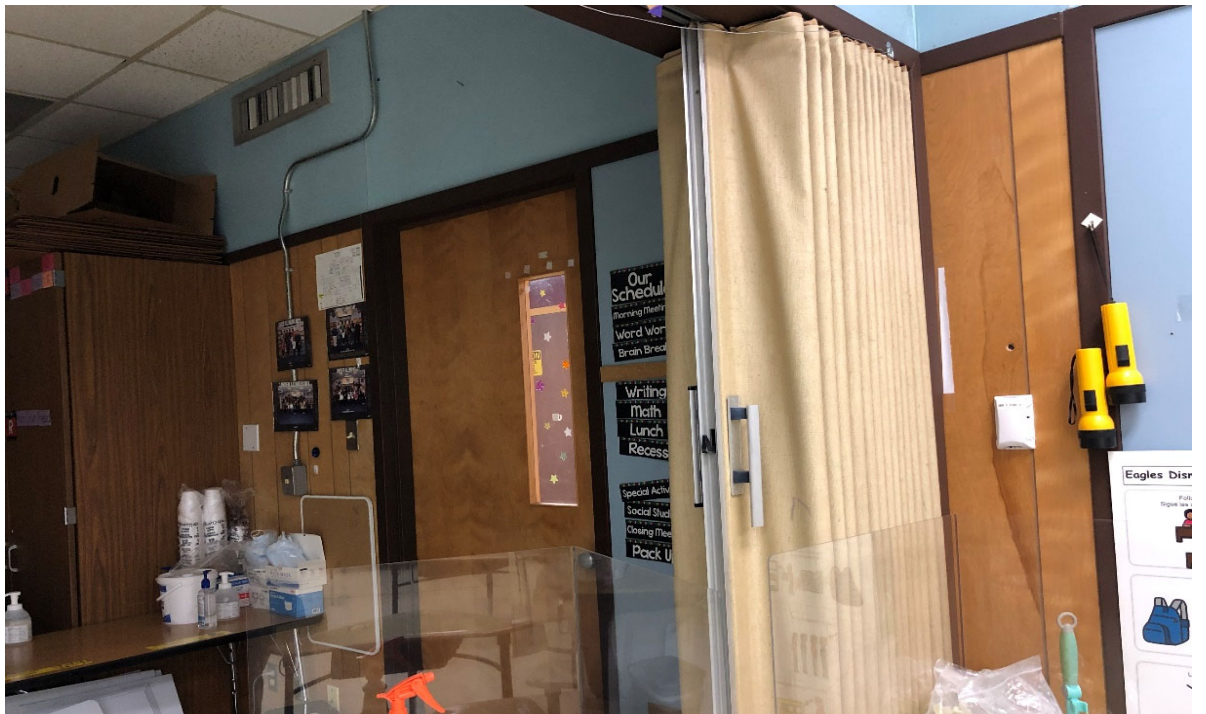
*About half of the studios have aged operable partitions that may not perform well acoustically and are not always in functioning condition.*

There are small windows in the studios and other learning spaces. Natural light is poor overall. Old foldable partitions do not seem to have good acoustics and do not function well.

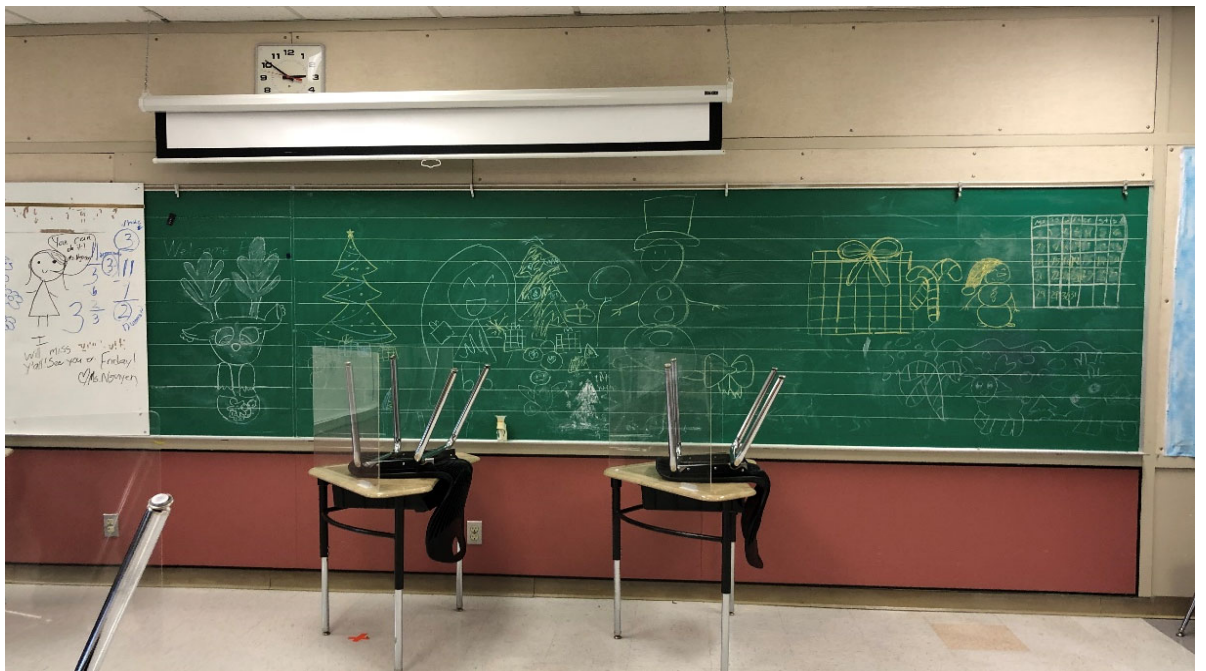
*Outdated chalkboards are not used for instruction and limit flexibility of teaching in studios.*

13.1	How well equipped are the facilities with instructional technology?			3				Comments	1.00 <b>3.00</b>	
1	Very unsatisfactory - Limited to no technology present in instructional spaces							Projectors and TV carts in most rooms; chalkboards in rooms not used.		
2	Unsatisfactory - One type of technology present									
3	Average - Multiple types of technology, smart boards, poor condition, limited to only certain areas of school									
4	Satisfactory - Multiple types of technology, smart boards, good condition.									
5	Very Satisfactory - Multiple types of technology, smart boards, excellent condition									
N/A	Does not apply

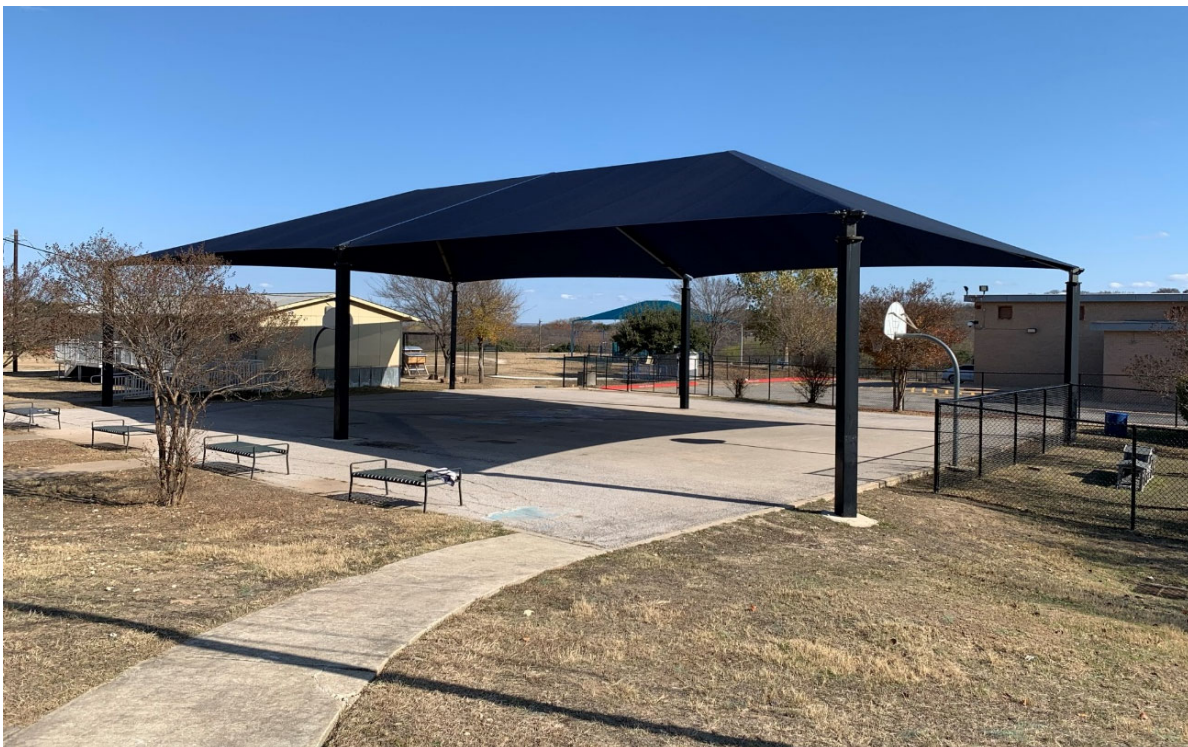
*Large outdoor court/play pad with a large canopy is in excellent condition.*

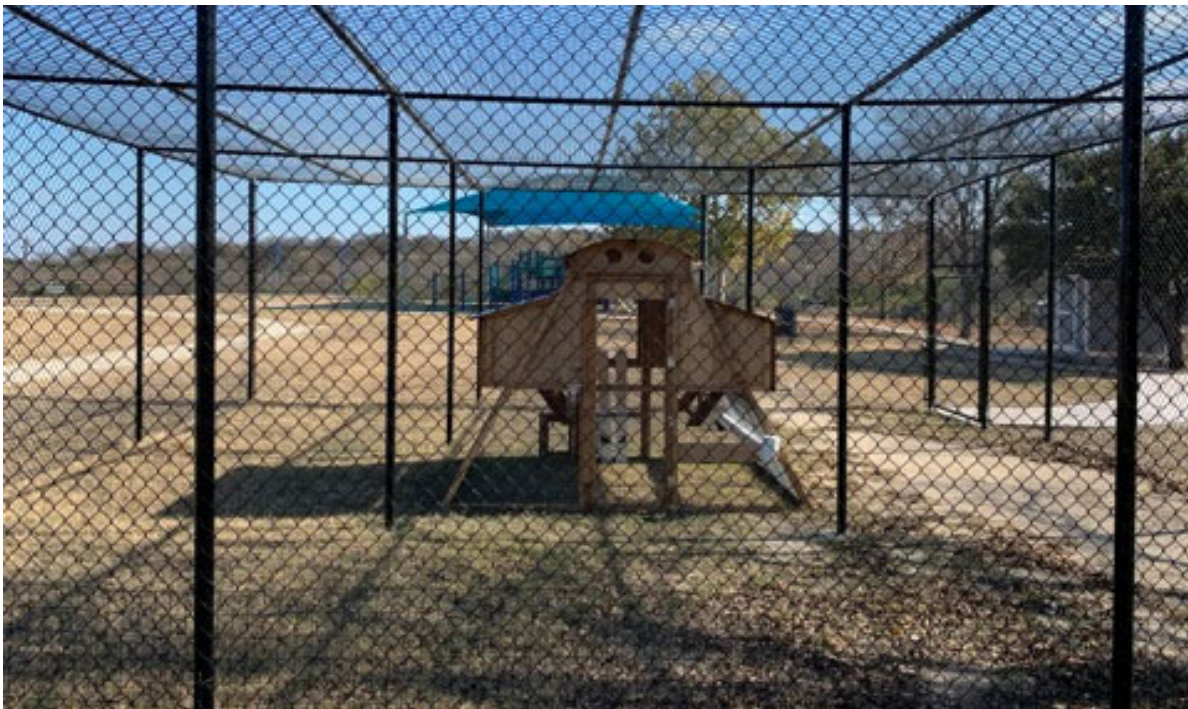
*New chicken coop and fencing near small outdoor learning space.*

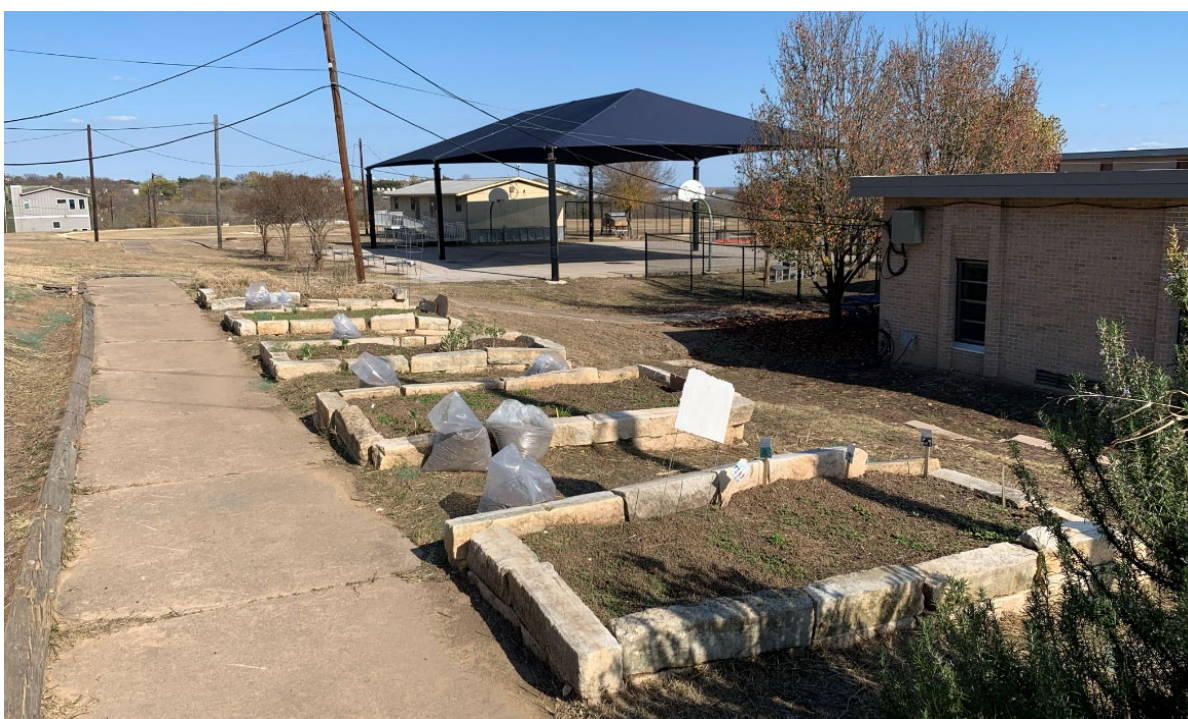
*Campus garden spaces have close access to water and are near other outdoor activity and learning features.*

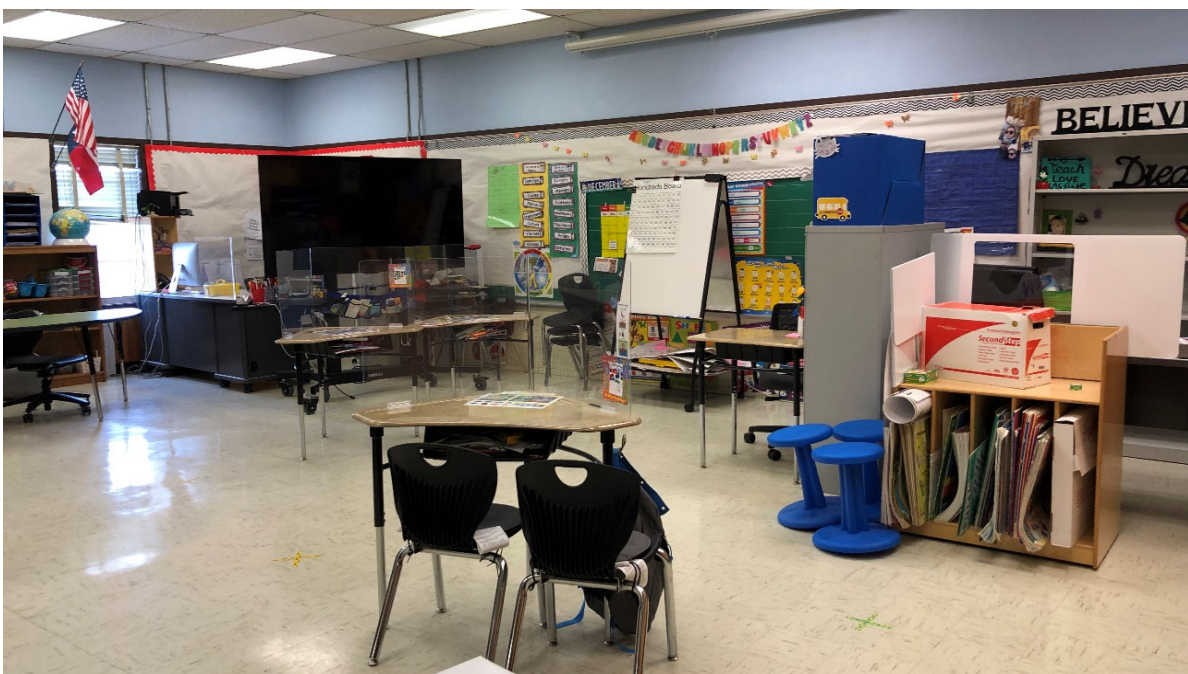
*Many studios need more storage space and have a mix of old and new furniture.*

Furniture is aged and mismatched. No flexibility or variety of furniture available in studios and throughout major spaces. Studio furniture is composed of tables with loose chairs.
