Educational Suitability Summary Report

Norman-Sims Elementary School

Date: 01/25/2021

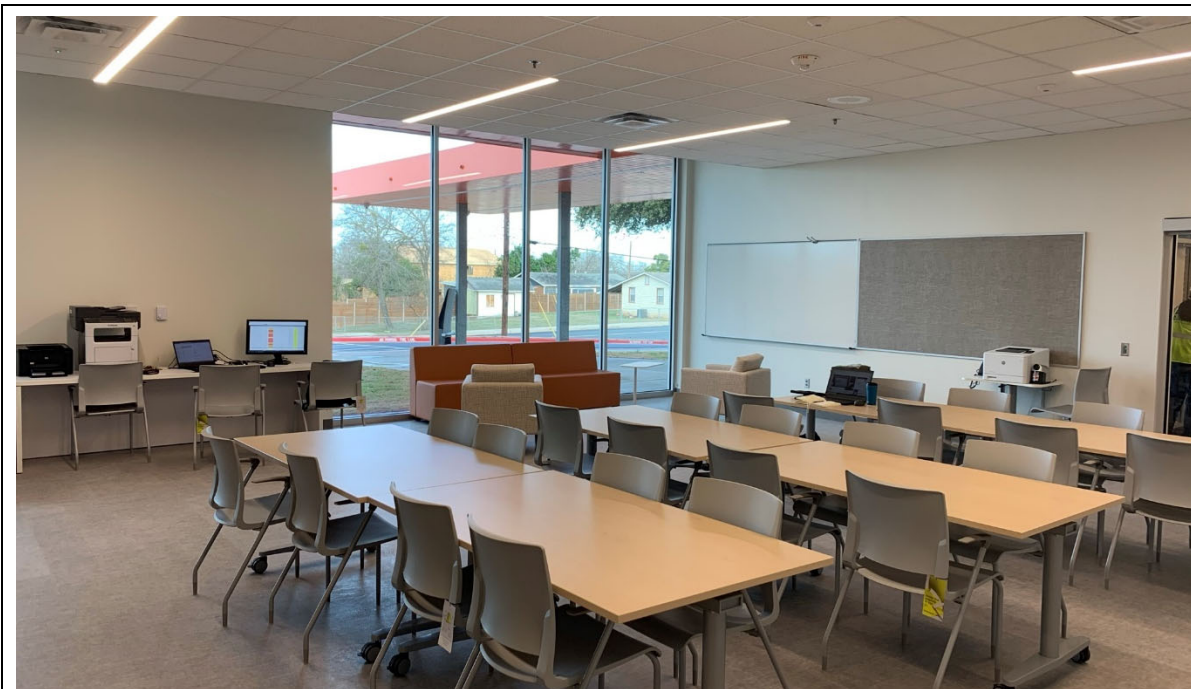
A community room is easily accessible at the main entry and can be used after-hours.

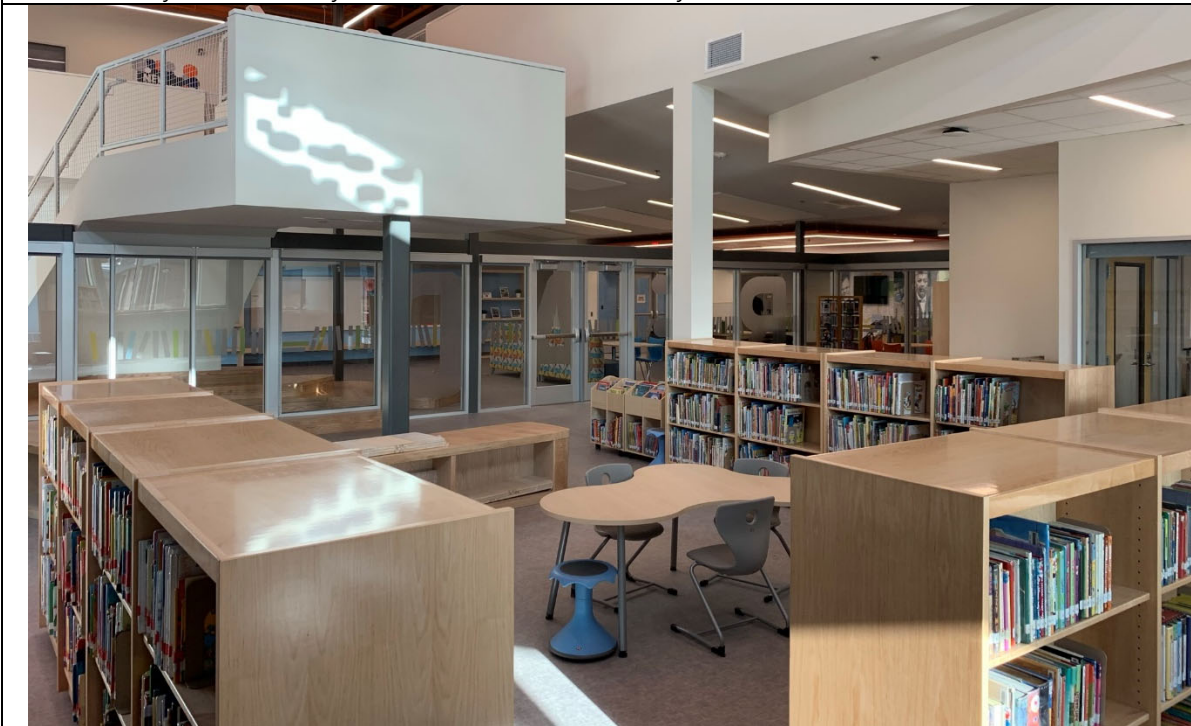
Media Resources: Library space is small and mostly taken up by stacks with limited area for

collaboration or furniture.

The library is highly visible and directly accessible from the main entry. It is undersized and while there is some of informal seating, there is very limited space for groups to gather for collaborative learning. The Literacy Library located on the second floor is currently used for teacher workspace and was not included in the square footage considerations for the library. There is no projector or screen in the main library space, but there were mobile TV displays present.

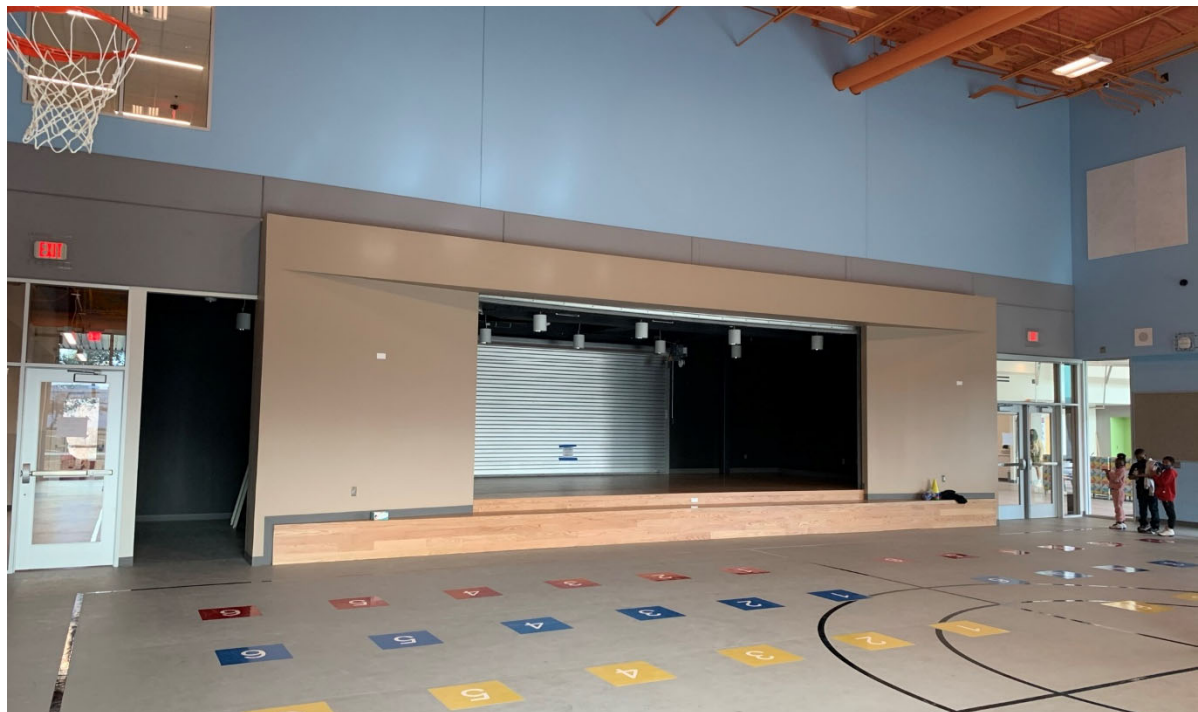
Dual-sided stage is in the gym, but it is disconnected from the music room and lacks performance lighting or technology.

The stage is between pre-K and kindergarten dining commons and the gym. It does not have adequate storage, but stage lighting is provided. The music studio is in a different area of the building and not well connected to the stage area, but it has an attached restroom, large instrument storage and a recording/practice room. The art studio is adequately sized with appropriate storage and support, including an attached restroom.

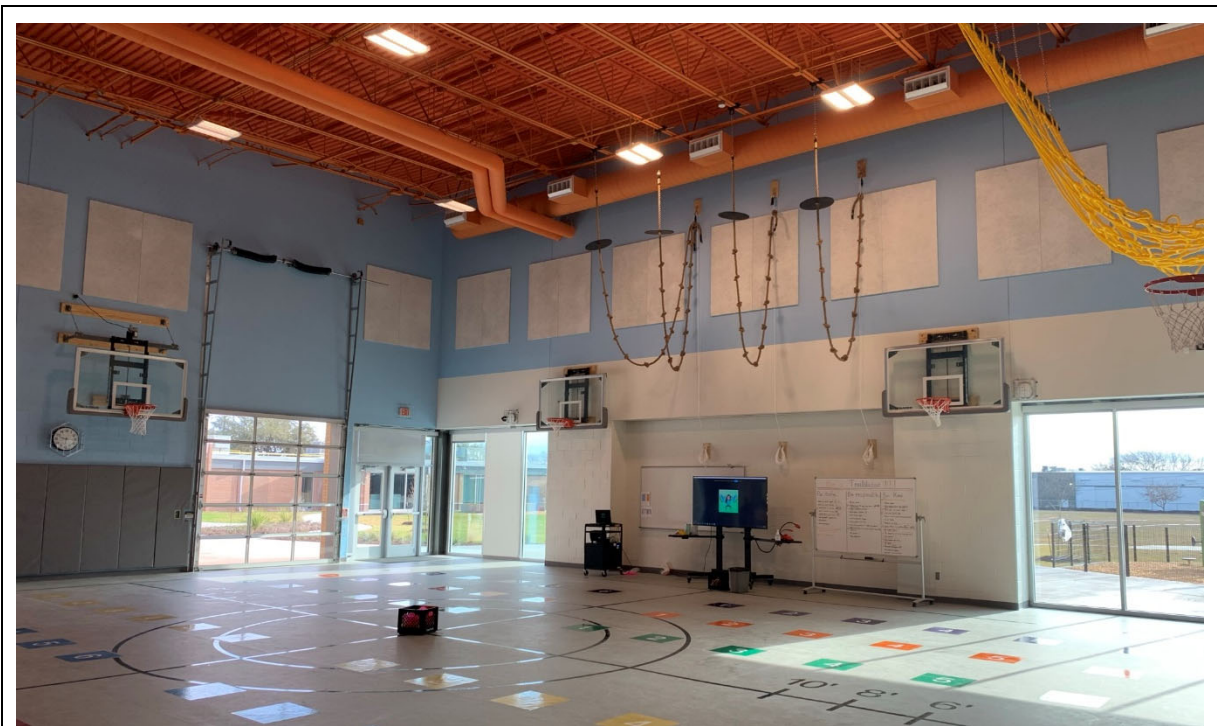
Gym is well-located with connection to outdoor activity spaces and playgrounds.

The gym is adequately sized and has ample natural light and a connected stage. There is large storage space with indoor and outdoor access, as well as a large office and attached restrooms.

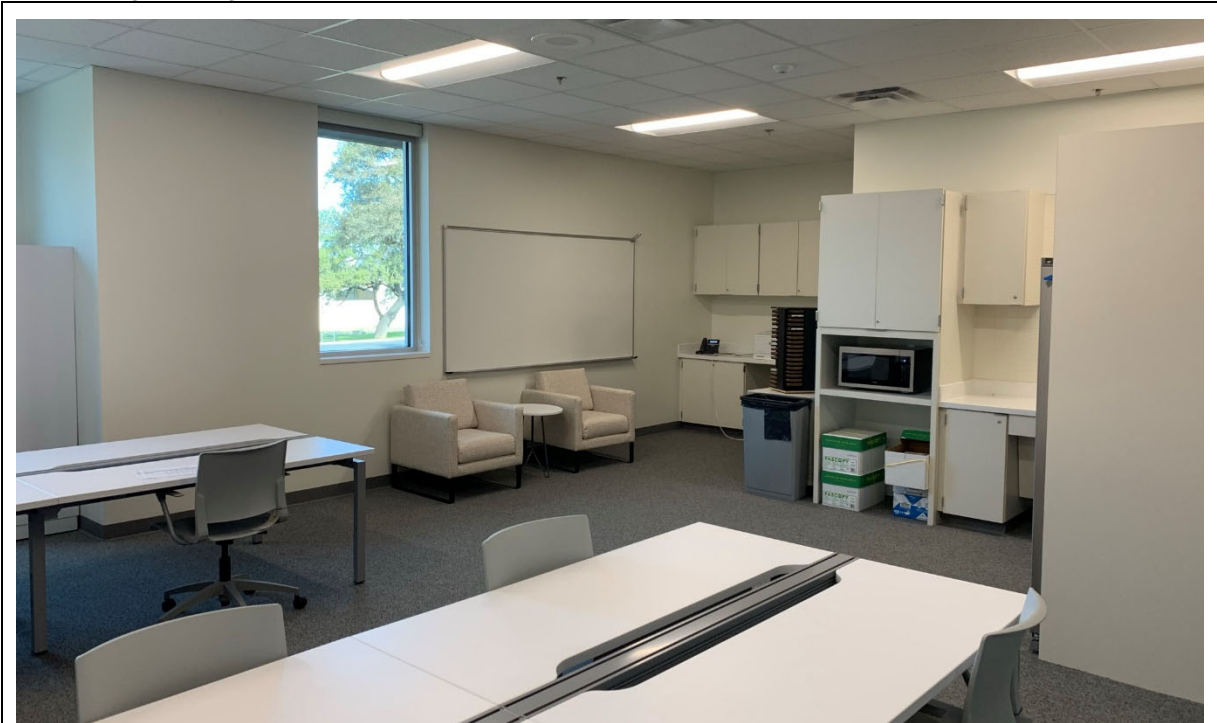
Professional learning centers are located in each wing for shared collaboration space.

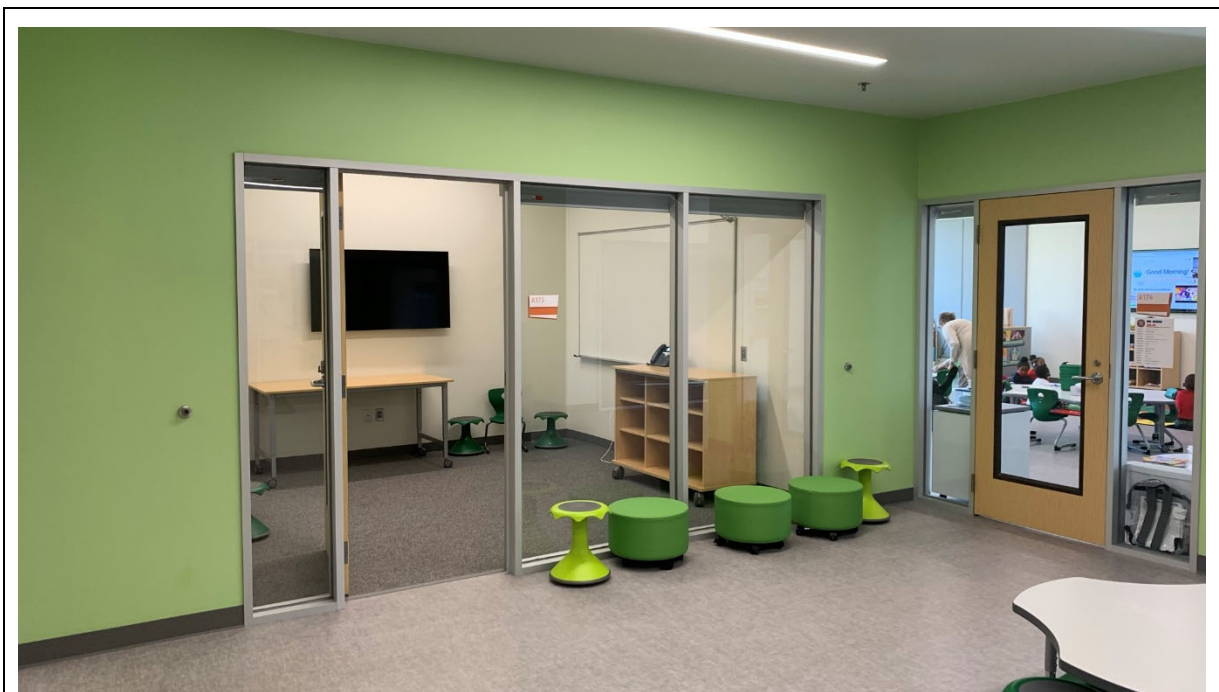
Learning neighborhoods have shared breakout rooms along with a common collaborative flex space in the corridors.

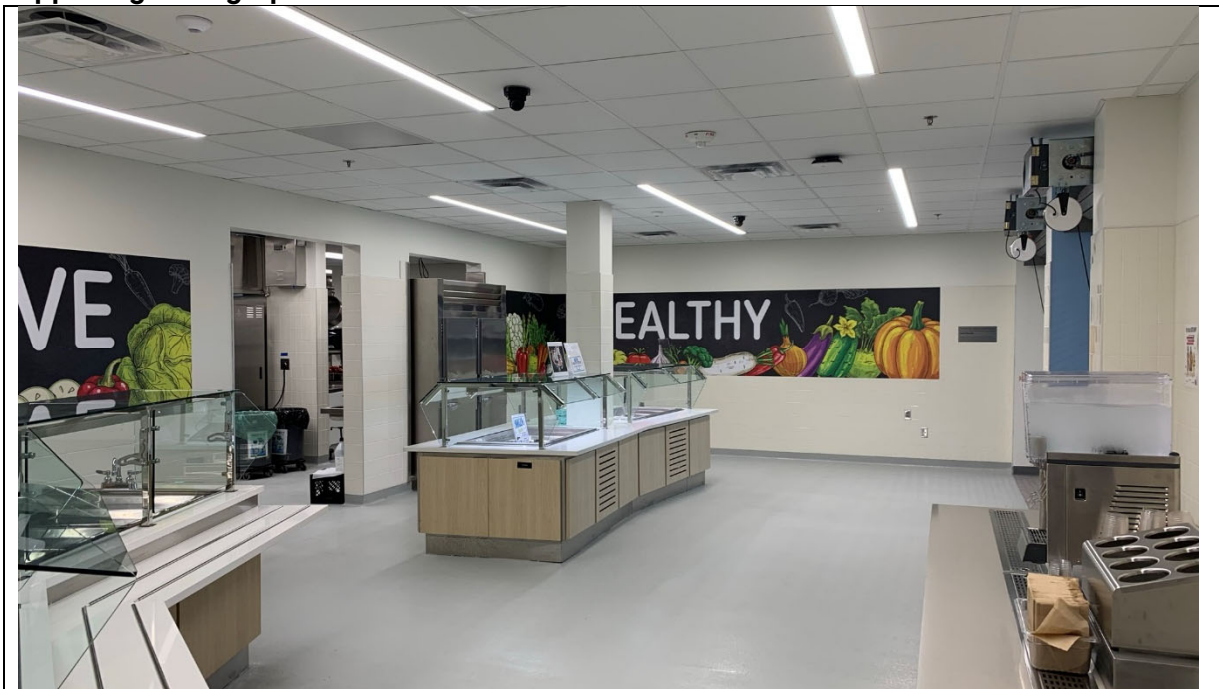
Serving lines are very generous and are double-sided. With the distributed dining model, the serving space is separate from the dining area. The principal noted in the interview that this model

has worked very well for students and developed their autonomy and independence.

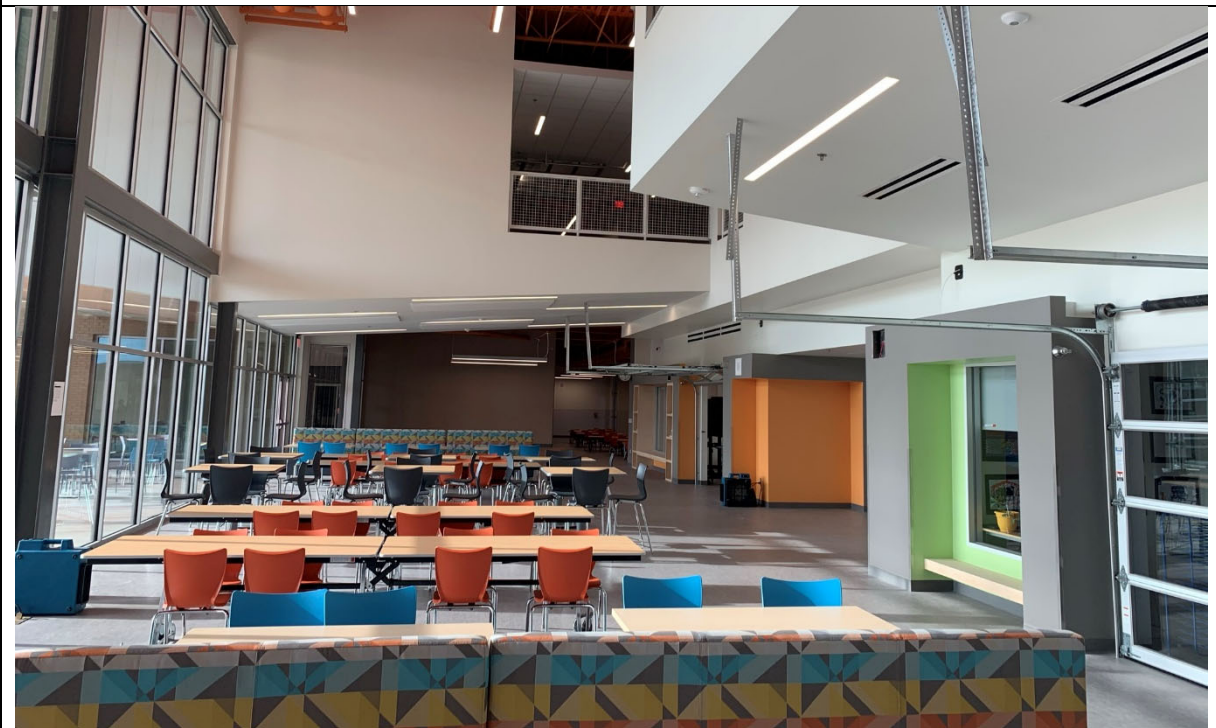
Dining commons is a large open corridor space in the main hall off the entry. Pre-K and Kinder dining with size-appropriate furniture is down the hall near the pre-K and kinder wing.

There is no formal cafeteria. Instead, seating is distributed in common areas around the first floor. There are multiple seating types and areas present for lower grade levels closer to their studios.

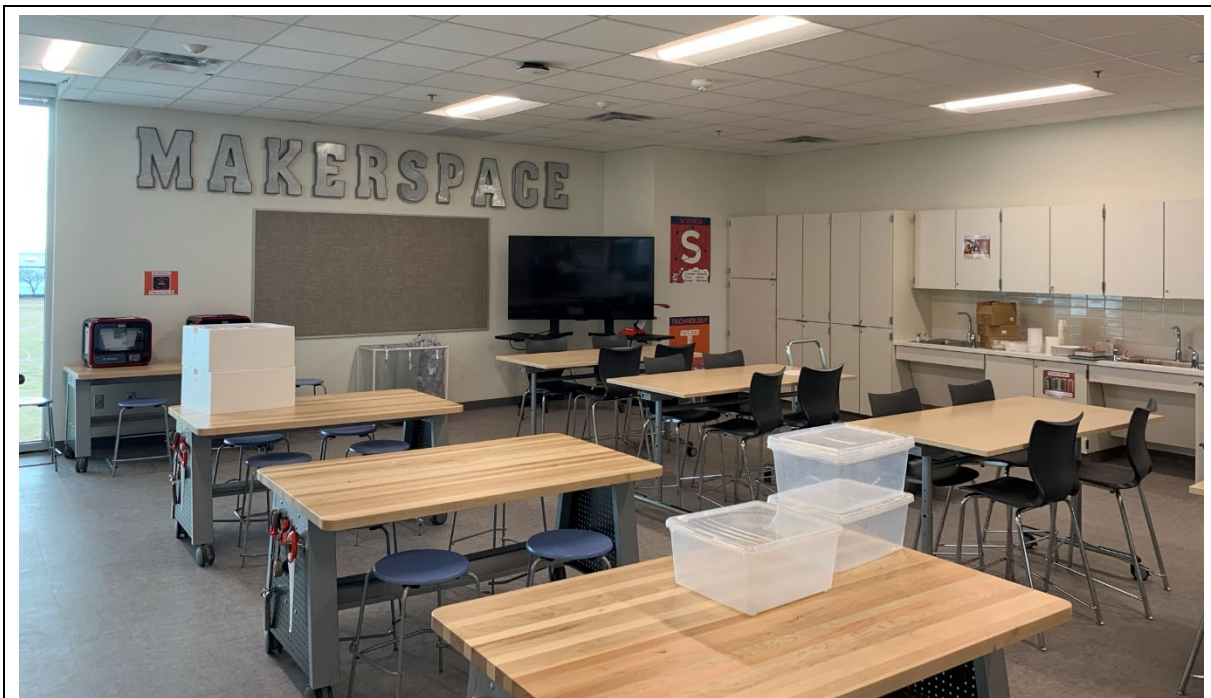
There are two dedicated maker spaces for lower and upper grades.

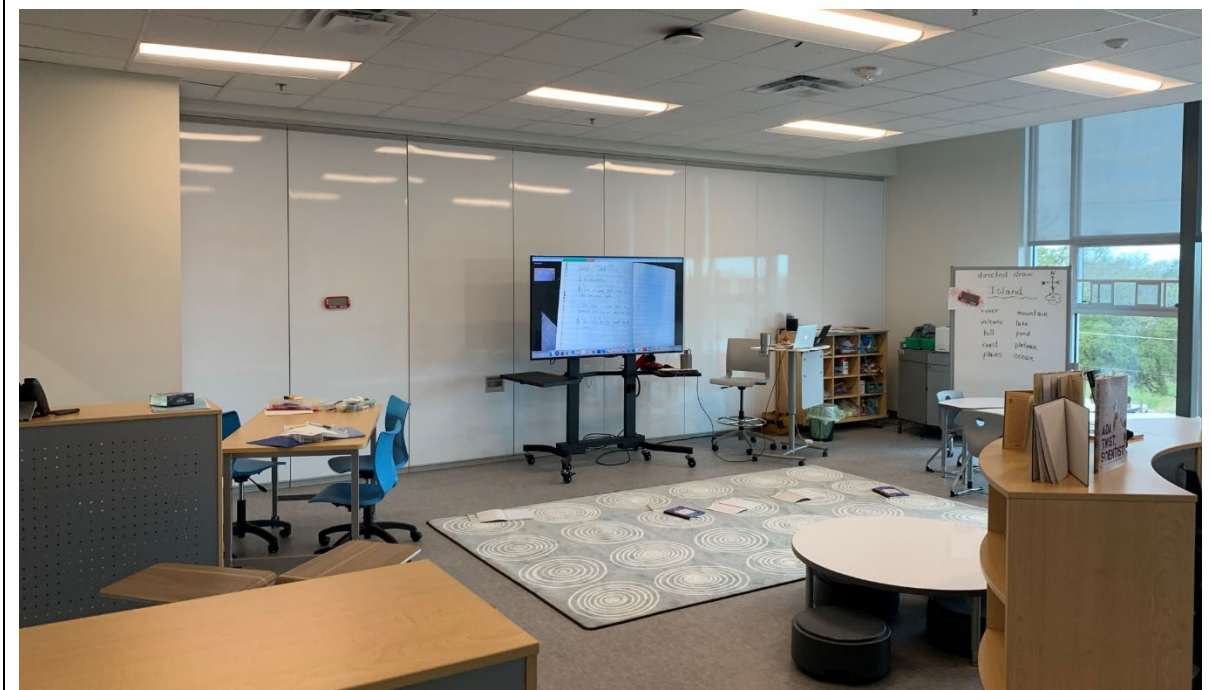
Studios are equipped with a mobile TV display and its attached accessories, plus ample whiteboard space on moveable walls. Furniture is appropriately sized per grade level.
