Educational Suitability Summary Report

Oak Springs Elementary School

Date: 1/14/2021

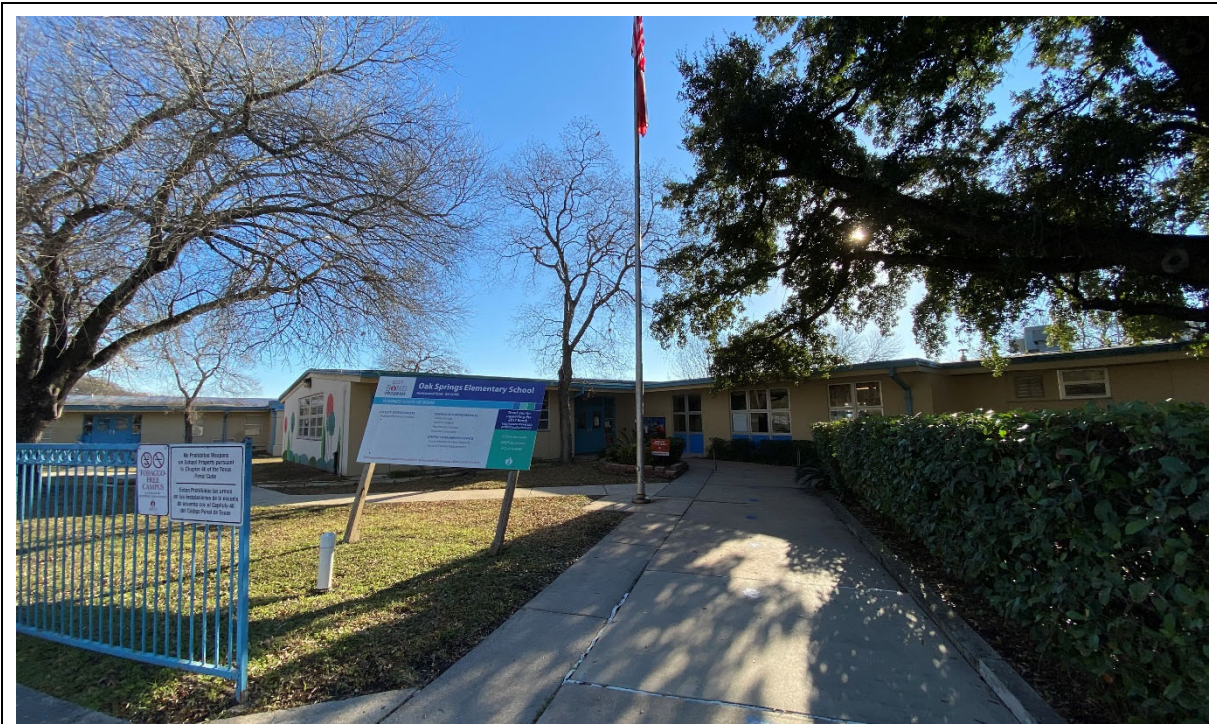
Main entrance is not clearly marked and is not directly accessible from a student drop off area.

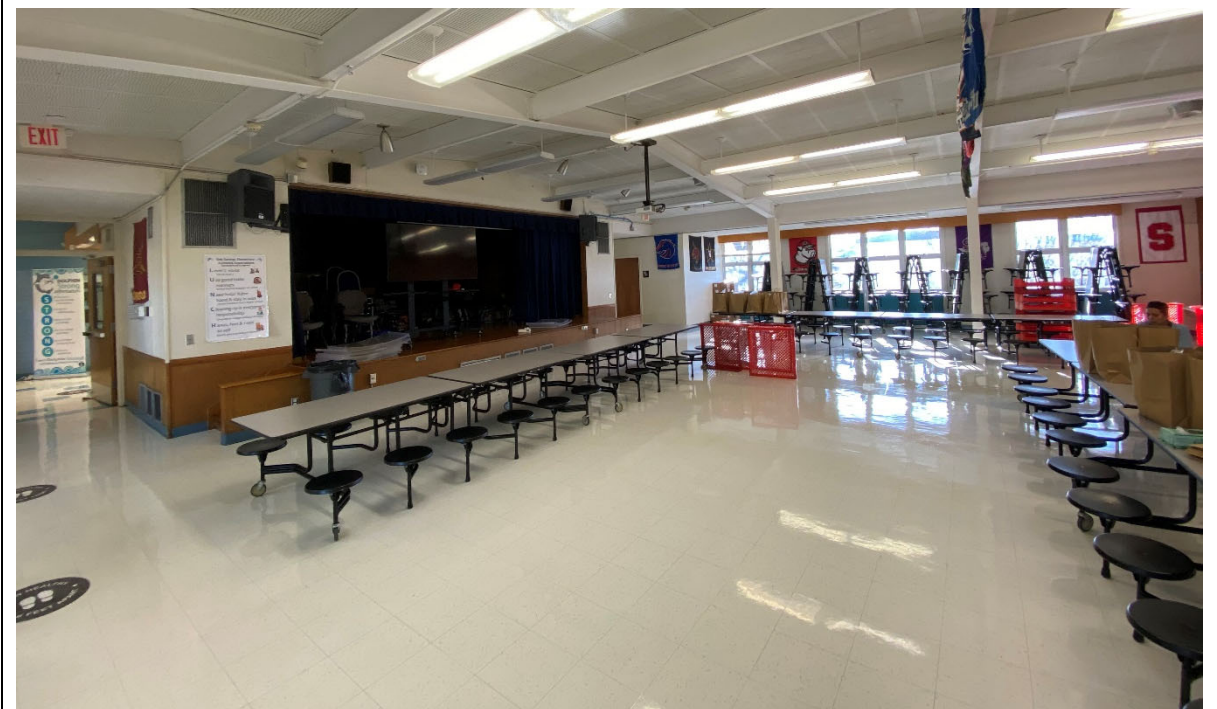
The cafeteria stage has inadequate storage and is not ADA accessible. Variety in seating is not provided. Kitchen is on the smaller side and needs updates.

Cafeteria stage is not ADA accessible, and storage is inadequate. There is no variety in the types of seating provided.

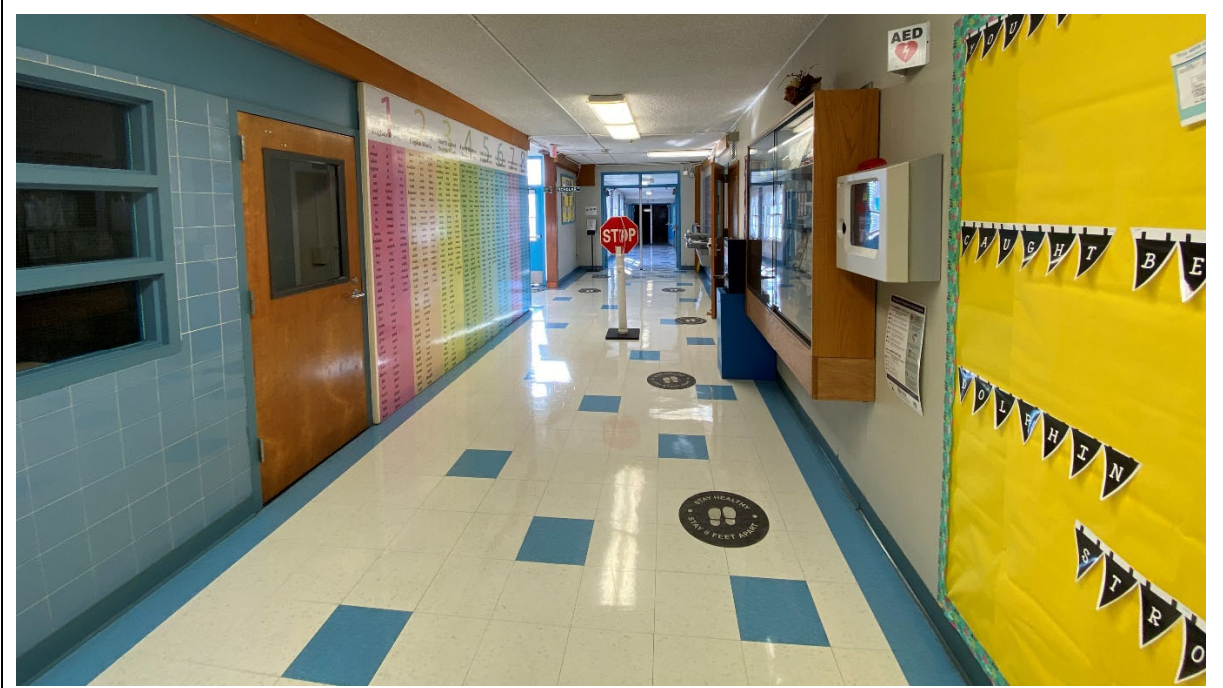
Corridors are wide and well lit. There are locations for 2D and 3D display in corridors.

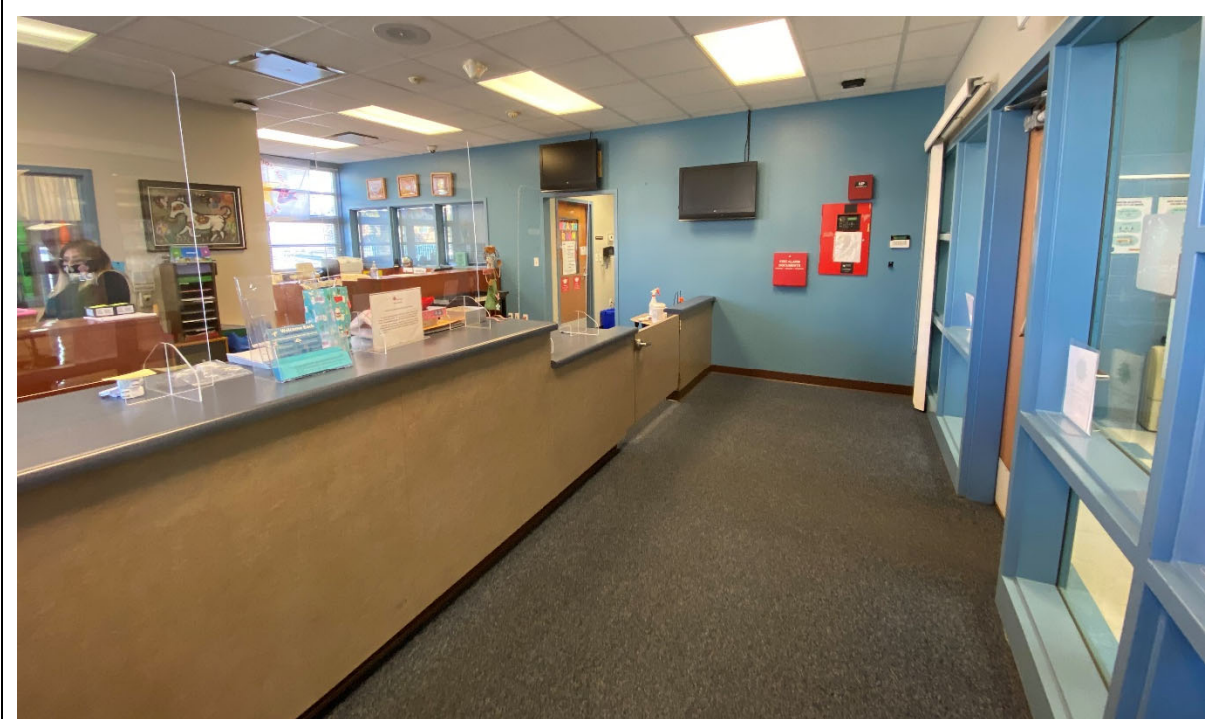
Administration Office: Good acoustic privacy in the admin area. Digital media signage is present and is in good condition.

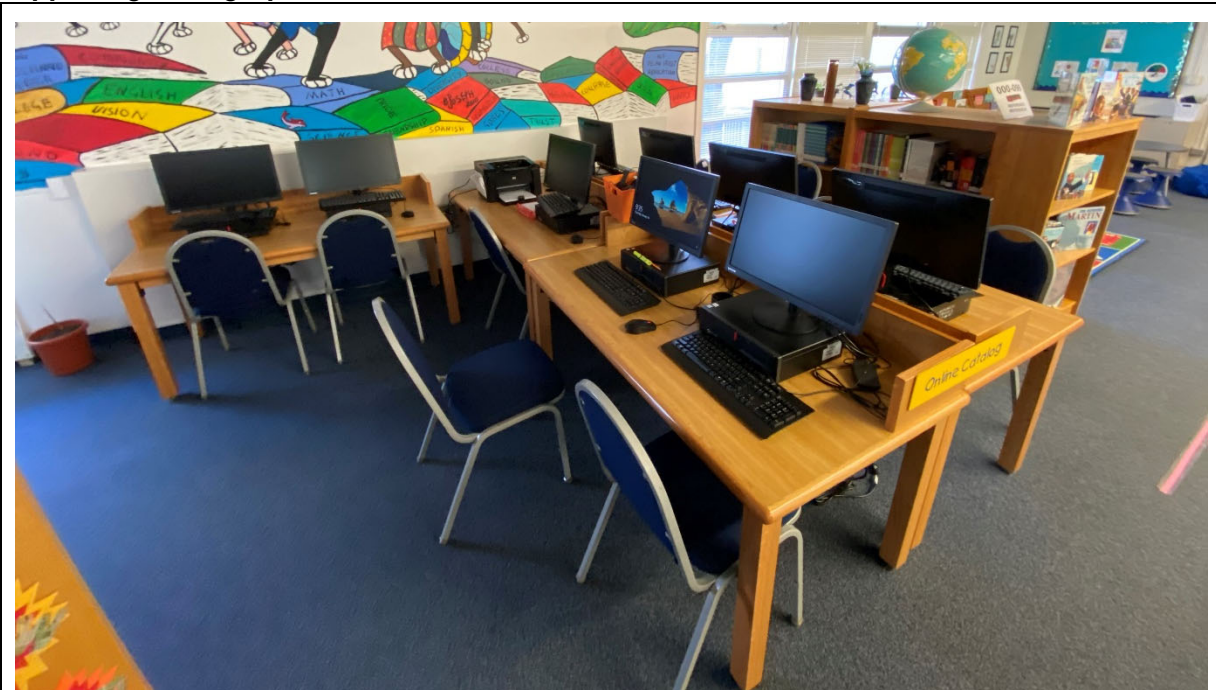
Media Resources: Insufficient computers and outdated furniture is bulky and not flexible.

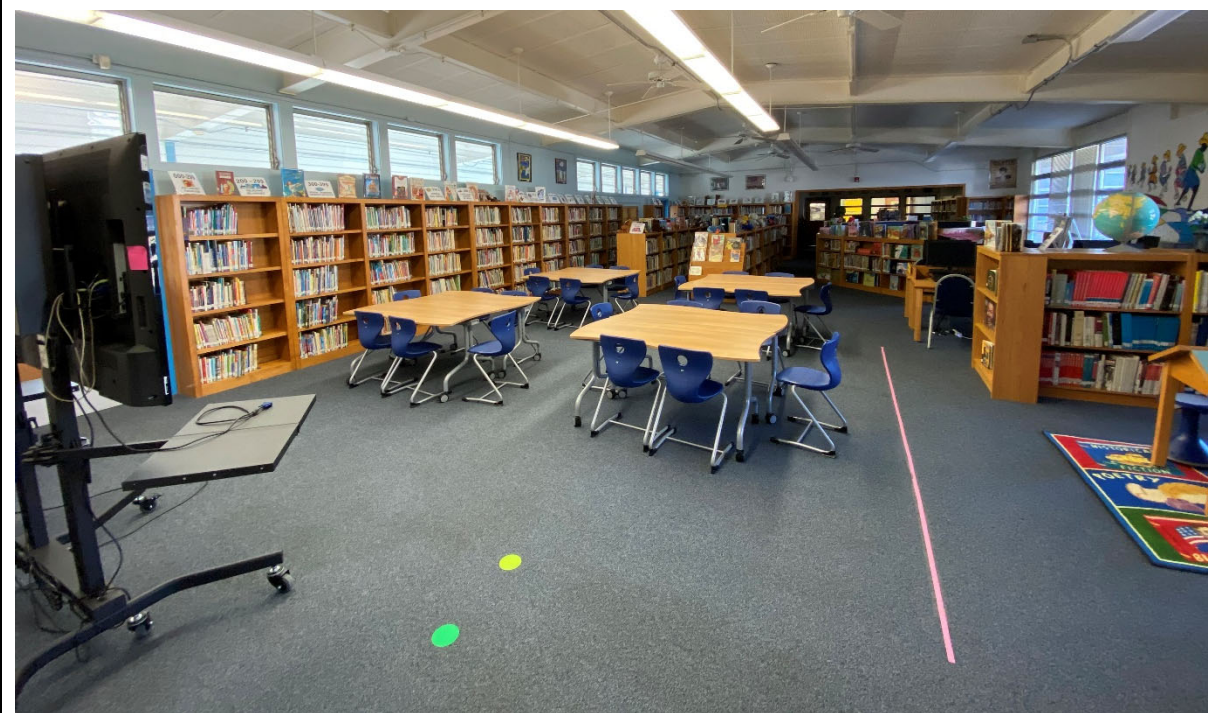
Media Resources: Space is adequate in size, but no quiet study rooms provided. There is a mix of old and new technology.

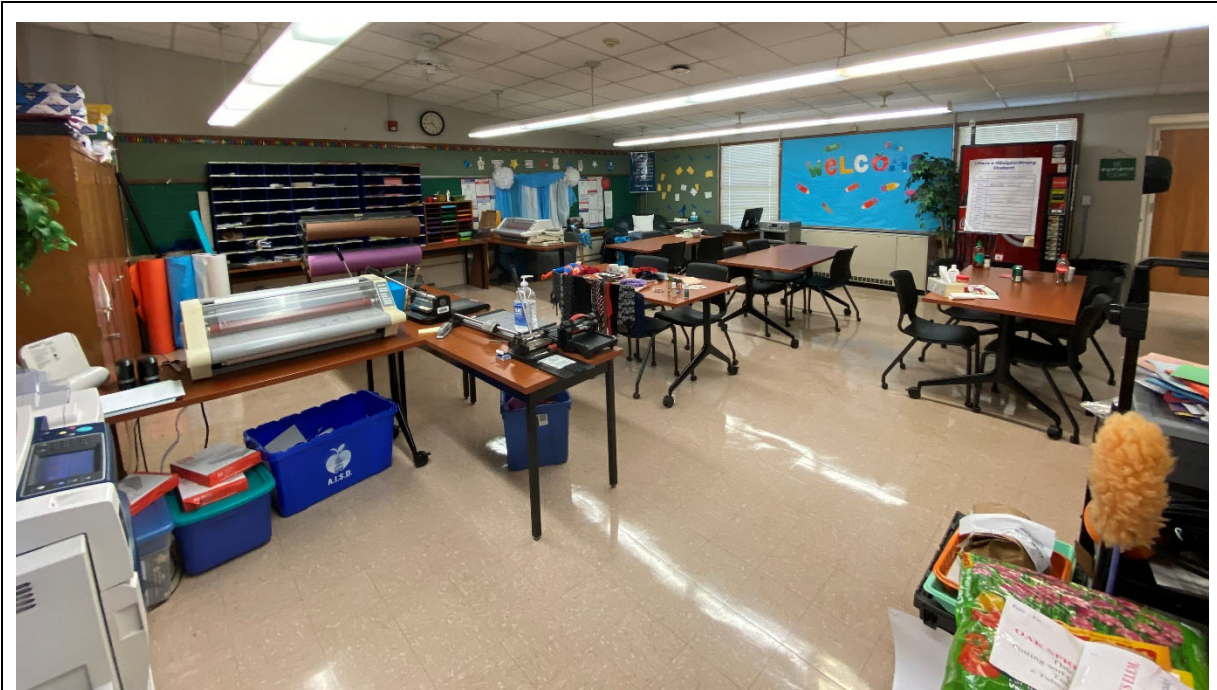
Repurposed space used as a workroom.

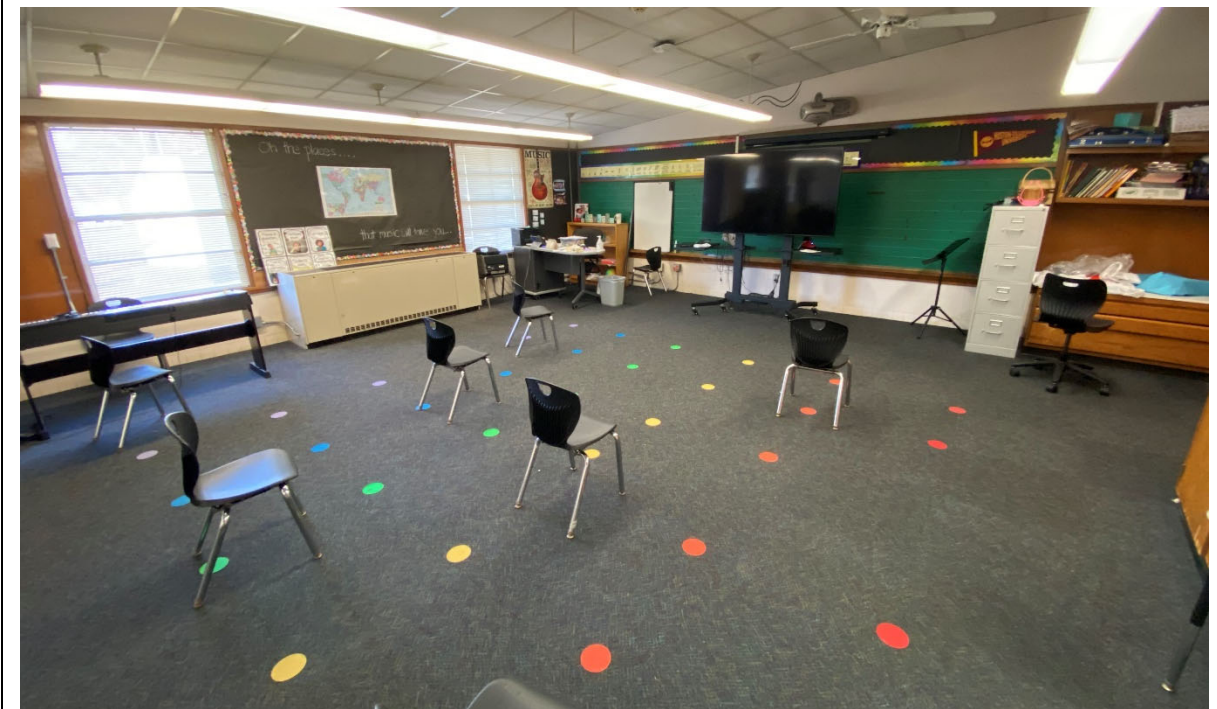
Academics and Learning: Good natural light in the space. Studio is adapted to current COVID-19 protocols. There is a mix of old and new technology. Projector is outdated and storage space is inadequate.

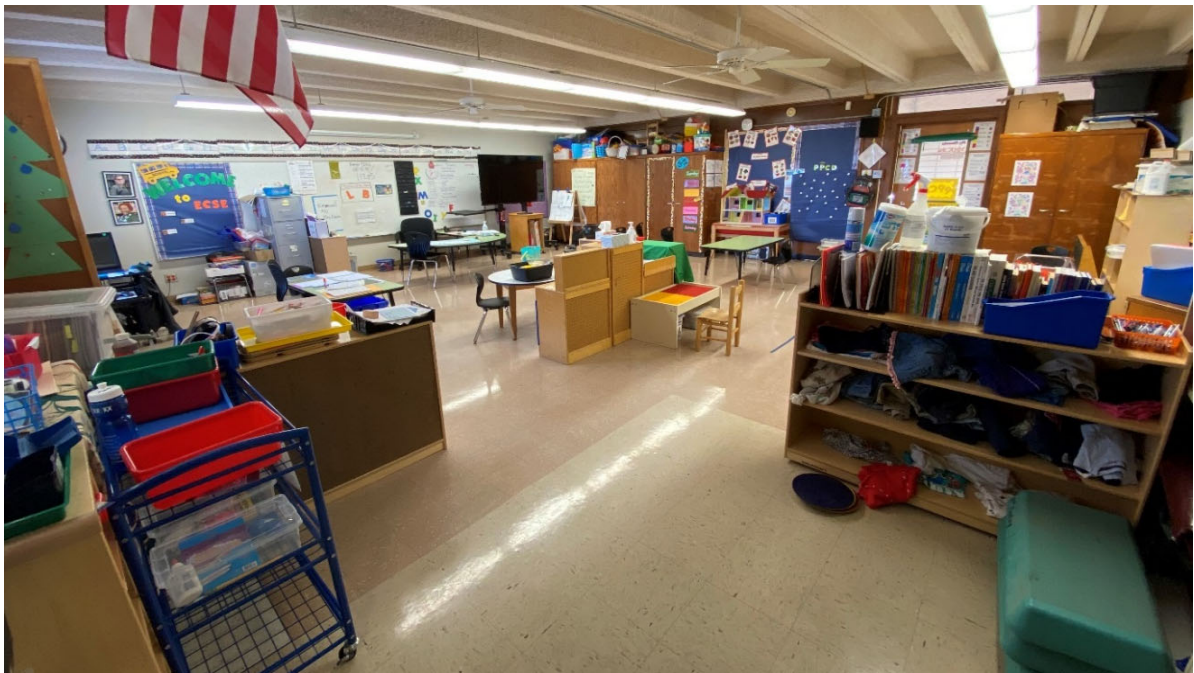
Pre-K studio: Space is adequate. Storage is not standardized in the studios.

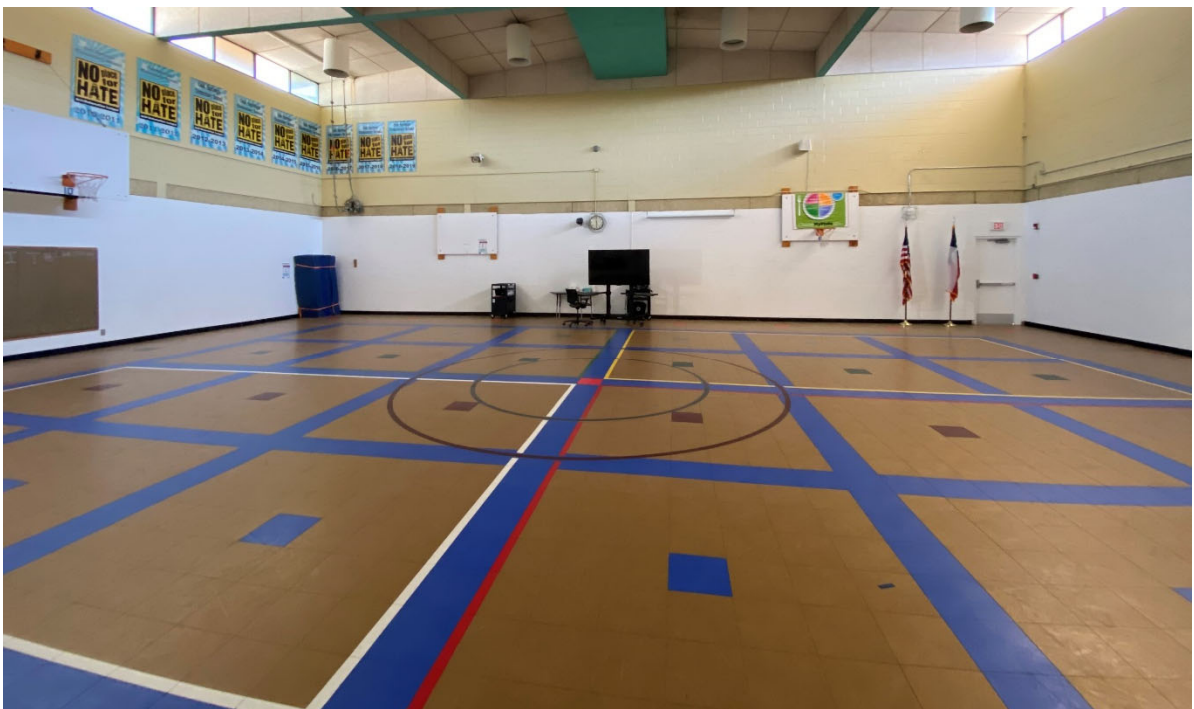
Gym is small and flooring needs to be renovated. Storage is not adequate.

PE and Wellness: Gym is adequately sized but needs updates to function well. Flooring is uneven and outdated. There is shortage of storage space.

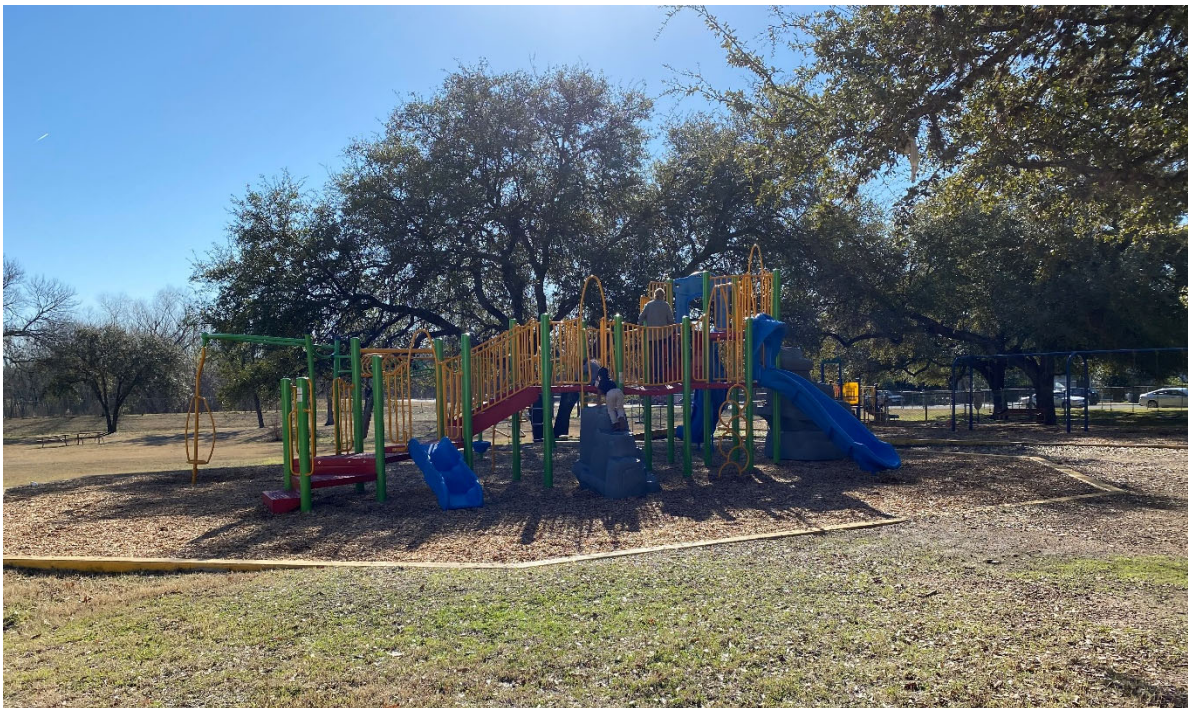
Outdoor play areas are provided but do not have shade.

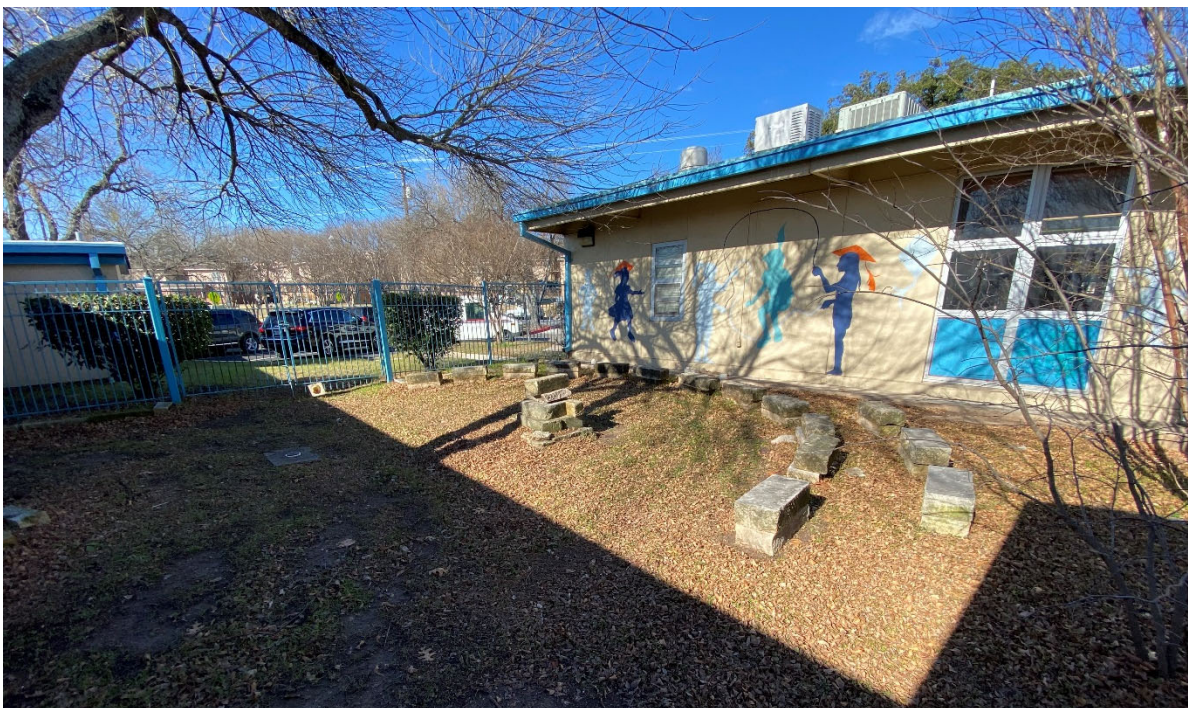
The major outdoor space is a central courtyard near the entrance. Stone seats are provided, but it needs shade and updated furniture to function well as an outdoor learning space. Play structures do

Central courtyard near the entrance serves as outdoor learning space. It needs shade and appropriate furniture to function well.
