Educational Suitability Summary Report

Perez Elementary School

Date: 01/26/2021 Score 75% Satisfactory

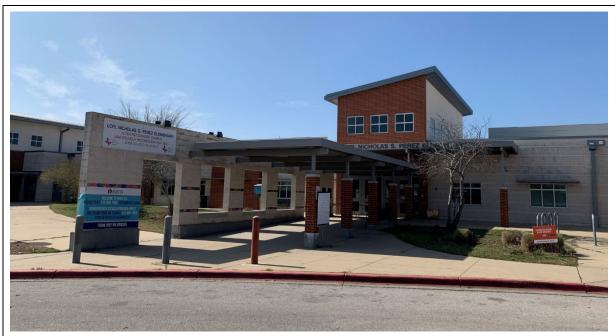
Exterior: Main entrance is easily recognizable. Student work on display under canopy conveys pride for students.

The drop-off sequence for the building is well thought out with separate bus and parent drop-off and both have canopies. The trash, recycling and compost dumpsters are all near the kitchen and on an accessible route. Wayfinding through the building is not apparent. The main entrance of the building is easily recognizable.

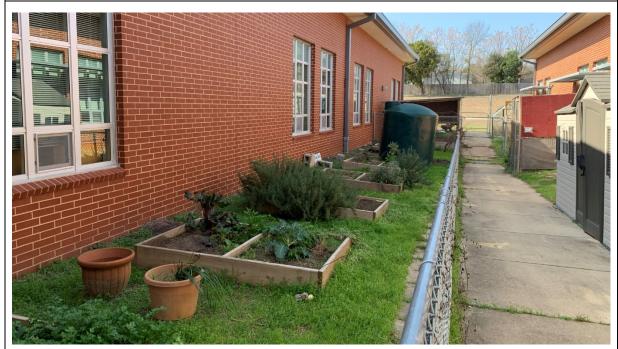
Outdoor Learning and Activity: Outdoor garden space is narrow but is taken care of and has the necessary items for outdoor learning.

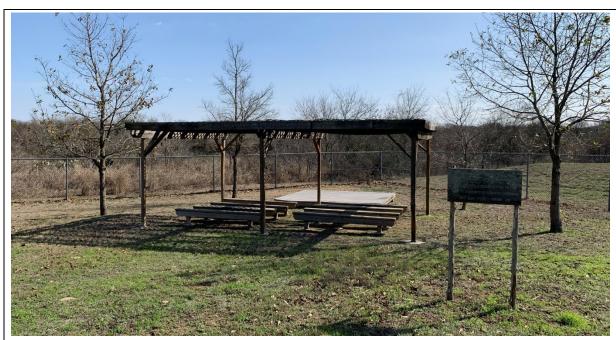
Outdoor Learning and Activity: Outdoor studio that was donated to the school through an Eagle Scout project.

2.	Are outdoo	r studios and support spaces appropriately configured per		2					Comments 1.00 2 .	.00
	1 2 3 4 5	Very unsatisfactory - No dedicated outdoor studios Unsatisfactory - Too small, poor condition, disconnected from learning spaces, no flexibility, no shade provided Average - Adequate size, adequate condition, needs some renovations or updates to function well, 50% or less shade coverage over studio area Satisfactory - Good size, good condition, connected to learning spaces, good flexibility, more than 50% shade coverage over studio area Very satisfactory - Generous size, excellent condition, connected to learning spaces, excellent flexibility, full shade coverage over studio area							Only 1 outdoor classroom buit via an Eagle Scout project. No other outd learning areas besides gardens and pond.	oor

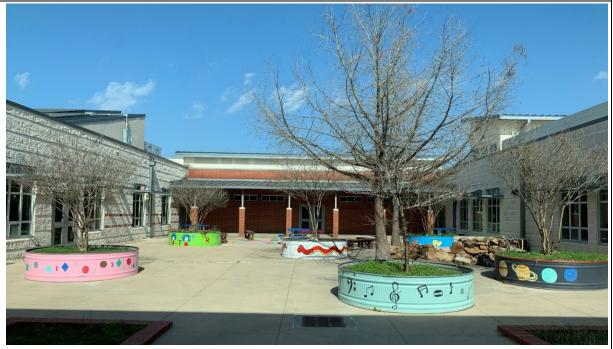
Outdoor Learning and Activity: The internal courtyard with seating, planters and a learning pond (right side of photo).

2.7	Does the sc	hool have a learning pond? (optional)					5		Comments	0.00	0.00
	1 5	No Yes							In internal courtyard		
2.8	Does the sc	hool have a grass play field and walking trail?					5		Comments	1.00	5.00
	1	No Vac							Disconnected from learning pods

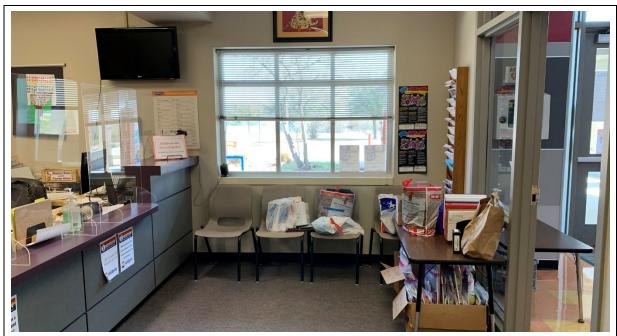
The reception area feels welcoming and has plenty of natural daylight and transparency to the main entrance and lobby.

The reception is off the main lobby and is the only path into the building. The space feels welcoming with good transparency into the lobby and access to natural daylight. Informal seating is provided in the waiting area. There is an easily accessible conference room directly behind the reception area for parent and public use. Staff told us that acoustics could be improved and that they use white noise machines when necessary.

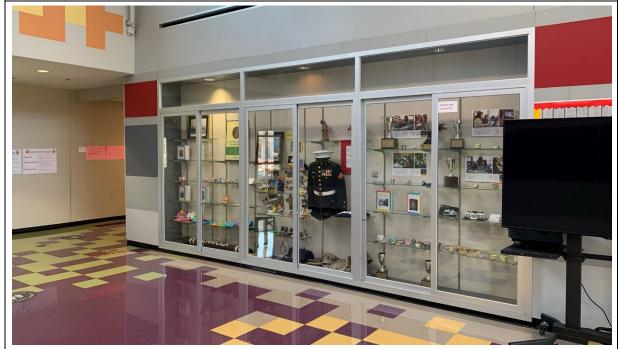
This large display case in the front lobby displays artifacts from Lance Cpl. Nicholas Perez, the school's namesake, as well as academic-related items.

8.9		dequate places to display the evidence and artifacts of			3				Comments		
	learning (bo	oth 2D and 3D)?								1.00	3.00
	1	Very unsatisfactory - No dedicated space							Only 1 display case near entry. 2D tackable space all	over learning p	pods.
	2	Unsatisfactory - Too small, non-dedicated, poor									
		condition									
	3	Average - Adequate size, adequate condition, needs									
		updates or renovations to function well									
	4 Satisfactory - Good size, good condition										
	5	Very Satisfactory - Generous size, excellent condition									
	N/A	Does not apply

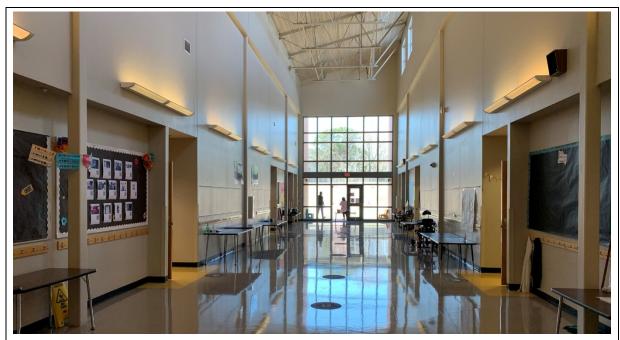
Academics and Learning: One of the collaboration spaces that the second- and third-grade studios share. It has an abundance of natural light but lacks transparency.

8.4		earning neighborhoods have small group rooms and open		2					Comments		
0.4	collaboratio	on space?							Comments	1.00	2.00
	1	Very unsatisfactory - No breakout rooms or open							2 learning pods have open collab space in the middle	e, but visibility	into the
		collaboration spaces are provided							studios is poor.		
	2	Unsatisfactory - Too small or too few, poor condition, no									
		flexibility, lacks visual connection to learning									
		neighborhood, poor acoustic privacy									
	3	Average - Adequate size, adequate condition, needs									
		some renovations or updates to function well									
	4	Satisfactory - Good size, good condition and flexibility,									
		transparency and connection to learning neighborhood,									
	_	acoustic privacy									
	5	Very Satisfactory - Generous size, excellent condition									
		and flexibility, transparency and connection to learning

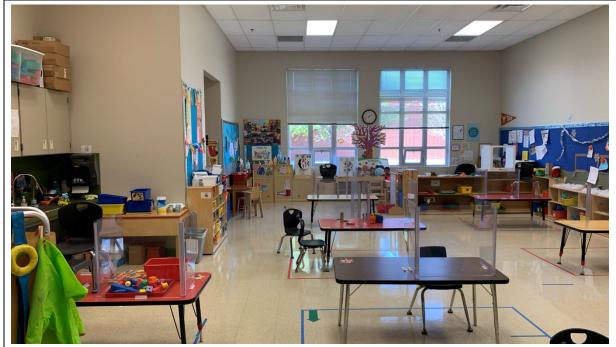
Academics and Learning: Studios are generously sized and have large windows for natural lighting. Furniture is not new but is in good condition.

Studios are generously sized and allow for flexibility. There are good-sized support spaces, with every studio having a closet and connecting toilets. Two of the learning pods have a collaboration space, but visibility into them is poor. There are no breakout rooms for individual or group study. There are no professional learning center rooms or teacher support spaces.

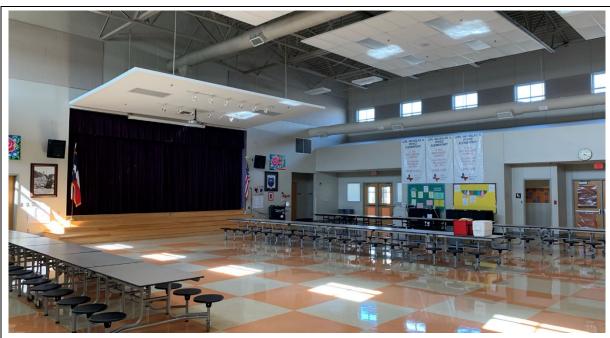
The cafeteria is spacious and has access to natural daylight through clerestory windows.

The cafeteria is large and has natural abundant natural light through clerestory windows. The kitchen and support spaces are arranged efficiently and there are dedicated restrooms within the cafeteria.

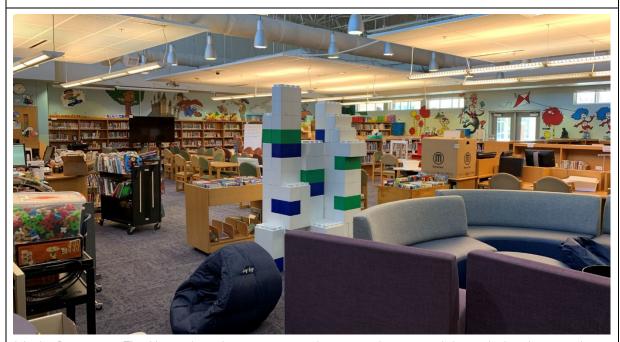
Media Resources: The library has direct access to the internal courtyard through the doors to the right in this image. Informal seating at the entrance creates different learning environments in this space.

The library is near the main entrance, but difficult to find. There is only one large space, which does not support quiet study. There is informal furniture for social interaction and multiple areas for groups to collaborate, both large and small. The library supports multiple projector areas and mobile screens but lacks markerboards and smartboards.
