## **Educational Suitability Summary Report**

Pillow Elementary School

Date: 1/22/2021

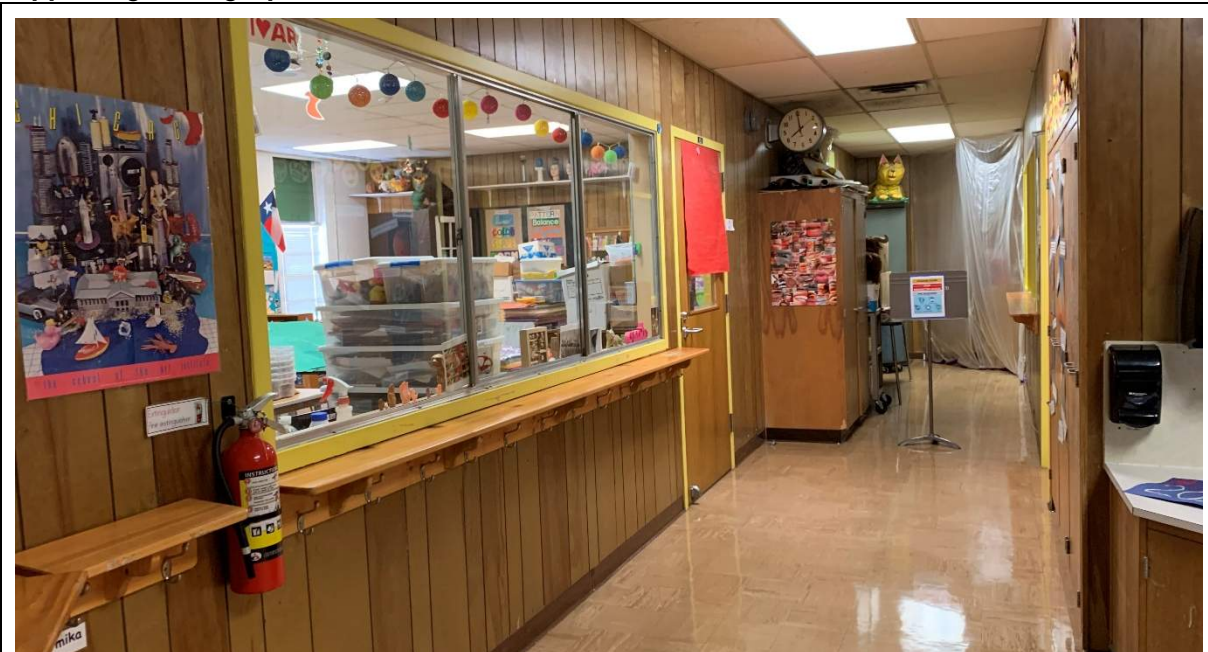
*Academics and Learning: Typical learning neighborhood are connected by a semi-circular corridor and share restrooms, a multipurpose room and support spaces. Finishes are dated.*

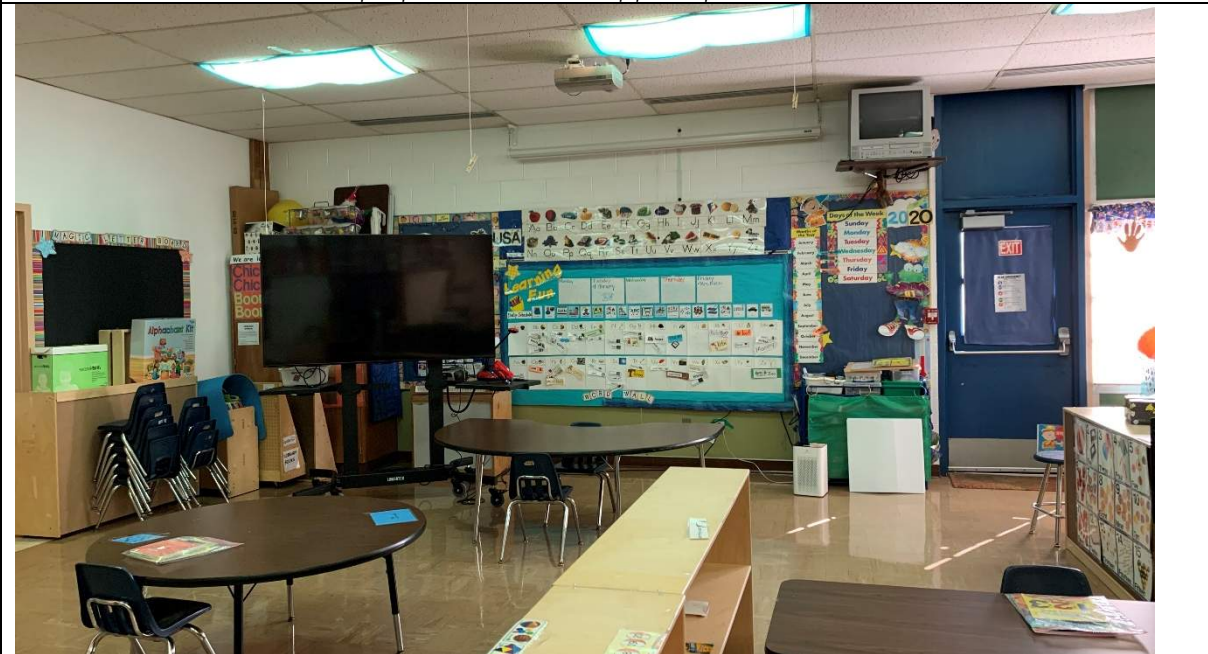
*Academics and Learning: Typical studios within the pods. There are typically six studios per pod. Old technology is still present in some of the studios.*

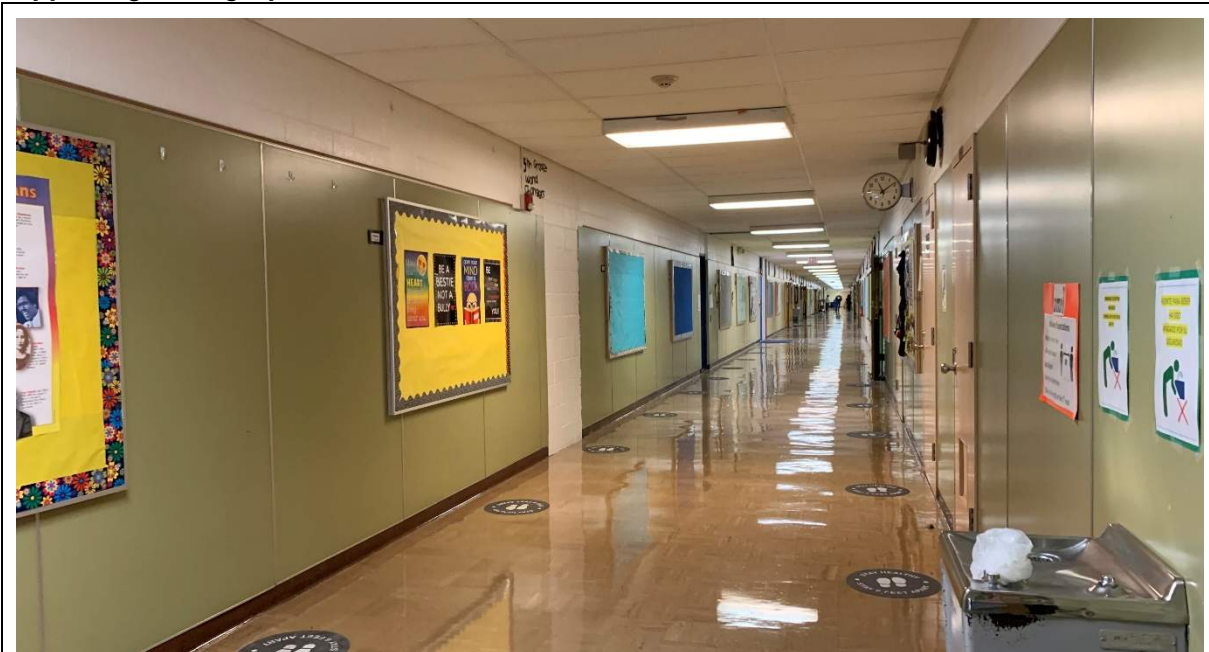
*General Building: Main corridor is wide and have ample locations for 2-D display. Finishes and lighting are dated.*

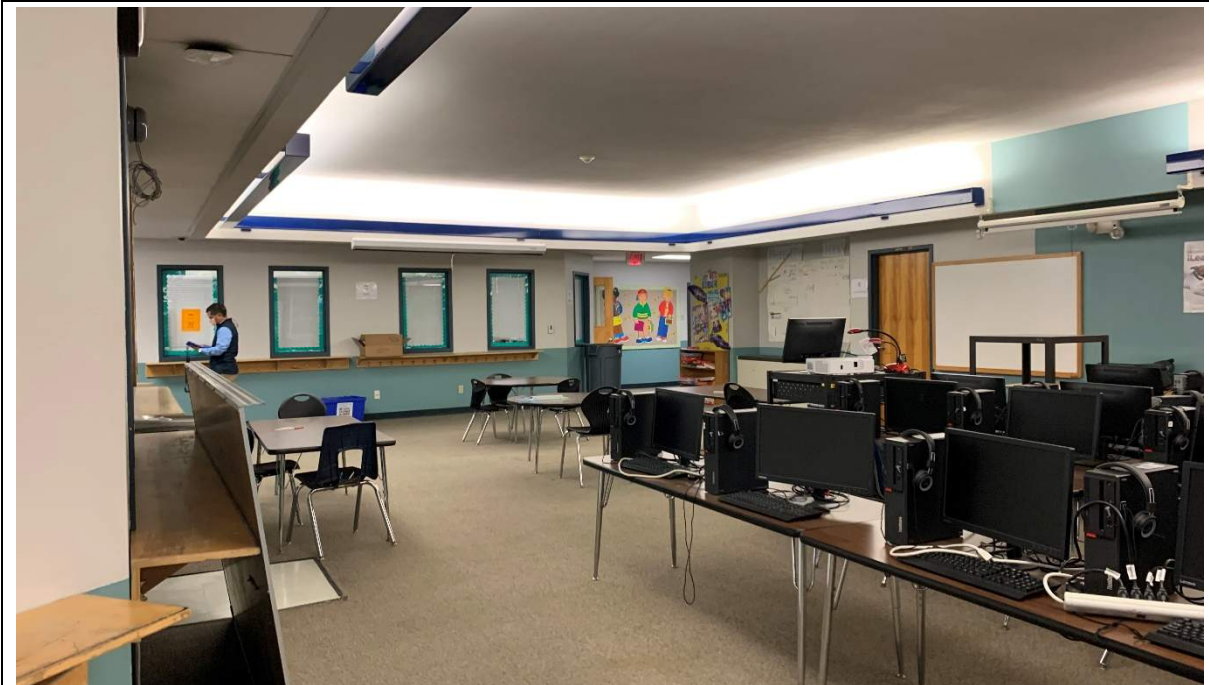
*Academics and Learning: Open collaboration space in one of the newer pods. Currently used as a computer lab.*

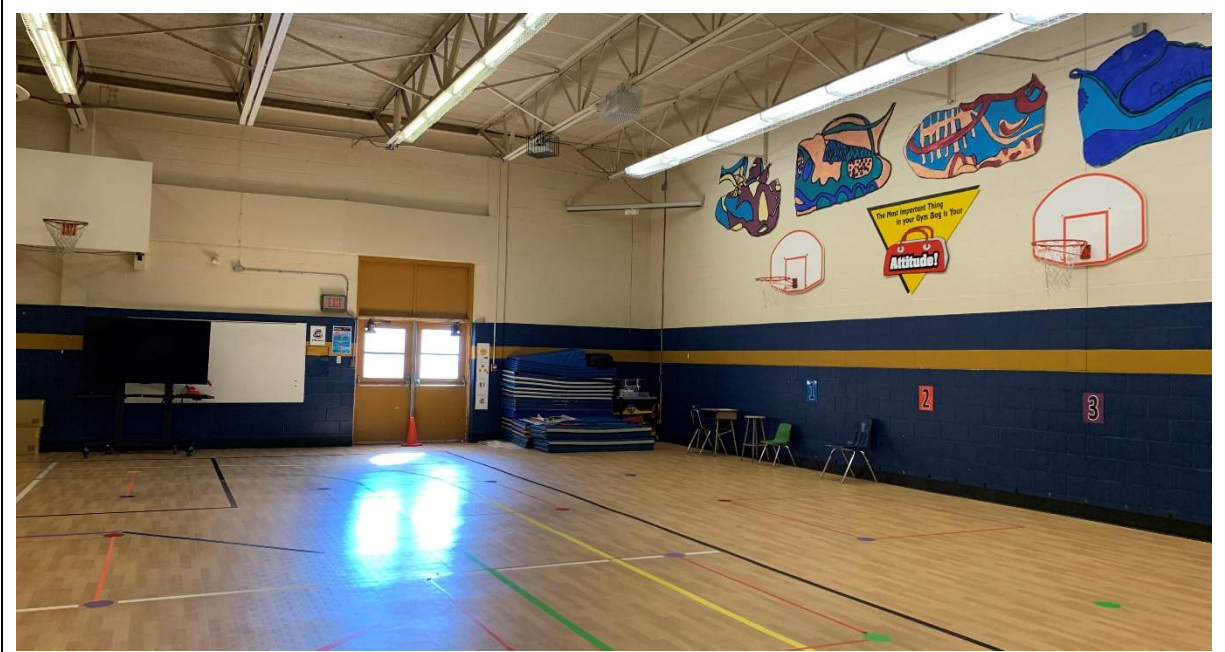
*PE and Wellness: The gym is adequately sized and connects to the cafeteria with a movable partition. There is limited storage.*

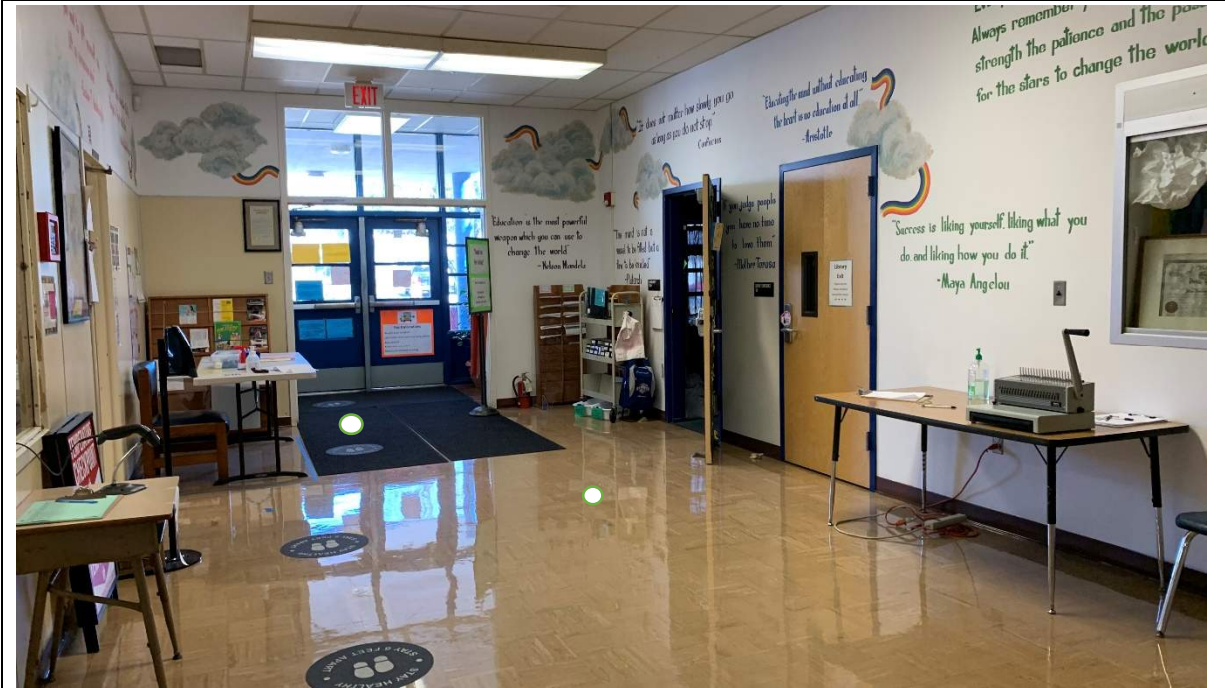
*Main entry doors.*

*Administration is on the left side of photo, and the library is on the right but has limited visibility to the main corridor.*

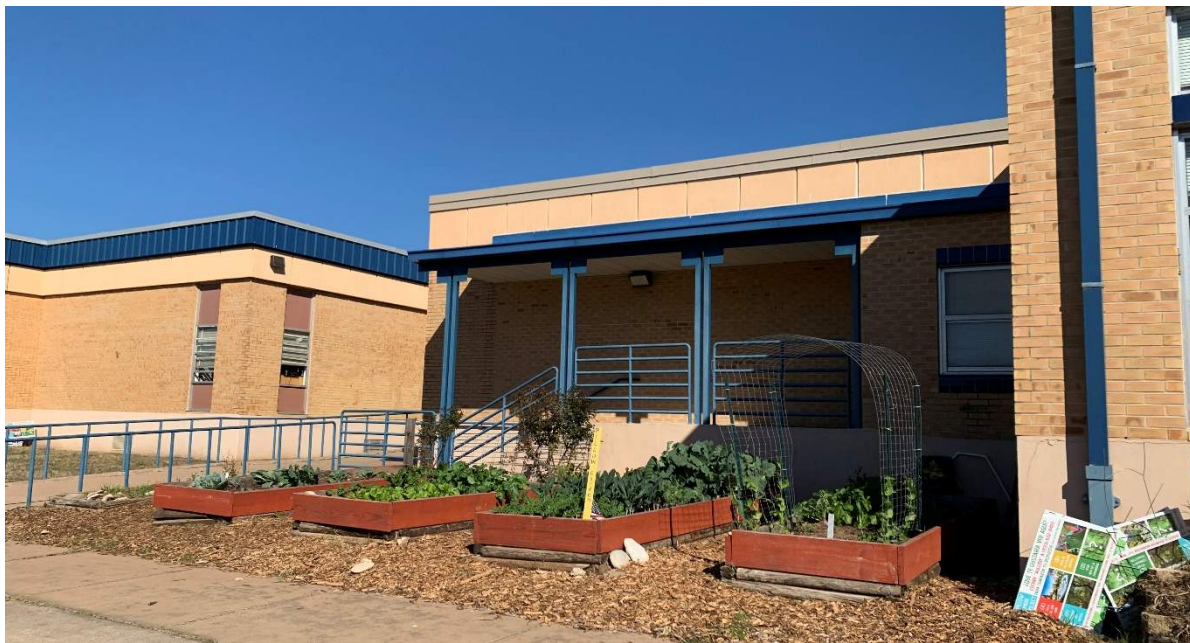
*Outdoor Learning and Activity: Well-tended garden*

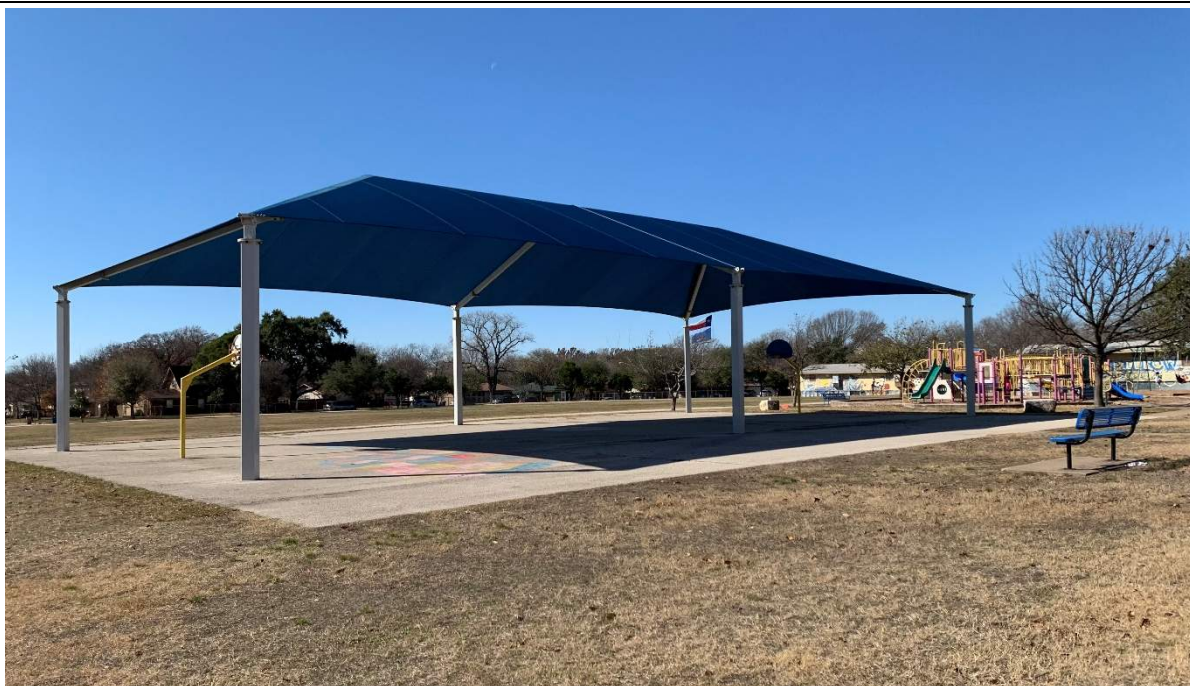
*Outdoor Learning and Activity: Covered basketball court near indoor gym but playscape beyond does not have shade.*

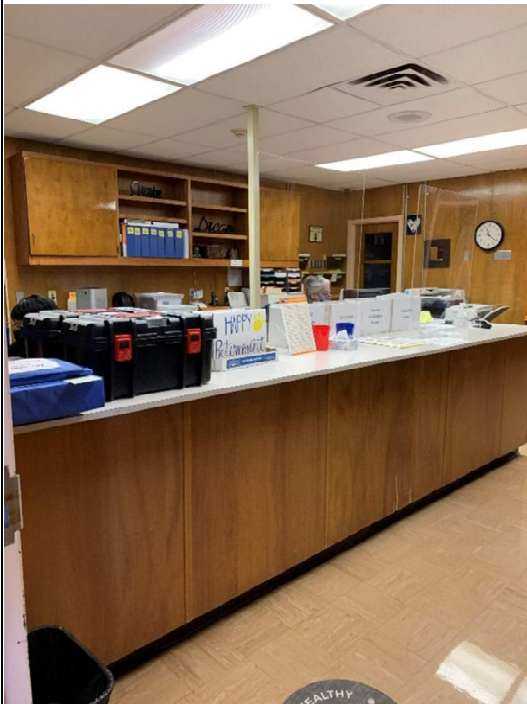
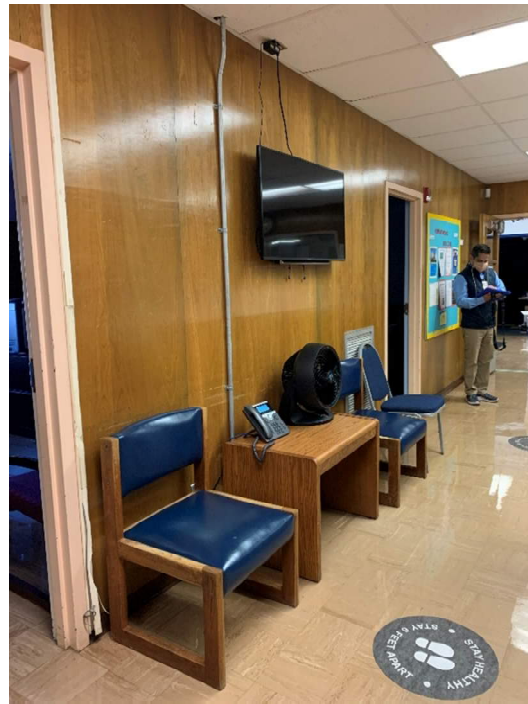
*Administration Space: Reception area is not welcoming and has limited seating. The wood paneling throughout the school is dated, makes spaces feel dark and is not in good condition.*

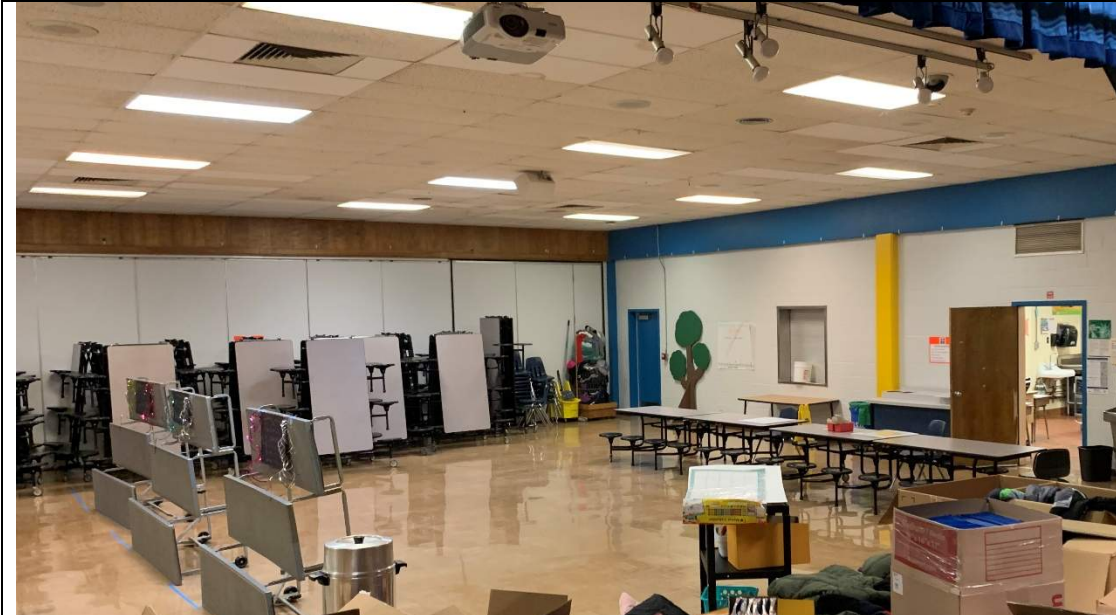
*Food services: Cafeteria is adequately sized for student capacity. Stage is adequately sized but finishes throughout need upgrades. Stage is currently being used for storage for COVID-19 protocols.*
