Educational Suitability Summary Report

St. Elmo Elementary School

Date: 01/26/2021

Score 54% Average

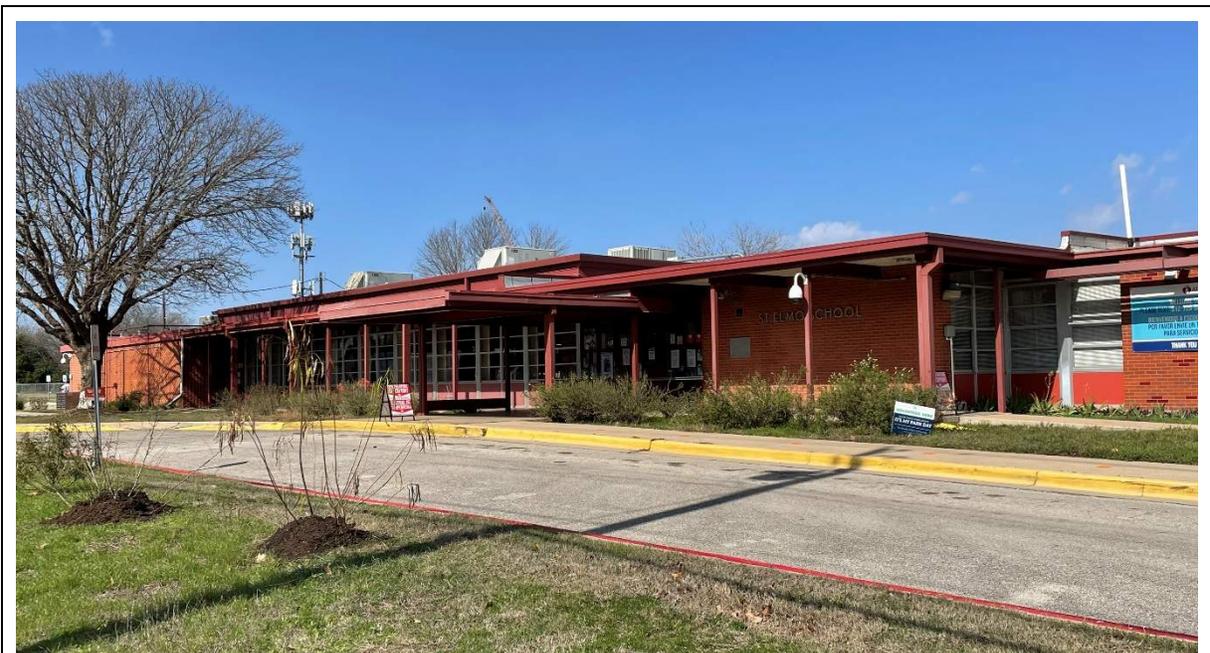
Exterior: Building exterior is in good condition considering the age of the school.

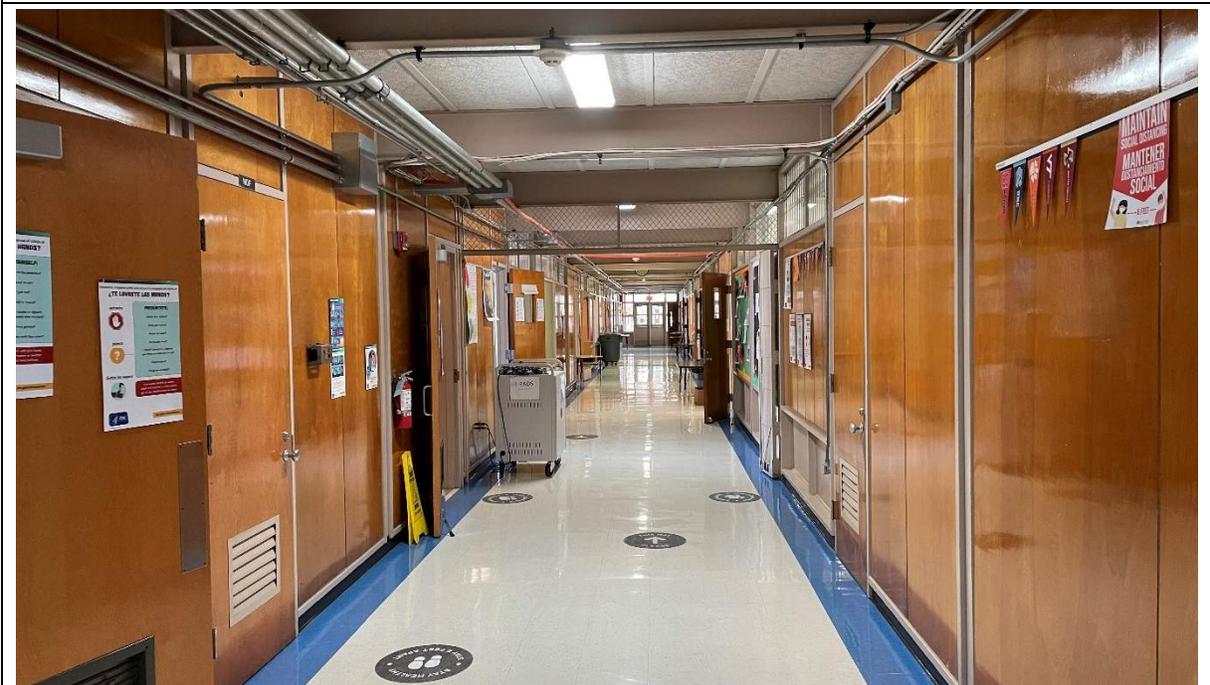
The school has wood paneling in the hallways, which appears original to the school. The cafeteria and stage have a dedicated entrance and can be used for after-school activities. The gym is in the rear of the school and very far from the parking lots, which makes it difficult to host events.

General Building: Exposed conduit and wood paneling have not been updated. This vintage feel is liked by the school. Commercials have asked to film at the school because of this look.

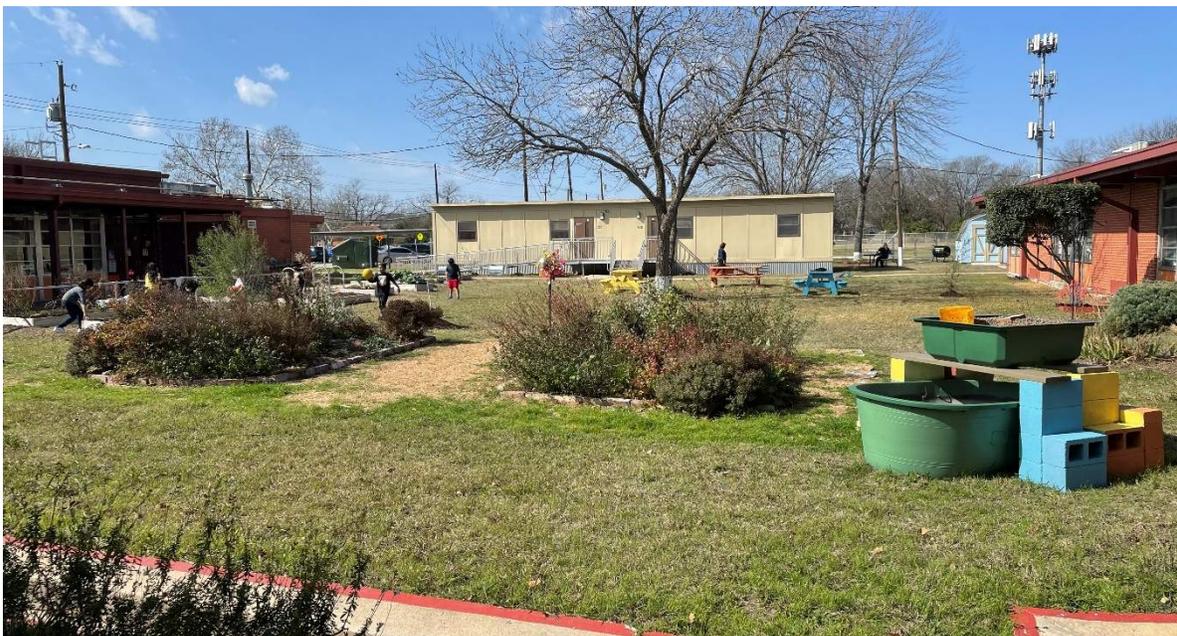
Outdoor Learning and Activity: Butterfly garden is in satisfactory condition with required support.

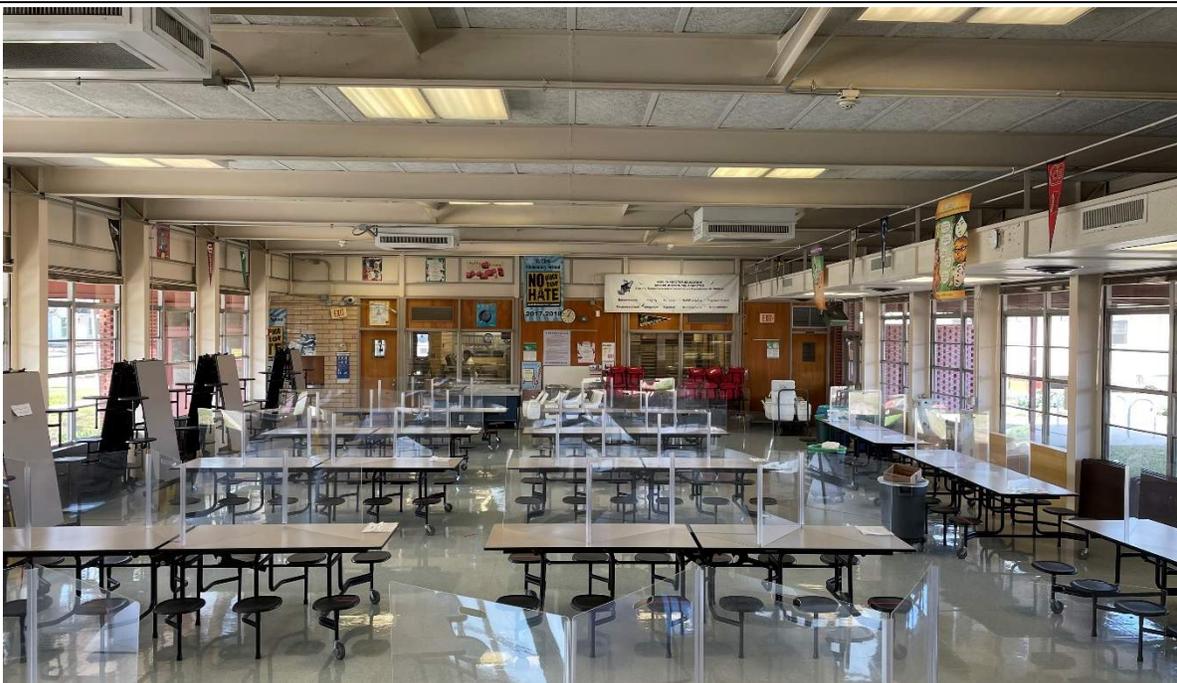
The cafeteria dining space is adequately sized for the campus capacity. Full walls of windows on two sides provide views to the outside along with ample daylight. Cafeteria is next to a covered outdoor deck inside the courtyard. Kitchen is slightly undersized, and students must walk through the cafeteria to enter the food service line.

Food Services: Cafeteria is sized appropriately for campus capacity with natural daylight and views to the outdoors provided by windows along both sides.

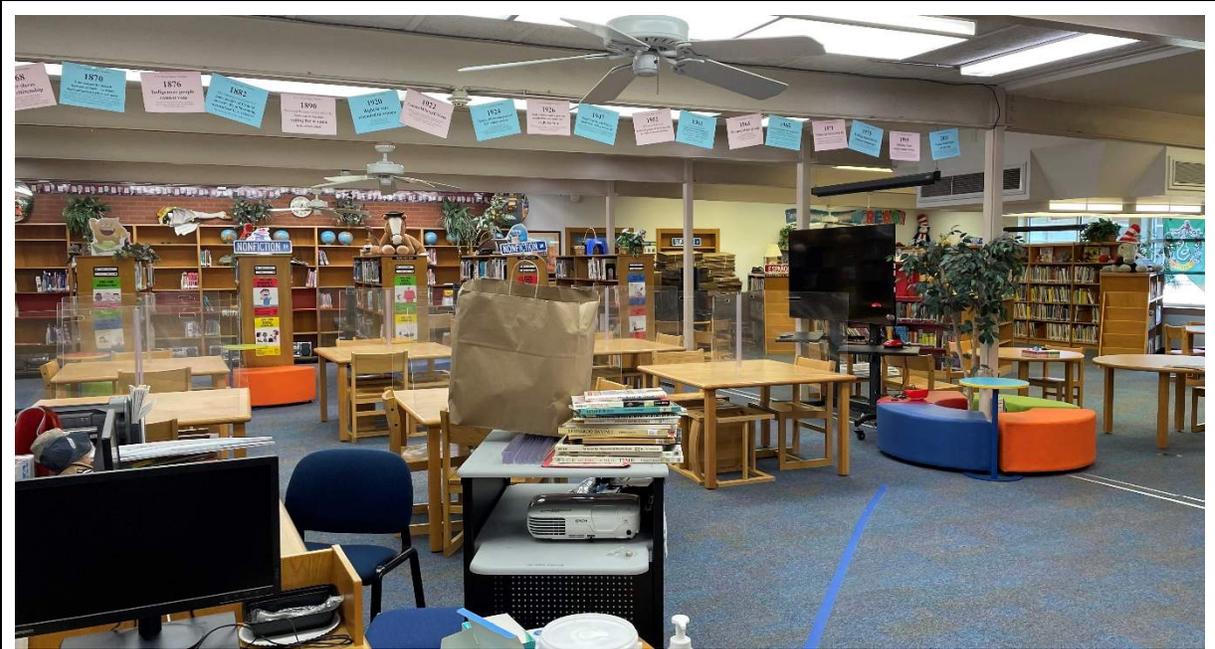
The library is near the main entrance but has poor transparency and signage for visitors. The ceiling in the space is low due to large ducts running under it. There are no breakout rooms in the library, but smaller areas for group activity are defined by furniture.

Media Resources: Library has some informal seating, but furniture is mostly heavy and lacks flexibility.

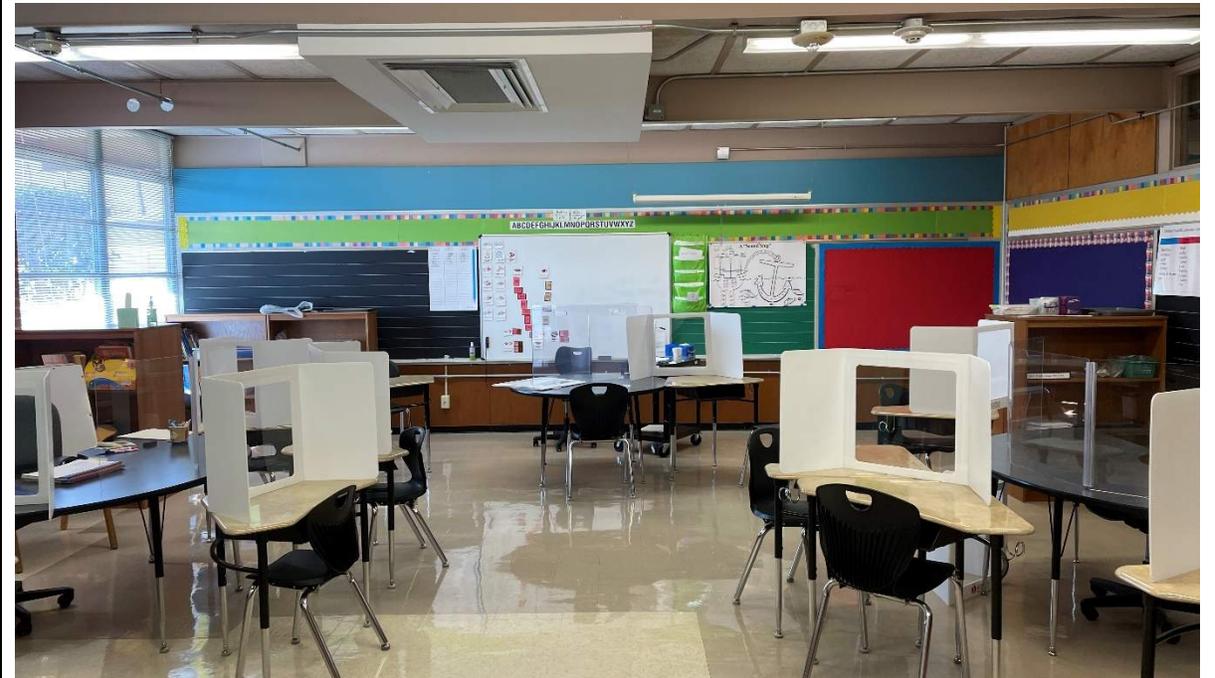
Studios are organized along long hallways with no transparency to the hallway or breakout areas. The studios are all over 800 square feet with adequate storage but offer no flexibility for different teaching methods or group sizes. Special education is currently housed in a typical studio.

Academics and Learning: Typical studios are over 800 square feet with large windows.

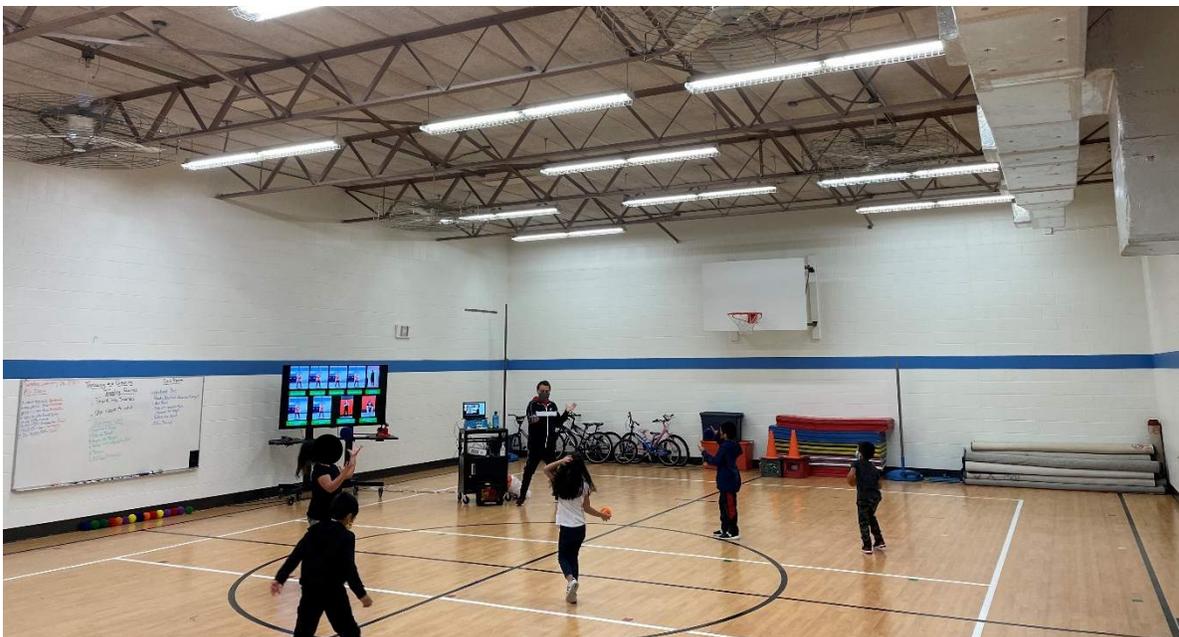
The gym has no natural light, and support spaces are poor. A small office with restroom is attached, but storage spaces are limited to one small storage room with only one access. The gym floor has been recently renovated, but the basketball goals are original.

PE and Wellness: Gym does not meet size requirements in Ed Spec, with original hoops and no natural light. Support spaces are not adequate.

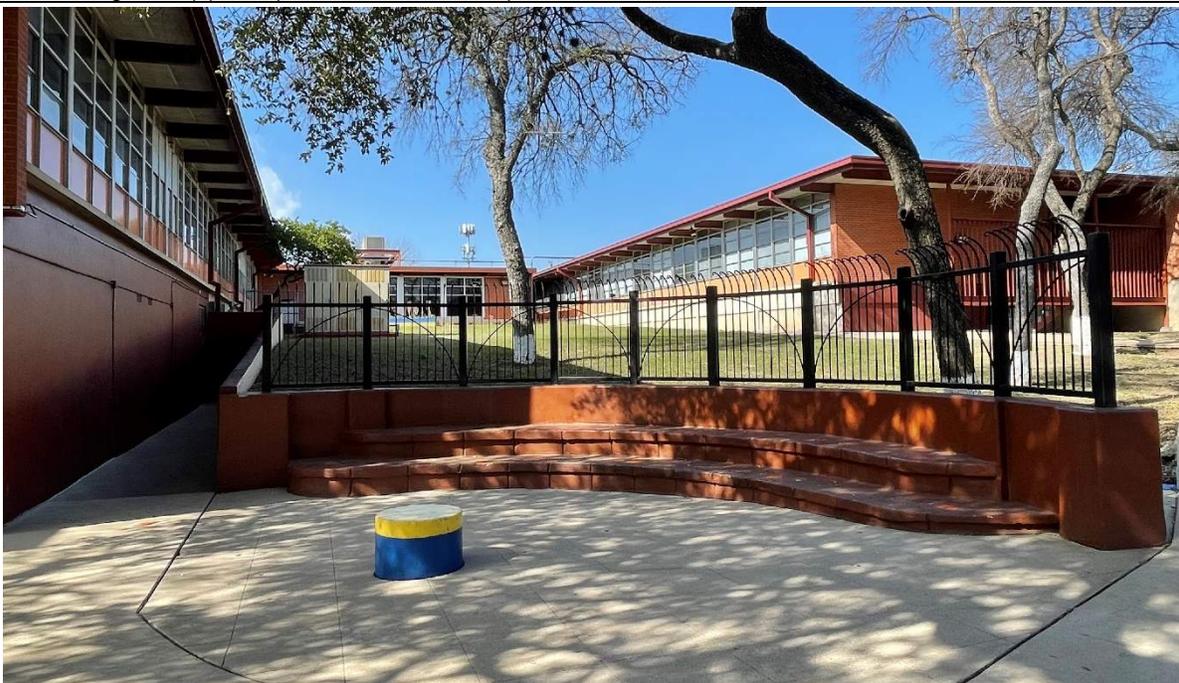
Principal McCormack sees a growing momentum for outdoor learning and wants St. Elmo to focus on this moving forward. The outdoor learning amphitheater is functional, but it is too close to a major road, which creates noise and distractions for students. The school has received a grant to create

Outdoor Learning and Activity: Small amphitheater is only outdoor studio on campus.

vegetated barrier to address this issue. They need more spaces with dedicated seating and shade to better integrate outdoor learning into the curriculum. Their butterfly garden is popular with the students, but they have not yet been able to get the aquaponics learning pond to function. The school is in the process of adding an aviary for beekeeping and would like to add a chicken coop in the future.

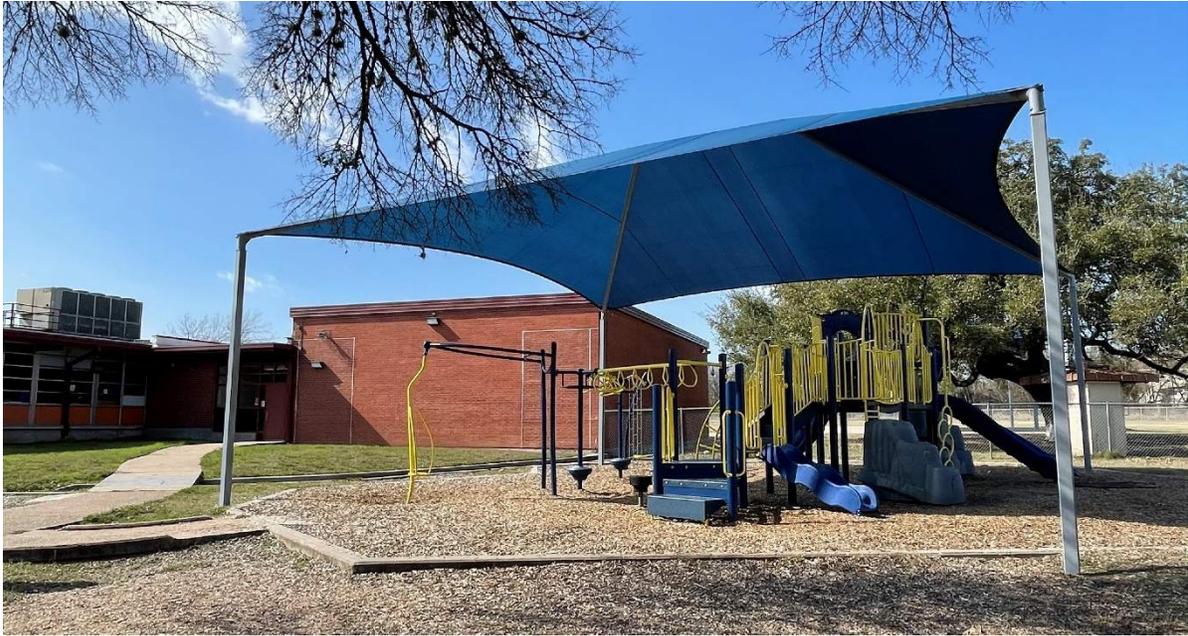
The learning garden and support spaces are large and in very good condition. There is limited outdoor studio space. The playscapes are not new but are in good condition and most are covered with shade structures.

Outdoor Learning and Activity: Covered playscape is in good condition.

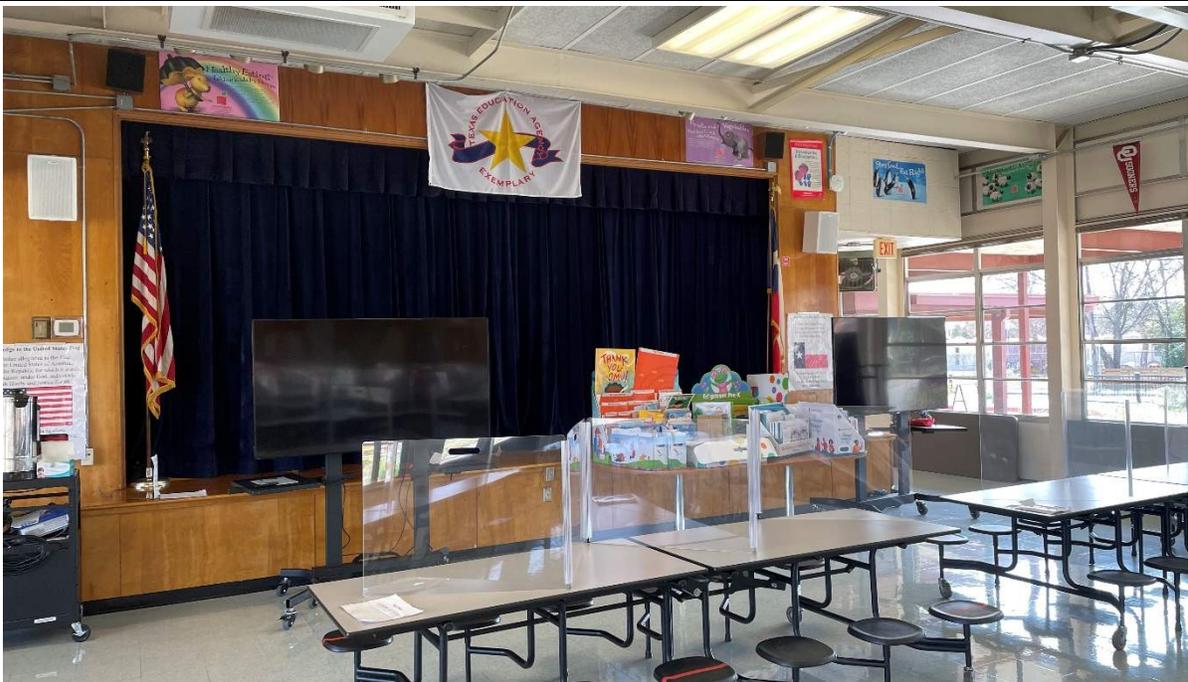
The cafeteria stage is small with limited support spaces or storage. Art takes place in a studio that shares a restroom and a small hallway with another studio occupied by a counselor. Music takes place in a portable. For the upcoming school year 2021-2022, music and art will be in a wing downstairs to give the classes more dedicated space.

Visual and Performing Arts: Cafeteria stage is small with limited storage.
