Educational Suitability Summary Report

Summitt Elementary School

Date: 10/29/2020

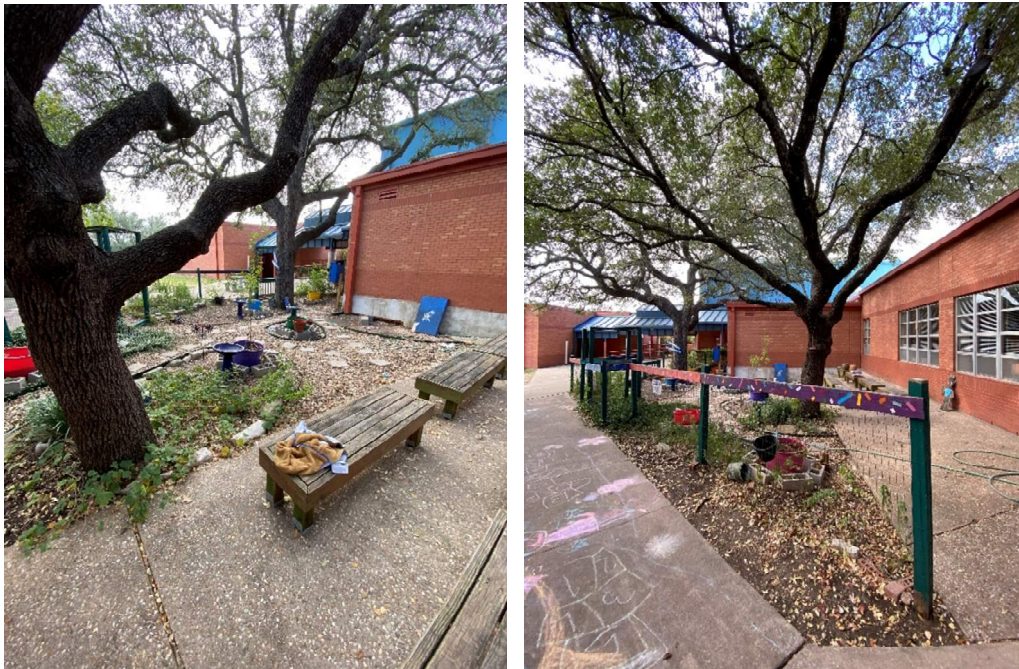
An outdoor learning area is located near the annex building, but for most studios in the main building and in the portables, this location is disconnected from the learning spaces.

2.1	Are outdoor studios and support spaces appropriately configured per the ed spec?			3				Comments	1.00	3.00
1	Very unsatisfactory - No dedicated outdoor studios							One small outdoor space with a picnic table has shade/covering. Other outdoor spaces only have some coverage with trees. Furniture needs updating and spaces need updates to function well.		
2	Unsatisfactory - Too small, poor condition, disconnected from learning spaces, no flexibility, no shade provided									
3	Average - Adequate size, adequate condition, needs some renovations or updates to function well, 50% or less shade coverage over studio area									
4	Satisfactory - Good size, good condition, connected to learning spaces, good flexibility, more than 50% shade coverage over studio area									
5	Very satisfactory - Generous size, excellent condition, connected to learning spaces, excellent flexibility, full shade coverage over studio area

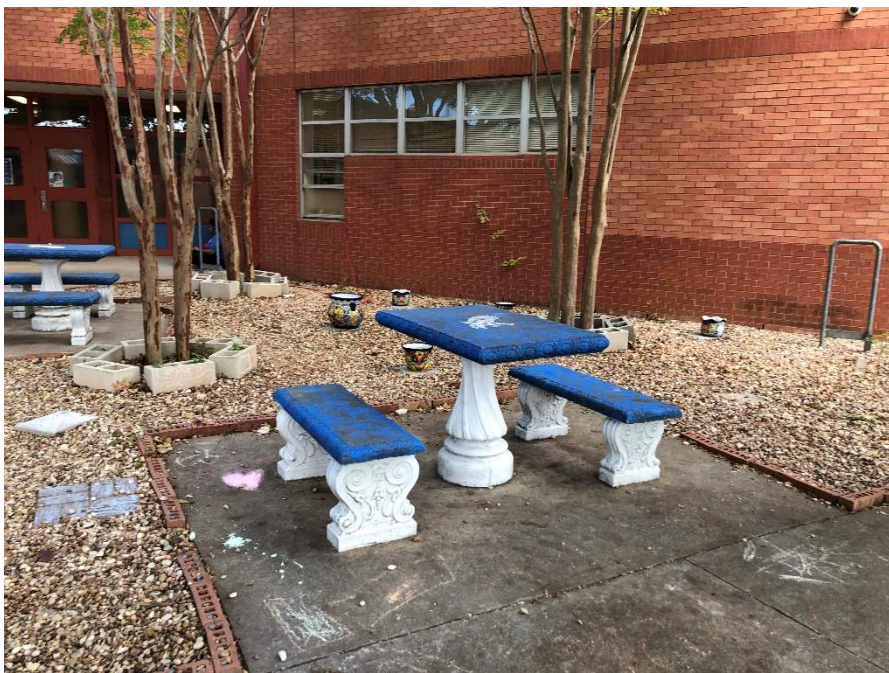
Outdoor areas lack adequate age-appropriate furniture.

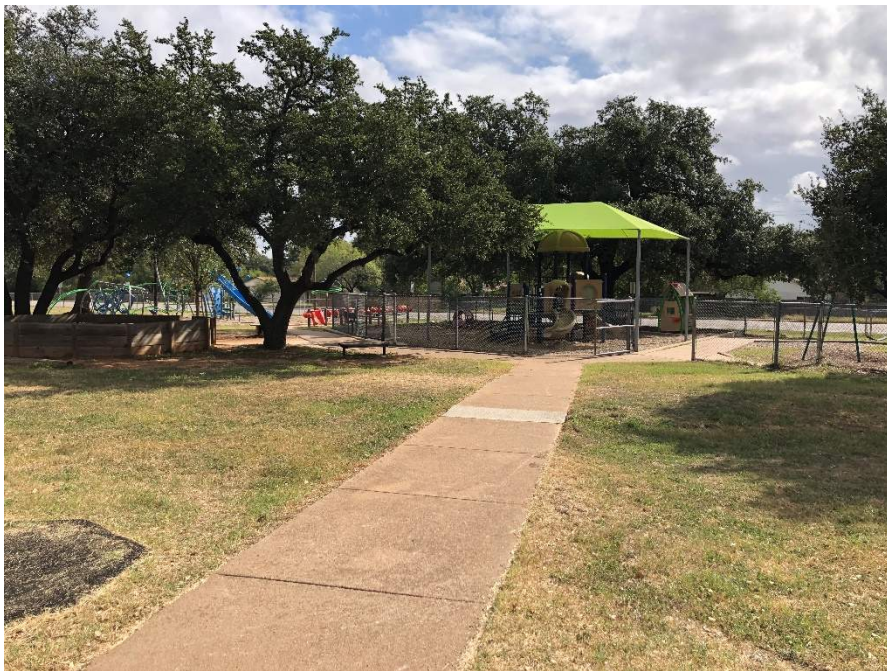
Active playgrounds are equipped with shade covering.

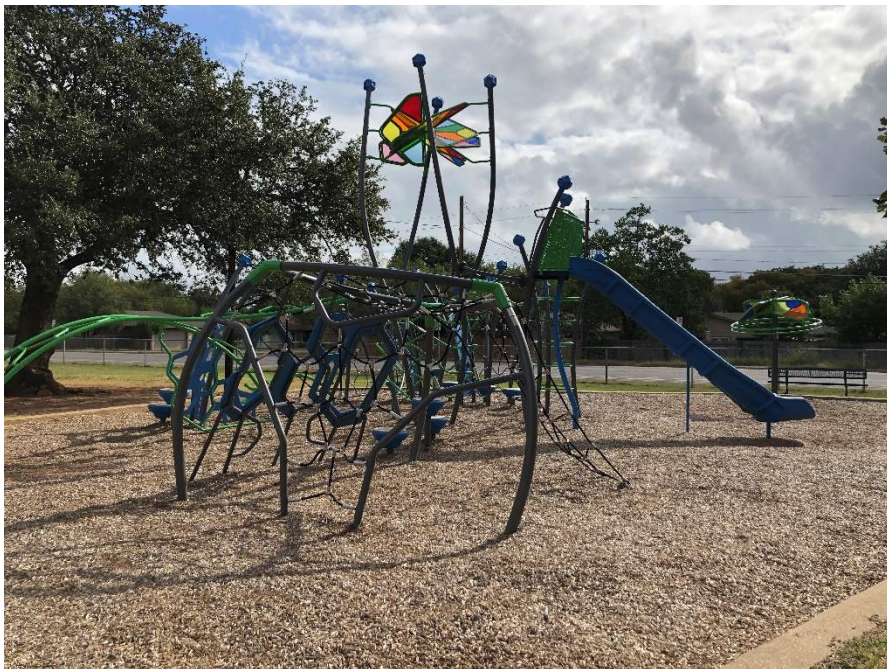
Active playgrounds are in good condition and suitable for a variety of ages.

N/A	Does not apply									
2.2	Are active playgrounds (elementary only) and support spaces configured per the ed spec?				4			Comments	1.00	4.00
1	Very unsatisfactory - No dedicated active playground							Playgrounds in good condition. Two of the three playgrounds equipped with shade structure.		
2	Unsatisfactory - Too small, poor condition, no shade provided									
3	Average - Adequate size, adequate condition, needs some renovations or updates to function well, 50% or less shade coverage over play structure									
4	Satisfactory - Good size, good condition, more than 50% shade coverage over play structure									
5	Very satisfactory - Generous size, excellent condition, full shade coverage over play structure									
N/A	Does not apply

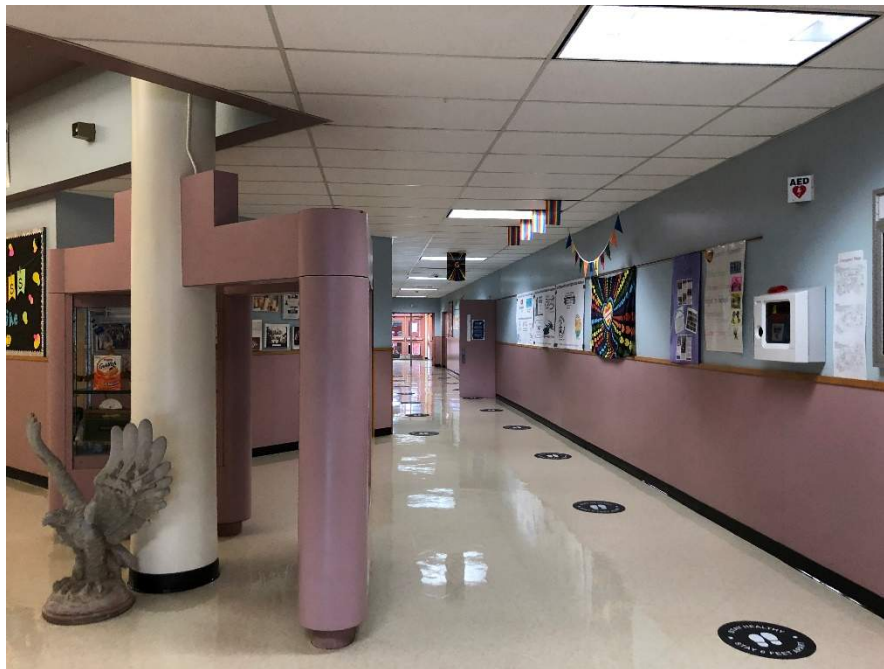
The corridors have areas for displays and highlights school price.

8.9	Are there adequate places to display the evidence and artifacts of learning (both 2D and 3D)?				4			Comments	1.00	4.00
1	Very unsatisfactory - No dedicated space							Multiple locations within campus displaying 2D and 3D artifacts of students.		
2	Unsatisfactory - Too small, non-dedicated, poor condition									
3	Average - Adequate size, adequate condition, needs updates or renovations to function well									
4	Satisfactory - Good size, good condition									
5	Very Satisfactory - Generous size, excellent condition									
N/A	Does not apply

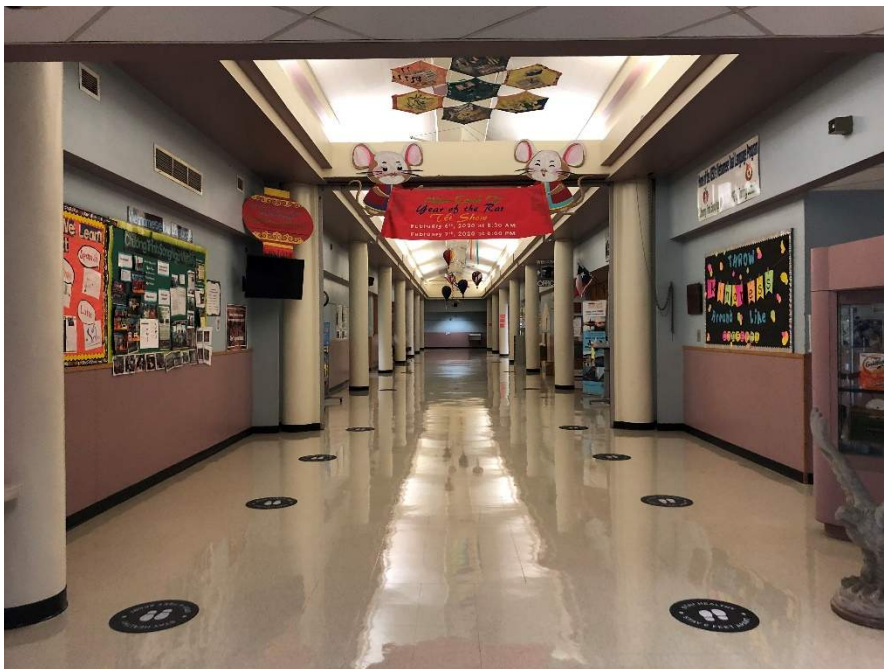
Main hallway is generous width, but lighting is poor, making hallway feel dark and dated.

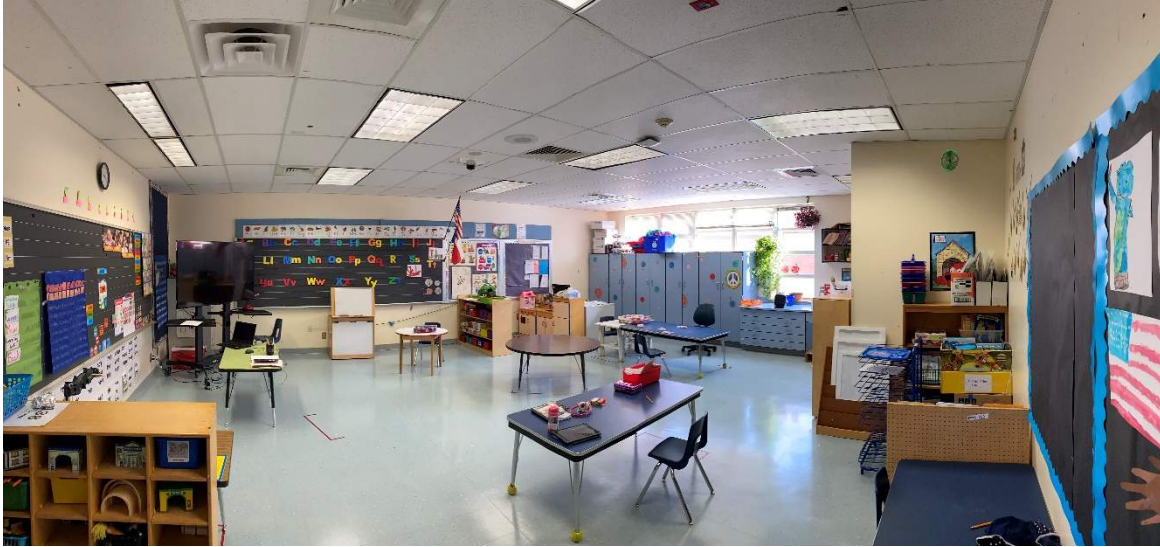
Access to natural light and adequate lighting in typical studio.

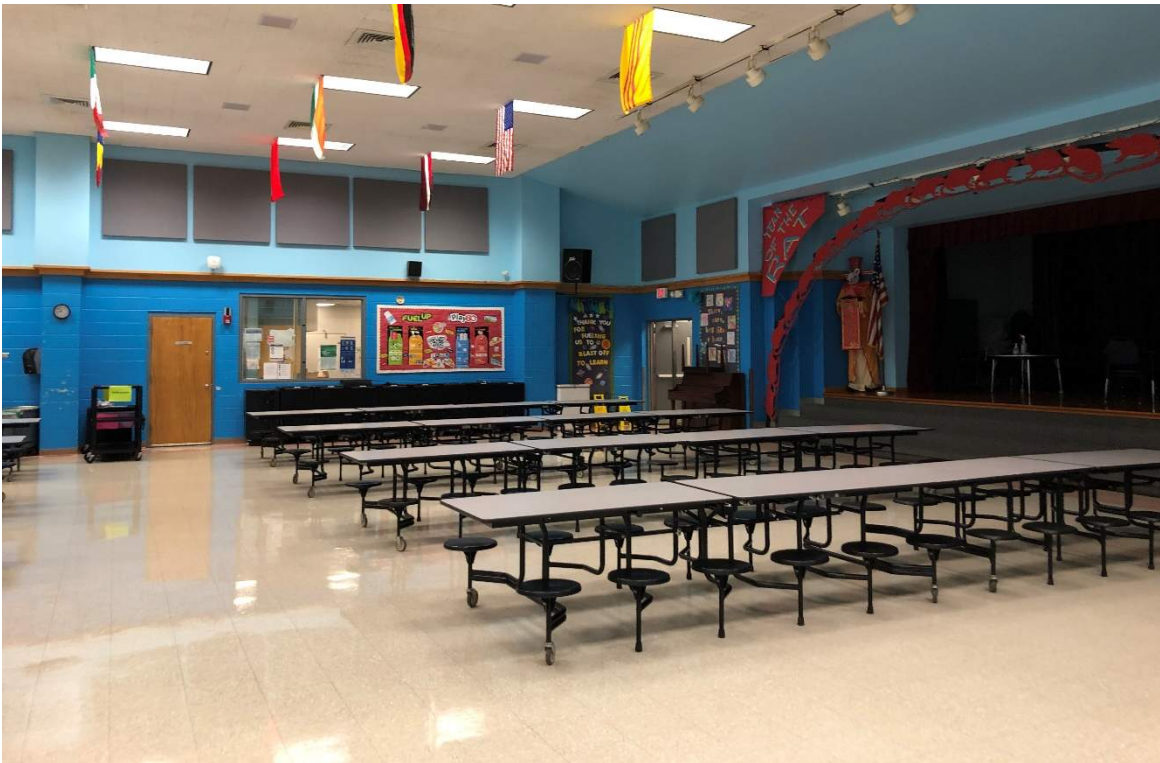
Cafeteria is undersized for campus capacity and only one type of seating is provided. Stage is adequately sized with a ramp provided for accessibility.

11.1	Is the Dining Commons appropriately configured per the ed spec?		2					1.00	2.00
	1 Very unsatisfactory - Too small, missing program spaces 2 Unsatisfactory - Too small, poor condition, only one option for eating space provided, inadequate circulation 3 Average - Adequate size and condition, needs updates or renovations to function well 4 Satisfactory - Good size and condition, good circulation, multiple options for eating space (ex: connection to outdoor eating space) 5 Very Satisfactory - Generous size, excellent condition and circulation, multiple options for eating space (ex: connection to outdoor eating space) N/A Does not apply	Dining commons is undersized at 3,450 square feet. Based on campus capacity, cafeteria should be 4,1400SF. It is even more undersized because the current enrollment exceeds capacity. Space is in good condition and appears well maintained. Only one type of seating is provided.

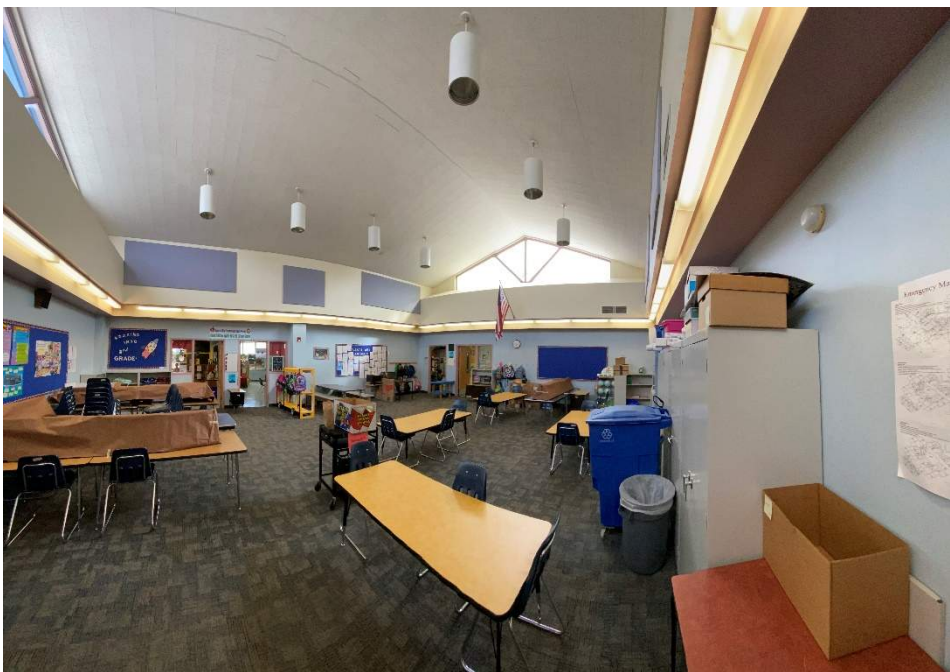
Learning neighborhood with large collaboration space. It has limited storage and limited furniture for different types of activities.

8.4	Do typical learning neighborhoods have small group rooms and open collaboration space?			3				Comments	1.00 3.00
	1 Very unsatisfactory - No breakout rooms or open collaboration spaces are provided 2 Unsatisfactory - Too small or too few, poor condition, no flexibility, lacks visual connection to learning neighborhood, poor acoustic privacy 3 Average - Adequate size, adequate condition, needs some renovations or updates to function well 4 Satisfactory - Good size, good condition and flexibility, transparency and connection to learning neighborhood, acoustic privacy 5 Very Satisfactory - Generous size, excellent condition and flexibility, transparency and connection to learning neighborhood, acoustic privacy N/A Does not apply	No breakout rooms within the learning neighborhoods. Some neighborhoods have an open common space.

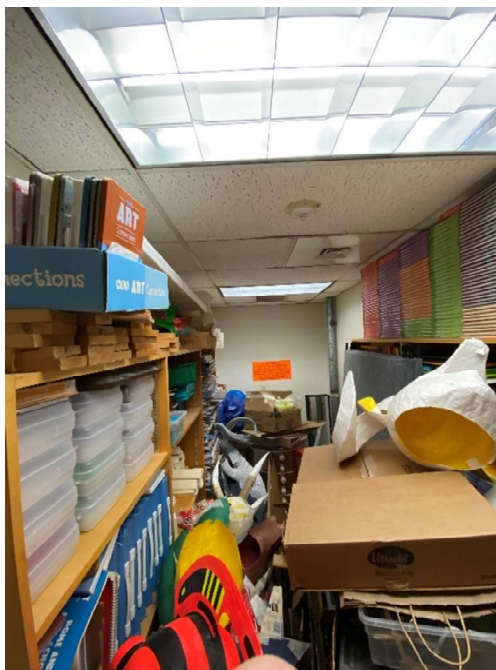
Art spaces with lack of storage and appropriate support spaces.

9.3	Are Visual Arts spaces and storage appropriately configured per the ed spec?		2					Comments	1.00 2.00
	1 Very unsatisfactory - Too small, missing program spaces							One art room is a dedicated art room and is lacking storage. Another typical studio being used as art room.	
	2 Unsatisfactory - Too small, poor condition								
	3 Average - Adequate size, adequate condition, needs some renovations or updates to function well								
	4 Satisfactory - Good size, good condition								
	5 Very Satisfactory - Generous size, excellent condition								
	N/A Does not apply

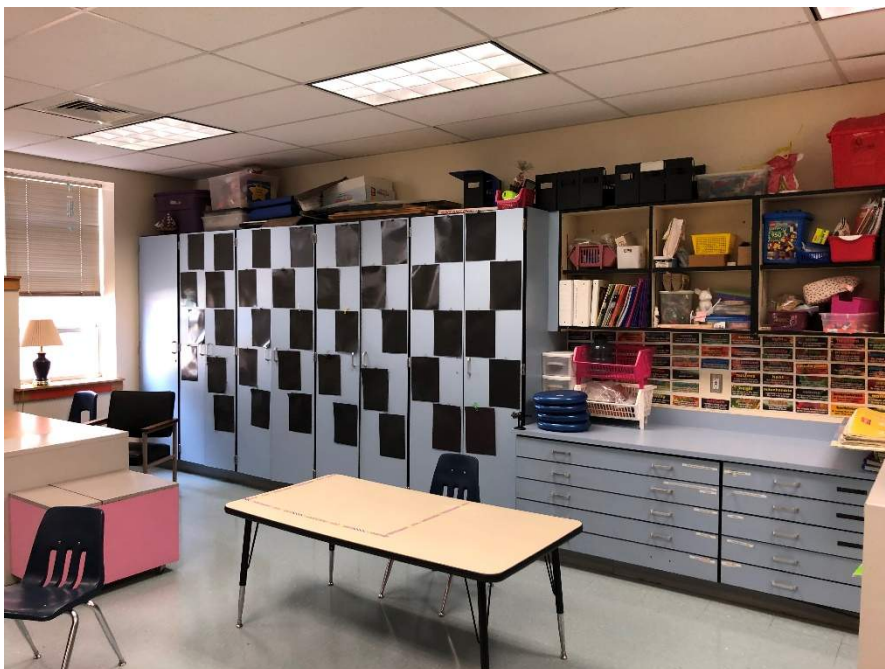
Studio being used as an art room. Does not have enough square footage per Educational Specifications or appropriate support spaces.
