Educational Suitability Summary Report

Travis Heights Elementary School

Date: 01/19/2021

Score 50% Unsatisfactory

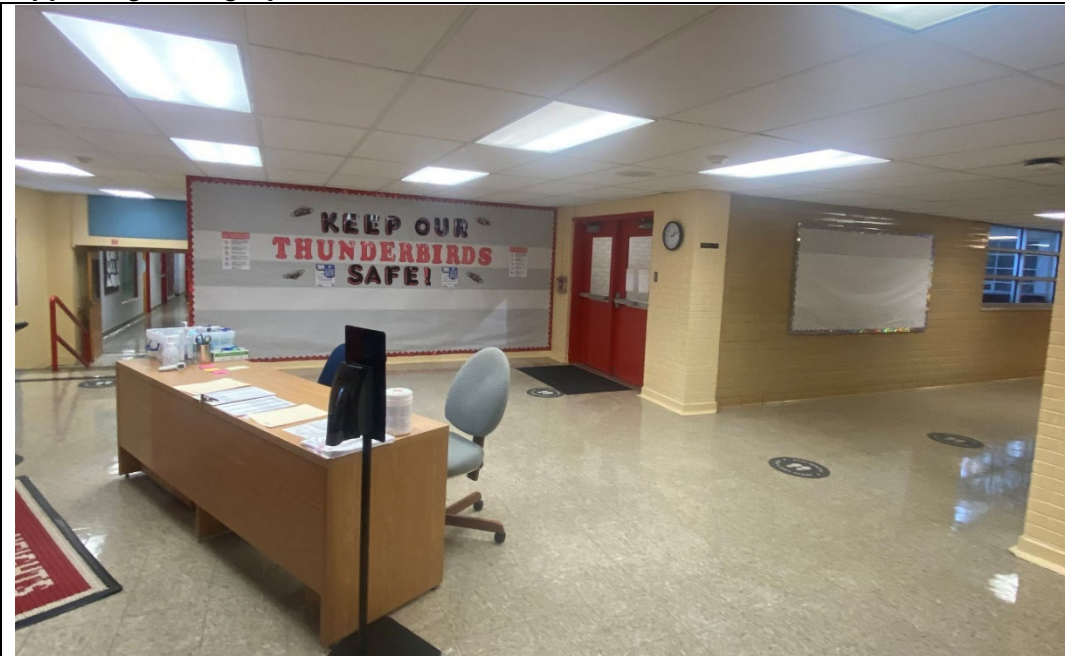
Main Entrance: [REDACTED] The ceilings are low, making the space feel unwelcoming. [REDACTED]

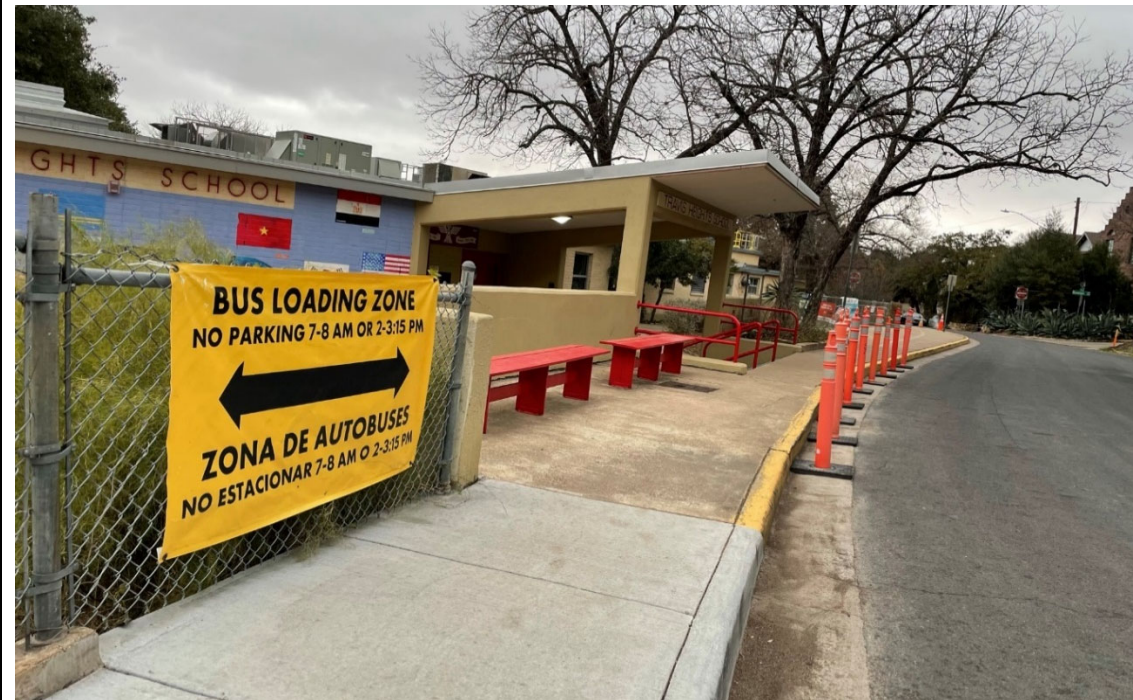
Main Entrance: The cones designate where the bus loop is set up at the beginning and end of the day. This is a residential street with houses across from the school.

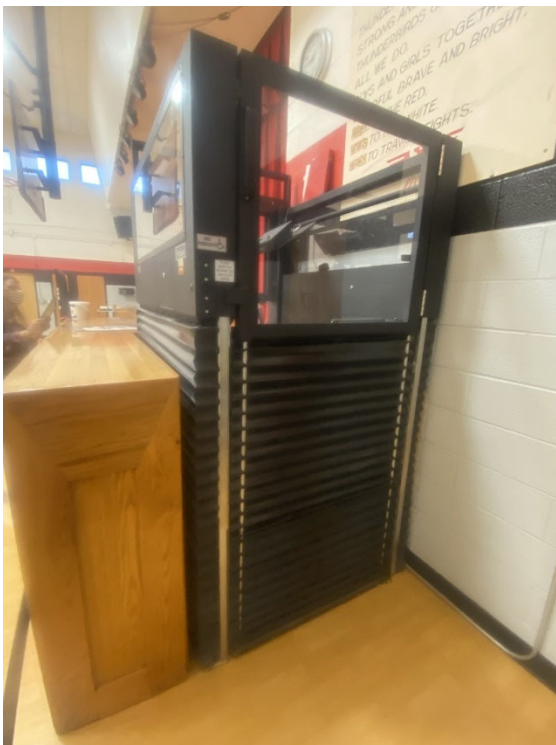
Gymnasium: The stage lift is being used for A/V purposes and there is no ramp to the stage.

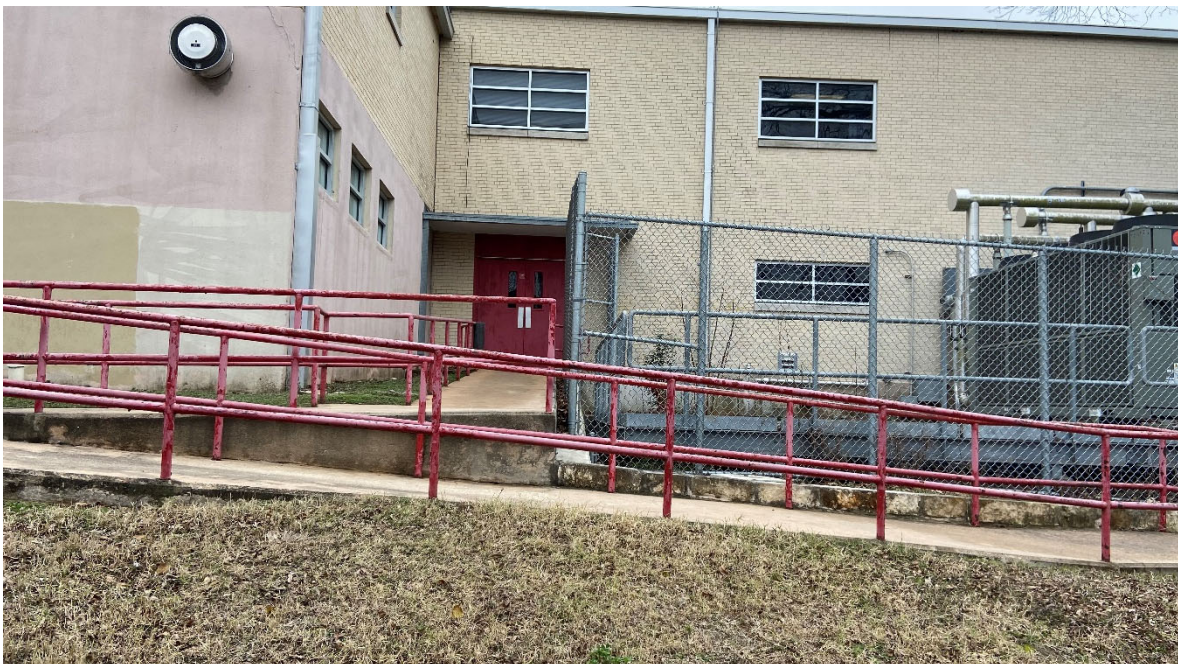
Exterior: There are several winding ramps throughout the campus to provide accessibility. The ramps lack any kind of overhead protection from weather.

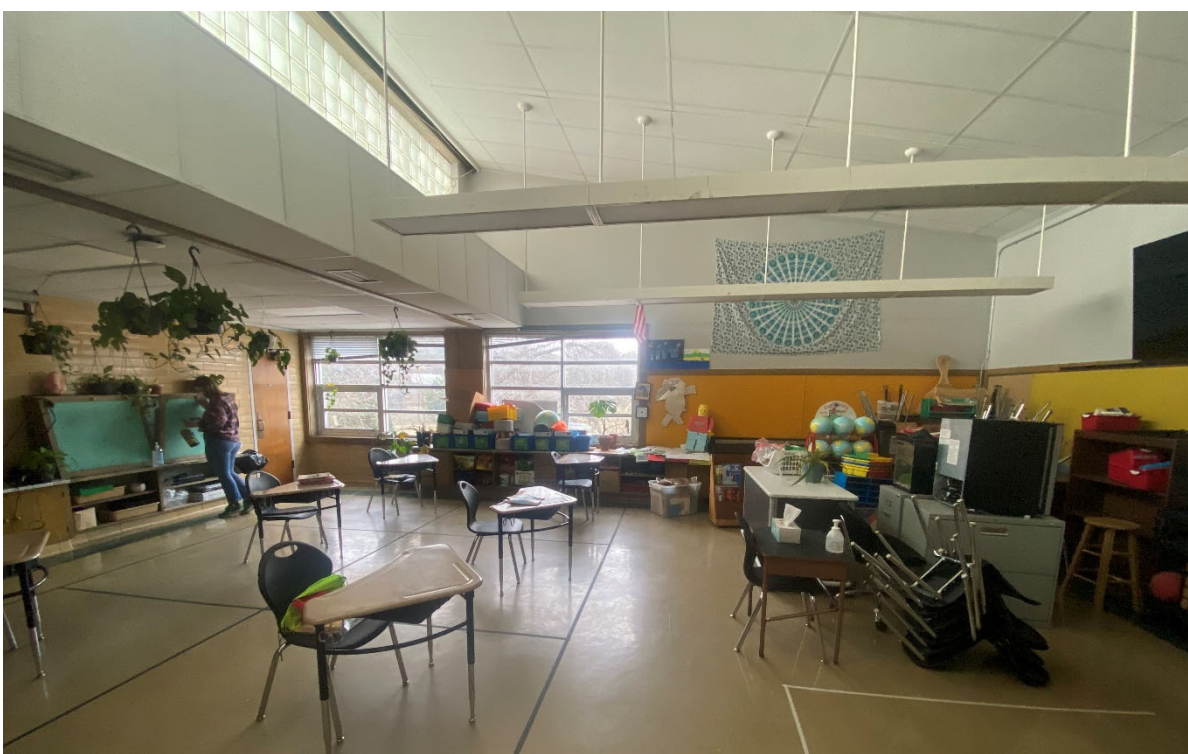
Original Building Studio: These studios provide a lot of natural light, but storage is old and not functioning well.

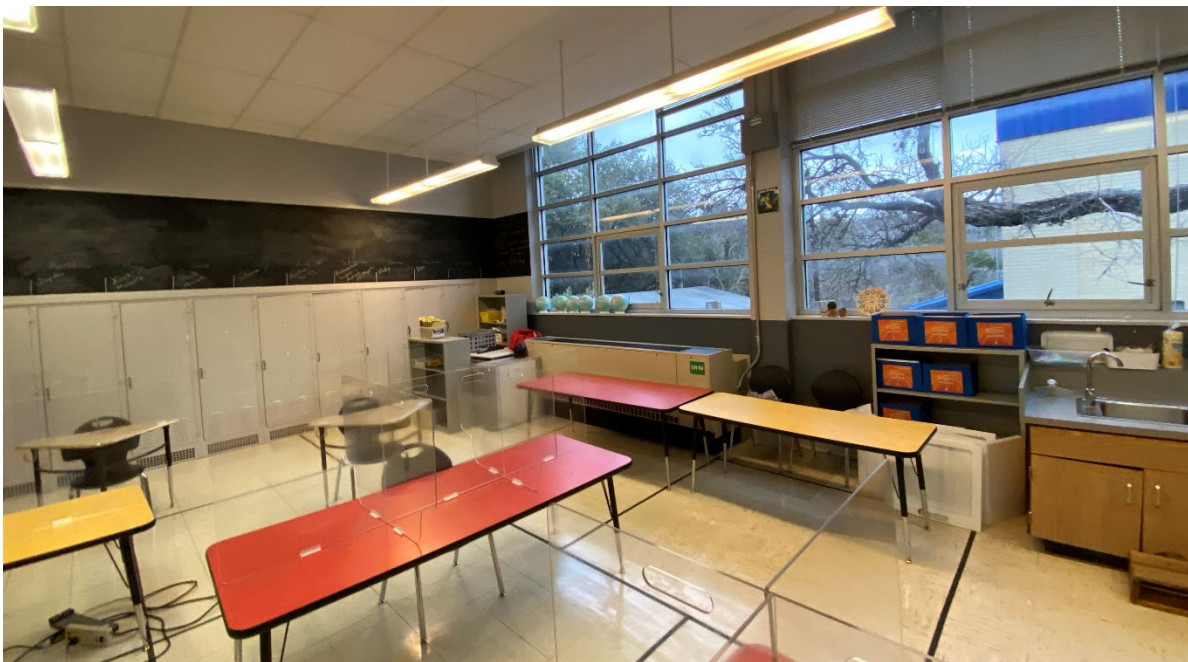
Academics and Learning: Studio has nice views to the outdoors, but storage is not usable and there is only one possible teaching wall.

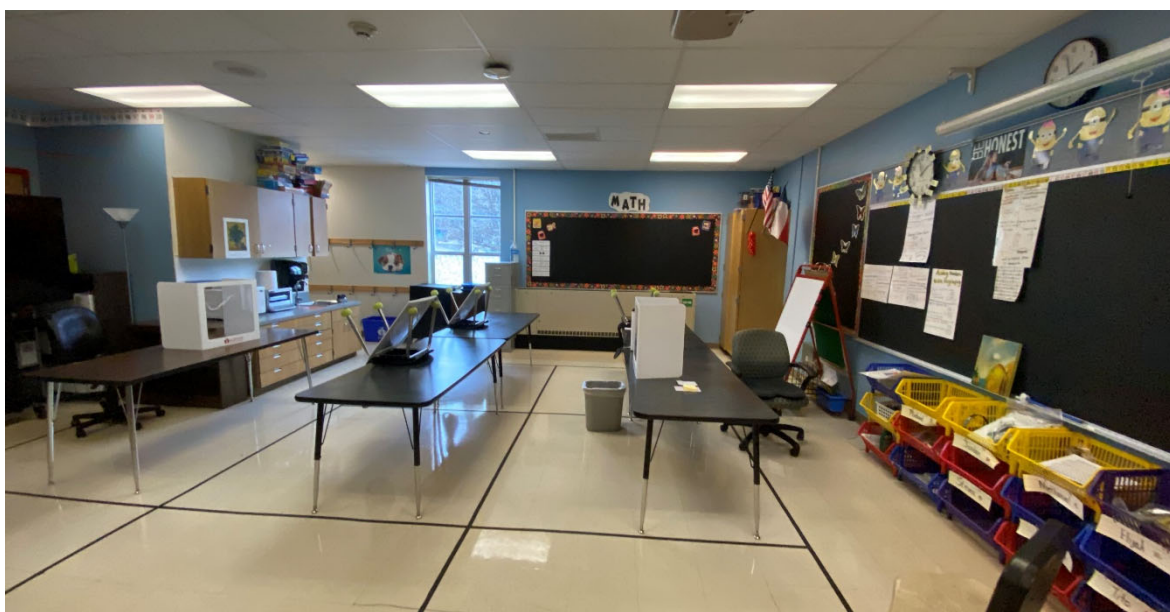
Academics and Learning: This studio has adequate storage and lighting, but there is limited visibility to the exterior and no visibility into the studios building.

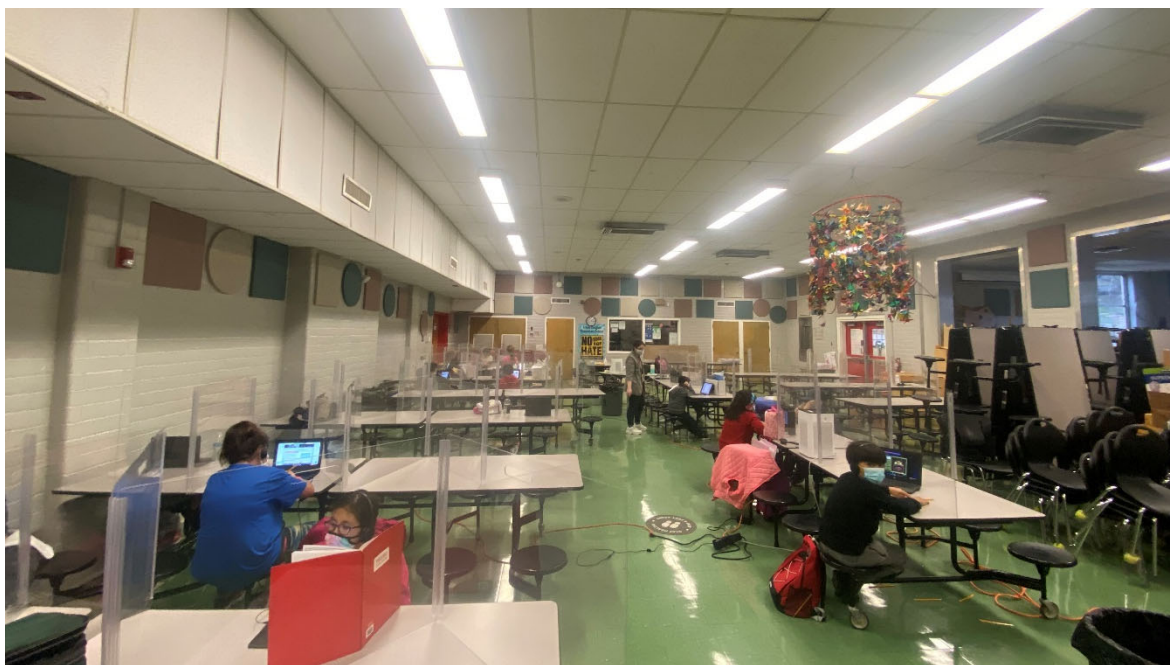
Food Services: The cafeteria is open and flexible but outdated and undersized. The serving line is pictured at the far end of the room.

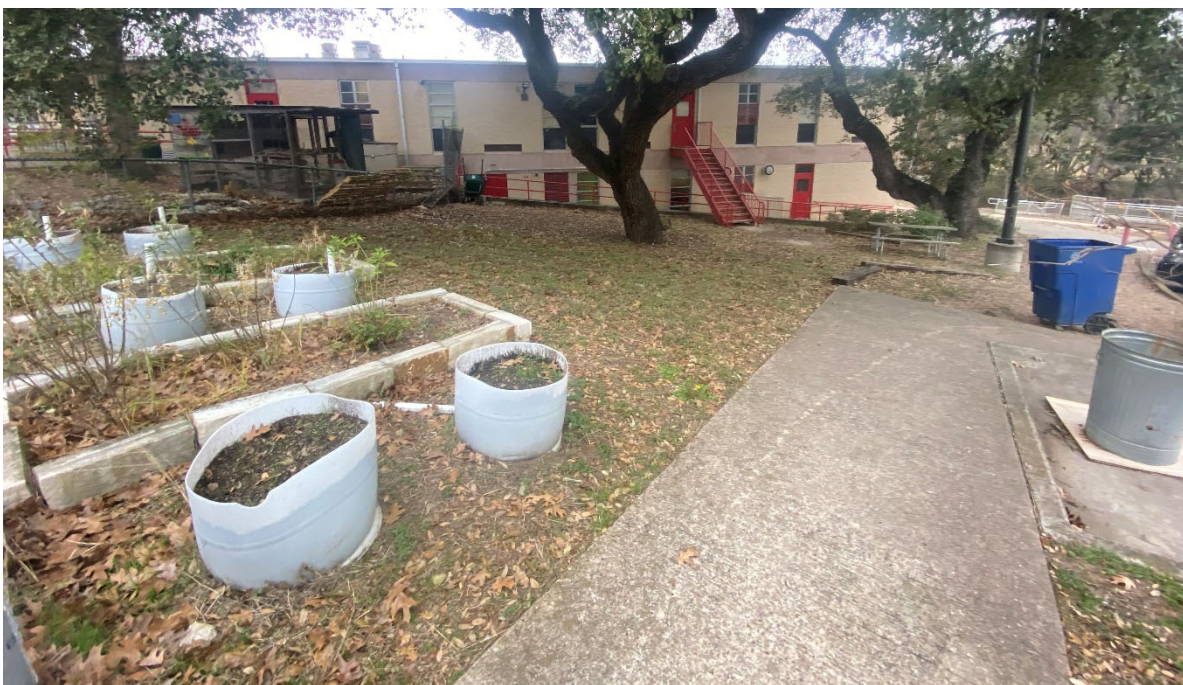
Exterior: There are several gardens and outdoor learning areas, [REDACTED]

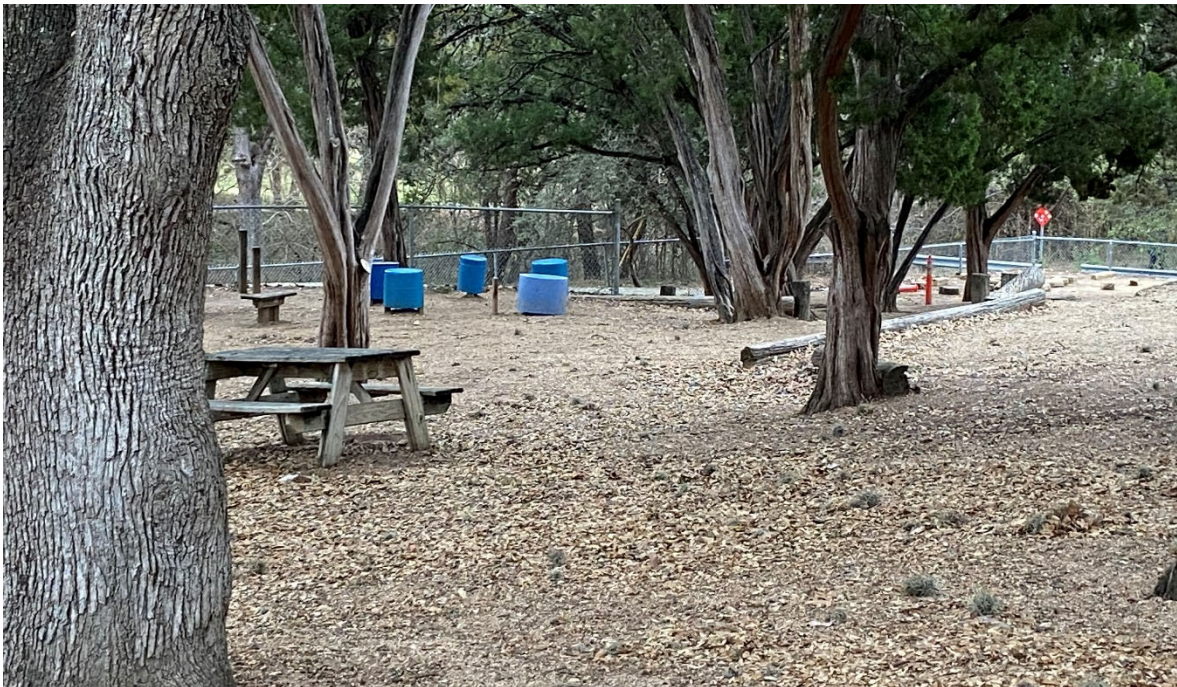
Wildman Woods is underdeveloped. The school notes [REDACTED], a lack adequate play structures for students to utilize, and has accessibility concerns
