Educational Suitability Summary Report

Uphaus Early Childhood Center

Date: 12/21/2020 Score 81% Very Satisfactory

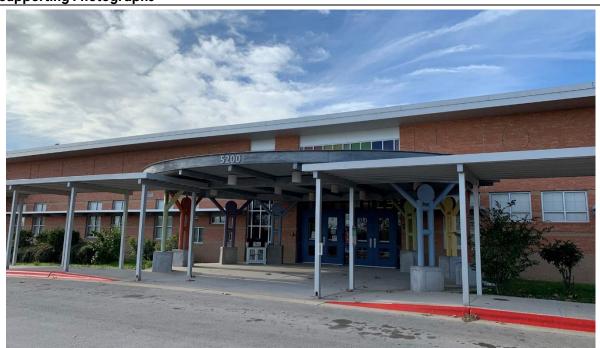
Exterior: Covered main entry and canopy along drop-off area at front of the building.

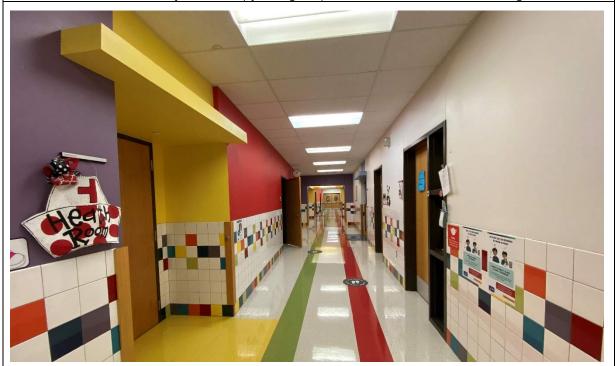
General Building: Corridors vary in width throughout the building, but wayfinding is clarified with colors

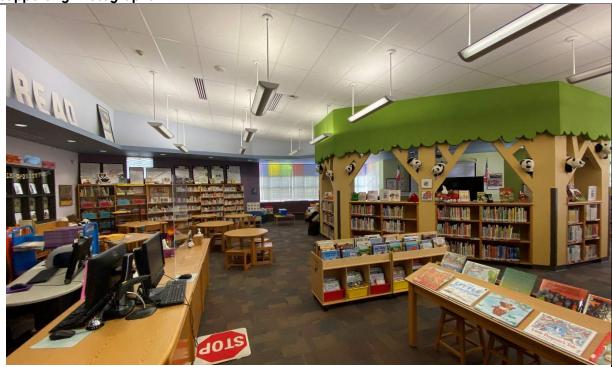
Media Resources: Playful library space is well sized with multiple areas for small group learning.

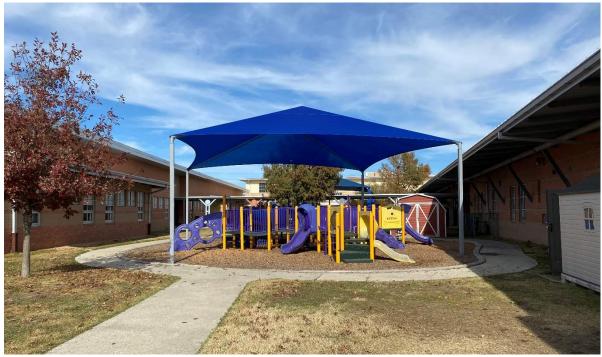
Outdoor Learning and Activity: Play structures all have covered canopies as well as the concrete play pad. Location in courtyards makes these areas centralized for the whole campus.

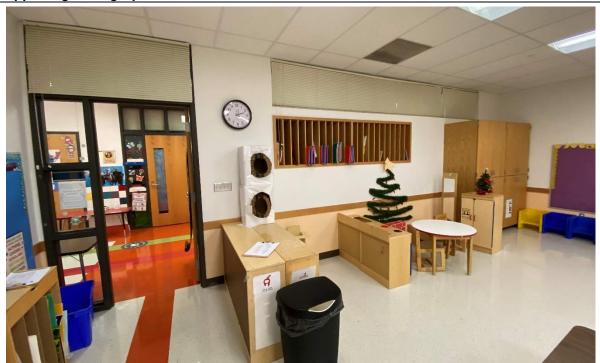
Windows adjacent to doors allow for narrow visibility to corridors and borrowed light from clerestory windows brings in light from skylight in the corridor flex space.

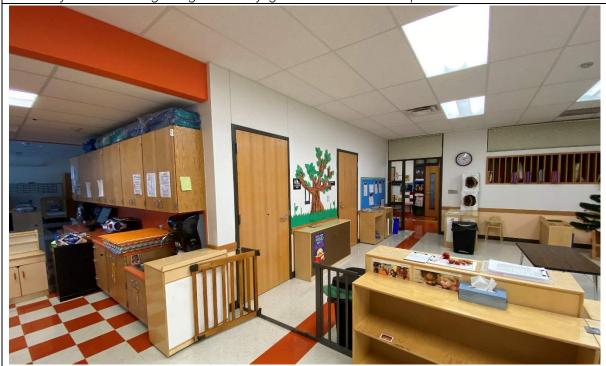
Pairs of studios are connected through a common storage and sink area.

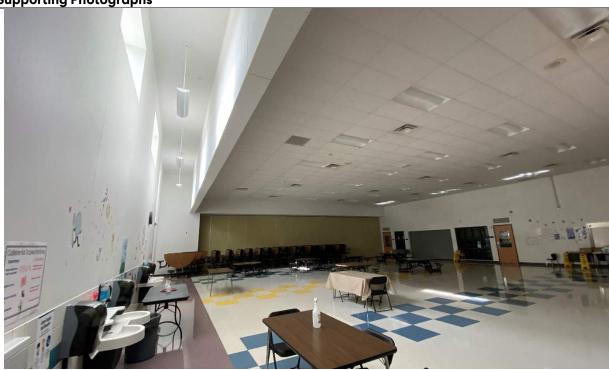
Food Services: Clerestory windows let natural light into the cafeteria. An operable partition connects to the gym in the back.

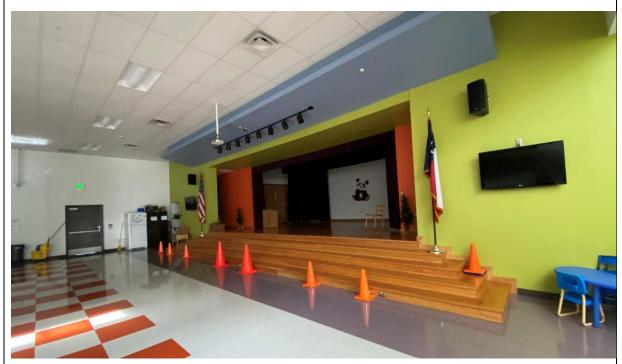
Visual and Performing Arts: The stage is undersized for larger performances and projection and technology are small for the space.

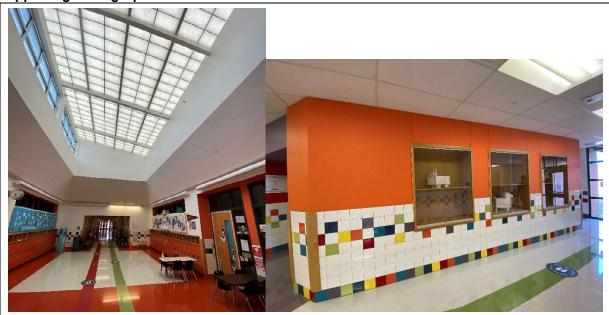
Each learning neighborhood has a shared flex space in the corridor complemented by a large skylight. 3D displays are scattered throughout the building.

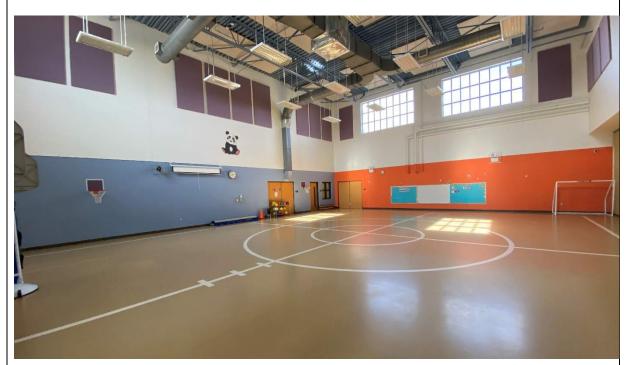
PE and Wellness: The gym is well sized and has access to the central courtyard where all the outdoor activity spaces are located.
