## Educational Suitability Summary Report

Williams Elementary School

Date: 01/21/2021

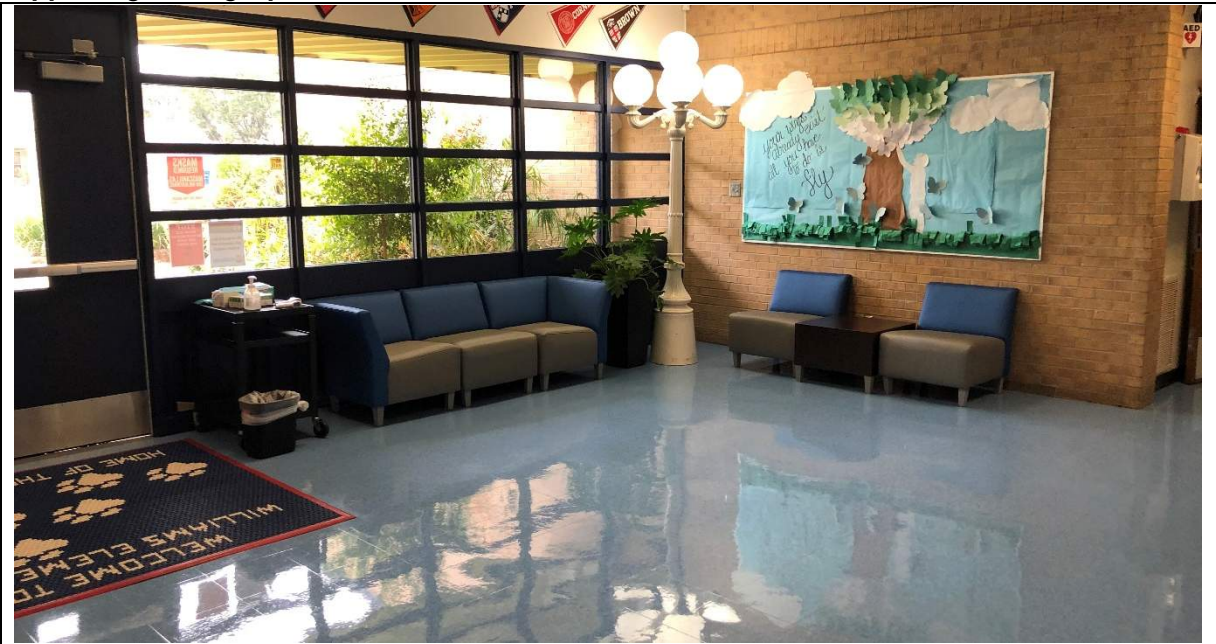
Main entry is generous, open space.

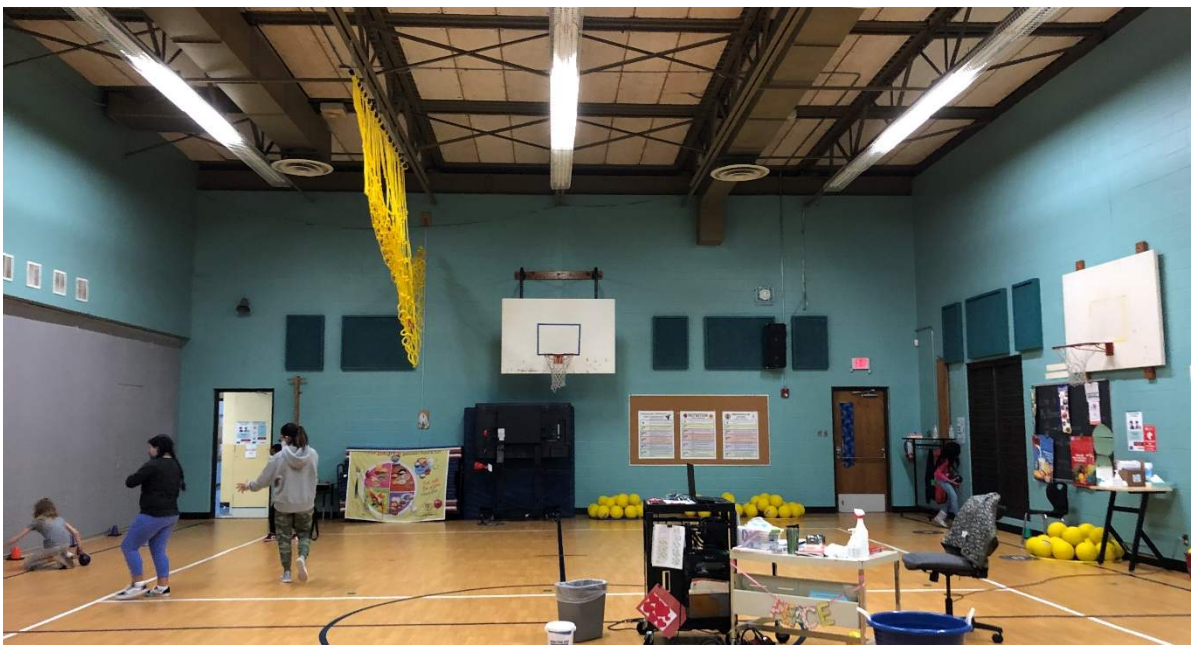
*PE and Wellness: Gym is undersized and has no access to daylight.*

Gym is small with no natural light. The equipment appears to be original and in poor condition. Restrooms across the hall have been converted to storage rooms and offices.

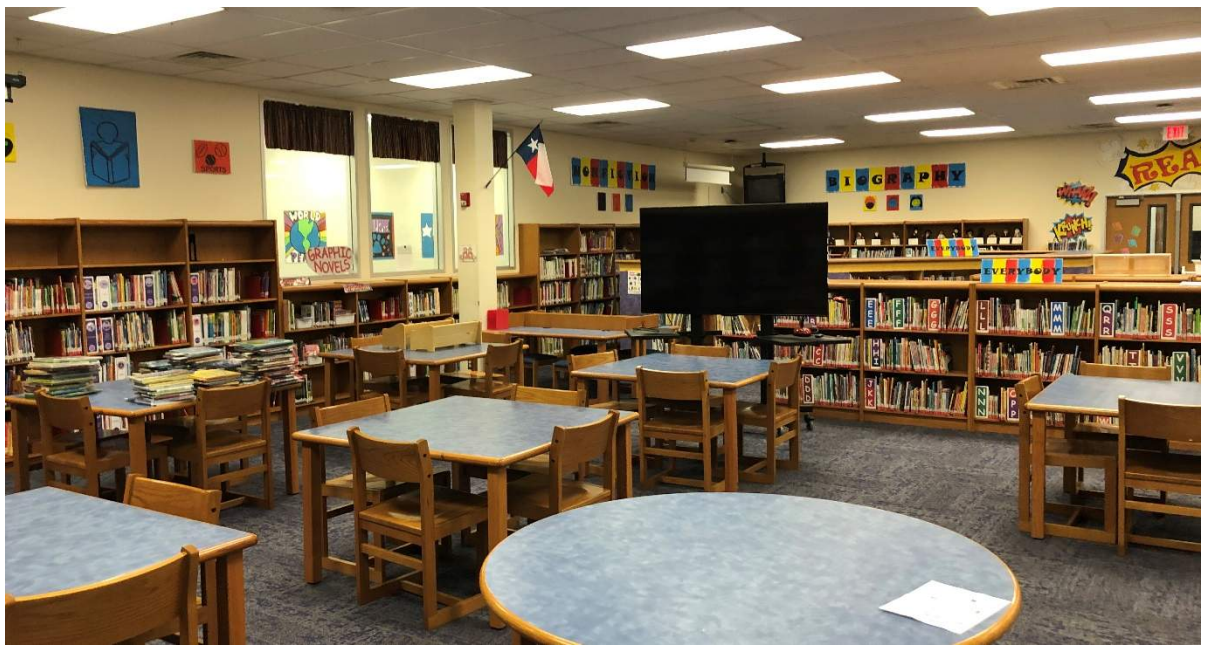
*Media Resources: Library has limited visibility to the rest of the school. Furniture is dated and not easily reconfigurable.*

Library is central in the building with no transparency. Signage is lacking to allow visitors to find it. There are no areas for quiet study or any breakout rooms. The furniture is heavy and not easily reconfigured.

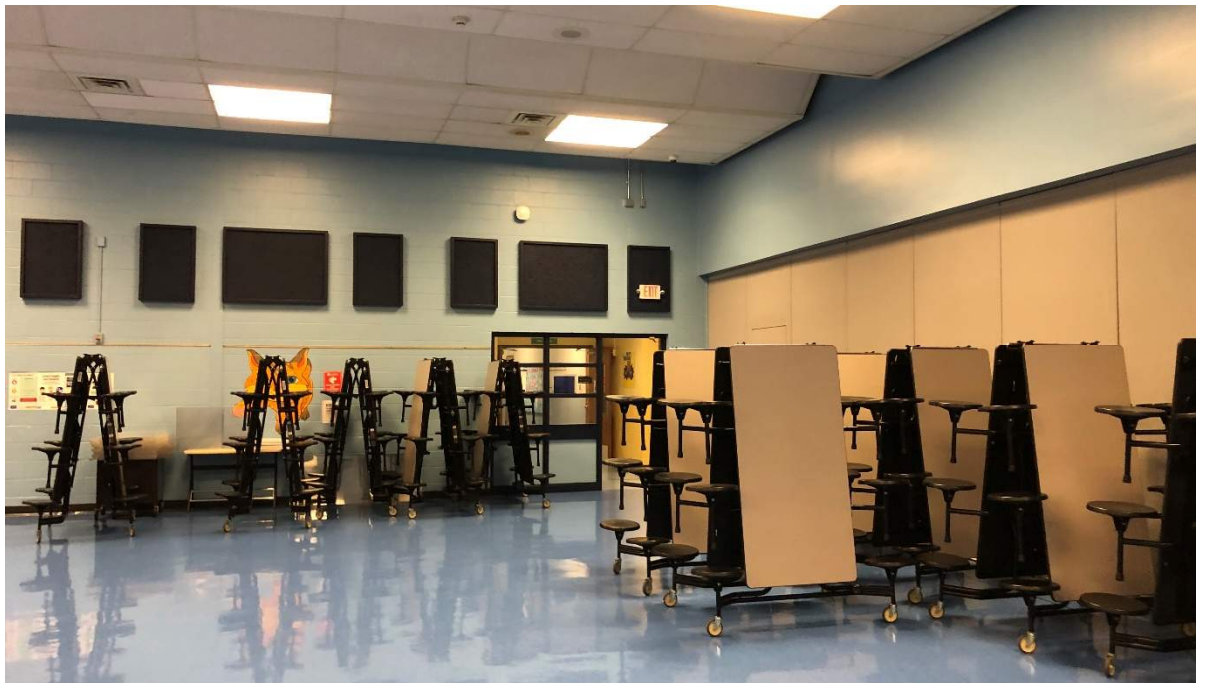
*Food Services: Cafeteria is undersized for current school capacity. Stage requires updates, and finishes are dated.*

Cafeteria is small with low ceilings and no access to natural light. The area lacks sufficient storage, and the kitchen area lacks an office.

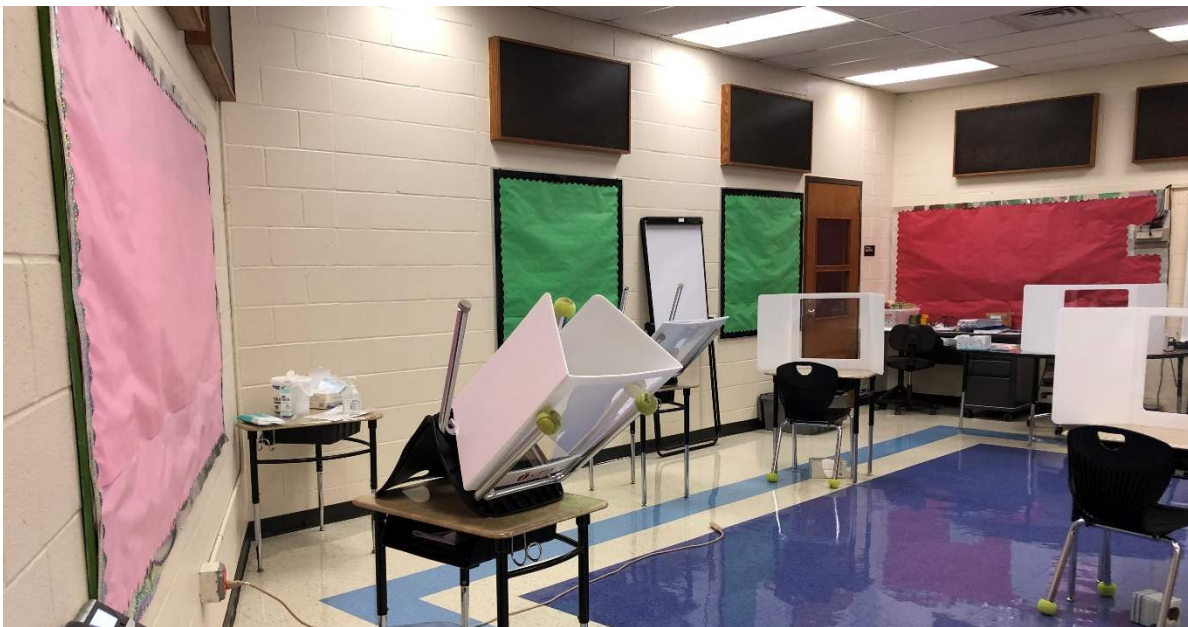
*Fifth-grade studio converted from previous music room with acoustic wall panels. The space does not have access to natural light.*

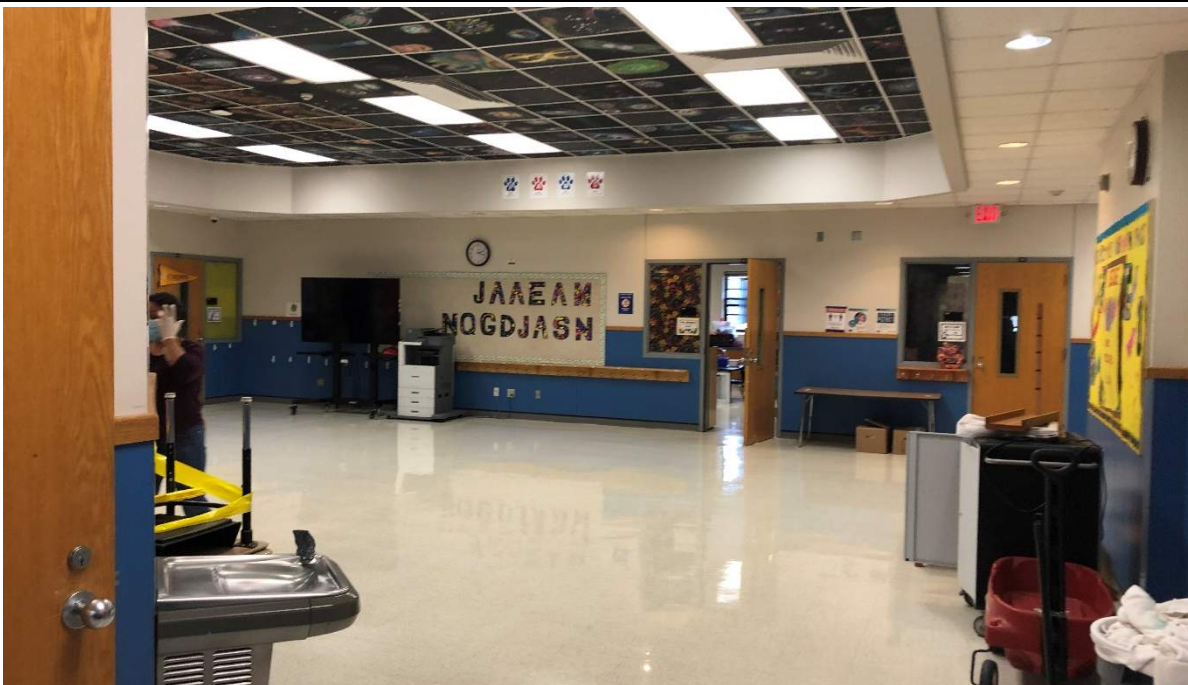
*Kindergarten and pre-K wing learning neighborhood with shared common/collaboration space. Studios are connected through a restroom corridor.*

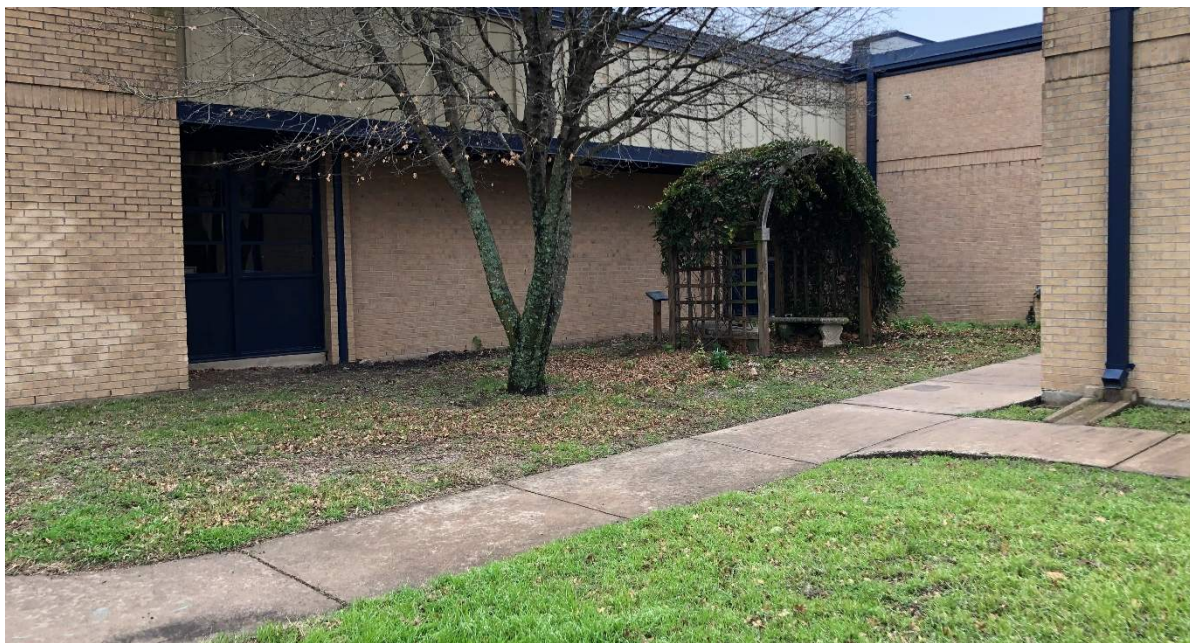
*Small outdoor learning space with insufficient seating and needs further development.*

The campus only has two gardens, and these need further development. Both are small with limited planting areas. The campus has one small cistern at the front of the campus, and another is connected to the roof of a portable.

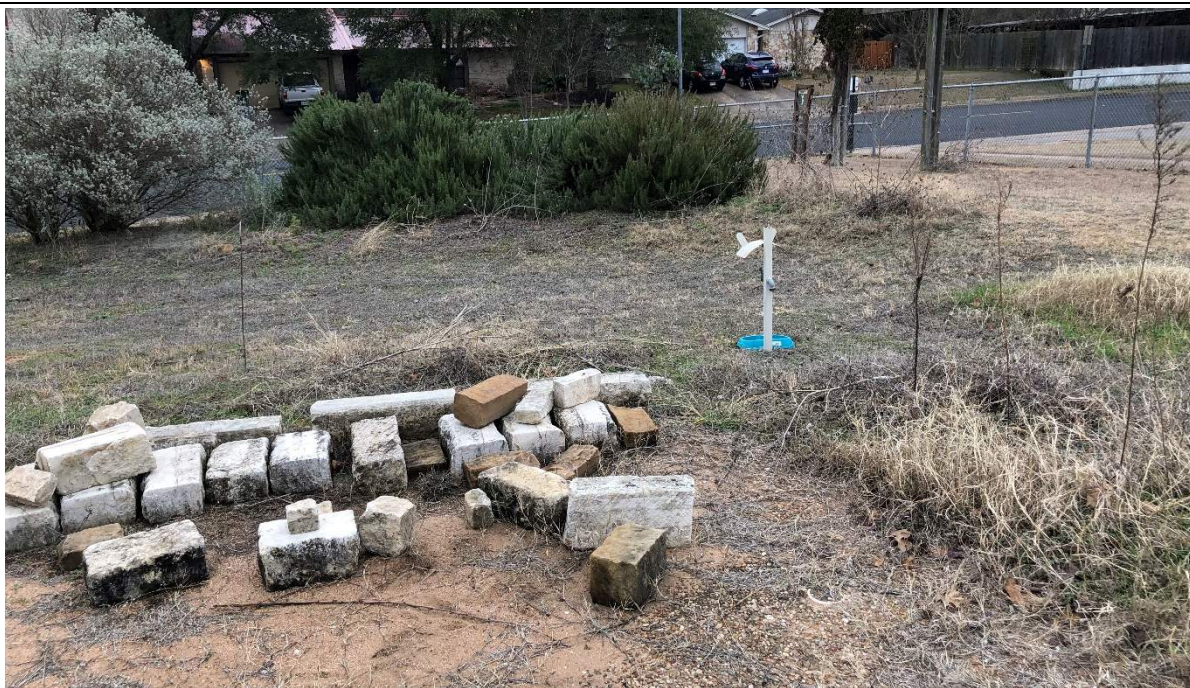
*Outdoor space with water connection but not well-developed as a learning space.*
