FACILITY CONDITION ASSESSMENT

Eastside Memorial & International ECHS | July 2021

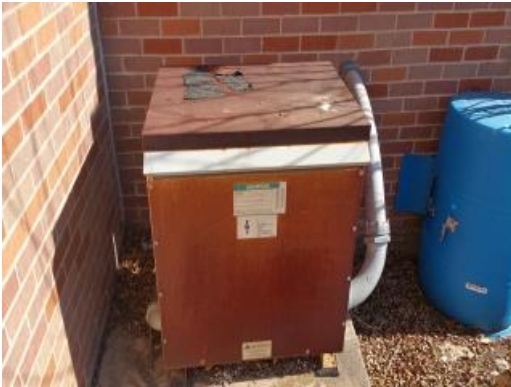
Electrical transformer aged

Deficiency	Category	Qty	UoM	Priority	Repair Cost	ID
Distribution Panel Replacement	Capital Renewal	1	Ea.	2	\$16,905	5154
Electrical Transformer Replacement	Capital Renewal	1	Ea.	2	\$75,780	5153
Electrical Transformer Replacement	Capital Renewal	1	Ea.	2	\$7,287	5155
Panelboard Replacement	Capital Renewal	6	Ea.	2	\$16,692	5156
Panelboard Replacement	Capital Renewal	1	Ea.	2	\$5,500	5160
Switchgear Replacement	Capital Renewal	1	Ea.	2	\$38,387	5152
Sub Total for System		6	items		\$160,551

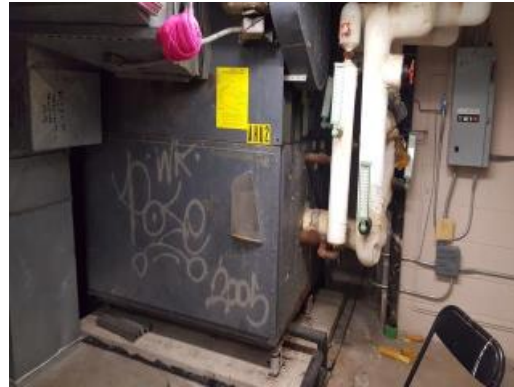
Air handling unit beyond useful life

Deficiency	Category	Qty	UoM	Priority	Repair Cost	ID
Air Handler HVAC Component Replacement Note: end of useful life	Capital Renewal	2	Ea.	2	\$171,918	5123
Air Handler HVAC Component Replacement Note: end of useful life	Capital Renewal	1	Ea.	2	\$29,014	5124
Copper Tube Boiler Replacement Note: end of useful life Location: mech room	Capital Renewal	1	Ea.	2	\$32,565	5119
Mechanical / HVAC Piping / System Is Beyond Its Useful Life Note: end of useful life	Capital Renewal	10,851	SF	2	\$46,160	5120

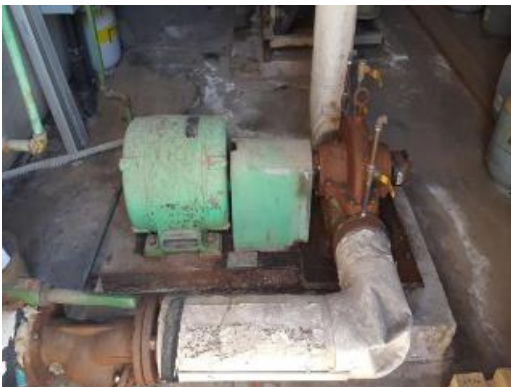
Pump beyond useful life

Deficiency	Category	Qty	UoM	Priority	Repair Cost	ID
Circulation Pump Replacement Note: end of useful life	Capital Renewal	2	Ea.	3	\$23,121	5122
Circulation Pump Replacement Note: end of useful life	Capital Renewal	1	Ea.	4	\$6,850	5121
Sub Total for System		6	items		\$309,628

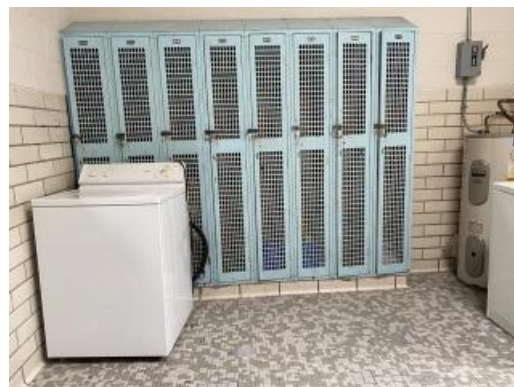
Metal lockers beyond useful life

Deficiency	Category	Qty	UoM	Priority	Repair Cost	ID
Metal Gym Locker Replacement Note: beyond service life Location: shop area	Capital Renewal	48	Ea.	4	\$23,304	5165
Sub Total for System		1 items			\$23,304	
Sub Total for Building 019A - Main building includes Administration Offices, Classrooms, Cafeteria, & Gym.		73 items			\$15,124,035

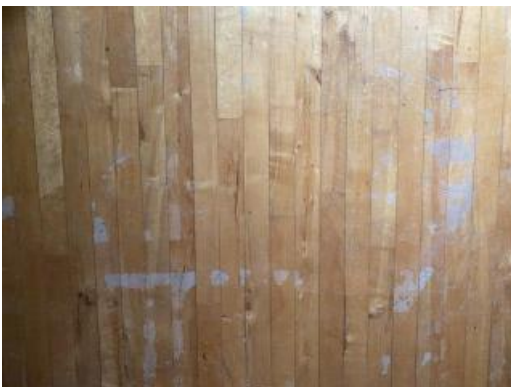
Wood floor worn and stained

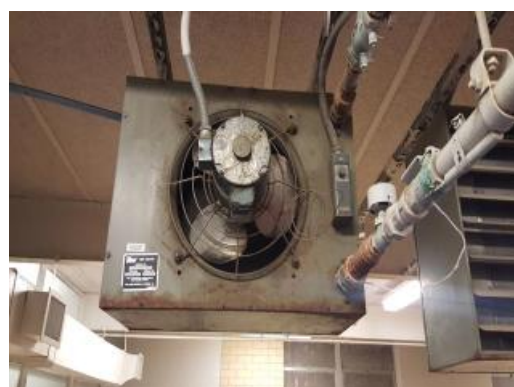
Unit heater beyond useful life

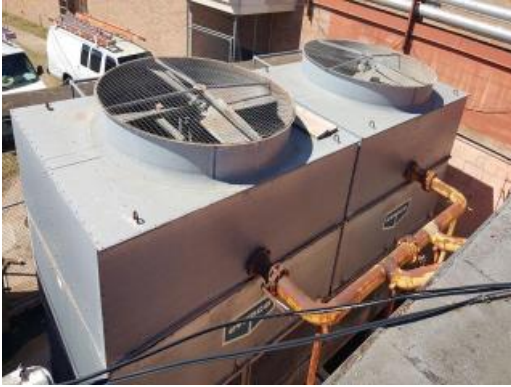
Cooling tower rusted

Chiller HVAC Component Replacement Note: end of useful life Location: room 140	Capital Renewal	2	Ea.	2	\$136,220	5070
Copper Tube Boiler Replacement Note: end of useful life	Capital Renewal	1	Ea.	2	\$32,565	5066
Exterior Metal Cooling Tower Replacement Note: end of useful life Location: mech yard	Capital Renewal	1	Ea.	2	\$105,407	5071
Fan Coil (Chilled Water) HVAC Component Replacement Note: end of useful life Location: penthouses	Capital Renewal	33	Ea.	2	\$188,555	5077
Fan Coil (Chilled Water) HVAC Component Replacement Note: end of useful life	Capital Renewal	11	Ea.	2	\$37,291	5078
Gas Piping Replacement (SF Basis) Note: 40% of system is at the end of useful life	Capital Renewal	91,655	SF	2	\$3,178,161	5055
Gas Unit Heater Replacement Note: End of useful life	Capital Renewal	11	Ea.	2	\$36,439	5067
Package Roof Top Unit Replacement Note: unit uses R-22 refrigerant and is obsolete Location: roof	Capital Renewal	6	Ea.	2	\$145,415	5079

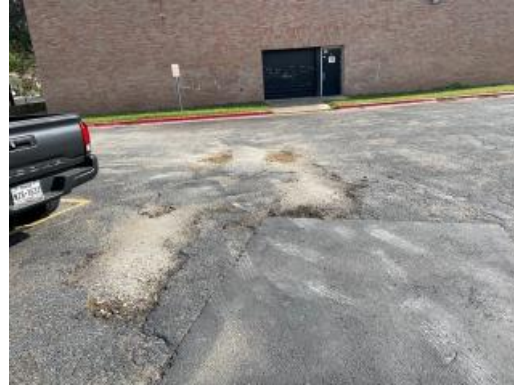
Damaged asphalt in parking lot

Deficiency	Category	Qty	UoM	Priority	Repair Cost	ID
Asphalt Paving Replacement	Capital Renewal	13	CAR	4	\$18,860	4913
Note: Holes, damage to asphalt						
Location: Southwest, cafeteria area lot						
PROGRAM DEFICIENCIES	ADA Compliance	535,755	EACH	5	\$919,881	5762
PUBLIC DEFICIENCIES	ADA Compliance	561,350	EACH	5	\$963,827	5761
TAS ACCESSIBILITY DEFICIENCIES	ADA Compliance	338,587	EACH	5	\$581,347	5763
	Sub Total for System	4	items		\$2,483,916	
	Sub Total for School and Site Level	4	items		\$2,483,916
