Allan Elementary School Site Summary

Address	4900 Gonzales Street Austin, TX 78702
Number of Permanent Campus Facilities	3
Original Year of Construction	1957
Total Campus Building Area (combined)	112,679 SF

Introduction

Main School Building – BLDG-142A

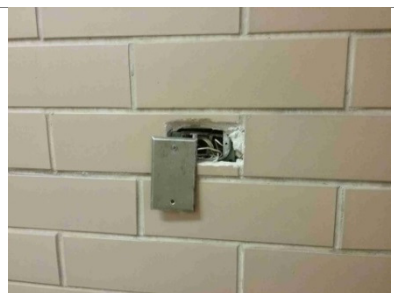
Electrical Distribution

System	Subsystem	Condition and Deficiency Overview	System Condition Rating
		<p>end of its typical service design life. The Square D 408VAC 1600-amp switchboard, located in the northern electrical room adjacent to the west kitchen wall, was nearing the end of its typical service design life. A wall plate located in corridor 3 had become detached, leaving exposed cabling. A junction box located in corridor 2 was missing an enclosure cover, leaving cabling exposed.</p> <p>Rocker-style switches exist for corridor lighting, which are outdated and difficult to find replacement parts.</p> <p>Various exterior lighting illuminate by photocells and not timers, which often need replacing.</p> <p>The facility requested lighting be installed in crawl spaces and additional receptacles be added in classrooms.</p>	
	Lighting	<p>The exterior of the building is outfitted with what appears to be wall-mount HID (high-intensity discharge) fixtures located near the roofline of the building. There are exterior-style flood fixtures mounted at certain corners of the building, and covered walkways are illuminated by surface-mounted ceiling fixtures. The parking lot and property areas are illuminated with pole lights. The interior lighting consists of troffer, flush ceiling-mount, and hanging fluorescent fixtures. Most closets and mechanical rooms are illuminated with screw-type fixtures. The stage is equipped with specifically designed lighting to support stage productions, and the gymnasium contains hanging fluorescent fixtures.</p> <p>The lighting was observed to be in average condition.</p> <p>The exterior lighting seemed to be sparse. An exterior flood-style fixture was inoperable. The exterior lighting was observed to be in average condition.</p> <p>There are exit signs at every exit. Various signs were not illuminated..</p>	Average

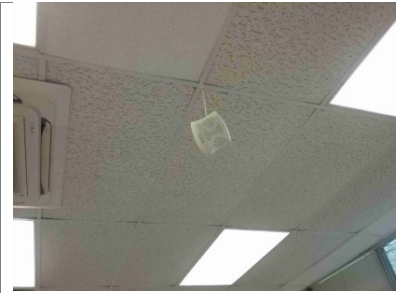
Communications & Security

System	Subsystem	Condition and Deficiency Overview	System Condition Rating
		<p>rack-style configuration. The facility appears to have wireless routers installed in classroom ceilings strategically throughout the building.</p> <p>There were no damaged security panels or cameras observed.</p> <p>The equipment was observed to be in good condition.</p> <p>A wireless router located in room 304 appeared to be hanging from a CAT 5 cable in the ceiling.</p>
