Andrews Elementary School Site Summary

Introduction

Main School Building – BLDG-102A

Gymnasium – BLDG-102B

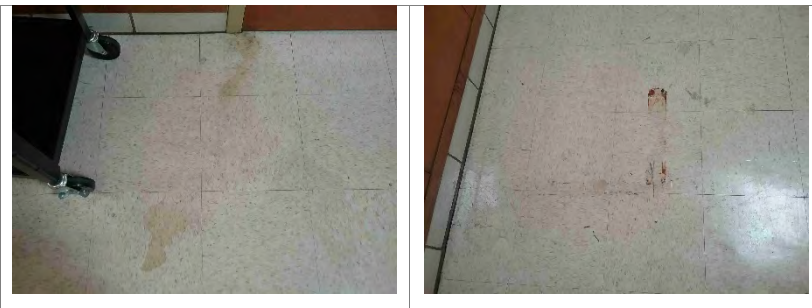
System	Subsystem	Condition and Deficiency Overview	System Condition Rating
	Interior Floor Finishes	<p>VCT (vinyl composition tile) is found throughout the building, and ceramic tile floor is present in the restrooms and quarry tile is present in the kitchen. There is a wood stage located at the front of the cafeteria. The administration offices and library are finished with carpet and VCT.</p> <p>The majority of the flooring appeared to be in good condition, though a few spots of staining and scuffing were observed.</p>	Good
	Interior Ceiling Finishes	<p>The interior ceilings are mostly wood wool (tectum) panels which appear original to the building with a small area of acoustical ceiling tile (ACT). The library ceiling is finished with painted wood wool (tectum) panels and metal. The cafeteria ceiling is finished with wood wool (tectum) as well.</p> <p>Much of the wood wool (tectum) panels were water damaged. The 100- and 300-wings were observed to have water damaged panels. The roof above the 100- and 300-wing was not observed to be excessively discolored but did exhibit dark streaking. The paint was observed to be peeling from the panel support tees. The library ceiling appeared to be newer than the rest of the school and was observed to be in excellent condition. It was reported that there is leaking in the chair storage area in the northwest corner of the cafeteria, but no water damaged was observed. The ceiling in that area appeared new. Two sealed skylights were observed in the 200-wing. Discoloration was observed on the kitchen soffit, and a few broken ACT panels were observed.</p>	Average
