Barrington Elementary School Site Summary

Address	400 Cooper Drive Austin, TX 78753
Number of Permanent Campus Facilities	3
Original Year of Construction	1969
Total Campus Building Area (combined)	79,689 SF

Introduction

Main School Building – BLDG-149A

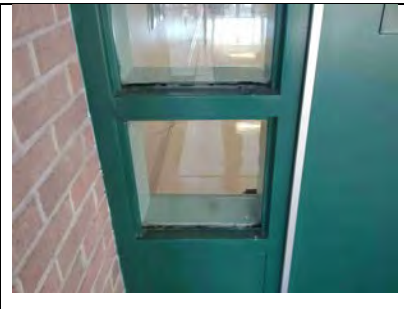
System	Subsystem	Condition and Deficiency Overview	System Condition Rating
Exterior	Exterior Walls	Exterior walls are primarily brick with mechanically fastened metal panels above and as infill panels at window units. The exterior walls were observed to be in good condition. Deficiencies noted for the brick work included missing or aged sealant at the control joints and cracking of brickwork or grout at the outside corner of room 307. The metal panel system had a loose trim piece in one location and the fasteners appeared to be loose and missing in a few locations.	Good
	Exterior Windows	Exterior windows are aluminum framed single pane glazing units in a single hung configuration. The exterior windows were observed to be in good condition. One window unit was observed with damaged glazing. On all units, the sealants were noted as aged and cracking.	Good
	Exterior Doors	The exterior doors consist of hollow metal doors set in hollow metal frames. Typically, these units contain glazed vision panels. Mechanical rooms have door leafs without windows. The exterior doors were observed to be in good condition. The only deficiency noted was the lack of lower glazing stops in three locations at the southern exit from corridor C1.	Good
