Barton Hills Elementary School Site Summary

Introduction

Main School Building – BLDG-103A

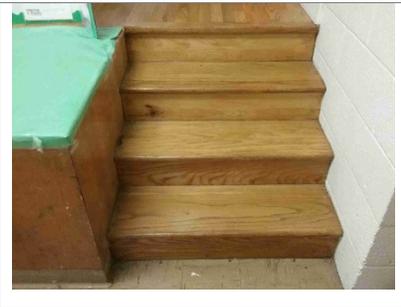
| System | Subsystem | Condition and Deficiency Overview | System Condition Rating |
|---|---|---|---|
| | Interior Stairs | <p>A concrete ramp with galvanized pipe handrails is installed in corridor C5 instead of stairs as indicated in the currently recorded building plans. Elsewhere, four sets of corridor, sealed-concrete stairs with embedded abrasive nosing strips are installed with stained wood handrails. Additionally, two pairs of rear and front wood stairs access the cafeteria stage. These four stairs do not have handrails.</p> <p>All stairs and rails appeared to be in good condition.</p> | Good |

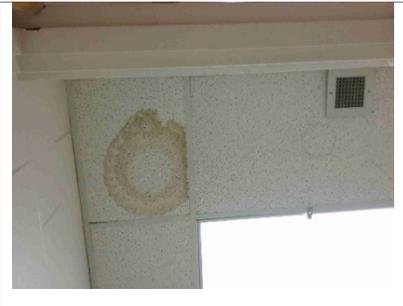
Interior Ceiling Finishes

| System | Subsystem | Condition and Deficiency Overview | System Condition Rating |
|---|---|--|---|
| | | <p>A 2'x2' vinyl-clad, lay-in ceiling is installed in the kitchen. There is a raised area of painted gypsum board ceiling in the library. An acrylic lens accent lite panel is installed outside of the administration reception area.</p> <p>All of these systems appeared to be in good condition, except in the cafeteria toilet rooms where tiles should be replaced.</p> | |
