Becker Elementary School Site Summary

Address	906 W. Milton Street Austin, TX 78704
Number of Permanent Campus Facilities	4
Original Year of Construction	1936
Total Campus Building Area (combined)	59,669 SF

Main School Building – BLDG-104A

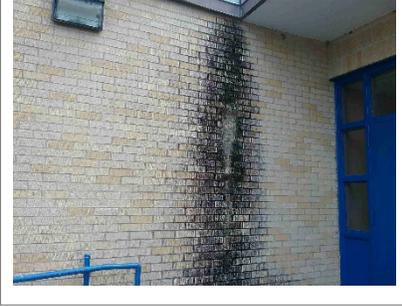
System	Subsystem	Condition and Deficiency Overview	System Condition Rating
Exterior	Exterior Walls	<p>The exterior of the building consists of a brick façade with plaster accents.</p> <p>The exterior walls appeared to be in good condition, with isolated areas of discoloration.</p>	Good
	Exterior Windows	<p>The exterior windows vary between single-hung windows in aluminum frames, fixed narrow windows in aluminum frames and glass block. The single-hung windows sit atop concrete sills.</p> <p>The windows were in conditions ranging from good to poor. Some windows in metal frames, original to construction, had deteriorated sealant and rusting frames. The windows in the annex building, original to construction, were loose and rattled in the wind. Some windows frames were rusting. Most of the sills were stained and discolored. The majority of windows were in good condition, but with dirtied frames. It was reported that the classroom windows on the second floor had problems with leaks, but no damage was detected.</p>	Average

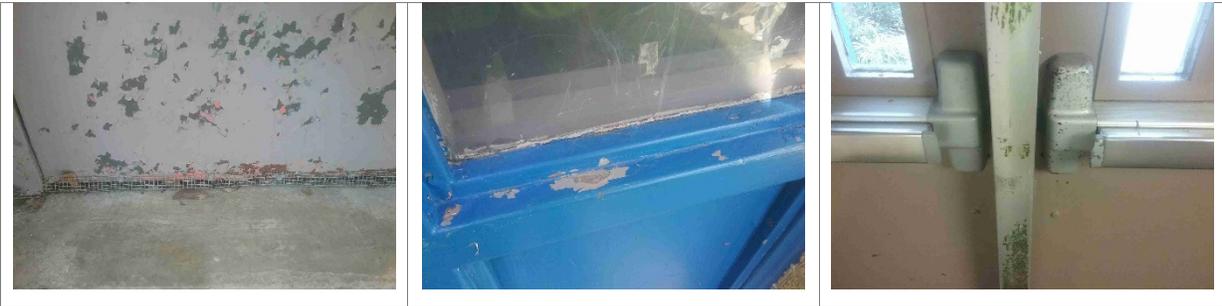
Exterior Doors	<p>There are multiple exterior doors leading into the building. They are metal with narrow lites and are set in a storefront system.</p> <p>The exterior doors were in average condition with peeling paint and paint bleeding onto the glass. Some of the paint on the frames was worn off.</p>	Average

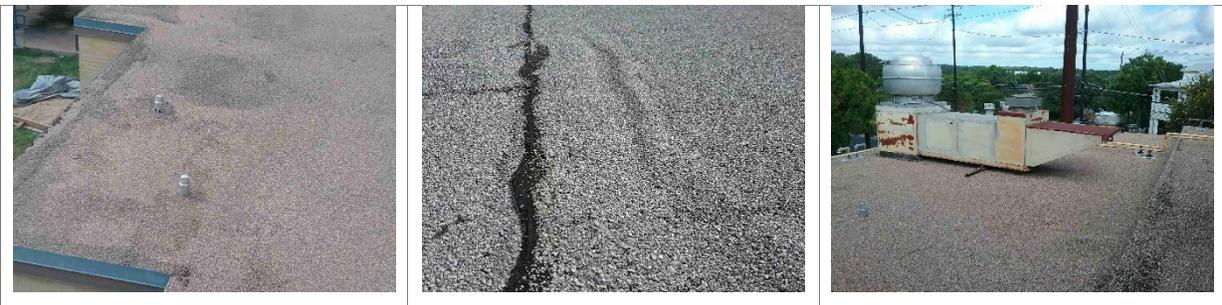
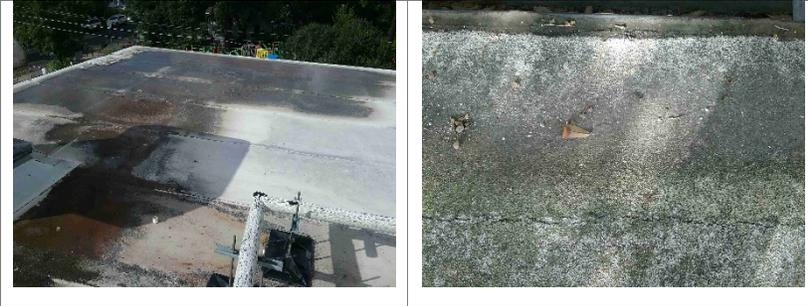
Roofing Deficiency Examples

System	Subsystem	Condition and Deficiency Overview	System Condition Rating
Roofing		<p>The roof material covering the building varies between built-up asphalt with a granular topping, modified bitumen, and a small portion of single-ply membrane.</p> <p>The roof surfaces were in average condition due to discoloration and ponding. Large swaths of discoloration were observed. A strong sewage odor was blowing from the fan above the kitchen. Portions of the gymnasium roof were slightly depressed and discolored. Ridges and folds in the membrane were also observed. A very large portion of the roof had a 1/2-inch deep layer of ponding water. A pipe leading to RTU-2-11 (roof top unit-2-11) was actively dripping. The underside of the gymnasium eave, which is concrete, was discolored from water. Many areas of ponding were observed on the single-ply membrane roof, and an excessive amount of leaves had collected at the parapet walls.</p>	Average

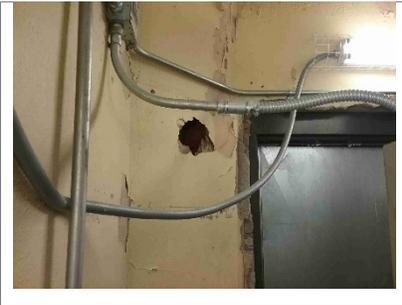
Interior Construction	Interior Walls	<p>The interior walls are built of CMU (concrete masonry unit), brick, and portions of drywall over steel stud construction.</p> <p>The interior partitions appeared to be in good condition with minor areas of damaged drywall.</p>	Good
	Interior Doors	<p>The interior doors are wood in metal frames. Some doors have narrow lights with acrylic glazing. Some doors have wired glazing.</p> <p>The doors were in average condition, typically undamaged, but some frames and door bases were severely damaged from every day use. The acrylic door lites were very scratched. Door 303 was very difficult to close.</p>	Average
	Interior Specialties	System not present.	N/A
Stairs	Exterior Stairs	<p>There is one metal exterior stair used for fire egress from the annex building. It is a two-run stair with diamond plate treads.</p> <p>Corrosion and damage were not observed on the stair, but a large amount of bird droppings were dried on the metal. The space between balusters was more than four inches clear.</p>	Good

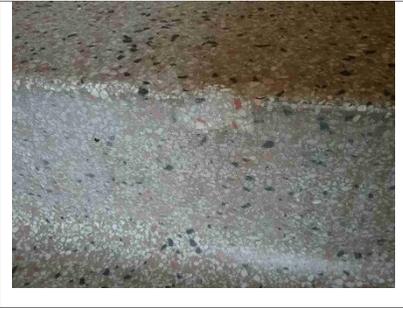
Interior Stairs	<p>There are three staircases in the building, two in the main building and one in the annex. The stairs are concrete with wood handrails. Two of the stairs are finished in terrazzo.</p> <p>The stairs appeared to be in good condition with only a few minor chips in the terrazzo material.</p>	Good
Interior Finishes	Interior Wall Finishes	<p>The interior wall finishes include ceramic-faced masonry units, unpainted brick, painted drywall, and painted acoustical wall panels.</p> <p>The ceramic-faced masonry wall in the gymnasium had damaged grout and adhesive residue. Some of the paint</p>	Average

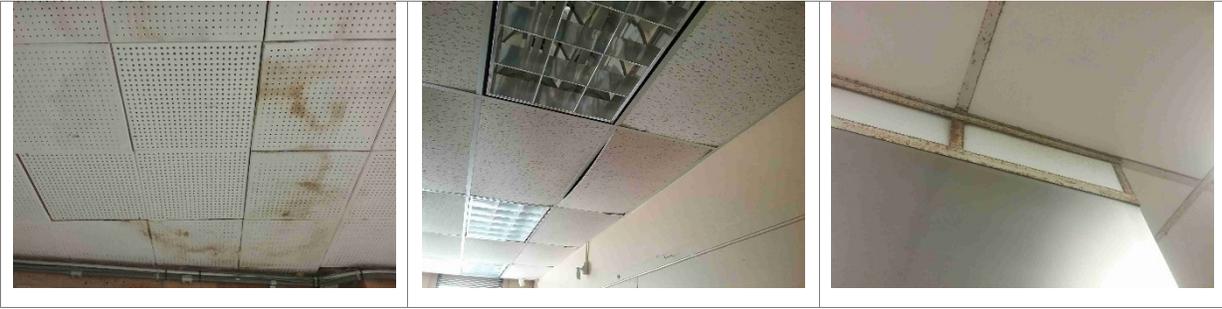
Interior Ceiling Finishes	<p>The majority of interior ceiling finishes include gypsum with popcorn texture and ACT (acoustical ceiling tile). Some wood wool paneling is present in the building.</p> <p>The ceiling appeared to be in poor condition with water damage and bowing tiles. The ceiling in the kitchen had spotting on the ceiling tile tees, but the nature of the spotting could not be determined.</p>	Poor
Conveying	System not present at facility.		N/A
Plumbing	Plumbing Fixtures	<p>The building consists of male and female restrooms on two floors. The typical restroom has vitreous china hand sinks with manual faucets. There are water coolers throughout the building, typically located near a restroom.</p> <p>One of the urinals in the male restroom on the first floor of the annex building did not flush. The male restroom on the second floor had a toilet with a flush knob that stayed in the flush position. There was a urinal that would not flush. There was no hot water distribution to the sinks, which is typical in elementary schools. One of the sinks in the library was missing the handle for the hot water valve.</p>	Good

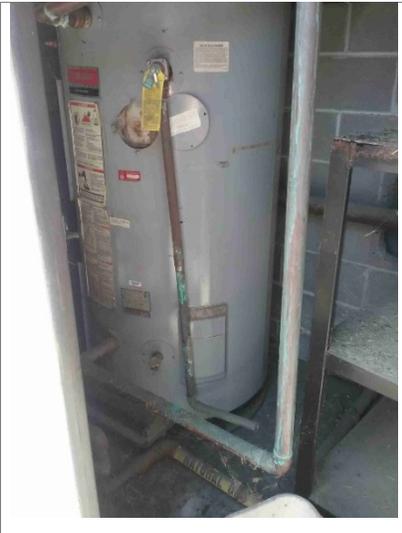
Domestic Water Distribution	<p>The water heaters for this building are located near the cafeteria kitchen, the administrative offices, and the gymnasium.</p> <p>EWH-1 next to C1 COR appeared to be in good</p>	Average

System	Subsystem	Condition and Deficiency Overview	System Condition Rating
		condition. GWH-1 in the kitchen appeared to be in poor condition. All pipes connected to the unit were corroded and in poor condition. It was observed that the unit was not being maintained.	
	Other Plumbing	Roof drains were present. Several roof drains were corroded. The roof drains located at A13 on the northeast wing were blocked off by debris. Standing water was present near RTU-2-11 located at A17 above the library. No roof drains were observed at this location.	Poor
Mechanical/ HVAC		<p>The major mechanical equipment consists of split system AHUs (air handling units) located in mechanical rooms, packaged RTUs (roof top units), and thru-wall heat pumps in the majority of the classrooms throughout the building. The AHUs that are located in the mechanical rooms are connected to direct expansion, air-cooled condensers.</p> <p>The condenser units on the roof and throughout the building exterior were in good condition. The AHUs associated with these condensers were in good condition as well. Water was leaking from AHUs -9, -10 and -12 located in the AHU 8 MECH room.</p> <p>The heat pumps in the classrooms appeared to be in average condition. These units were aged, but functional. The exterior housing was typically rusted and showed signs of wear and tear.</p> <p>The FCU (fan coil unit) in the CU COR as well as HP-16 and HP-12 in the storage closets of the annex building were in poor condition. The exterior housings were corroded or aged. The units did not appear to be maintained on a regular basis.</p> <p>The exhaust fan hoods on the roof appeared to be in average condition. There were signs of hail damage and bent supports on some hoods. The other exhaust hoods were in good condition.</p>	Average

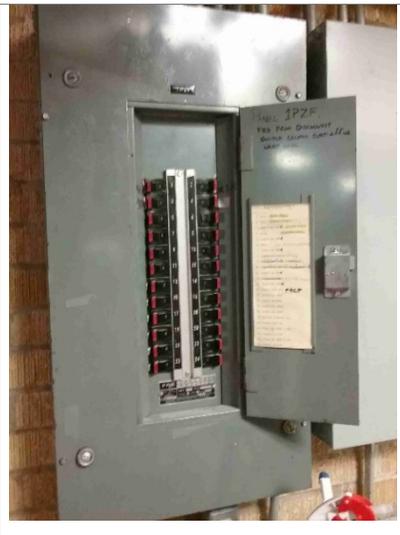
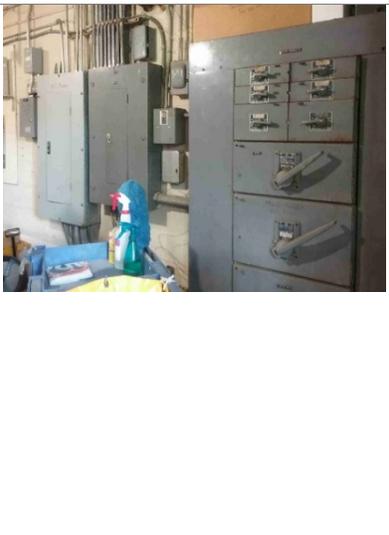
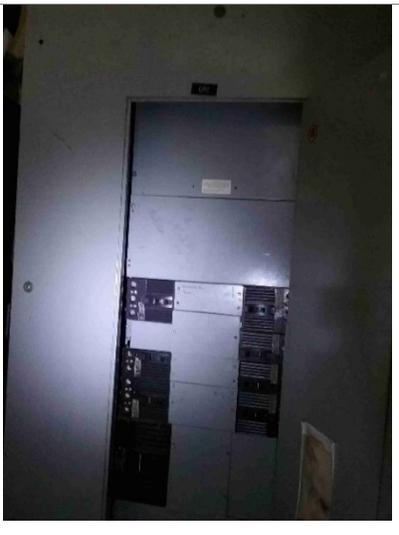
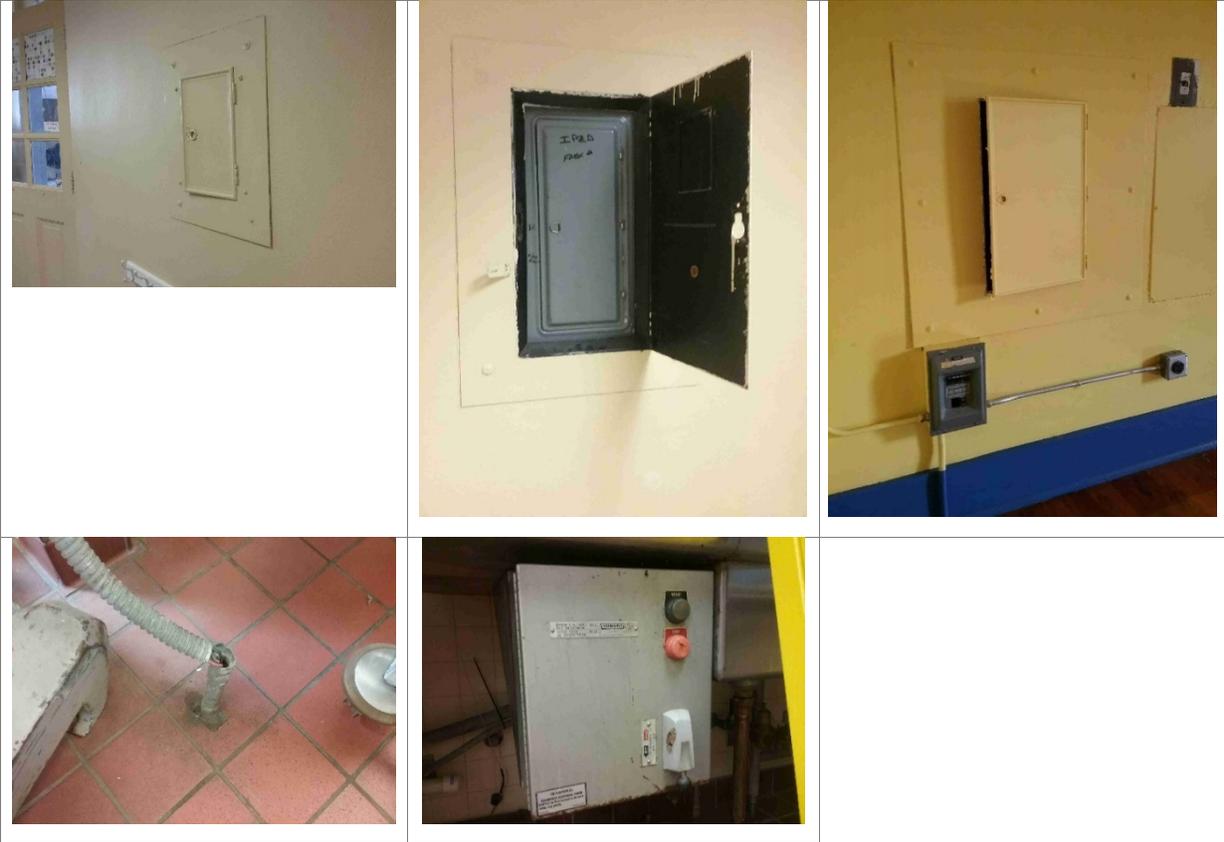
Electrical Distribution

System	Subsystem	Condition and Deficiency Overview	System Condition Rating
		<p>transformer bank that serves a 3000A 240/120V, 3P, 4W DELTA switchboard located in the main mechanical room (old boiler room). The pad-mounted utility transformer bank appears to be from the original 1936 construction. In 1998, a 75KVA interior distribution K-13 transformer and additional branch circuit panels were installed to distribute clean 208/120V power to additional loads. This work was done for both the main building and the annex building. In 2009, some panels were replaced, and additional panels were added to the distribution system of the main building.</p> <p>Most of the distribution equipment consists of older panels and switchgear that are from the original construction and are still active. Some of the original panels are in corridor areas, for example the 200-wing. The main switchboard is dated and worn out and has six disconnecting means. There is no disconnecting means to interrupt incoming power to the entire switchboard (i.e., main breaker), which could be considered a potential maintenance issue.</p> <p>The 1938 annex building had a separate electrical service. There is a 3-phase pole-mounted utility company transformer bank that serves a 600A 240/120V, 3P, 4W DELTA distribution panel located in the annex main electrical room. The pole-mounted utility bank appeared to be newer.</p> <p>It was reported that the electrical service to the annex needs replacement. The main distribution panel and branch circuit panels that serve the annex were indeed dated and worn out. There is a 600A main disconnect switch for the main distribution panel that interrupts incoming power to the panel.</p> <p>The facility does not have a lightning protection system.</p> <p>The annex building classrooms have rotary switches for the ceiling fans. These were observed to be functioning; however, there was humming, and the ceiling fans did not run at full speed.</p> <p>The electrical distribution at this facility was observed to be in poor condition. A majority of the assets were corroded. There were also screws missing from the housing enclosure of some of the units that should be replaced. Three panelboards were missing breaker covers, and the bussing was exposed behind the breaker board. This condition could be considered a life safety hazard. An active Federal Pacific panelboard</p>

System	Subsystem	Condition and Deficiency Overview	System Condition Rating
		<p>'1PZF' was in the janitorial closet in the 500-wing. In the kitchen, there was conduit stubbed up through the floor with exposed wires, which could be a potential safety concern. The disposal in the kitchen had an outdated and worn-out combination starter disconnect switch. The clean power transformers added in 1998 were hot to touch and were humming, which could indicate they are overloaded.</p>	
	Lighting	<p>The majority of the lighting at the main school building consists of 2x4 fluorescent fixtures. The 500-wing corridor area has surface-mounted 1x4 fluorescent fixtures. Classrooms have 2x4 lensed fluorescent fixtures. There are no occupancy sensors present in the building.</p> <p>The exit signs appeared to be newer and functioning. Emergency lighting is accomplished by integral emergency lighting on designated exit signs. It was observed that there is inadequate emergency lighting throughout the building, which is a potential life safety issue.</p> <p>Gymnasium administration areas have 2x4 surface-mounted fixtures. The gymnasium has HID (high-intensity discharge) lowbay lighting, and some bulbs were out. There are also lowbay 1x4 fluorescent fixtures, some of which have emergency battery packs. There were some outdated emergency lighting in the gymnasium.</p> <p>The kitchen has 2x4 fluorescent fixtures and no occupancy sensors. The kitchen has one emergency lighting fixture that is not functioning. There is insufficient lighting at the location of panels M and L in the kitchen.</p> <p>The annex building has 1x4 surface-mounted fluorescent fixtures throughout. Restrooms have 2x4 lay-in lensed fixtures. Exit signs are similar to those in the main building; however, none appeared to be functional. There are no occupancy sensors in the annex.</p> <p>It was reported that there is no lighting in the crawlspace and that mechanical room AHU-14 has substandard conditions; however, the lighting was newer and found to be adequate for a mechanical room.</p> <p>Exterior lighting was observed to be lacking at the facility, which could be considered a safety concern.</p>	Average

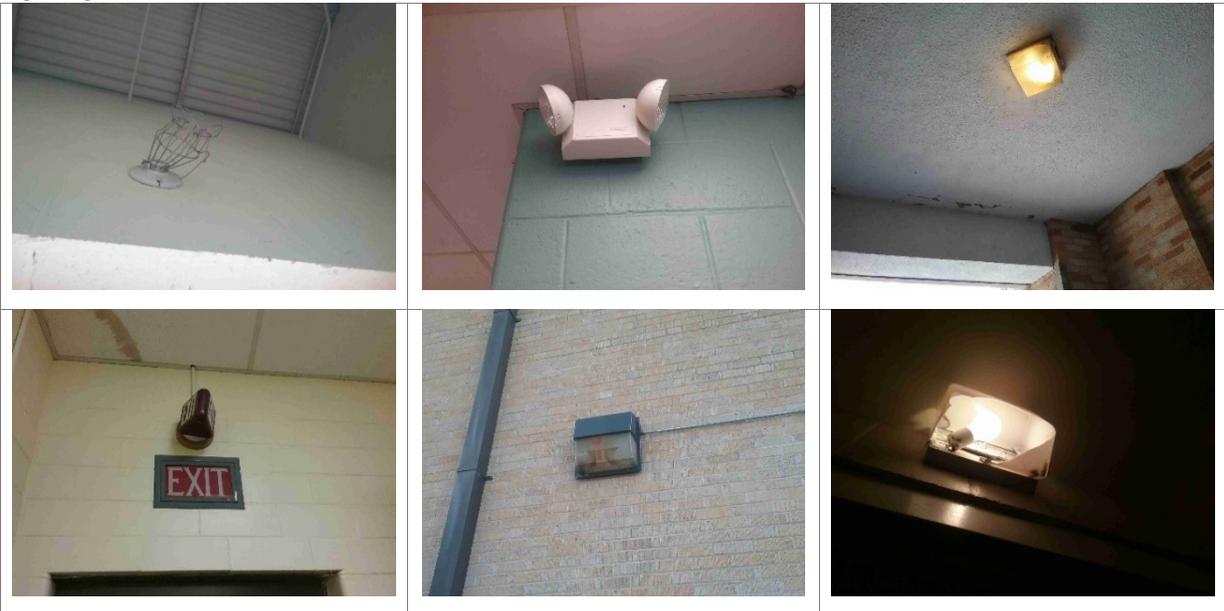
Lighting

System	Subsystem	Condition and Deficiency Overview	System Condition Rating
		<p>Exterior lighting was very dated and worn out. Most is HID, with some CFL (compact fluorescent lamp) fixtures and even some incandescent fixtures. Specifically, it was reported that there was no exterior lighting at the main entrance and by the dumpster and there was poor lighting by the kitchen loading dock.</p> <p>The lighting for the building was in average-to-poor condition. Many interior and exterior light fixtures appeared to be aged past their typical design service life. Observed deficiencies included broken lenses, inconsistent color temperatures, and non-functional fixtures. There are exit signs present in the building, one of which was observed to be from the 1936 original construction. Several appeared to be non-functional at the time of assessment.</p>	
	<p>Communications & Security</p>	<p>There is a public address system in the building. There is a Gemini security system including surveillance cameras at the facility. The building is equipped with telecommunications systems.</p> <p>The security cameras throughout the building are in good condition. However, it was reported that there is poor camera coverage at the exterior of the building, no camera coverage at the annex building (200- and 400-wings), and poor camera coverage at the entry door on the west end of corridor C4, adjacent to room 106.</p> <p>The public address system appeared to be in average condition.; however, it was reported that the corridors, portables, and various rooms in the main building and annex building have no public address services. The school bell and clock system appears to be from the original construction. There is an outdated Dukane public address system located in the gymnasium, which appears to be serving the gymnasium and the cafeteria.</p> <p>The main backbone equipment for the telecommunications system is located in an inaccessible room. Wi-Fi access points are present throughout the facility and appeared to be in good condition.</p>	<p>Poor</p>

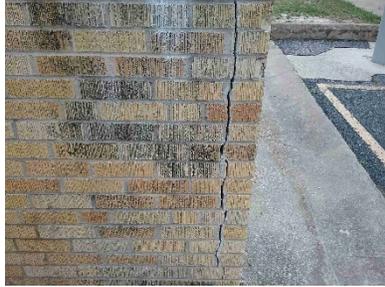
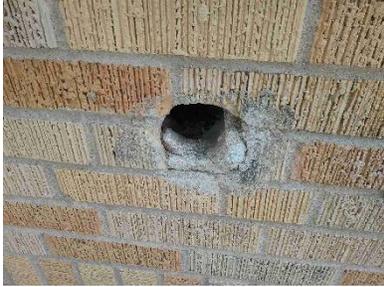
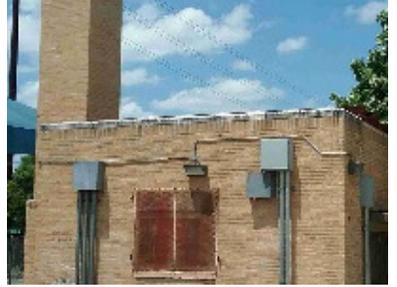
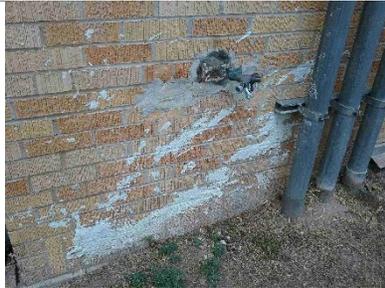
System	Subsystem	Condition and Deficiency Overview	System Condition Rating
Exterior	Exterior Walls	The exterior of the building consists of a brick façade. The exterior walls were in average condition due to age. A centimeter-wide vertical crack was observed in the brick, and an unsealed piping hole was observed. Streaking from the roof parapet was observed, giving the impression of uncleanliness and disrepair. Splattered concrete was also observed near a patched hole.	Average
	Exterior Windows	There are two sets of exterior windows on opposite sides of the building. One is covered with a metal grate, and the other is exposed. The windows consist of single-pane plastic glazing units with metal frames. The panes are opaque. The windows were observed to be in failing condition. The frames were rusted, and some of the window panes were missing.	Fail
	Exterior Doors	There is one entryway located at the east side of the building; these doors are painted wood with a grille on one leaf. The exterior doors were observed to be in poor condition due to age and difficulty operating. The paint and surface of the wood was peeling and splitting.	Poor

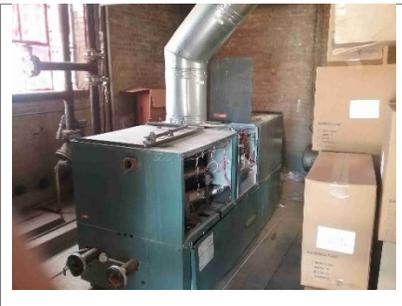
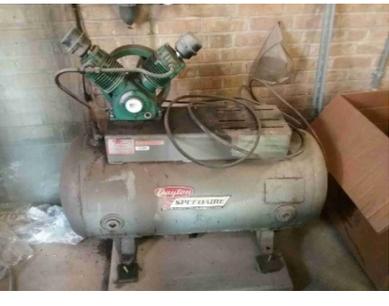
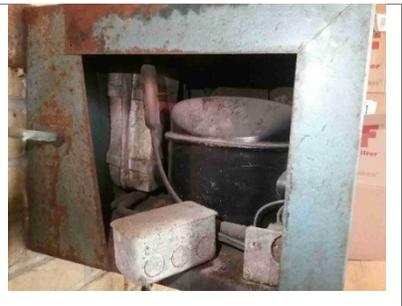
Mechanical/HVAC System Deficiency Examples

Domestic Water Distribution	System not present.	N/A
	Other Plumbing	System not present.	N/A
Mechanical/ HVAC	The mechanical system for this building consists of an air dryer, a boiler, and a pump. The mechanical equipment in this area appeared to not be operational. The boiler was under repair at the time of assessment, and the internal components of the air dryer were corroded and aged.		Poor
Fire Protection	Fire Alarm	System not present.	N/A
	Fire Protection/ Suppression	System not present.	N/A

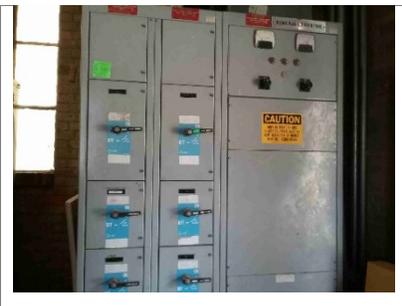
Electrical Distribution

System	Subsystem	Condition and Deficiency Overview	System Condition Rating
<p>Electrical</p>	<p>Electrical Distribution</p>	<p>The main 3000A 240/120V, 3P, 4W DELTA switchboard that distributes power to the entire campus is located in this room. The pad-mounted utility transformer bank appears to be from the original 1936 construction. In 1998, a 75KVA interior distribution K-13 transformer and additional branch circuit panels were installed to distribute clean 208/120V power to additional loads. This work was done for both the main building and the annex building. In 2009, some panels were replaced, and additional panels were added to the distribution system of the main building.</p> <p>Most of the distribution equipment consists of older panels and switchgear that are from the original construction and are still active. Some of the original panels are in corridor areas, for example the 200-wing. The main switchboard is dated and worn out and has six disconnecting means. There is no disconnecting means to interrupt incoming power to the entire switchboard (i.e., main breaker), which could be considered a potential maintenance issue.</p>	<p>Poor</p>

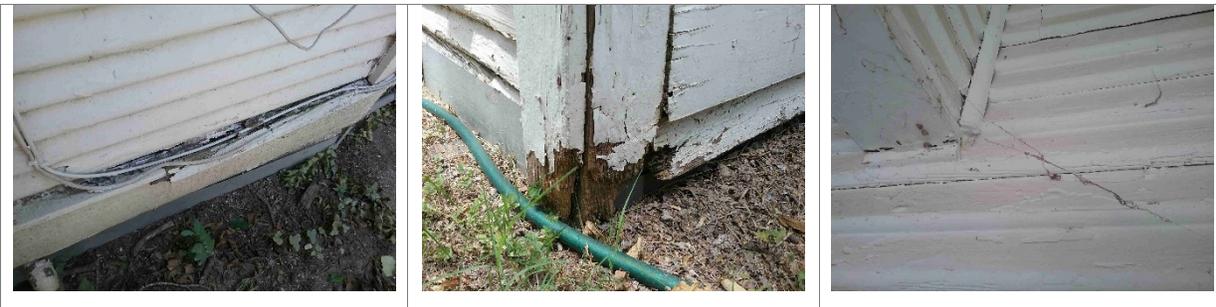
System	Subsystem	Condition and Deficiency Overview	System Condition Rating
Exterior	Exterior Walls	<p>The exterior of the White House is constructed of wood siding over wood stud framing.</p> <p>The exterior walls appeared to be in average condition due to their age. The base of the wood siding was splitting and deteriorating in areas, and the corners of the building were deteriorating as well. The surface of the walls were dirty and littered with cobwebs.</p>	Average
	Exterior Windows	<p>The exterior windows consist of double-hung windows in wood frames behind insect screens in metal frames. There are windows on every side of the house, totaling approximately 20 units.</p> <p>The windows appeared to be in average condition due to their age. The paint on the frames and sills was peeling at each window, and wasp nests were prevalent between the screens and windows. Some screens were disconnected at the corners, allowing this intrusion. From the inside of the house, cracks were observed at the corners of the window frames, and one window was sealed sloppily after the installation of a window unit.</p>	Average

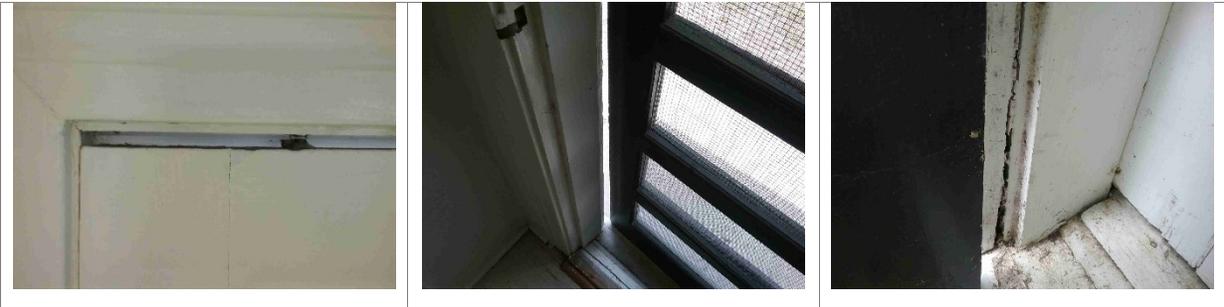
Exterior Doors	<p>There is one main public entryway located at the north side of the building; this door is painted wood with half glazing. The back door to the house is also wood with glazing, situated behind a screen door in a wood frame. The side door is solid wood.</p> <p>The exterior doors appeared to be in average to poor condition due to age. The front door and back screen door appeared to not be plumb, and the back screen</p>	Average

System	Subsystem	Condition and Deficiency Overview	System Condition Rating
		door did not fully close. The frames were extremely dirty and splitting, but the door leafs themselves were in good condition.	
Roofing		The roof material covering the building is asphalt shingles. The roof surfaces were in average condition, showing signs of discoloration at the edges of the roof.	Average
Interior Construction	Interior Walls	The interior partitions are predominantly constructed of wood stud framing finished with painted drywall. The interior partitions appeared to be in average condition with instances of minor cracking and chipping throughout all wall surfaces. Diagonal hairline cracks were observed at every window and door frame.	Average
	Interior Doors	The interior doors are wood in wood frames. One door has glazing. The interior doors appeared to be in average condition. One door was not plumb in the frame, exhibiting a large gap at the top of the door. Another door had peeling paint and messily painted edges at the glazing. The bases of some doors were deteriorating.	Average

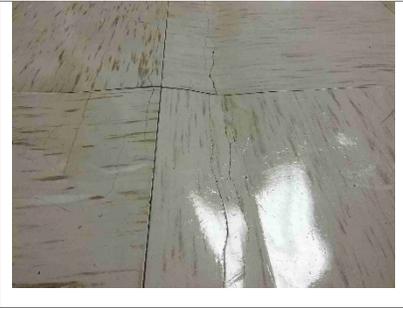
Interior Floor Finishes	The floor of the White House is finished with linoleum floor tile throughout. The flooring appeared to be in poor condition as cracking and buckling were observed throughout the	Poor

System	Subsystem	Condition and Deficiency Overview	System Condition Rating
		linoleum flooring system. Various stains were also observed on the floor finish.	
	Interior Ceiling Finishes	The interior of the White House ceiling is finished with ACT. The ceiling appeared to be in poor condition as most tiles showed signs of damage. The majority of tiles were bowing up at their four corners, and many tiles were deteriorating at the corners. Water damage was observed on various tiles near the walls.	Poor
Conveying	System not present.		N/A
Plumbing	Plumbing Fixtures	This building has two small restrooms with vitreous china hand sinks and manual faucets. All plumbing fixtures were functioning and appeared to be in average condition. The fixtures were aged, but still operational. The hot water valve in one of the hand sinks did not function. The cold water valves functioned for both hand sinks.	Average

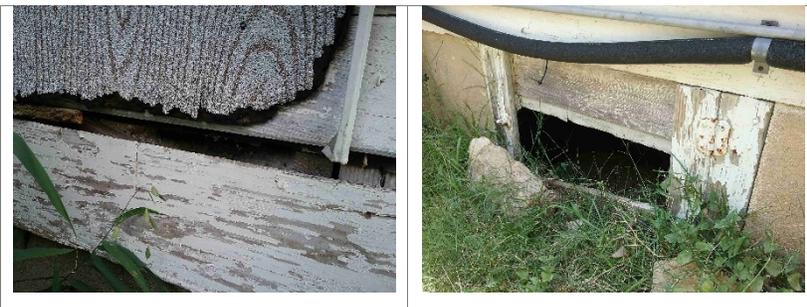
System	Subsystem	Condition and Deficiency Overview	System Condition Rating
Exterior	Exterior Walls	<p>The exterior of the Green House is constructed of pressed asphalt siding over wood stud framing. The siding is unpainted but finished to resemble wood.</p> <p>The exterior walls appeared to be in poor condition due to their age. The siding was deteriorating in many areas, and some areas were missing pieces of siding. The small wooden door to the crawlspace was missing, possibly providing interior access to pests.</p>	Poor
	Exterior Windows	<p>The exterior windows consist of double-hung windows in wood frames. There are windows on every side of the house, totaling approximately 20 units.</p> <p>The windows appeared to be in poor condition due to their age. The paint on the frames and sills was peeling at each window, and paint was bleeding onto the window panes. The sealant was dried and deteriorated at the windows.</p>	Poor

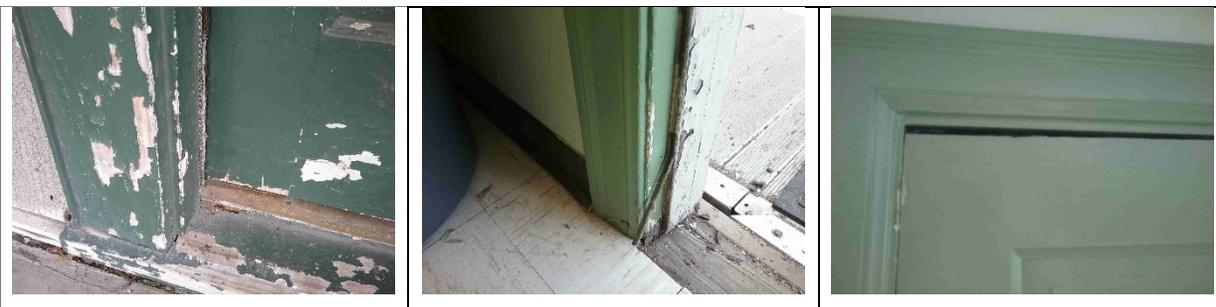
Exterior Doors	<p>There is one main public entryway located at the west side of the building; this door is painted wood behind a screen door on a wood frame. The back door to the house is also wood with glazing behind a metal screen.</p> <p>The exterior doors appeared to be in poor condition due to age. The paint on the doors and frames was excessively peeling. The wood thresholds were splitting, and the front door was not plumb.</p>	Poor

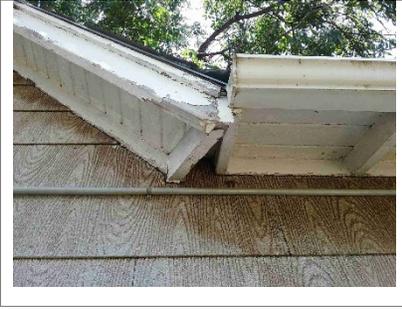
Roofing Deficiency Examples

System	Subsystem	Condition and Deficiency Overview	System Condition Rating
Roofing		The roof material covering the building is asphalt shingles with wood eaves. The roof appeared to be in good condition, but the wood eaves were observed to be in poor condition. The paint was peeling excessively.	Average
Interior Construction	Interior Walls	The interior partitions are predominantly constructed of wood stud framing finished with painted drywall. The interior partitions appeared to be in average condition with instances of minor cracking and chipping were observed throughout all wall surfaces. Areas of dented wall board were observed as were hairline cracks near the window and door frames.	Average
	Interior Doors	The interior doors are wood in wood frames. One door has glazing. The interior doors appeared to be in average condition. The paint was peeling on the door frames, and the door handle of one door was slightly detached.	Average

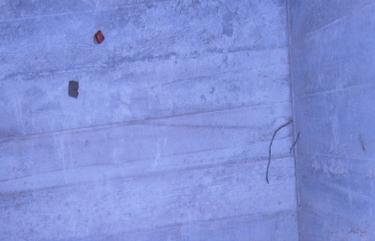
Exposed Structure

<p>Honeycombing in interior beams, columns, and the underside of the slab</p>	<p>Formwork nails in suspended beam</p>
