## Blanton Elementary School Site Summary

## Main School Building – BLDG-106A

Building Purpose	Administrative, Classrooms, Library, and Cafeteria
Inspection Date	August 11, 2016 (Morning)
Inspection Conditions	85° - Sunny and Dry

**CRAWL SPACE – Blanton ES – Stand-Alone Classroom Building (BLDG-106C)**

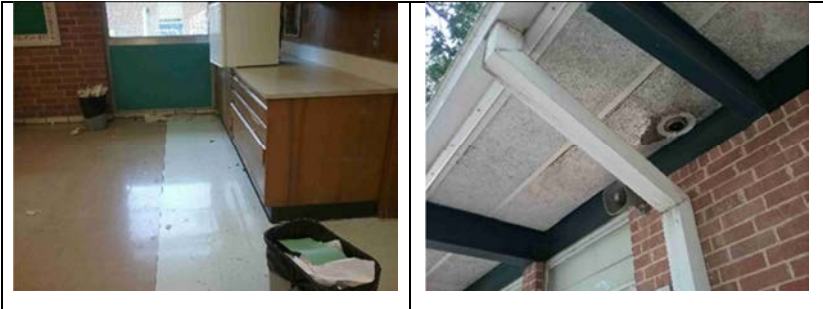
System	Subsystem	Condition and Deficiency Overview	System Condition Rating
Exterior	Exterior Walls	<p>The building exterior masonry walls are original multiwythe brick exposed on both interior and exterior surfaces. The north wall of the basement level (300-wing) is poured in place concrete with waterproofing below grade. The primary structure is exposed, painted, steel beams with cement fiber deck. The building has crawl space beneath suspended concrete slab.</p> <p>The exterior brick appeared in good condition. The exposed steel structure is currently undergoing painting and no significant rust is visible. Joint sealant is in average condition. A small hole was observed in the brick joint at the window sill in room 203. The roof deck along the south overhang of 200-wing was damaged and collapsing. No evidence of this was visible at the roof surface but could have been obscured by tree limbs. There was no evidence observed of failing waterproofing at below grade concrete wall in the 400-wing except a small area of peeling paint in the female restroom.</p>	Good

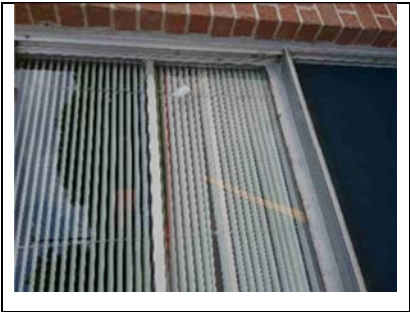
Exterior Windows	<p>The windows are original aluminum awning type, single glazed, with insulated spandrel panels below.</p> <p>The windows appeared to be original and in good working condition. One pane was observed to be cracked in room 101. The sealant appeared to be in average condition and spandrel panels are currently being painted. Leaking around windows has been</p>	Good

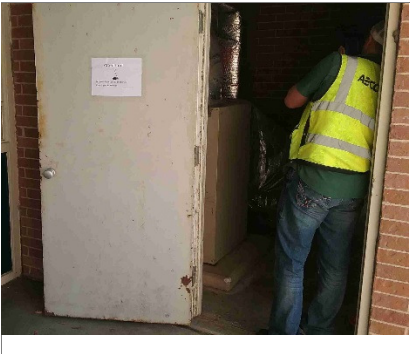
System	Subsystem	Condition and Deficiency Overview	System Condition Rating
		reported in the cafeteria along the east wall that may be due to deteriorating sealant.	
	Exterior Doors	<p>The exterior doors are steel with hollow metal frames with wire glass vision panels and side-lites.</p> <p>The exterior doors and frames generally appeared to have been replaced recently or are in good condition with a few exceptions. Doors to mechanical rooms appeared to be original although in good condition with some rust apparent on the inside surfaces.</p>	Good
<b>Roofing</b>	<p>The roof appears to have been recoated in 1999, according to warranty signage on the Stand-Alone Gymnasium. The roof is both low slope over the majority of roof area, and steep slope (saw-tooth) over the cafeteria/kitchen area. The flashing system and gutters at the perimeter appear to have been installed recently.</p> <p>The roofing showed significant bubbles forming under the membrane over large expanses of the roof area and was observed to be in poor condition. Each wing has limited areas where ponding is occurring and roofing has split. Evidence of roof leaking is minimal inside however; the roof has exceeded 80% of life and is showing signs of deterioration. Flashing and gutters are in good condition with a few exceptions where rusting was visible. Significant areas of the roof have overhanging tree limbs touching the roof surface causing abrasion and the potential for damage during a windstorm.</p>		Poor

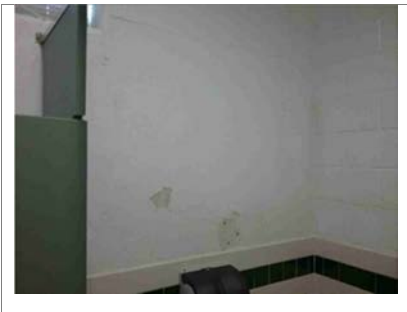
#### Interior Walls

<b>Interior Construction</b>	Interior Walls	<p>The interior walls consist of; double-wythe brick, stud with drywall, and some painted CMU (concrete masonry unit) walls at the 300- and 400-wings.</p> <p>The interior walls appeared to be in average condition relative to their age. Scuffing was visible. The CMU and gypsum board walls have been recently painted.</p>	Average
	Interior Doors	The interior doors are a mix of solid core wood doors in both wood frames and painted hollow metal frames. Doors and frames appeared original and in good condition relative to age.	Good
	Interior Specialties	System not present.	NA
<b>Stairs</b>	Exterior Stairs	<p>The exterior stairs are poured in place concrete with steel pipe railing located adjacent to the kitchen with access from the lower level and access to the loading dock.</p> <p>The exterior concrete stairs and steel railings are in good condition and appeared to be newer than the original construction.</p>	Good

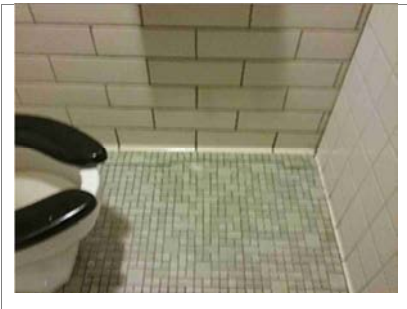
#### Interior Floor Finishes

System	Subsystem	Condition and Deficiency Overview	System Condition Rating
		to CMU walls. There are numerous sloped floors in hallways transitioning changes in finish floor elevation. The stairs and handrails appeared to be in good condition with no visible defects.	
<b>Interior Finishes</b>	Interior Wall Finishes	<p>The interior wall finishes consist of; 1) exposed brick, 2) painted drywall partially covered with stained wood paneling, 3) painted CMU or concrete, and 4) glazed brick in kitchen. Restrooms have ceramic tile walls or wainscot.</p> <p>The interior wall finishes were observed to be in average condition given their age. Walls appeared to have been recently painted. The wood panels appeared aged with some scuffing visible but in serviceable condition. The ceramic tile is original and appeared to be in average condition.</p>	Average
	Interior Floor Finishes	<p>The floor finishes consist of vinyl tile of various sizes in the corridors, classrooms, cafeteria, and library. The administrative office flooring is carpet, and the kitchen has non-slip quarry tile.</p> <p>The vinyl tile, although it continues to be functional, appeared to be near end of service life. Tile appeared to be original to the facility with substantial areas of patching visible. The carpet appeared to be recently installed and in good condition. The quarry tile in kitchen appeared to be relatively new and in good condition. The ceramic tile in the restrooms appeared to be original and in deteriorating condition. There are some instances of buckling of ceramic tile observed in the restrooms at perimeter walls.</p>	Average

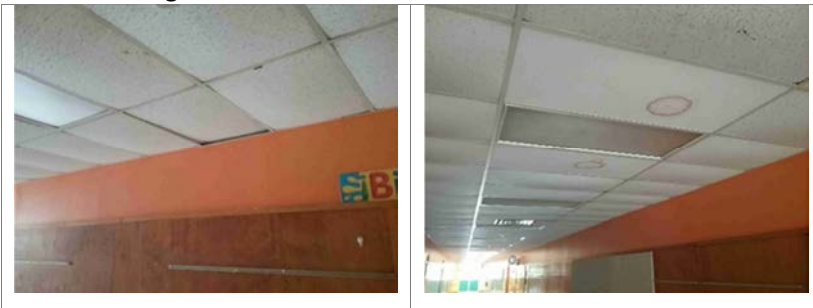
#### Interior Ceiling Finishes

Interior Ceiling Finishes	<p>The ceilings in the original building are painted exposed cement fiber roof deck and exposed steel structural members. Ceilings in the 300-and 400-wings are lay-in suspended acoustical tiles.</p> <p>The ceilings were observed to be in average condition with some tiles stained or broken, a result of roof or mechanical/plumbing leaks.</p>	Average
<b>Conveying</b>	System not present.		N/A
<b>Plumbing</b>	Plumbing Fixtures	The building is composed primarily of single-user restrooms for students and staff located throughout the facility. These restrooms typically contained floor-mounted, porcelain toilets with manual flush valves. The 300-wing contains a multi-user restroom for students that contains floor-mounted porcelain toilets and wall-hung porcelain sinks. Typical classrooms contain single	Good

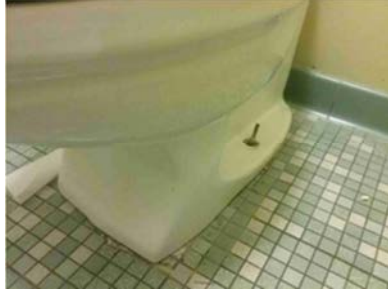
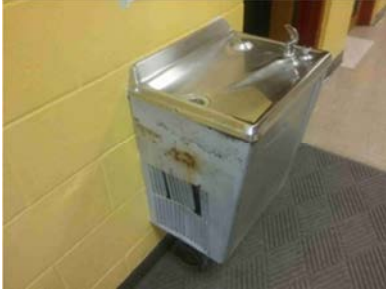
#### Plumbing Fixtures

System	Subsystem	Condition and Deficiency Overview	System Condition Rating
		<p>bowl stainless steel sinks with a drinking fountain attachment. The facility also has various wall-mounted and floor-mounted drinking water fountains located throughout the building. The kitchen has multiple stainless steel dish/preparation sinks and kitchen equipment.</p> <p>It was reported that the male restroom in the 300-wing had damaged wall-mounted toilets, but site assessment confirmed all toilets were floor-mounted and in average condition. The plumbing fixtures had minor signs of age and deterioration but appeared to be in good condition. Some of the floor-mounted toilets throughout the facility were misaligned and may have deteriorated wax rings. Overall, the plumbing fixtures were in good condition.</p>	
	Domestic Water Distribution	<p>Domestic hot water is provided to the kitchen by one 100-gallon, GWH (gas water heater) located in the "KITMECH" room. Smaller 10-gallon EWHs (electric water heaters) are located throughout the facility to provide hot water to specific locations. Domestic hot water was primarily supplied to janitor closets but did not appear to be supplied to classroom fixtures.</p> <p>The domestic water system is in average condition and had typical wear and tear for the systems age. The 100-gallon GWH that supplied the kitchen, assumed to be installed in 2000, was in average condition with minor corrosion. The boiler located in the "MAINMECH" room appeared to be original to the building, and was in poor condition. The operational status of this boiler should be confirmed, and should be considered for removal if abandoned. It was reported that sanitary lines in the 100-, 200- and 400-wings are near the end of their service life.</p>	Average

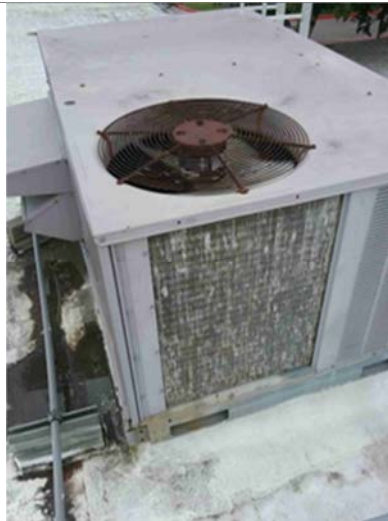
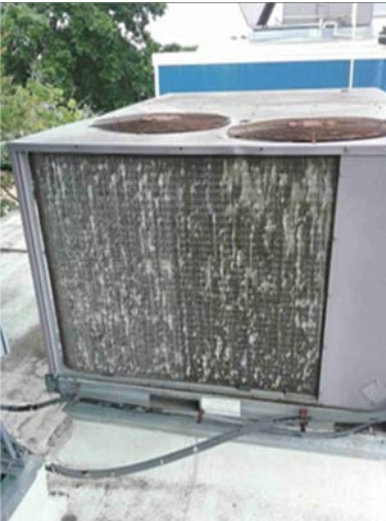
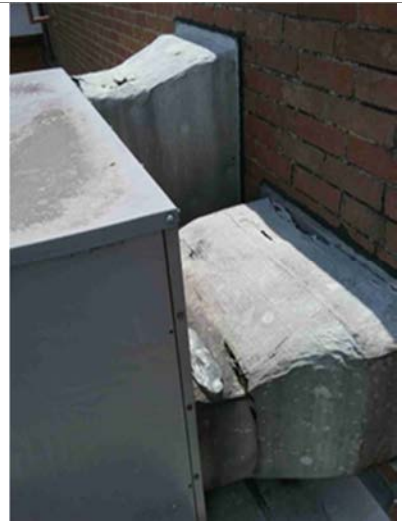
### Mechanical/HVAC System Deficiency Examples

System	Subsystem	Condition and Deficiency Overview	System Condition Rating
		<p>CFM, serve the building.</p> <p>The HVAC system for the building is in average condition. It appeared the majority of the HVAC system has an install date ranging from 1992 to 2006. The individual heat pumps located in the 100- and 200-wings, assumed to be installed in 1992, are beyond their expected service life. The entire HVAC system, apart from the RTU serving the cafeteria, uses R-22 refrigerant, which is an outdated refrigerant that is being phased out of use. These systems are in average to good condition. The split system air cooled condensing unit serving the 300- and 400-wings was installed in 2006 and was reported having temperature regulation problems. Building staff was interviewed during the field inspection and reported that a possible poor design of the ACCU's (air cooled condensing unit's) ductwork and distribution is the leading cause of the uneven cooling. The exhaust fans on the roof were installed in 2006 and were in average to good condition. Apart from slight degradation due to normal wear and tear, only a few exhaust fans were observed to have excessive vibration. The 120 CFM exhaust fan, located near HP-30, was inoperable and did not have a motor.</p>

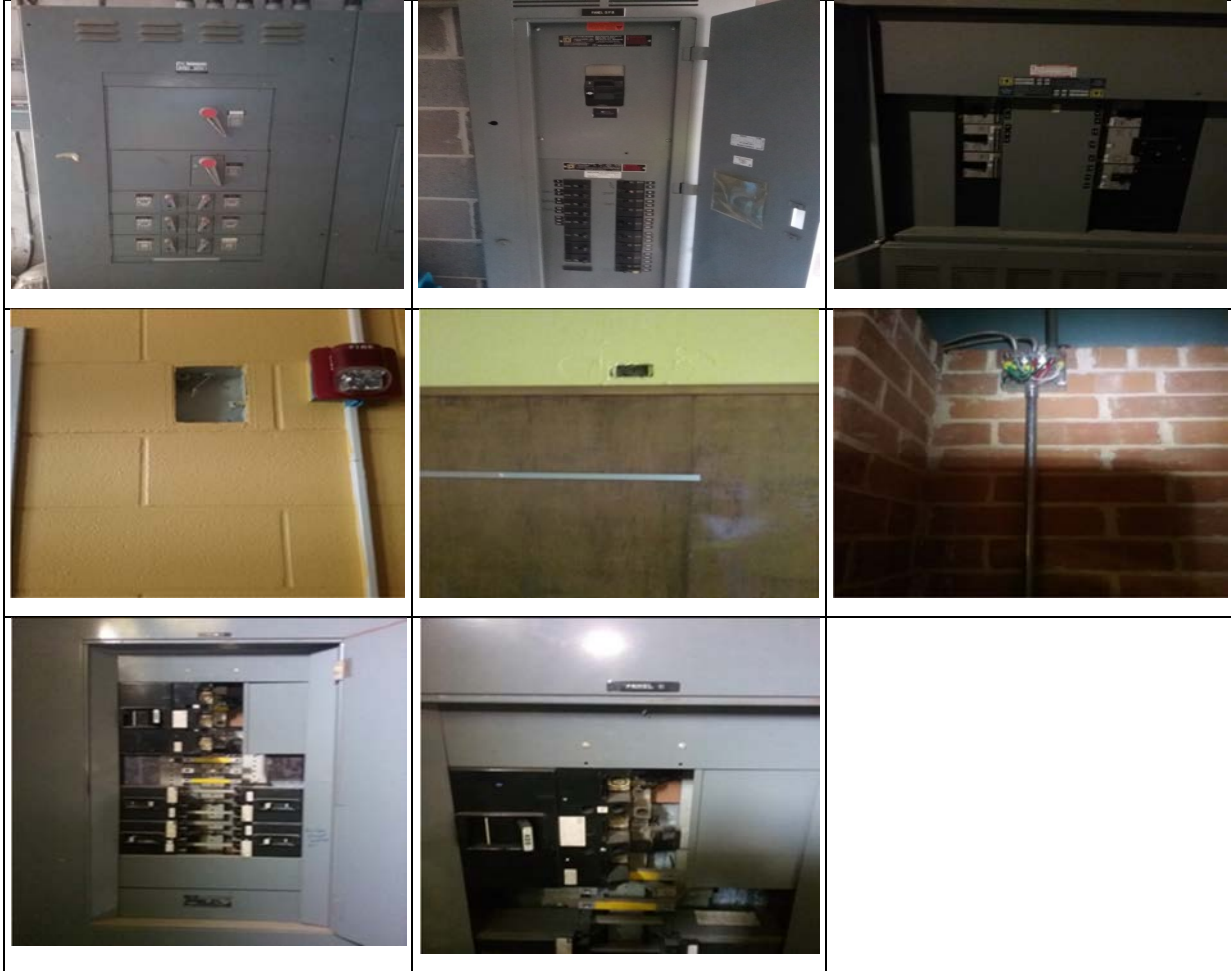
### Electrical Distribution

System	Subsystem	Condition and Deficiency Overview	System Condition Rating
		<p>panelboard feeds two sub panelboards labeled TP1A 225-amp and TPGA 100-amp. This CUSTSTO room had substantial stored materials in it that are a fire safety risk.</p> <p>Other panelboards were located in the MECH100 and STO100 rooms immediately adjacent to the library and 100-wing classrooms, the CC200 room adjacent to the ramp to the 200-wing, and MAINMECHMECH room outside the 300-wing. Panelboards located in kitchen, and stage area were a combination of original and updated equipment. Some old electrical equipment appears to be abandoned in place, and two switchboards at the main cut-off switches are missing their protective covers. Electrical service was observed in average condition.</p>	
	Lighting	<p>Lighting at this facility consists primarily of 4x4 T-8 florescent luminaries set in troffers in classrooms, administrative offices, and hallways. Classroom bathrooms, small storage areas contained small recessed single lamp lighting fixtures. Adult restrooms have smaller florescent luminaries. Exterior lighting consisted of wall mounted wall pack HID luminaries around the entire perimeter of this facility with evidence of some HID wall mounted wall packs having been replaced with LED wall mounted wall packs.</p> <p>It was reported that there was no emergency egress lighting present in this facility. It was reported that the playground has no lighting. The staff also reported that exterior lighting was inadequate for the kitchen staff and voiced concern over inadequate lighting in the parking lots. The lighting system is in average condition.</p>	Average

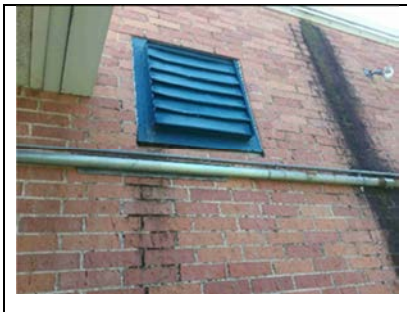
#### Exterior Walls

System	Subsystem	Condition and Deficiency Overview	System Condition Rating
<b>Exterior</b>	Exterior Walls	<p>The building exterior masonry walls are original multi-wythe brick exposed on both interior and exterior faces. Large operable louvers previously used for building ventilation have been abandoned in place with painted aluminum panels covering the exterior.</p> <p>The building exterior walls were observed to be in average condition. The louver on the north wall is missing flashing and the wood rough frame has deteriorated allowing rainwater to enter wall cavity. Organic matter is accumulating on the face of the brick below the louver. A similar larger area of adjacent wall surface showed organic growth that may be result of roof or flashing leaking into wall cavity.</p>	Average
	Exterior Windows	<p>The exterior windows are aluminum single hung and are located only at the restrooms. Windows are used for ventilation since restrooms are not air conditioned.</p> <p>The windows are functioning and in average condition; however, screens are in disrepair.</p>	Average

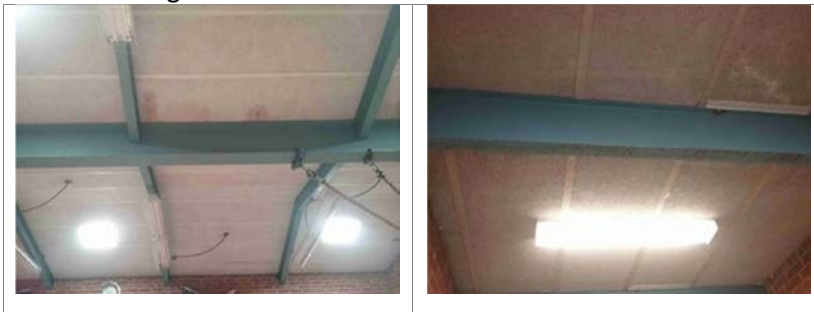
#### **Interior Ceiling Finishes**

Interior Specialties	System not present.	N/A
<b>Stairs</b>	Exterior Stairs	System not present.	N/A
	Interior Stairs	System not present.	N/A
<b>Interior Finishes</b>	Interior Wall Finishes	The interior wall surfaces are exposed brick and ceramic tile.  Both the brick and ceramic tile wall finishes appeared to be original and in average condition. The ceramic tile surfaces were visibly worn and scuffed.	Average
	Interior Floor Finishes	The interior floors are painted concrete, ceramic tile and special gymnasium play flooring.  The ceramic tile located in the restrooms was observed to be original and in average condition. The special play flooring in the gymnasium appeared to have been installed recently.	Average
	Interior Ceiling Finishes	The interior ceilings are painted exposed cement fiber roof deck and exposed steel structural members.  The interior ceilings were observed to be in average condition. Some water staining on exposed deck from apparent roof leaks was visible.	Average

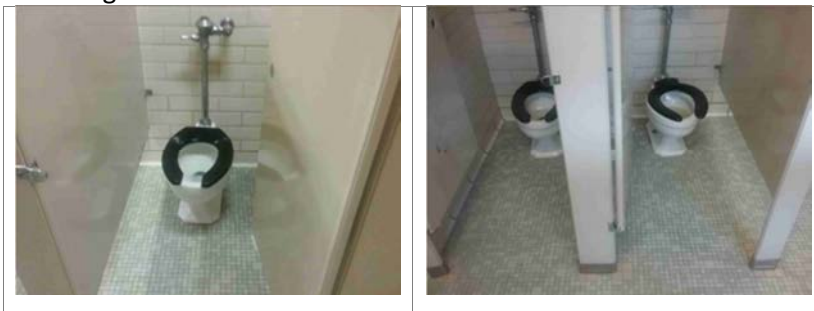
#### **Plumbing Fixtures**

<b>Conveying</b>	System not present.		N/A
<b>Plumbing</b>	Plumbing Fixtures	The building has both single-user and multi-user restrooms for students and staff. The restrooms have wall-hung porcelain sinks with manual faucets along with floor-mounted porcelain toilets with manual flush valves. There are also wall-hung porcelain urinals with manual flush valves located in the male restroom. A multi-station wall-mounted stainless steel drinking water	Average

System	Subsystem	Condition and Deficiency Overview	System Condition Rating
		fountain is located outside of the male restroom. The plumbing fixtures in the building showed typical signs of wear and tear associated with the system's age and are in average condition. Most of the floor-mounted toilets in the multi-user restrooms appeared to be misaligned.	
	Domestic Water Distribution	Domestic hot water is provided to a sink and shower located in the single-user restroom by a 10-gallon EWH. Domestic hot water is not supplied to the multi-user restrooms in the facility. The EWH located in room "GYMSTO" was in average condition but appeared to be outdated.	Average
	Other Plumbing	The facility has floor drains located throughout. The drains were observed to be in good condition.	Good
<b>Mechanical/ HVAC</b>	The building's HVAC system is composed of an air source heat pump package unit that is located on the roof. The unit was estimated to be installed in 1999 and has a capacity of 12 ton. The building also has rooftop exhaust fans ranging in size from 120 CFM to 250 CFM.  The HVAC system for the building is in average condition. Excessive wear and tear was noted for the air source heat pump and is in overall poor condition. The unit also uses R-22 refrigerant which is being phased out of use. Exhaust fans on the rooftop were installed in 2006, had typical wear and tear, and were rated in average condition.		Average

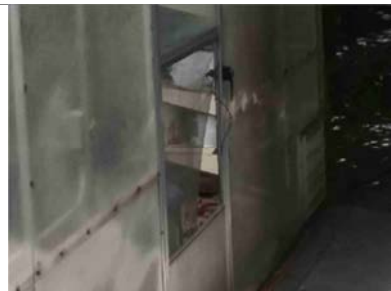
#### Exterior Doors

System	Subsystem	Condition and Deficiency Overview	System Condition Rating
<b>Exterior</b>	Exterior Walls	The Greenhouse is a pre-manufactured type aluminum frame with both flat and corrugated fiberglass panels.  The structural frame appeared to be in good condition; however, fiberglass panels are aged and showing significant deterioration from ultra violet exposure. Panels are brittle and some seams do not seal properly.	Poor
	Exterior Windows	System not present.	N/A
	Exterior Doors	There is one exterior aluminum door.  The door is a residential type storm door and appeared to be functioning except the screen is damaged allowing intrusion of pests.	Poor
<b>Roofing</b>	The roof of greenhouse is corrugated fiberglass panel similar to the exterior walls. The fiberglass roof panels were visibly aged and showing significant deterioration from ultra violet exposure. The roof panels are brittle and some seams do not seal properly. The greenhouse roof was observed to be in poor condition.		Poor
