Brentwood Elementary School Site Summary

Address	6700 Arroyo Seco Austin, TX 78757
Number of Permanent Campus Facilities	2
Original Year of Construction	1951
Total Campus Building Area (combined)	62,890 SF

CRAWL SPACE – Brentwood ES – Main School Building (BLDG-107A)

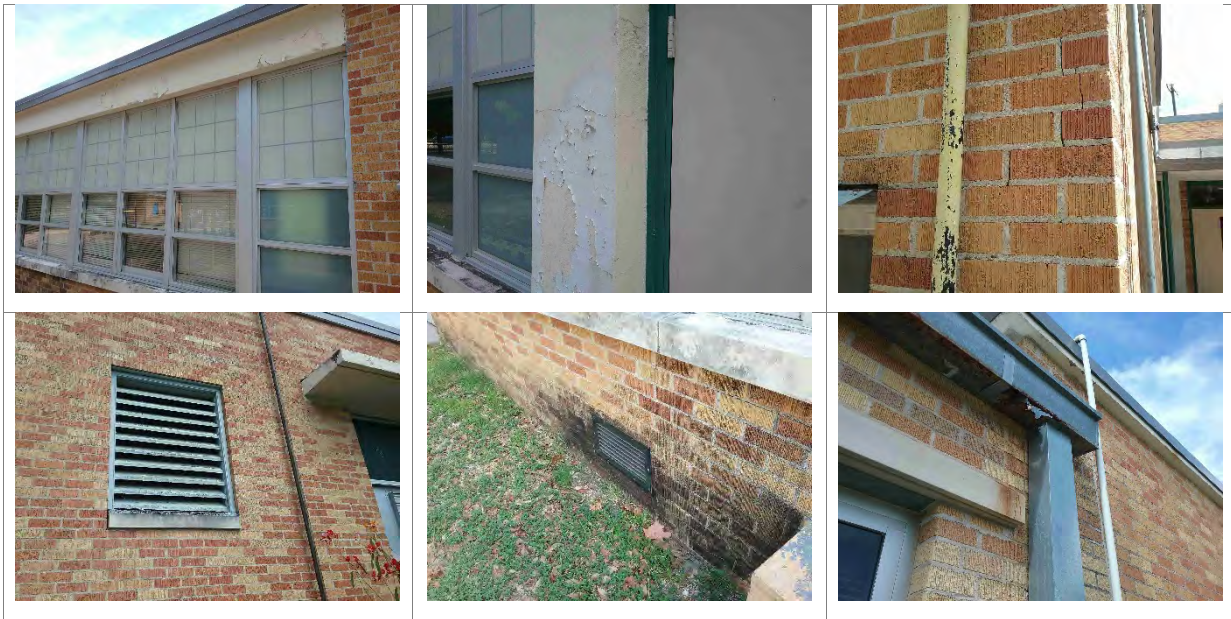
System	Subsystem	Condition and Deficiency Overview	System Condition Rating
Exterior	Exterior Walls	<p>The exterior walls are brick veneer with masonry unit backup. The 100-wing's concrete structure is exposed and painted. Newer building additions have cut limestone parapet caps, window headers and sills. The original building 100-wing classrooms have a glass block clerestory. The glass block has been covered with metal siding on the exterior but is still visible from inside. There are gutters and downspouts along some walls.</p> <p>The exterior walls were observed to be in average condition. There was visible discoloration on courtyard walls at the 100-wing that may be related to moisture in the crawlspace. Peeling paint was visible on the 100-wing concrete structural members. There was organic growth on some brick and limestone surfaces around the building. The gutters were visibly aged and severely corroded on the north and east walls near administration offices. Gutters were not present along the courtyard side of the 100-wing, which was reported to contribute to organic growth on the masonry surfaces. Cracks were observed in the masonry wall at the corner of room 101. Sealants were typically flexible and intact. No specific penetrations were visible, but pests and rodents were reported to be seen in the building, possibly entering from the crawlspace or foundation.</p>	Average

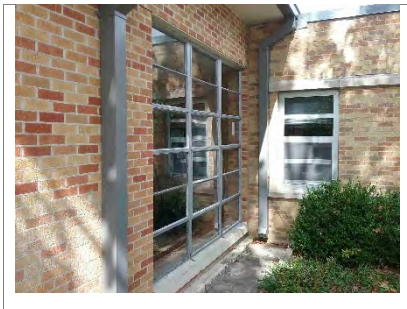
Exterior Windows	The exterior windows are metal framed with single-pane glazing and translucent fiberglass panels. Exterior	Good

System	Subsystem	Condition and Deficiency Overview	System Condition Rating
		windows in the classrooms have an operable sash. The exterior windows have been recently replaced, except in the gymnasium and at the building entrance. The original exterior windows in the gymnasium and main entrance were aged and were reported to be difficult to open and close. The newer metal-framed exterior windows appeared to be in good condition. A cracked pane was reported in a window in room 208.	
	Exterior Doors	The exterior doors are steel with metal frames. The building's entrance doors and individual doors to 100-wing classrooms have transoms, and in some locations, sidelights. The exterior doors were observed to be in average condition. The exterior doors are original to the building and were reported to be difficult to latch. The exterior doors and hardware were observed to be aged and marginally functional in some locations.	Average

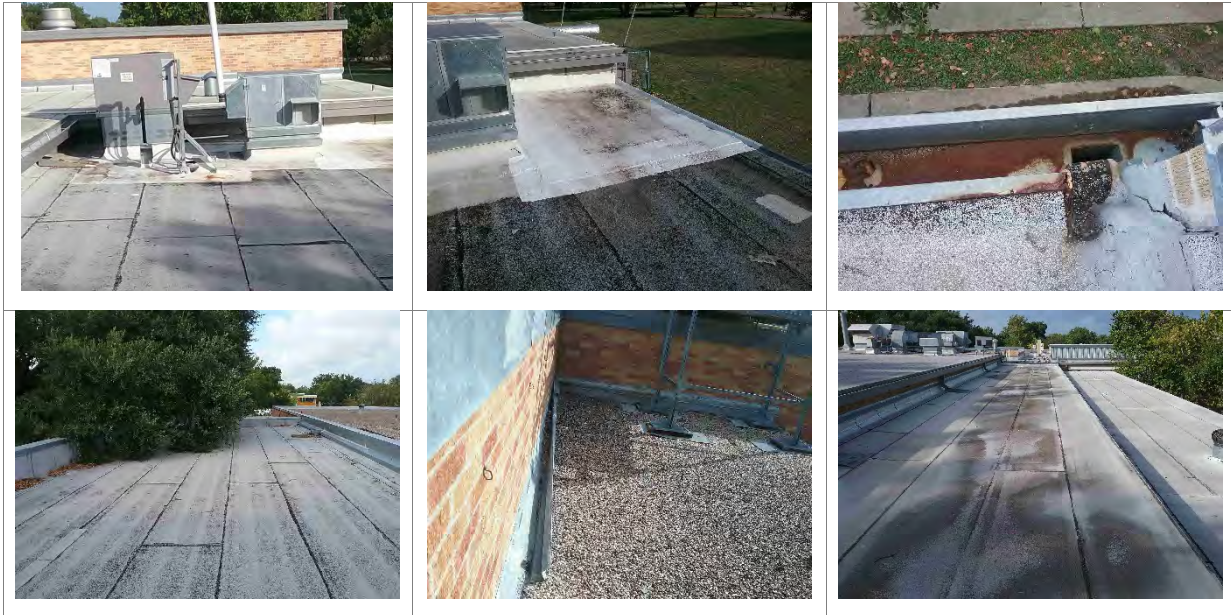
Roofing Deficiency Examples

Roofing	Approximately 90% of the roof has a modified bitumen membrane, while the remainder is built-up. The roof system was observed to be in average condition. The built-up roofing and about half of the modified bitumen roofing were nearing the end of their typical design service lives. The aged modified bitumen roof surfaces had areas of ponding, loss of granular surface, and blisters. Some gutters and downspouts appeared relatively new, other gutters had corrosion and holes and were not functional. The scuppers at the 300-wing appeared undersized relative to the roof area, likely resulting in ponding during significant rain events. A roof leak was reported above office 4. This roof area had been recently repaired. However, ponding was still evident, and a roof from a higher adjacent area unnecessarily discharged directly to this problematic roof area. The counterflashing on roof area A-14 above the kitchen was detached from the wall.		Average

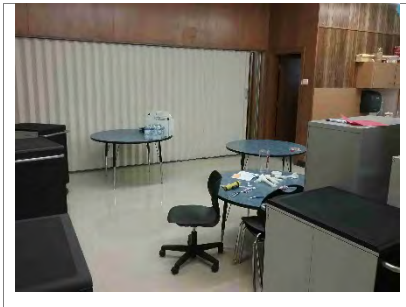
Interior Construction	Interior Walls	Most of the interior walls in the original building are constructed of glazed masonry units on the lower half and brick above. The interior walls in the 300-wing classroom addition are painted CMU (concrete masonry unit) or are framed partitions with wood paneling surfaces. Some recently renovated spaces such as the library have gypsum board surfaces. The cafeteria has its original metal-framed windows with operable sashes along the interior corridor wall. In the 300-wing, accordion partitions separate pairs of classrooms. The interior walls were observed to be in good condition. Accordion partitions appeared to be in average condition. Campus staff requested removal of	Good

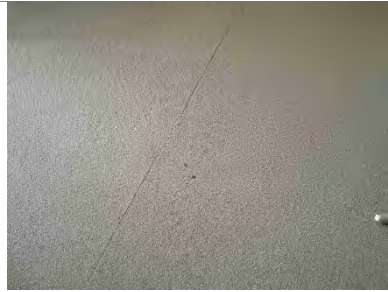
Interior Stairs	The only interior stairs in the building provide access to the stage and have wood framing and treads. The interior stairs were observed to be in good condition.	Good
Interior Finishes	Interior Wall Finishes	The predominant interior wall finish in the building is glazed masonry units with painted brick on the upper half of the wall. The upper brick walls in the gymnasium are unpainted. The library has painted gypsum board surfaces. The wood paneling in the 300-wing classrooms is stained and sealed. The recently renovated restrooms near the gymnasium have ceramic tile wall finishes. The interior wall finishes were observed to be in average condition due to the building's age and signs of wear and use. Some scuffing was visible, and peeling paint was observed on the concrete columns in corridor C5.	Average
	Interior Floor Finishes	The predominant interior floor finish throughout the building is vinyl tile with a 4-inch rubber base. Carpet is found in the library, in some administration spaces, and in some classrooms in the 100- and 200-wings. The kitchen has quarry tile, and all restrooms have ceramic tile. The gymnasium has a special plastic interlocking	Average

System	Subsystem	Condition and Deficiency Overview	System Condition Rating
		<p>flooring system for play activities.</p> <p>The carpet in the music room, administration spaces and library appeared to be in good condition. The carpet in classrooms appeared aged and deteriorated. The carpet in rooms 101, 103, 202 and 204 was visibly worn and had split seams and rippling. The vinyl flooring throughout the building appeared to be in average condition. The majority of the ceramic and quarry tile floors appeared to be in average condition, depending upon their age.</p>	
	Interior Ceiling Finishes	<p>The building's interior ceilings are both suspended and attached acoustical tiles. The tiles in the kitchen are vinyl covered. The ceilings in the restrooms near the gymnasium are painted cement plaster.</p> <p>The interior ceilings were observed to be in average condition. Ceiling tiles in the 100- and 200-wings were observed to have stains from roof leaks, and tiles in both wings had detached from their support structure.</p>	Average

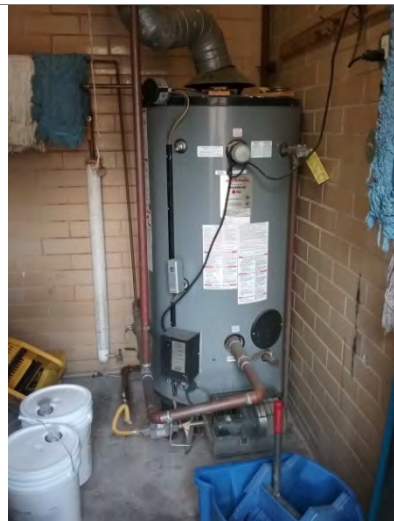
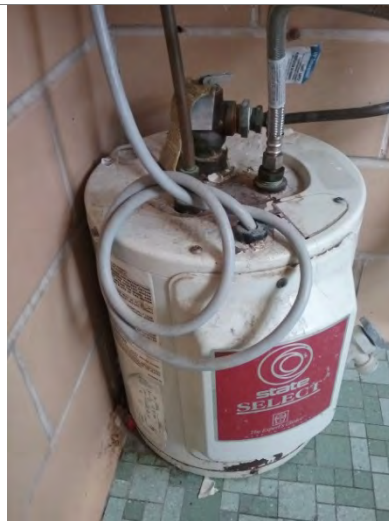
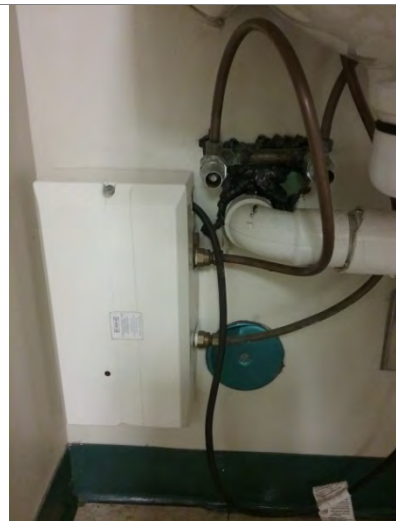
Domestic Water Distribution

System	Subsystem	Condition and Deficiency Overview	System Condition Rating
		<p>service for the building is provided by a GWH (gas water heater)-1, located in the kitchen mechanical room. The hot water in the staff restrooms is provided by a small EWH (electric water heater)-1.</p> <p>The plumbing distribution equipment serving the facility appeared to be in poor condition. The GWH serving the building was observed to be in average condition. The water heater nameplate indicated that it was installed in 2010. Both heaters appeared aged. The hot water piping insulation associated with the water heaters was either damaged or missing.</p> <p>The EWH in the library was past its typical design service life and appeared to be in poor condition. The nurse's office was equipped with a small EWH, which was not operating at the time of assessment.</p>	
	Other Plumbing	<p>The building is not equipped with roof drains.</p> <p>The plumbing equipment serving the facility was in poor condition, primarily due to age. Condensate drains terminated at the exterior wall, causing ponding on the ground below. Building staff reported that plumbing leaks occurred behind equipment in the walls.</p>	Poor

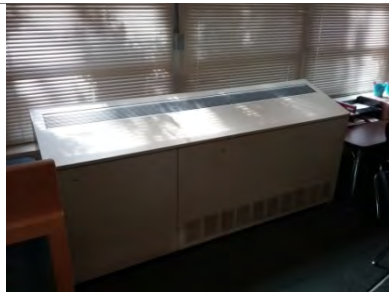
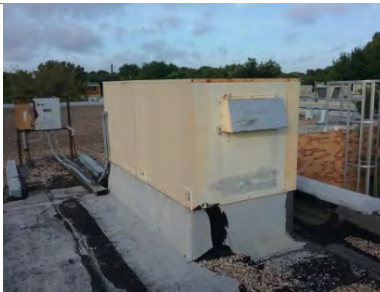
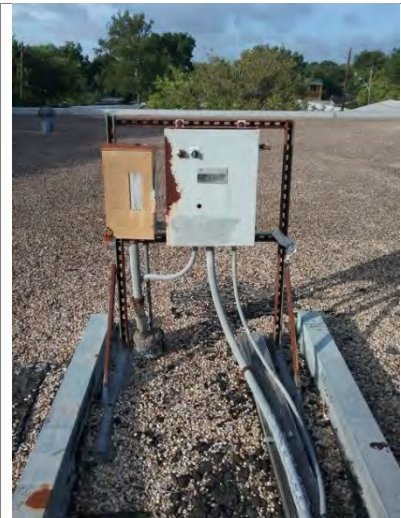
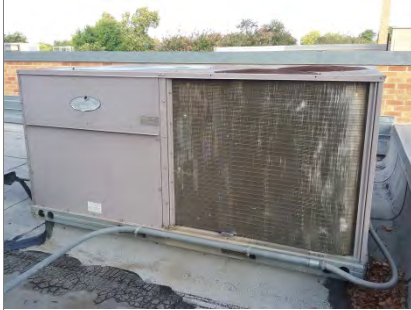
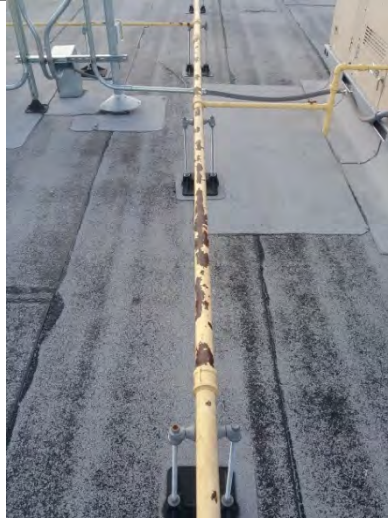
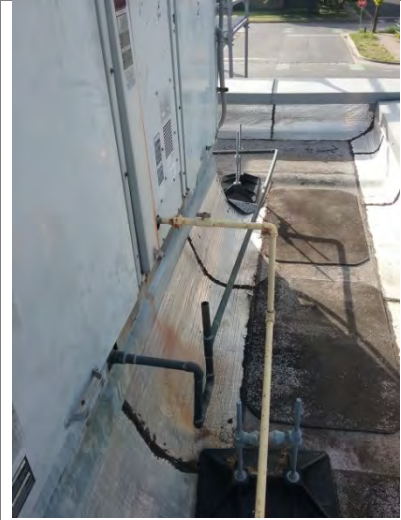
Mechanical/HVAC System Deficiency Examples

Mechanical/ HVAC	<p>The major mechanical equipment consists of RTUs (roof top units) located on the roof and serving the 300-wing and floor-mounted WSHPs (water-source heat pumps) within the classrooms. These serve the HVAC (heating, ventilating, and air conditioning) system along with roof-mounted exhaust fans and FCUs (fan coil units) serving select spaces. The mechanical drawings indicated a mechanical room housing a chiller, boiler and associated distribution pumps. The equipment was not present in the mechanical room at the time of assessment.</p> <p>The HVAC system appeared to be in poor condition. The majority of the classroom WSHPs were observed to be aged and in poor condition. The 300-wing was served by RTUs that were observed to be in average condition. The remaining RTUs were observed to be in aged and in poor condition. Coil damage was observed on several RTU condenser coils. Select electrical disconnects on the roof were rusted and corroded. Condensate drain piping was either damaged or missing for most of the units located on the roof. The gas piping was observed to be rusted and corroded. Rust and corrosion was observed on mechanical equipment housings throughout the roof. Abandoned piping was observed in the mechanical room. The through-wall air conditioning unit serving the library and the FCU serving the janitorial office appeared aged and need replacement. Aged fans and heaters were located throughout the building. The condenser unit associated with the FCU serving the MDF (main distribution frame) room appeared to be aged and needs replacement. The corridors were conditioned. The roof top EFs appeared aged and in poor condition.</p>		Poor

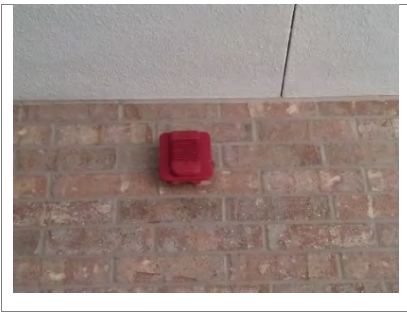
System	Subsystem	Condition and Deficiency Overview	System Condition Rating
Fire Protection	Fire Alarm	<p>The building has a fire alarm system that consists of alarm and signaling devices such as horns/annunciators, strobes, horn/strobe combinations, pull stations, and detectors. The fire alarm system is controlled by the Silent Knight control panel.</p> <p>The fire alarm system appeared to be in average condition.</p>	Average
	Fire Protection/Suppression	<p>A fire suppression system associated with the kitchen exhaust hoods is present. The building is protected by portable fire extinguishers placed throughout the facility. All observed portable fire extinguishers had inspection tags dated within the last year with the exception of one extinguisher located near the south entry door and another between rooms 303 and 304.</p> <p>The building's fire protection systems were observed to be in average condition.</p>	Average

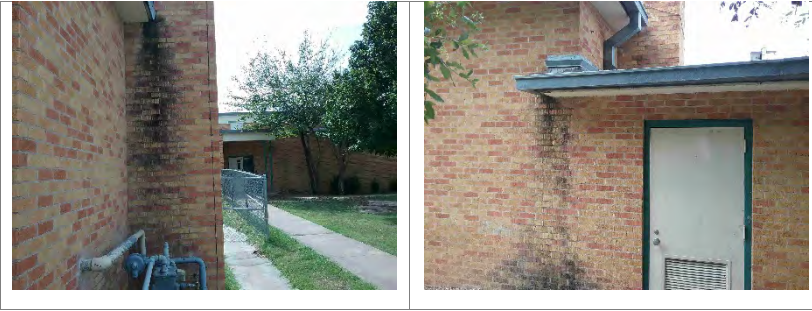
System	Subsystem	Condition and Deficiency Overview	System Condition Rating
Exterior	Exterior Walls	The exterior walls are solid brick and original to their 1951 construction. Organic growth was visible on some surfaces of the brick exterior walls.	Average
	Exterior Windows	The exterior windows are covered by cement plaster with a painted mural finish. The glazing was not visible at the time of the assessment. The exterior windows were presumed to be in poor condition. For security reasons, exterior windows may not be suitable to the building's current use as a play equipment storage room.	Poor
	Exterior Doors	The exterior doors are steel with hollow-metal frames. The exterior doors to the storage room were difficult to open. The door to the electrical room could not be opened. Corrosion was visible at the bottoms of all doors. The door hardware was aged and worn.	Poor
Roofing	The roof was not accessible, but was observed from an adjacent building's roof. The roof is built-up and most likely past its typical design service life. The roof was presumed to be in average condition. The roof was estimated to be of the same age and condition as the built-up roof on the Main School Building. The roof and gutter were visibly damaged at the building's northwest corner. No visible damage to the masonry wall was observed.		Average

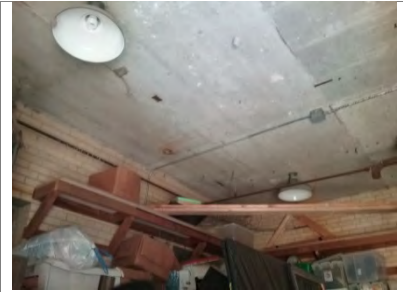
Electrical	Electrical Distribution	System not present.	N/A
	Lighting	The interior lighting consists primarily of incandescent lights. Exit signage was not present in the building. The interior pendant mounted light fixtures appeared to be in poor condition.	Poor
	Communications & Security	System not present.	N/A

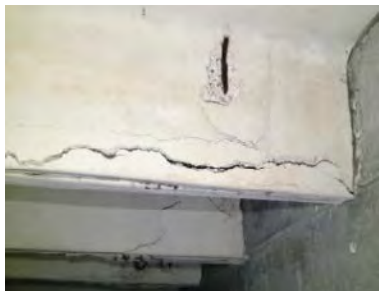
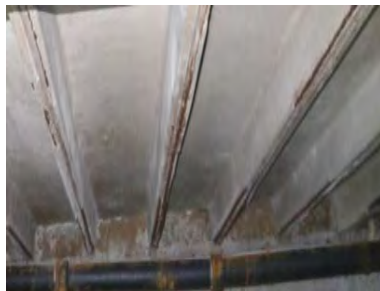
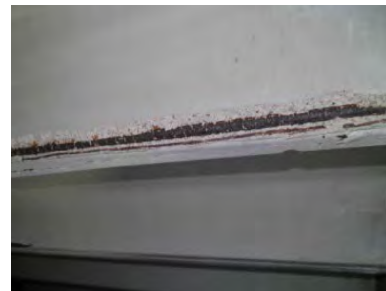
Exposed Structure

Longitudinal cracks along bottoms of precast channel legs
