## Cook Elementary School Site Summary

## Main School Building – BLDG-161A

## Stand-Alone Classroom Building – BLDG-161B

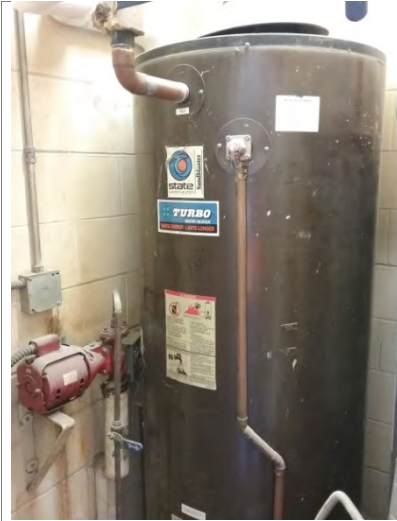
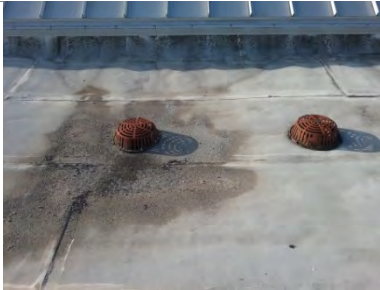
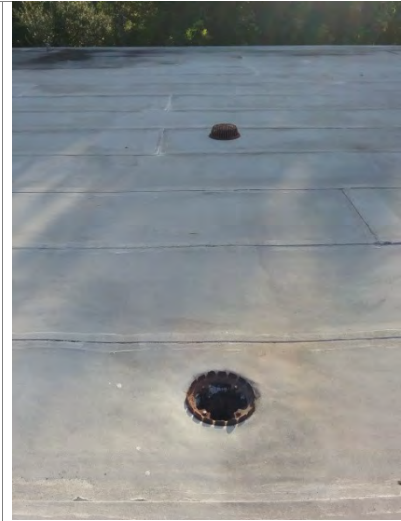
### Domestic Water Distribution

Domestic Water Distribution	The sinks located throughout the facility are not equipped with hot water with the exception of the	Poor

System	Subsystem	Condition and Deficiency Overview	System Condition Rating
		<p>lounge, kitchen, and administration restroom. The primary hot water service for the building, including the kitchen, is provided by two gas water heaters located in the kitchen mechanical room. The hot water in the lounge sink is provided by EWH-1 (electric water heater-1), located under the lounge sink. The hot water in the administration restroom is provided by EWH-1.</p> <p>The mechanical drawings indicated that EWH-1 was located in the vault. The vault was inaccessible at the time of testing. The mechanical drawings also indicated EWH-1 serving the gymnasium office which was located in the main electrical room. The water heater was not observed at the time of assessment. The gymnasium office was being utilized for storage, and hot water service to the office could not be determined.</p> <p>The water heaters serving the building were aged, past their service life, and appeared to be in poor condition. The hot water piping had corrosion in several areas. The hot water piping insulation associated with the water heaters was either missing or damaged. GWH-1 (gas water heater-1) which was located in the kitchen mechanical room appeared to be in poor condition.</p> <p>The plumbing distribution equipment serving the facility was observed to be in poor condition, primarily due to the deficiencies mentioned above.</p>

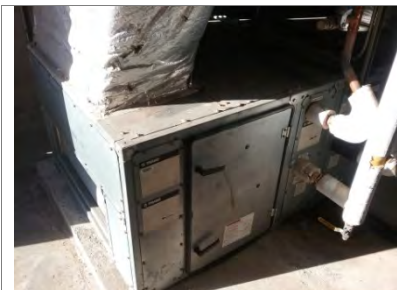
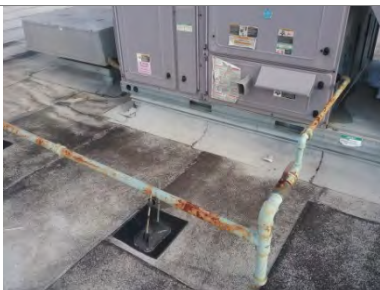
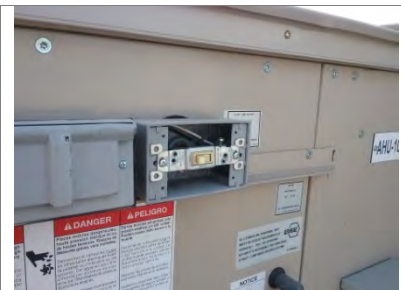
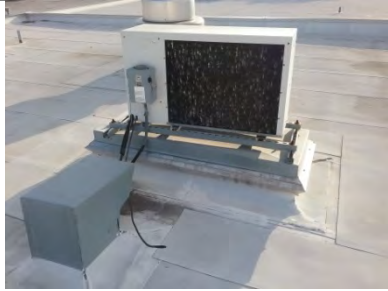
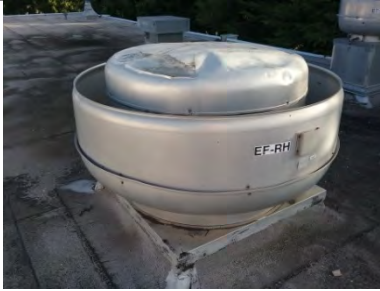
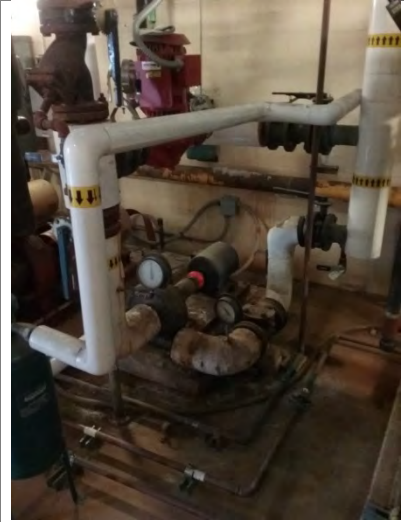
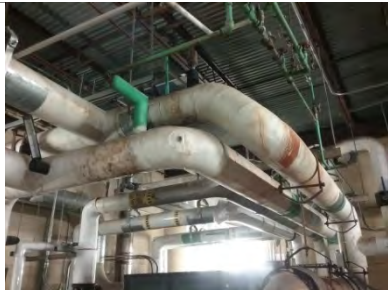
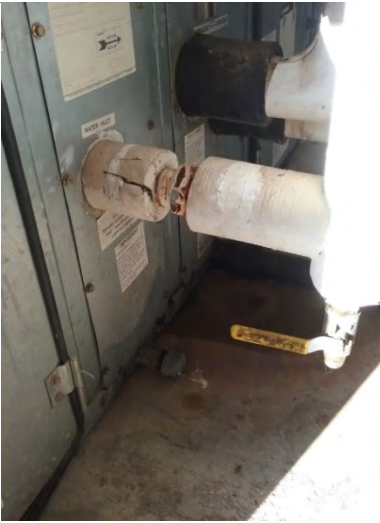
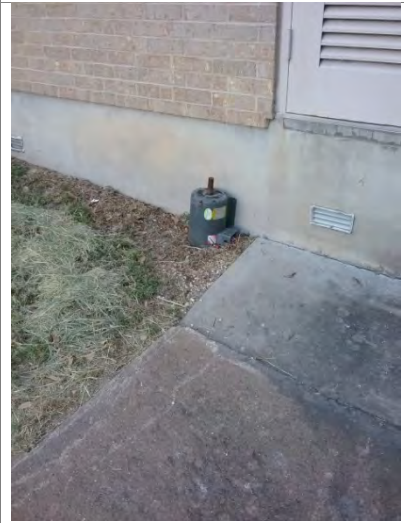
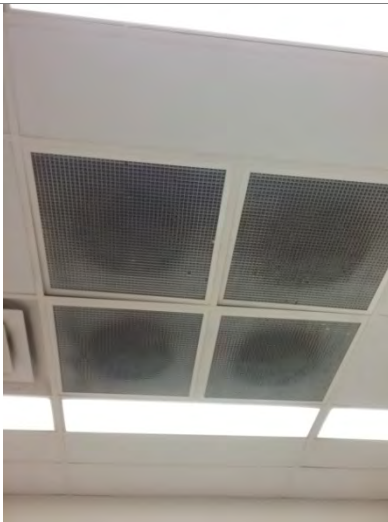
### Mechanical/HVAC System Deficiency Examples

System	Subsystem	Condition and Deficiency Overview	System Condition Rating
		<p>The HVAC system appeared to be in poor condition. Most of the AHUs appeared to be aged and needed replacement, while two appeared to have been recently replaced. Several interior AHUs were indicated on the mechanical drawings but were not installed at the time of assessment. During the Summer 2015 Bond Project #140020-COOK, AHU-10 was replaced and associated roof-mounted return duct over the lobby (A-3), but not over the kitchen. Also, over roof A-2, AHU-4 and -5 were replaced as was the roof-mounted cooling tower over the mechanical room. The RTUs appeared to be new and in good condition with one exception. The chillers were observed to be aged and needed replacement. The associated distribution pumps, piping, and insulation appeared aged and needed replacement. A condensing unit that appeared to be associated with the split system AHU serving the MDF (main distribution frame) room was aged with coil fin damage, presumably due to hail. The condenser refrigerant piping insulation was missing and damaged in areas. The gas piping associated with RTU-2 was corroded. A light switch cover on RTU-1 was missing. The FCUs were located in the ceiling plenum and were inaccessible for assessment. The building staff reported that the FCUs were original to the building and needed replacement. The supply diffusers in the building lobby were rusted and corroded, indicating humidity issues within the lobby. The return grilles in the kitchen were excessively dirty. Building staff reported that the ductwork was not replaced during the last renovation of the mechanical systems. It was reported that condensation leaks have damaged ceiling tiles in several areas. Building staff reported that the condenser unit between the gymnasium and the walk-in freezer, RU-F1, needed fencing around it due to students hiding behind it and damaging the piping.</p> <p>Supplemental mechanical equipment for the HVAC system included EFs serving the kitchen and restroom exhaust. Roof top EFs typically appeared aged and in poor condition with housing damage observed on several units. Building staff reported that the kitchen hood exhaust airflow was insufficient.</p>

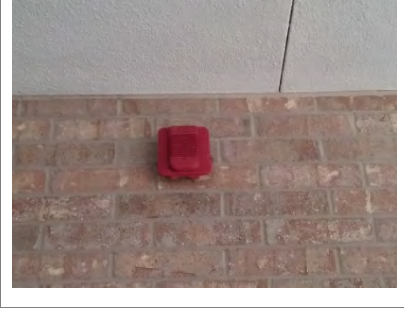
### Fire Alarm

Fire Protection	Fire Alarm	<p>The building has a fire alarm system that consists of alarm and signaling devices such as horns/annunciators, strobes, horn/strobe combinations, pull stations, and detectors. The fire alarm system is controlled by a Silent Knight control panel.</p> <p>The fire alarm system appeared to be in average condition. All of the exterior fire alarm devices showed age due to the outdoor elements.</p>	Average
	Fire Protection/Suppression	<p>A fire suppression system associated with the kitchen exhaust hoods was present. The remainder of the building is protected by portable fire extinguishers placed throughout the facility.</p> <p>All observed portable fire extinguishers had inspection tags dated within the last year with the exception of the exterior mechanical room containing AHU-1 and AHOA-1 and the bookroom.</p>	Average

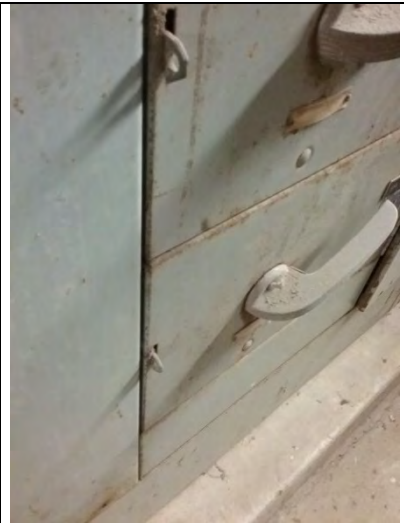
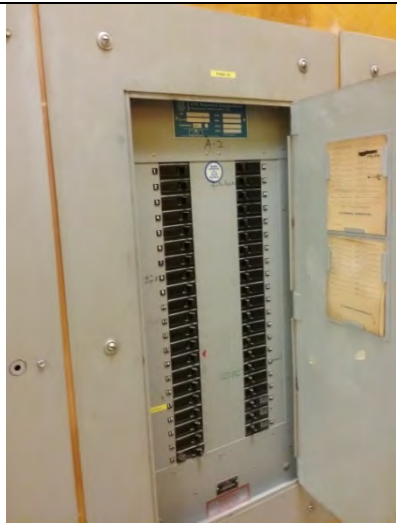
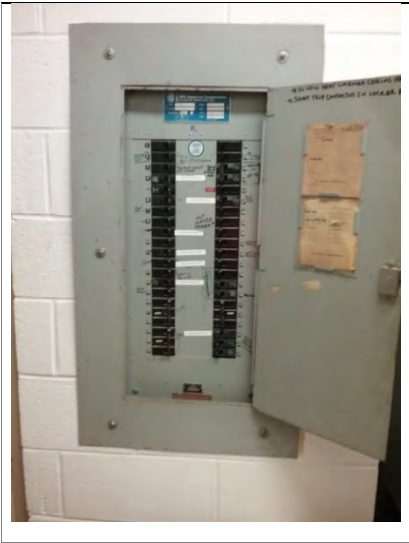
### Electrical Distribution

System	Subsystem	Condition and Deficiency Overview	System Condition Rating
		The building's fire protection systems were observed to be in average condition.	
Electrical	Electrical Distribution	<p>The electrical service enters the building at the 120/208-volt 3000-amp main exterior switchboard, located in the main electrical equipment room. The service feeds panelboards, which are located in various electrical rooms throughout the building.</p> <p>The electrical distribution equipment appeared to be in average condition. A majority of the assets were observed with out-of-date panels, and corrosion was on the enclosure of MSB-2.</p> <p>Facility staff reported that the panel in the kitchen and teacher's lounge needed to be replaced, and in the admin area, circuit breakers tripped frequently.</p> <p>The building does not have a lightning protection system.</p>	Average
	Lighting	<p>The building's exterior lighting consists of HID (high-intensity discharge) and LED (light-emitting diode) fixtures located along the entire perimeter and canopies. The interior lighting consists primarily of T8 fluorescent light fixtures.</p> <p>Lighting for the exterior of the building appeared to be in average condition. Approximately 10% of the HID light fixtures had discolored lenses and missing bulbs.</p> <p>About 80% of the interior lights appeared to have aged past their design life. Observed deficiencies included inconsistent lamp color temperatures and non-functional fixtures.</p> <p>The exit light signs present in the building appeared to be aged and in average condition.</p>	Average

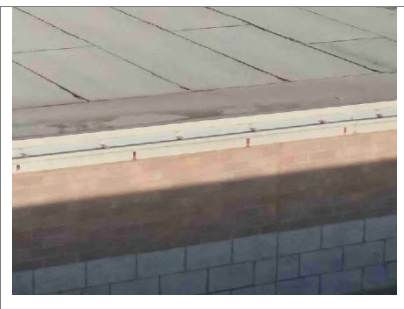
## **Roofing Deficiency Examples**

System	Subsystem	Condition and Deficiency Overview	System Condition Rating
<b>Roofing</b>	<p>The building has a modified bitumen membrane roof that is most likely original to the building's construction in 1998.</p> <p>The roof was viewed from the top of BLDG-161A. The building's roofing appeared to be in good condition; however, the roof membrane was nearing the end of its expected service life. Some evidence of ponding was visible near the roof edges. The continuous gutter system's hangers had visible corrosion, although the gutters and downspouts appeared to be in good condition.</p>		Average
<b>Interior Construction</b>	Interior Walls	<p>The interior walls are framed with gypsum board surfaces.</p> <p>The interior walls were in good condition.</p>	Good
	Interior Doors	<p>The interior doors are solid core wood with metal frames. The classroom doors have vision panels.</p> <p>The interior doors and hardware were in good condition.</p>	Good
