Doss Elementary School Site Summary

Address	7005 Northledge Drive Austin, TX 78731
Number of Permanent Campus Facilities	2
Original Year of Construction	1970 and 2010
Total Campus Building Area (combined)	61,102 SF

Main School Building – BLDG-154A

Stand-Alone Gymnasium – BLDG-154B

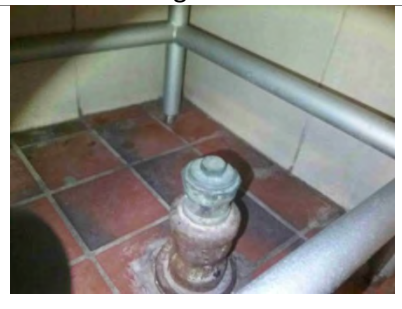
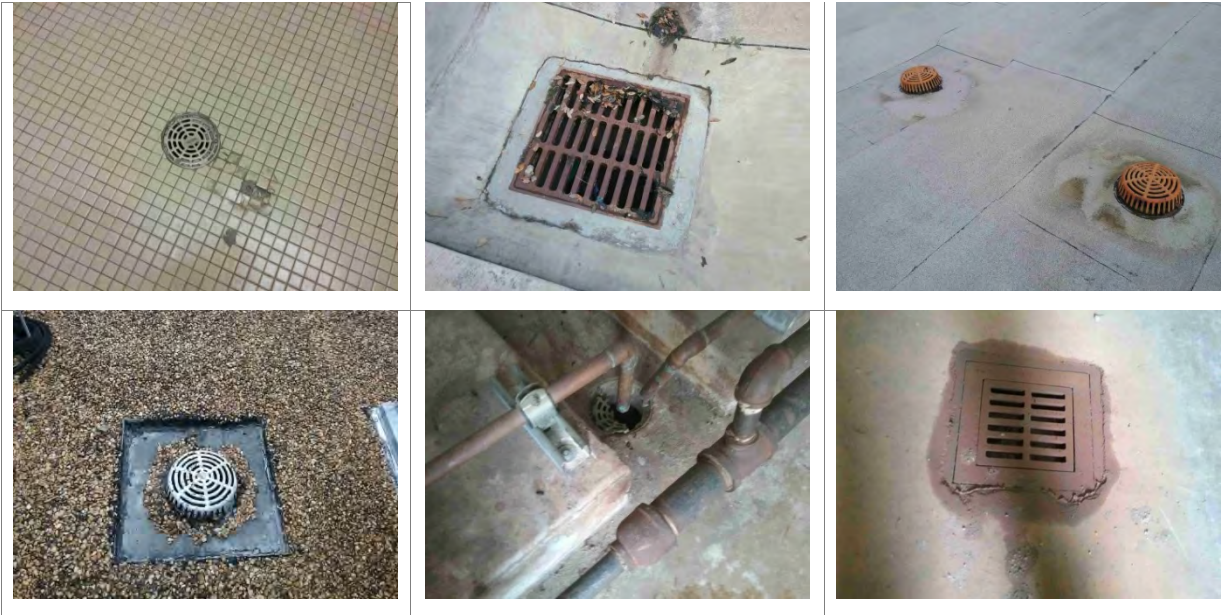
System	Subsystem	Condition and Deficiency Overview	System Condition Rating
		<p>plumbing fixtures.</p> <p>The GWHS feeding the cafeteria were in newer, good condition. The smaller units installed for hot water use to a specific location were in good to average condition, with some showing signs of age and deterioration. The water heater in the PTA office (PTAOFC) had signs of pests around the unit.</p> <p>The plumbing distribution equipment appeared to be in average condition with damaged insulation and corrosion and rust observed on piping throughout the building. Plumbing in the KITMECH room was aged and had damaged insulation, showing signs of excessive wear and tear.</p>	
	Other Plumbing	<p>There is a storm sump in the basement MAINMECH room. The MAINMECH room appeared to flood during rain events. Some roof drains were observed to have rocks around the grate, which could cause plugging. Some roof drains had rust on them. Storm drain covers were rusted. There was an exterior spicket leaking onto the ground.</p> <p>Associated other plumbing appears to be in average condition. The kitchen drain pipes had corrosion and rust. Male restrooms 505, 302, 307, 123, and 101, male administration restroom MFHRRADM, and janitorial closet CC300 had a foul odor. Some restroom floor drains were observed to be damaged, aged and have signs of corrosion.</p>	Average

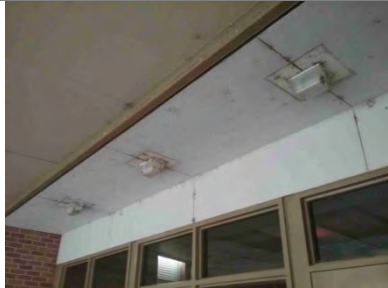
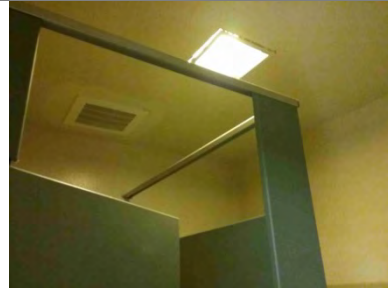
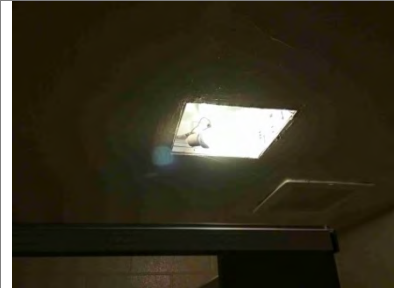
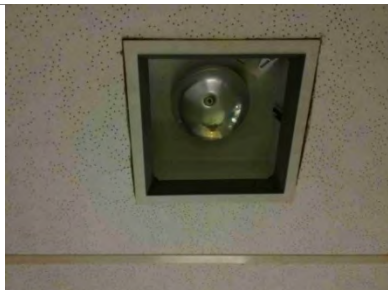
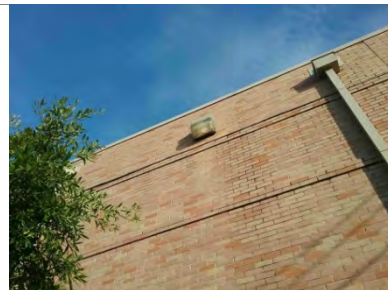
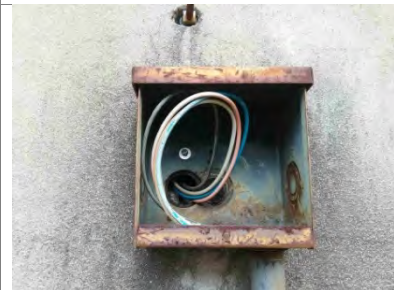
System	Subsystem	Condition and Deficiency Overview	System Condition Rating
		distribution equipment was original and near their end of life expectancy. Faculty also reported that the distribution panelboard for the administration area was at full capacity and needed to be upgraded, as additional circuits were required.	
	Lighting	<p>The building's exterior lighting consists of high pressure sodium/metal-halide, fluorescent, and LED (light-emitting diode) luminaires that are located at building egresses, covered walkways, and exterior walls. The interior lighting consists primarily of fluorescent luminaires. Emergency lighting luminaires are present in the corridors and multi-purpose rooms that connect the classrooms.</p> <p>The lighting for the building appeared to be in average condition. Several exterior luminaires appeared to be cracked or aged past their design life. A few exterior luminaires were on during the day. Observed interior lighting deficiencies included dim lamps, broken/missing lenses, and non-functional fixtures. These deficiencies were especially prominent within the student restrooms and administration areas. The stage has a lighting module for the stage lighting. This lighting module was found to have significant arcing when the light switches were activated.</p> <p>There were several issues in the branch wiring, including damaged or loose roof top conduit and missing junction box covers. Several exterior receptacles were found with broken or non-sealed covers. Several exterior and interior electrical receptacles were observed to be in poor condition. Many classrooms featured electrical outlets near sink areas that should be replaced with GFCI (ground fault circuit interrupter) receptacles.</p> <p>The faculty have requested additional exterior lighting at the portable buildings, playground, and the loading dock. The faculty also requested luminaire replacements for the classroom restrooms. Faculty have stated that the power packs for the luminaires are consistently failing, specifically the 277-volt luminaires.</p>	Average
