# Houston Elementary School Site Summary

<b>Address</b>	5409 Ponciana Drive Austin, TX 78744
<b>Number of Permanent Campus Facilities</b>	4
<b>Original Year of Construction</b>	1976
<b>Total Campus Building Area (combined)</b>	81,206 SF

## Main School Building – BLDG-162A

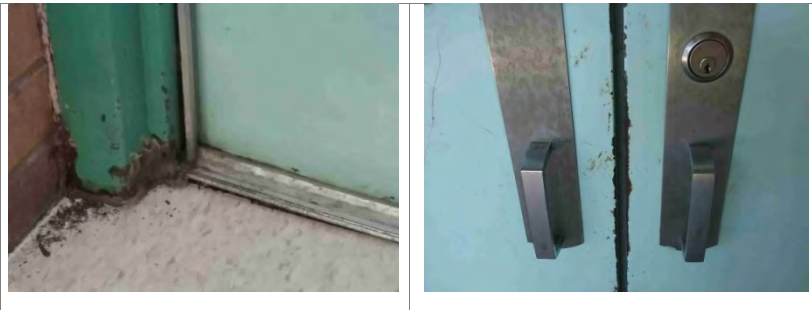
### Exterior Doors

System	Subsystem	Condition and Deficiency Overview	System Condition Rating
<b>Exterior</b>	Exterior Walls	The exterior of the building consists of a brick façade. The exterior of the building appeared in average condition. The walkway structure was rusted in many areas. The metal lintels over the doors and windows were pitted with rust. The metal overhang over the east exit door was severely bent.	Average
	Exterior Windows	The windows are single-paned aluminum metal frames inset into the brick façade. There was no indication that there was any problems with the windows. They appeared to be in good condition.	Good
	Exterior Doors	There are many double exterior metal doors with lites throughout the building. Some exterior doors are solid metal with no lites. The exterior doors were observed to be in average condition. Paint on the door frames and doors was chipped in well-used areas. There was rust at the bottom of door frame number 304, and ants were infiltrating.	Average

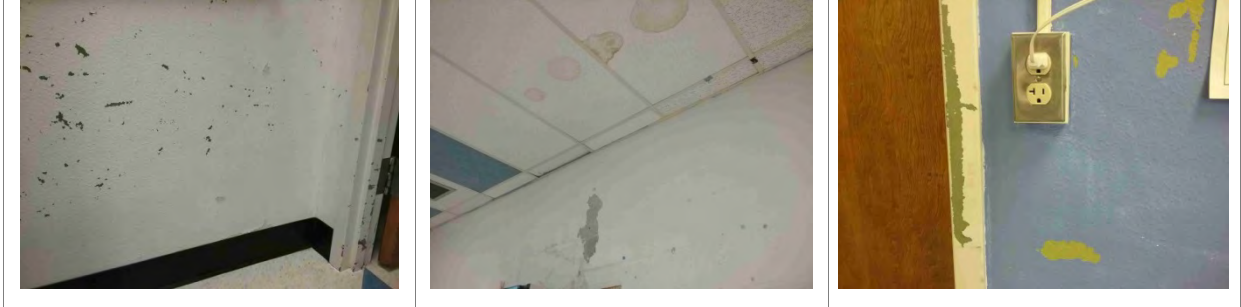
#### Interior Wall Finishes

Interior Specialties	System not present.	N/A
<b>Stairs</b>	Exterior Stairs	System not present.	N/A
	Interior Stairs	System not present.	N/A
<b>Interior Finishes</b>	Interior Wall Finishes	The interior walls are painted gypsum board in the classrooms, administration area, library, and lobby. There is painted CMU in the cafeteria and exterior classroom wall areas. The corridors are gypsum board at the top and plastic laminate from the floor up to six feet.  Most wall finishes were observed to be in average condition with some in poor condition. There were multiple scrapes, scratches, and gypsum board tears throughout the building.	Average
	Interior Floor Finishes	The interior floor finishes are VCT (vinyl composition tile) in the administration offices, corridors, cafeteria, and classrooms. Ceramic tile is in the restrooms and kitchen. The flooring is carpet in the library and three of the administration offices. There is wood flooring on the stage.  All floorings appeared to be in good condition.	Good

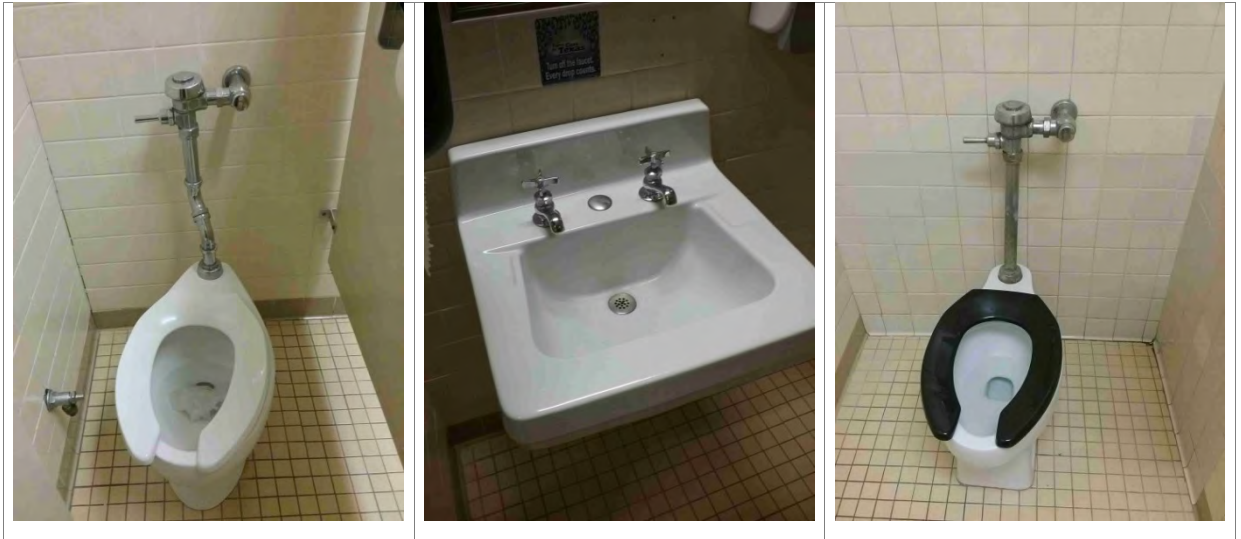
#### Plumbing Fixtures

System	Subsystem	Condition and Deficiency Overview	System Condition Rating
		was reported by two staff members that the stains were suspected to be caused by animal urine, and both had heard animals in the walls and ceilings.	
<b>Conveying</b>	System not present.		N/A
<b>Plumbing</b>	Plumbing Fixtures	<p>The facility contains multiple plumbing applications that service one level, consisting of in-classroom student restrooms, staff restrooms, janitorial closets with service sinks, and one commercial kitchen. The restrooms that are located inside classrooms have vitreous china floor-mount toilets with manual flushing valves. The classroom restrooms are not equipped with sinks; however, the classrooms have laminated particle board vanities with stainless steel sink/bubbler combinations mounted inside the vanities. The remainder of the facility's restrooms have vitreous china sinks with manual or metering faucets, along with vitreous china floor/wall-mount toilets and urinals with manual flushing valves. There are also wall-mounted service sinks in the janitorial closets.</p> <p>This building's restroom plumbing fixtures were observed to be in average condition. The staff reported the following deficiencies or planned/requested renovations with regard to the facility's plumbing fixtures:</p> <p>The public restrooms WRRCAFE TOILETF and MRRCAFE TOLIETM and student restrooms 100RR TOILET and 102RR TOILET are scheduled for renovation to create handicap access during the summer of 2017. It was reported that the sinks, faucets, and toilet fixtures throughout the campus were beyond their useful life and should be replaced. It was also reported that there was only one janitorial closet floor sink in the kitchen and staff requested that the janitorial closet CC300 also have a floor sink installed.</p> <p>The plumbing fixtures observed throughout the building were very aged, and some appeared to be original construction. Though the fixtures were aged, they were all functioning at the time of assessment.</p> <p>Other specific deficiencies noted during the assessment were many of the toilets appeared to flush slowly or had an insufficient amount of water volume, and the restroom partitions were also observed to be corroding.</p>	Average

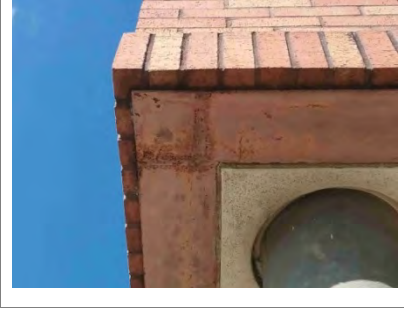
### **Exterior Walls**

System	Subsystem	Condition and Deficiency Overview	System Condition Rating
<b>Exterior</b>	Exterior Walls	The exterior of the building consists of a brick façade. The exterior of the building appeared to be in good condition. The metal lintels over the door overhangs were pitted with rust.	Good
	Exterior Windows	The windows are double-paned aluminum metal frames inset into the brick façade. There was no evidence of leaking windows as reported by staff. The windows appeared to be in good condition.	Good
	Exterior Doors	There are double exterior metal doors with lites throughout the building. The exterior doors appeared to be in average condition. The doors were chipped and scraped inside and out. The entry door window was fogged and scratched.	Average
<b>Roofing</b>	The building has a built-up roof. The roof appeared to be in good condition.		Good
<b>Interior Construction</b>	Interior Walls	The interior walls are gypsum board in the classrooms and corridors. The walls appeared to be in good condition. There was a chipped gypsum board corner exposing the metal bead in room 203.	Good

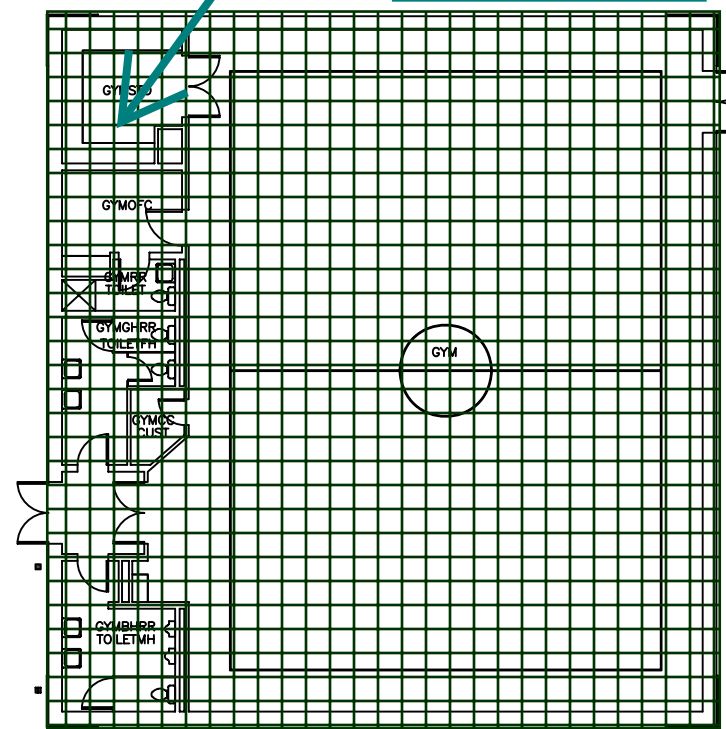
FLR-162C-01

APPROXIMATE LIMITS OF CRAWL SPACE OBSERVED DURING SITE VISIT

APPROXIMATE LIMITS OF CRAWL SPACE PER AVAILABLE PLANS AND SITE OBSERVATIONS

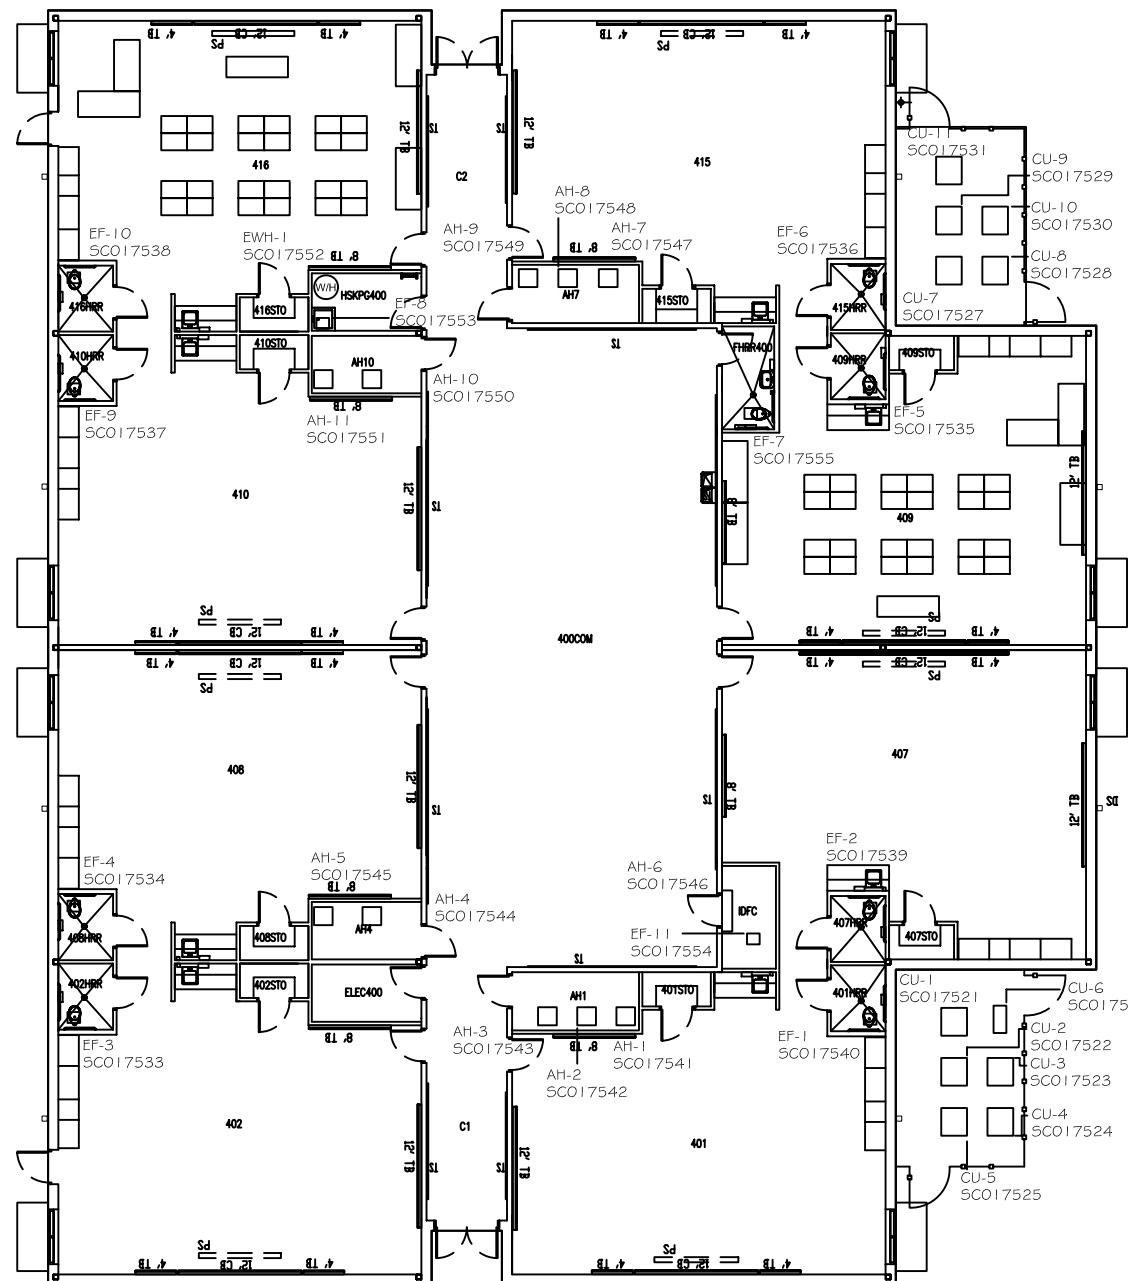
FLR-162D-01

Access thru wall hatch here

Deficiencies found in these locations:
