Joslin Elementary School Site Summary

Address	4500 Manchaca Road Austin, TX 78745
Number of Permanent Campus Facilities	3
Original Year of Construction	1954
Total Campus Building Area (combined)	45,628 SF

Main School Building – BLDG-120A

Stand-Alone Classroom Building – BLDG-120B

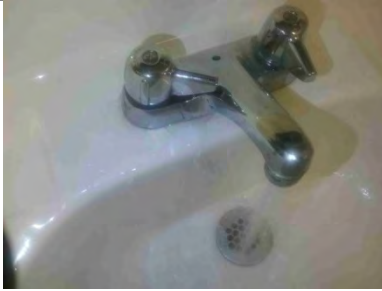
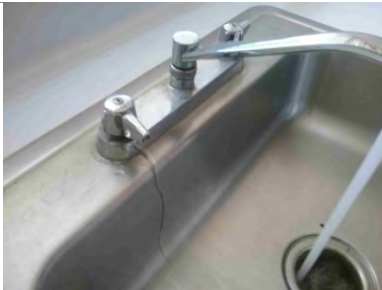
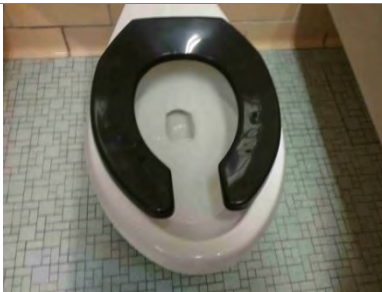
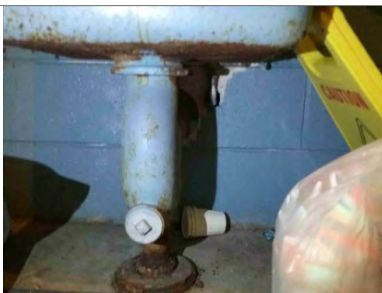
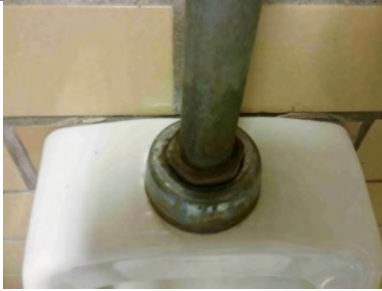
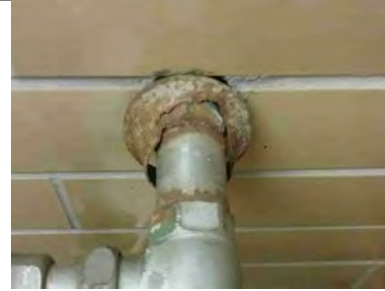
System	Subsystem	Condition and Deficiency Overview	System Condition Rating
		The 2x4 tile and grid systems in the classroom wings appeared to be sagging, broken, and ill-fitting. All other ceiling finishes appeared to be in good condition.	
Conveying	System not present.		N/A
Plumbing	Plumbing Fixtures	<p>BLDG-120A of Joslin Elementary School contains predominantly single-use restrooms throughout the facility, with multi-use restrooms found outside of the gymnasium and administration areas. Typical restrooms have floor-mounted vitreous china water closets with manual flush valves. Additionally, wall-hung vitreous china urinals with manual flush valves are located in the dedicated multi-use male restrooms. Typical classrooms contain a single-basin stainless steel or porcelain enamel metal sink with a drinking fountain attached or a porcelain enamel metal sink with separate vitreous china drinking fountain. Stainless steel drinking fountains can be found in the corridors of the building.</p> <p>A lounge contains a stainless steel double-basin sink. There is a porcelain enameled steel handwashing basin sink outside of the cafeteria that has three faucets. The kitchen contains stainless steel kitchen equipment, including a three-basin prep sink. It also has various wall-mounted vitreous china and stainless sinks for personal use. The building has service sinks located in various janitorial closets. There are showers located in the gymnasium office and in room 101.</p> <p>The majority of plumbing fixtures were observed to be in poor working condition, aged and showed signs of deterioration. The drinking fountain in room 205 was cracked and had low flow. The sink in the administration's female bathroom (WFRRADM) was observed to stick on longer than expected. The coated metal handwashing basin sink outside the cafeteria had three faucets. All three faucets were observed to leak. There is a vitreous china personal sink in the kitchen that was observed to leak. The corner sinks in restrooms in rooms 201-206 were old and did not work. They appeared to be abandoned in place. No flow was observed when only the hot water handle of restroom 101HRR's sink was turned on. The sink in room 102 had leakage from both faucets. The gymnasium office sink was spurting uneven flow. The water also had a gray tone. The handheld shower head in the gymnasium office was observed to be leaking.</p> <p>There is a toilet seat in BRRGYM that is undersized.</p>	Poor

System	Subsystem	Condition and Deficiency Overview	System Condition Rating
		Corrosion was observed on fixtures in BRRGYM, and an odor was being emitted. One of the urinals in this restroom appeared to not be operational and had a garbage bag over it. There was leakage observed from the toilet in the restrooms off rooms 102 and 104. The sinks in the janitorial closets were observed to be in average to poor condition, with some showing signs of leaks and corrosion around the base.	
	Domestic Water Distribution	Domestic hot water to the kitchen is provided by a 75-gallon water heater stored in the mechanical room (KITMECH) located inside the kitchen. A 50-gallon electric water heater was next to a washer and dryer in room 101LAUN. The unit is approximately 20 years old but appears to be in average condition with minor corrosion and rust on the connections. Various smaller electric water heaters are located throughout the building to provide heated domestic water to specific locations in the school (i.e., administration area and gymnasium shower). Domestic hot water is not supplied to the classroom plumbing fixtures. Damaged insulation, corrosion, and rust were observed on piping throughout the building. The plumbing distribution equipment was observed to be in average condition with typical wear and tear associated with the system's age and general daily use.	Average

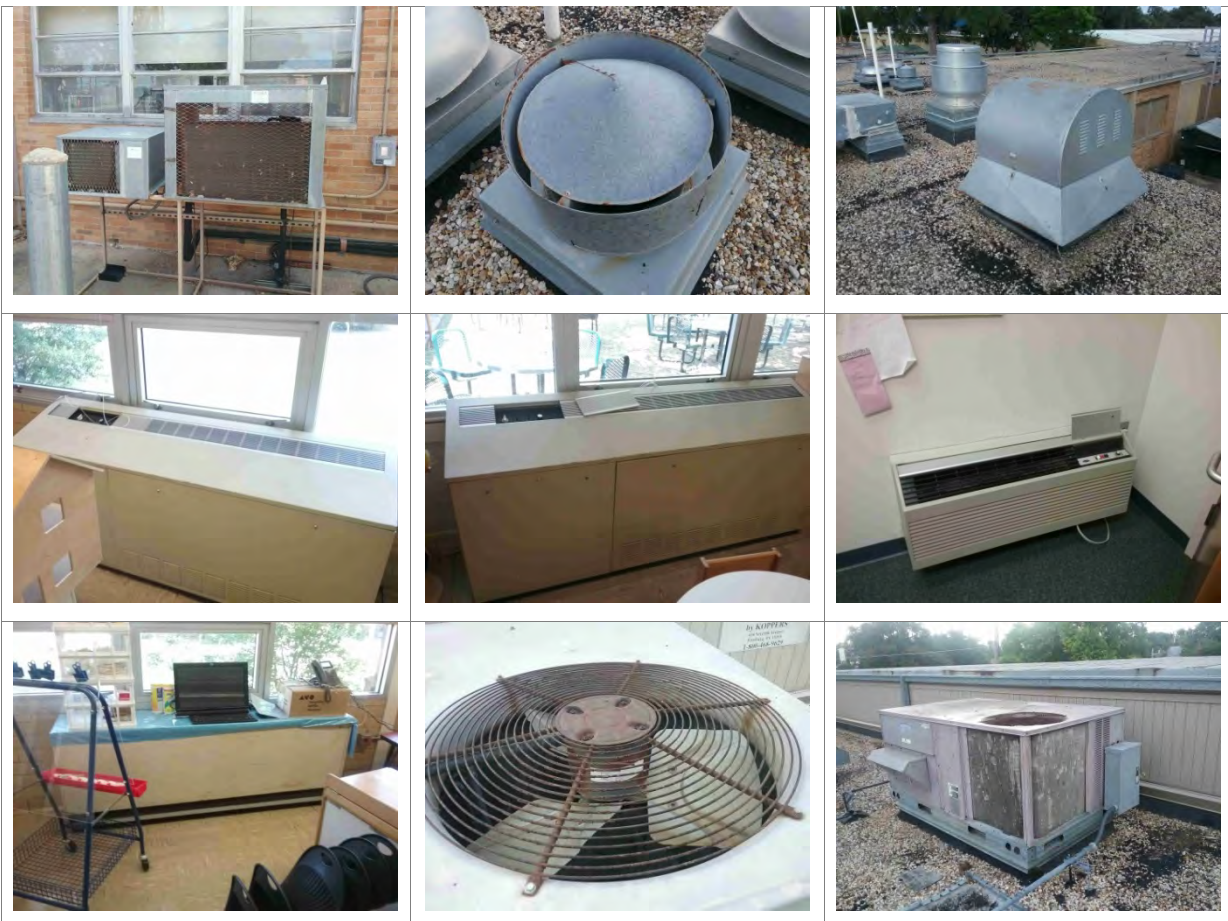
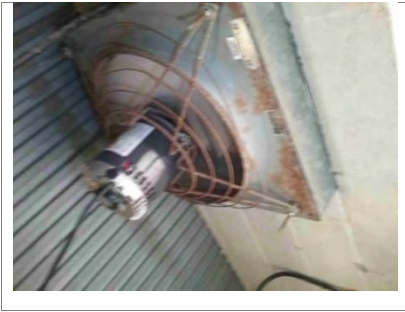
Mechanical/HVAC System Deficiency Examples

System	Subsystem	Condition and Deficiency Overview	System Condition Rating
		<p>building.</p> <p>The geothermal water pump units were approaching end of useful life, and it was reported in the facility interview that water needs to be manually added twice a year. This is not normal recommended maintenance for these units but was reported to be necessary to keep them functioning. It is suspected there may be a leak in the geothermal well system. Room 201 had a musty smell, possibly coming from the geothermal unit. The unit in room 104 was making a vibrating noise during operation. Two units found in the administration area appeared to be newer and in good condition. There was an in-wall packaged AC unit (PTAC-1) in the gymnasium office that was making a loud grinding noise. Old TRANE heating units were found in the majority of classrooms. It was reported that they were no longer in use and abandoned in place. Some roof top EFs had corrosion and rust. The EF in ELEC300 had corrosion and rust. The EF in the gymnasium was very loud. The kitchen source fan was aged and out of date, showing signs of corrosion and rust.</p>

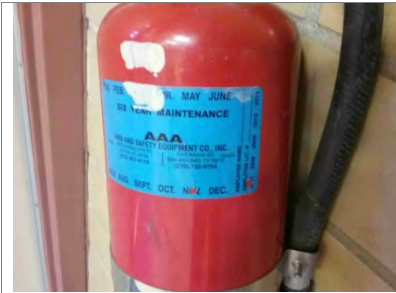
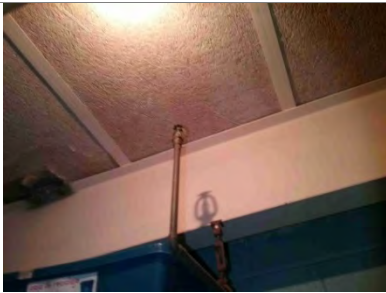
Fire Protection	Fire Alarm	<p>The building has a fire alarm system that consists of alarm and signaling devices such as horns, strobes, horn/strobe combinations devices, pull stations, detectors, and a system annunciator. The fire alarm system is controlled by the Silent Knight control panel.</p> <p>The fire alarm system was observed to be in average condition due to some of the fire alarm end devices being near their end of life or worn from outdoor exposure. It should also be noted that the book storage spaces do not have fire detection.</p>	Average
	Fire Protection/Suppression	<p>A fire suppression system is present for the range hood in the kitchen with a tank mounted to the wall at the ceiling. A single sprinkler head was observed in the CCGYM room that did not appear to be functional.</p> <p>The remaining fire suppression system consists of fire extinguishers throughout the building. Visual inspection showed these appeared to be in average condition. The majority of the extinguishers were up to date with inspections, but the extinguisher in the gymnasium was past due on its annual inspection.</p>	Average

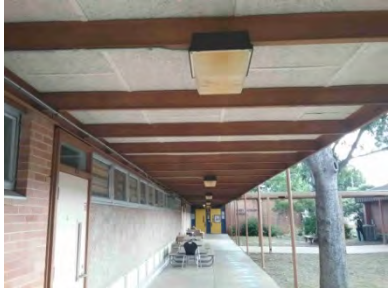
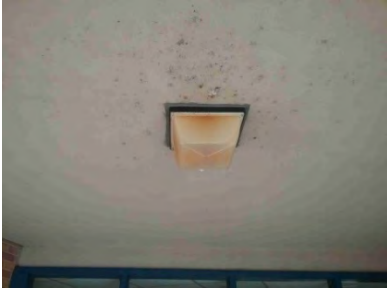
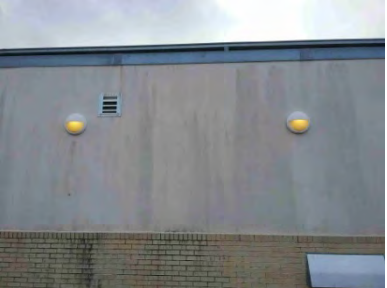
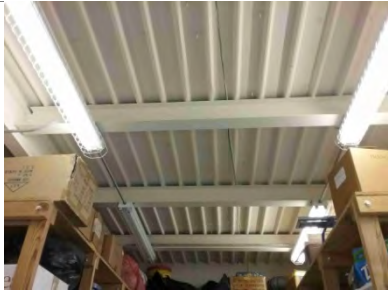
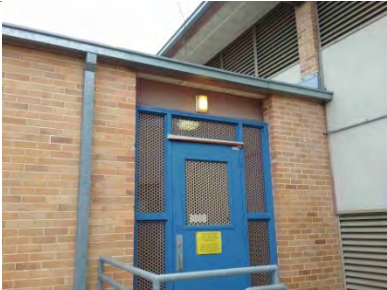
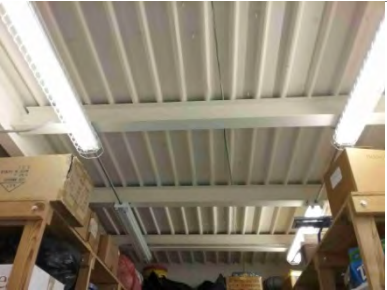
System	Subsystem	Condition and Deficiency Overview	System Condition Rating
		<p>Two panelboards, Panel N and Panel TP1B, had missing breaker covers, and the bussing was exposed behind the breaker board. This condition is a life safety hazard, and breaker covers should be installed immediately. There are several safety switches and equipment controls for equipment throughout the building that are dated and past life expectancy.</p> <p>The faculty has reported that breakers commonly trip due to overloaded circuits.</p>	
	Lighting	<p>The building's exterior lighting consists of metal-halide and fluorescent luminaires that are located near parking lots, playground, covered walkways, and building egresses. Exterior luminaires are made up of a variety of different fixture types but are predominately wall-mounted lights and canopy lights. The interior lighting primarily consists of recessed troffers, surface mounted strip lights, and suspended strip light, and recessed downlight fluorescent luminaires. Some storage rooms still feature dated screw-in lamp style luminaires.</p> <p>The lighting for the building appeared to be in average condition. Many interior and exterior luminaires appeared to be aged past their design life. Observed deficiencies included worn and discolored lenses, dim lighting, and non-functional fixtures. There are exit signs present in the building, but several were found to be poorly lit. There was also an instance of a temporary shop light being used as a permanent fixture in room IDF.</p> <p>There were several issues in the branch wiring, including damaged or loose conduit and missing junction box covers. Open conduit could lead to water and insect infiltration into the electrical systems. Several exterior receptacles were found with broken covers, without covers, or severely worn. Some interior electrical receptacles were found to be worn, have broken cover plates, or ground lugs (from a device plug) broken off inside the receptacle. The 100-wing classrooms were found with non-grounded electrical receptacles installed for overhead clocks. Many classroom light switches were worn and past their life expectancy. The faculty has reported that there are common issues with the electrical receptacles and associated circuits in the classrooms that result in tripped circuits. The faculty has also reported inadequate lighting in the restroom vestibules between</p>	Average

System	Subsystem	Condition and Deficiency Overview	System Condition Rating
		classrooms, under the covered walkways for the classrooms, and within the nurse's office. The faculty reported that many of the external luminaires were old and replacement parts were difficult to find.	
	Communications & Security	<p>The building is equipped with telecommunications/cable systems, with the main backbone equipment located in the inaccessible MDF (main distribution frame) room. Room 208 contains a cabinet named IDF1-B that houses additional data equipment. Networking Wi-Fi access points are also installed throughout the building. VOIP (voice over IP) telephones are used for voice communications.</p> <p>The building security includes surveillance cameras, motion detectors, and a proximity card access system.</p> <p>The communications and security systems appeared to be in good condition. The faculty reported that the timekeeping and intercom systems work well.</p>	Good

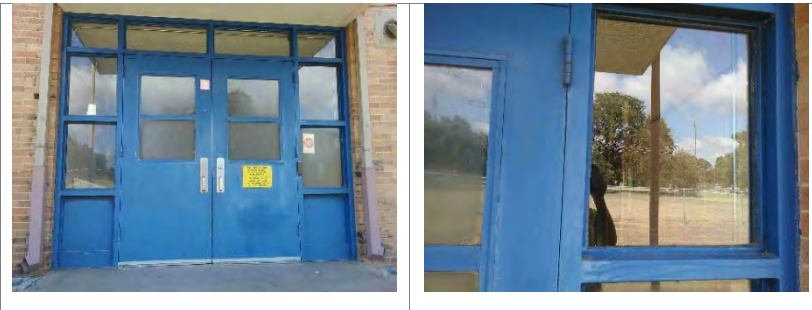
System	Subsystem	Condition and Deficiency Overview	System Condition Rating
Exterior	Exterior Walls	The exterior is all brick with cement plaster soffits above the south and north walls. An entry soffit exists over the west entry. These durable surfaces appeared to be clean and in good condition. The south roof fascia requires painting (see Roofing).	Good
	Exterior Windows	Windows are ganged, single-glazed, aluminum units with bottom awning sashes. The exterior windows appeared to be in poor condition. Most sash lights were missing putty. Interior film, particularly on the upper lights on the south side, showed age and was discolored. Several lights appeared to have been damaged by BB gun pellets.	Poor
	Exterior Doors	The only exterior doors are located at the west end of the building. This pair of painted, hollow metal, double doors is set in a painted hollow metal frame. The frame has fixed single-glazed sidelights and a transom. These doors appeared to be in average condition, though the paint finish was failing.	Average
