Kiker Elementary School Site Summary

Introduction

Main School Building – BLDG-180A

Stand-Alone Classroom Building – BLDG-180B

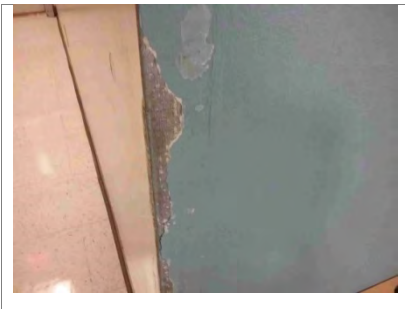
Interior Stairs	System not present.	N/A
Interior Finishes	Interior Wall Finishes	The interior walls are painted gypsum board in the classrooms, administration area, lobby, library, and cafeteria. There is CMU in the gymnasium. The corridors are gypsum board at the top and plastic laminate from the floor upward of 4 feet. Most of the wall finishes were observed to be in good condition. 10% of the cafeteria walls were scraped and gouged.	Good
	Interior Floor Finishes	The interior floor finishes are VCT (vinyl composition tile) in the administration offices, corridors, cafeteria, and classrooms. Ceramic tile is in the restrooms and nurse's office, and quarry tile in the kitchen. The flooring is carpet in the library, administration offices and classrooms in the 100-wing. There is a carpet sport court in the gymnasium. There is wood flooring on the stage. Most floor finishes were observed to be in good condition. There was ceramic tile buckling in the male restroom in room 202. There was missing VCT tile in room 504.	Good
