## Kocurek Elementary School Site Summary

### Introduction

## Main School Building – BLDG-172A

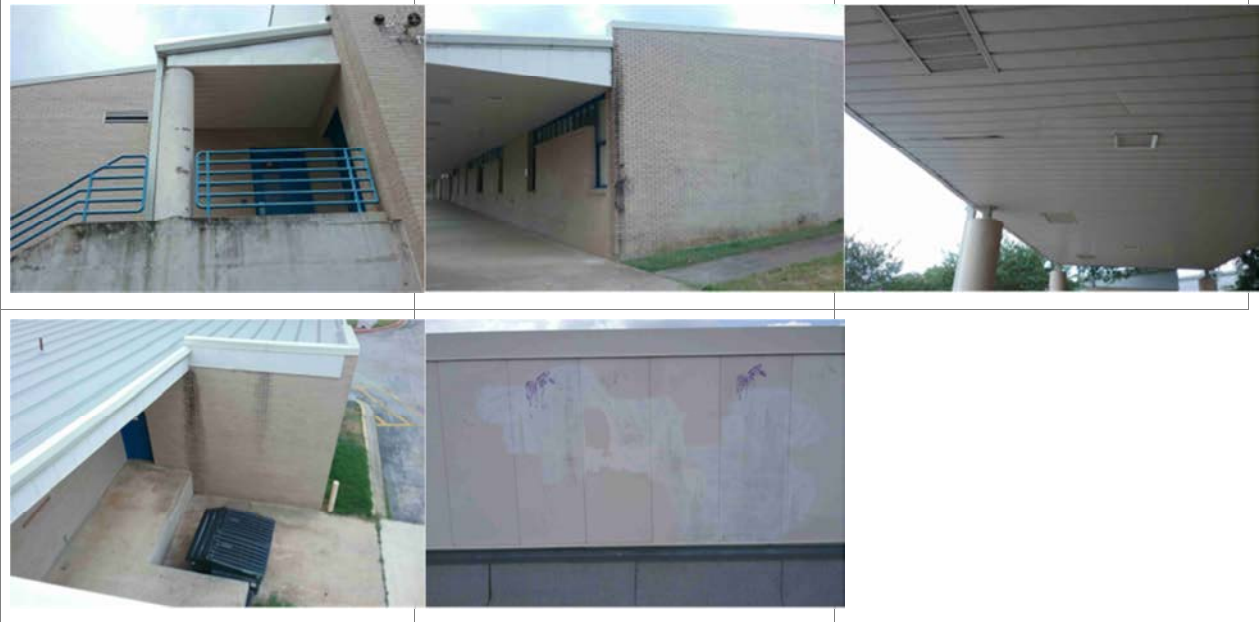
### Exterior Walls

System	Subsystem	Condition and Deficiency Overview	System Condition Rating
Exterior	Exterior Walls	Exterior walls are primarily comprised of brick with metal panels above roof lines.  Issues observed included water damage as a result of uncontrolled flow of water from the roofing system. Metal panels appeared to have sealant added to the system. In some cases, that sealant was bubbling out at the joints. Graffiti was observed on the upper metal panels of the gymnasium at the roof. In other areas, the canopy/soffit was damaged. One exterior column by the gymnasium was damaged from water infiltration, resulting in rusting rebar expansion.	Average
	Exterior Windows	The exterior windows are a mixture of aluminum single-hung and hollow metal window systems.  Units and sealants appeared to be in good condition. There was some minor finish degradation, and a number of units have had their glass glazing replaced with acrylic glazing that may cloud over with time. In one section at the front entrance, where the windows were less protected, there was rusting at the sills of the hollow metal window units. An open gap was observed in one window unit, and gaskets were seen to be coming out of another.	Good

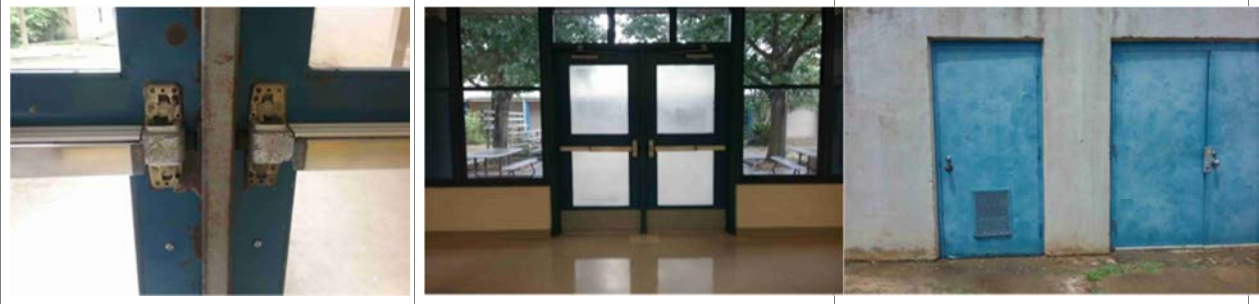
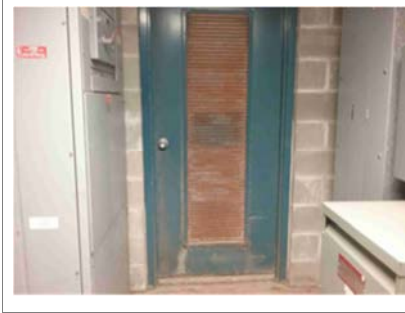
### Exterior Doors

Exterior Doors	Exterior doors are hollow metal doors set in hollow metal frames. Typically, these units contain vision lites. Some	Average

System	Subsystem	Condition and Deficiency Overview	System Condition Rating
		<p>mechanical rooms have louvers set in the metal doors.</p> <p>A large number of windows appear to be acrylic in the door units with side lights. Courtyard doors are generally acrylic.</p> <p>Courtyard doors have frosted over with age or were damaged. Individual issues included rusting and minor damage to doors and hardware.</p>	
<b>Roofing</b>	<p>The facility has two main types of roofing systems, low slope modified bitumen and steep sloped metal panels. All roofs are serviced by a gutter system or a collector head and downspout system.</p> <p>The roofing systems appear to function as intended based on the lack of widespread damage to the interior ceiling finish systems. In addition, the pitches on the modified bitumen roofs appeared generous. The metal roofs are all steep sloped limiting the amount of water that could physically remain on the roof. Some downspouts appeared clogged, and others appeared undersized. Some gutters appeared to have been bypassed as seen outside the 200-wing. This was evidenced by the erosion present under the the line of gutter and the dirt stains on the exterior wall. In other locations the gutter was being bypassed between the end of the gutter and an adjacent wall due to the lack of flashing directing the runoff. A significant number of balls were on the gymnasium and cafeteria roofs. The one scupper and collector head servicing the roof at the gymnasium were large enough that volleyballs passed through into the collector head. Two volleyballs and a tennis ball were observed in the collector head and removed. At some point, deflated balls will clog that portion of the system. Smaller balls may have already lodged at a reduction in the downspout. At roof areas A07 and A12, the overflow rainwater leaders lacked protection against objects such as baseballs and tennis balls entering the pipe. Nine balls were removed from the roof areas of A12 and A13.</p>		Average

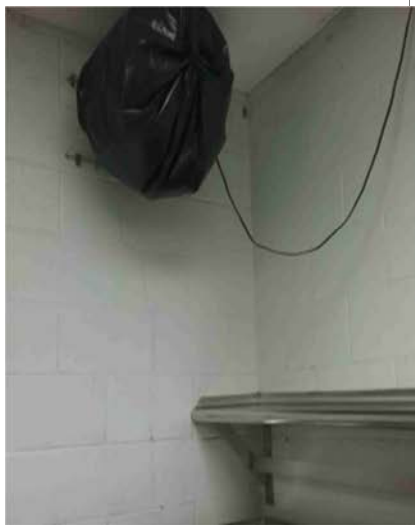
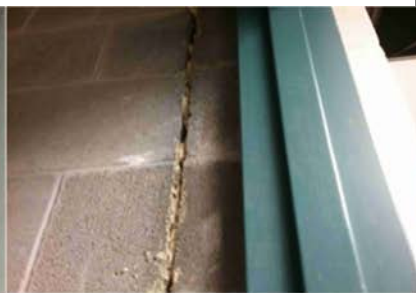
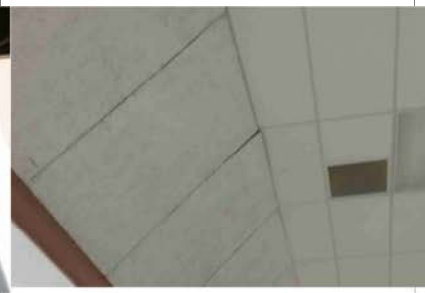
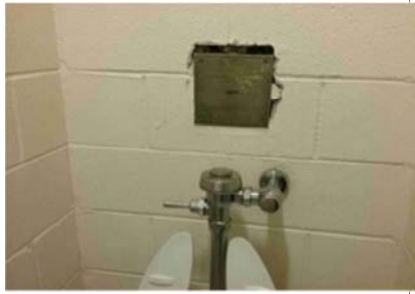
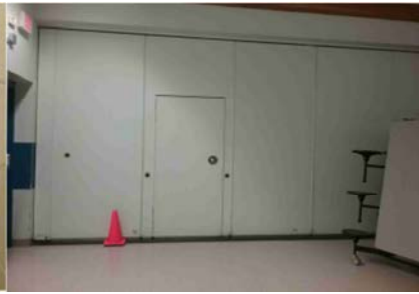
#### Interior Walls

<b>Interior Construction</b>	Interior Walls	<p>Interior wall systems are limited to gypsum board wall assemblies and CMU (concrete masonry unit).</p> <p>Deficiencies included cracking at CMU wall systems, acoustic treatment delamination in the Cafe, holes in the CMU system at a clean-out, and an exposed expansion joint. It was reported that the operable partition is has finish issues and is failing.</p>	Good
	Interior Doors	<p>Doors inside the building are solid core doors clad in laminate and set in hollow metal frames.</p> <p>The laminate system on the doors was showing significant wear and tear, resulting in many doors with missing laminate in part or in whole. The missing laminate appeared to be limited to pieces on the front</p>	Average

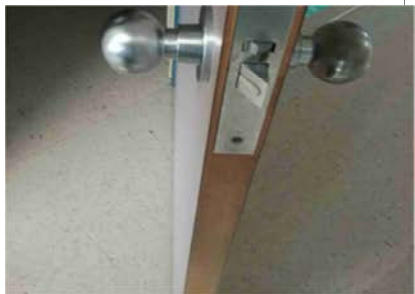
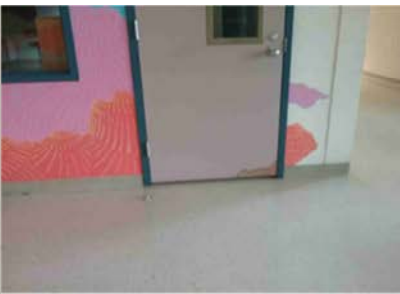
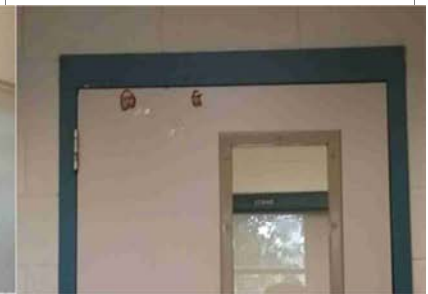
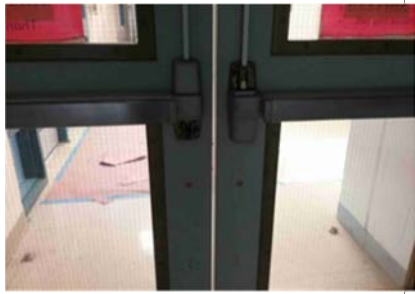
### Interior Doors

System	Subsystem	Condition and Deficiency Overview	System Condition Rating
		and back faces or along the edges. None of the doors assessed had ADA (Americans with Disabilities Act) compliant hardware. One missing closer was noted on a rated door, and one door had shifted in its frame enough that it would not close.	
	Interior Specialties	System not present.	N/A
Stairs	Exterior Stairs	All exterior stairs are comprised of cast-in-place concrete with metal railings.  Observed issues included rusting at railings where they connect with the concrete and degradation of the concrete stair by the gymnasium.	Average
	Interior Stairs	Interior stairs are limited to those required to access the stage.  These wooden stairs were observed to be in good condition.	Good
Interior Finishes	Interior Wall Finishes	Interior wall finishes are paint systems over gypsum board partitions or CMU. The restrooms include a mixture of painted gypsum board and ceramic tile.  Wall finishes within the building appeared to be in poor condition. A significant number of the classrooms and common areas required painting. During the assessment, the entire 400-wing, half of the 300-wing, all but four rooms in the 200-wing, and the kitchen were noted as needing paint. Many of the finish systems adjacent to classroom doors and windows were damaged to the point that metal corner beads were clearly visible. In male restrooms, the areas behind the toilets were limited to a painted block wall, which limits the ability to clean these areas. In common areas, damage was noted at coat racks mounted to the gypsum board wall system.	Poor

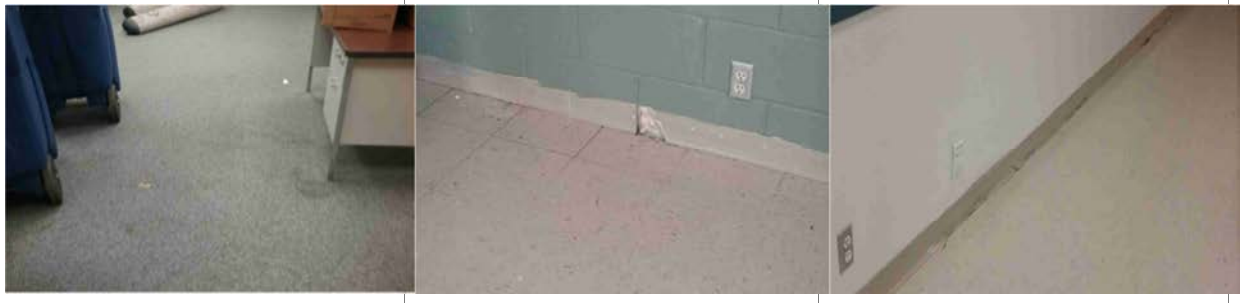
### Interior Floor Finishes

Interior Floor Finishes	Interior floor finishes include VCT (vinyl composite tile), carpet, strip wood flooring at the stage, quarry tile in the kitchen, and an interlocking plastic tile system in the gymnasium.  Flooring issues observed were limited to cove base damage or adhesion and damaged carpet.	Average

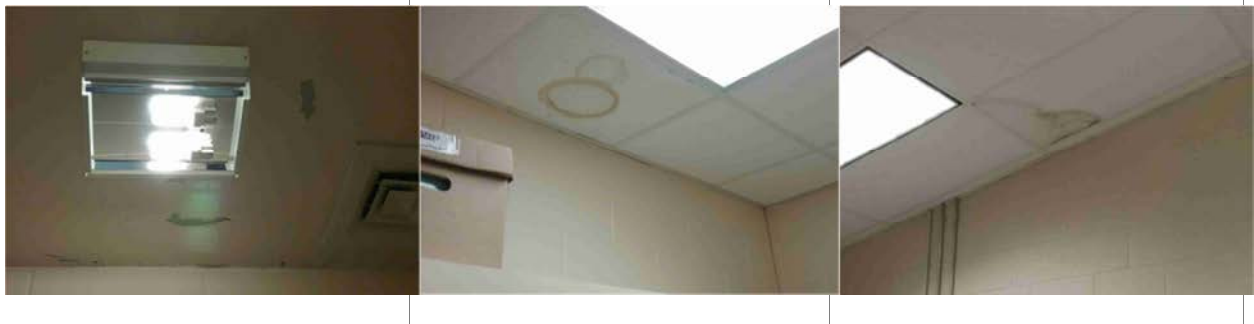
### Interior Ceiling Finishes

System	Subsystem	Condition and Deficiency Overview	System Condition Rating
	Interior Ceiling Finishes	<p>Ceiling systems consist of 2x4 suspended acoustical tiles with limited amounts of gypsum board ceilings in restrooms or as accents.</p> <p>Within the building, a limited number of water-damaged tiles were likely related to roof leaks. A large number of ceiling tiles were damaged, stained, or out of alignment relating to the HVAC (heating, ventilating, and air conditioning) equipment contained between the ceiling and roof structure. There were some number of water stained tiles that must be related to water infiltration in the building envelope. There were a limited number of issues with the paint system or water damage with the finished gypsum board in restrooms.</p>	Average
Conveying	System not present.		N/A
Plumbing	Plumbing Fixtures	<p>The building has public restrooms for men, women, and students and separate staff restrooms located throughout the facility. These restrooms generally have vitreous china hand sinks in counters with manual faucets, along with vitreous china, floor-mount/wall toilets with manual flushing mechanisms, and vitreous china, wall-hung urinals in the male restrooms with manual flushing mechanisms. There are service sinks in the janitorial closets, and water coolers located throughout the facility, typically near the public restrooms.</p> <p>The restroom plumbing fixtures were observed to be in average condition as the fixtures were typically aged but still operational.</p>	Average

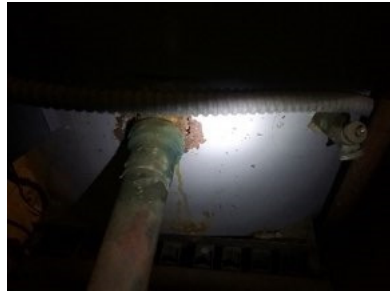
#### Domestic Water Distribution

Domestic Water Distribution	<p>All of the plumbing fixtures are serviced with domestic cold water. A gas water heater adjacent to the kitchen services the kitchen.</p> <p>The water heaters near the kitchen spaces were observed to be in serviceable condition with no identified or reported deficiencies.</p> <p>EWHS (electric water heaters) in the stand-alone classroom buildings serve janitorial closets and were observed to be in good condition.</p> <p>The plumbing distribution equipment was observed to be in average condition.</p>	Average
	Other Plumbing	<p>The roof drains are equipped with metal grate covers to prevent debris from entering the drainage system.</p>	Average

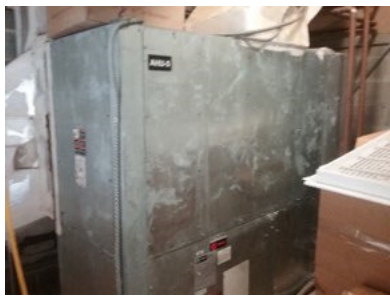
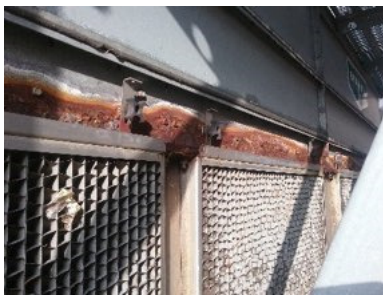
### **Mechanical/HVAC System Deficiency Examples**

System	Subsystem	Condition and Deficiency Overview	System Condition Rating
		<p>The roof drains were observed to be in good condition.</p> <p>It was noted in the interview that the grease trap clogs frequently and has been a persistent maintenance issue.</p> <p>Also noted within the interview is the sanitary loop around the exterior of the building. The loop is thin wall PVC and breaks regularly.</p>	
<b>Mechanical HVAC</b>		<p>The major mechanical equipment consists of indoor multi-positional WSHP (water source heat pumps). The loop water temperature is controlled by a cooling tower located adjacent to the main mechanical room as well as a boiler located in the main mechanical room. Three HRUs (heat recovery units) located on the roof provide outside air to the building.</p> <p>Most WSHPs were located above the ceiling and were not observable. It was reported that all WSHP units located above the ceiling were replaced within the last two years.</p> <p>Three WSHP units located on the mezzanine serve the kitchen, cafeteria, and gymnasium. These units were not replaced and showed their age. They were leaking water on the floor.</p> <p>The HRUs were original and were past their service date.</p> <p>The cooling tower was observed to have significant rust and build up on the tower intake as well as leakage in the water basin onto the ground around the tower.</p> <p>The boiler serving the water loop had been replaced within the last ten years. It was reported that the boiler was oversized and short cycled. This created accelerated wear on the boiler internal heat exchanger, causing it to prematurely wear and age.</p> <p>There are reported issues within the music room HVAC.</p> <p>Due to the items above pertaining to the cooling tower, HRUs and the boiler, the system was rated as average.</p>	Average

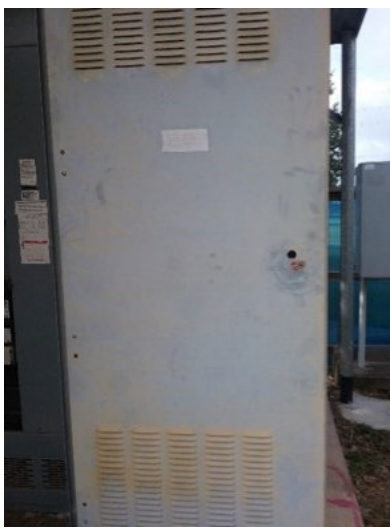
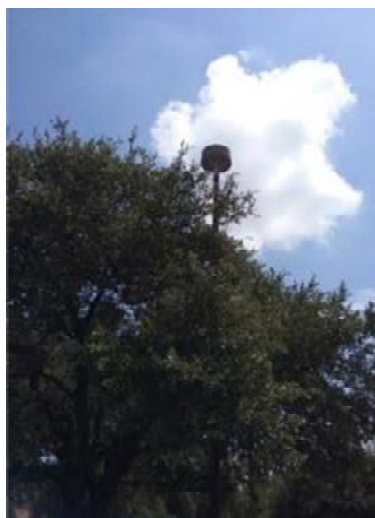
#### Electrical Distribution

System	Subsystem	Condition and Deficiency Overview	System Condition Rating
<b>Electrical</b>	Electrical Distribution	<p>The electrical service enters the building from the 277/480-volt 1600-amp main switchboard "MSB" located on the exterior near the service transformer. The service also feeds another 1600-amp switchboard "MDP" in the ELECTRICAL MDP room that distributes service to branch transformers, panelboards, and equipment located in various electrical rooms throughout the building.</p> <p>The exterior switchboard "MSB" was missing a locking handle on one door, leaving main switches accessible to the public. The interior electrical distribution equipment appeared to be in good condition, although the Interview Notes stated the building had no main switchgear.</p> <p>The building does not have a lightning protection system.</p>	Average
	Lighting	<p>The building's exterior lighting consists of incandescent downlights and HID (high-intensity discharge) pole light fixtures that are located along the entire perimeter. The interior lighting consists primarily of T8 fluorescent light fixtures.</p> <p>The interior lighting appeared to be in good condition and well maintained. Exit signs in the building appeared to be in good condition.</p> <p>It was reported that the playground area had insufficient lighting and the exterior lights are old and failing, and in poor condition.</p>	Good

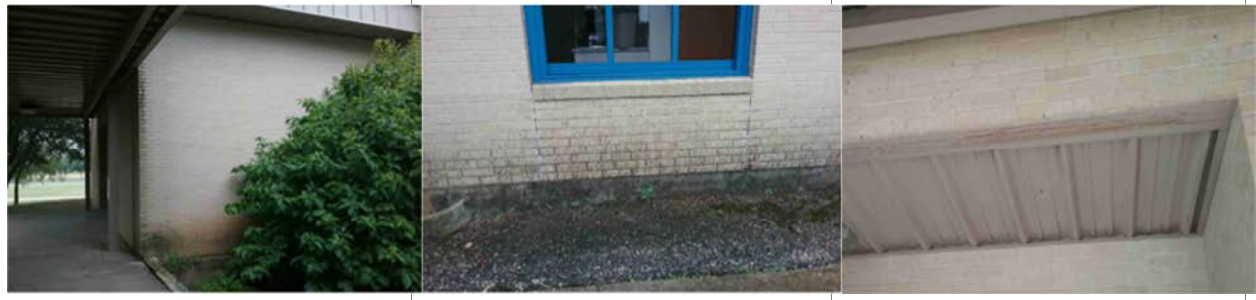
#### Exterior Walls

System	Subsystem	Condition and Deficiency Overview	System Condition Rating
<b>Exterior</b>	Exterior Walls	The exterior walls are modular brick.  Issues with the facade system were limited to failed sealant at joints between brick panels and discoloration related to uncontrolled runoff from the roof. In one location, the exposed shelf angle supporting brick had rust developing on it.	Good
	Exterior Windows	Exterior windows are aluminum framing with single-pane glazing.  No deficiencies were noted.	Good
	Exterior Doors	Exterior doors are hollow metal doors set in hollow metal frames. Typically, these units contain windows.  Deficiencies noted included mismatched hardware and minor rust due to finish system failure.	Average
<b>Roofing</b>		The roofing is metal with perforations at the eaves and no gutter system.  The roof area was inaccessible do to the lack of a ladder, and it was raining. From a review of the interior, it appeared that the roof was leaking in a limited number of locations. These appeared to be at the ridge and EF (exhaust fan) penetrations in the roof system. The lack of a gutter system allows water to erode the grade around the building and the splashing action deposits dirt and moisture on to the exterior walls.	Average

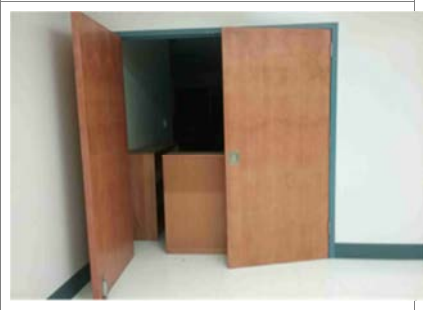
#### **Interior Doors**

System	Subsystem	Condition and Deficiency Overview	System Condition Rating
<b>Construction</b>		between classrooms or service areas. No deficiencies were observed.	
	Interior Doors	Interior doors are solid core wood veneer door slabs set in hollow metal frames.  In one instance, it was observed that the door could not open all the way because it dragged on the floor.	Good
	Interior Specialties	System not present.	N/A
<b>Stairs</b>	Exterior Stairs	System not present.	N/A
	Interior Stairs	System not present.	N/A
<b>Interior Finishes</b>	Interior Wall Finishes	Interior wall finishes are paint systems over gypsum board partitions or CMU. The restrooms include a mixture of painted gypsum board and ceramic tile.  The wall finishes appeared to be in average condition, but the laminate-clad millwork was observed to be in poor condition.	Average
	Interior Floor Finishes	Interior floor finishes include VCT and sheet vinyl in the faculty restroom.  The VCT was observed to be in good condition, but the sheet vinyl was not. The small area of vinyl was comprised of three different pieces, and the adhesive at the joints was failing due to water intrusion from cleaning.	Good

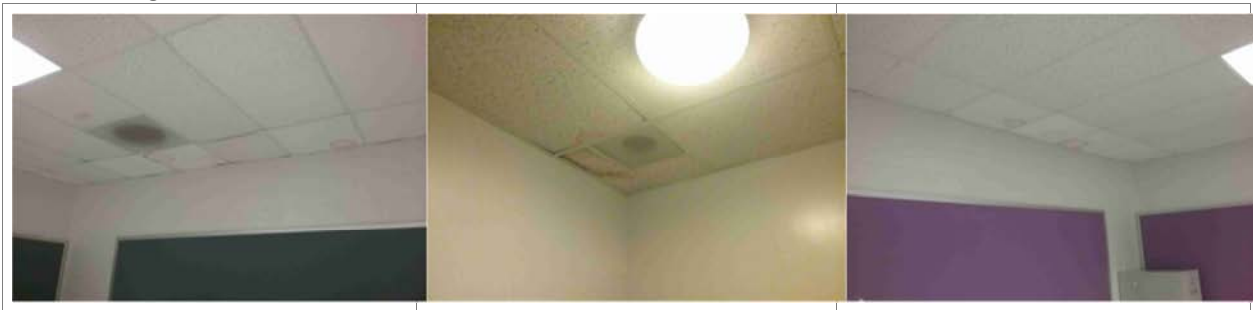
### Interior Ceiling Finishes

Interior Ceiling Finishes	Ceiling systems consist of 2x4 suspended acoustical tiles with limited amounts of gypsum board ceilings in restrooms or as accents.  Damage to the suspended ceiling tiles was limited to staining from water intrusion. A evaluation of the underside of the roof from the mezzanine suggested that this issue was the result of roof leaks.	Average
<b>Conveying</b>	System not present.		N/A
<b>Plumbing</b>	Plumbing Fixtures	The building has restrooms for students in each classroom, and separate staff restrooms located in the corridor. These restrooms generally have vitreous china hand sinks in counters with manual faucets, along with vitreous china, wall toilets with manual flushing mechanisms, and vitreous china, wall-hung urinals in the	Good
