## Langford Elementary School Site Summary

## Main School Building – BLDG-168A

### Exterior System Deficiency Examples

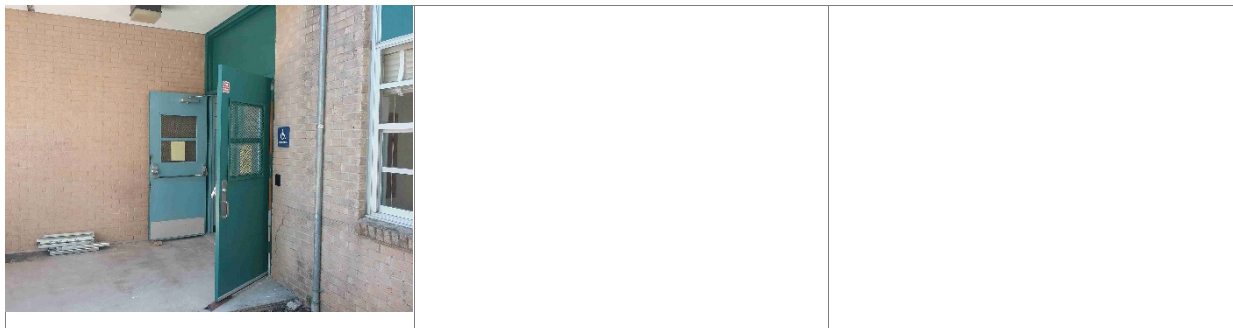
#### Exterior Doors

System	Subsystem	Condition and Deficiency Overview	System Condition Rating
		<p>appear to have been glass at one point but are now opaque panels.</p> <p>The exterior doors were observed to be in average condition due to age and peeling paint. Facility staff requested all exterior doors be replaced. The exterior door at corridor C5 reportedly did not function properly.</p>	
<b>Roofing</b>	<p>The roof covering is modified bitumen with various pre-finished metal caps on dividing walls that extend above the roof level. There is a prefinished metal fascia at the perimeter. There are no gutters and downspouts except for a small section at the main entrance. There is a roof hatch in the gymnasium storage room.</p> <p>The roof covering appeared to be in poor condition. Construction crews were replacing the mechanical units on the roof and patching the surrounding roof covering at the time of the assessment. Construction crews were repairing significant damage to the interior ceiling, wall, and floor finishes in the 100-wing, 400-wing, and library due to roof leaks. Approximately 50% of the ceiling tile had been removed for repairs due to roof leaks and mechanical ductwork replacement. It was unknown how much of the existing roof covering would be repaired. There was evidence of ponding water on roof areas A-04, A-07, and A-08. There were bubbles and previously patched areas on the A-01 roof covering. The absence of roof gutters contributed to dirt accumulation on the exterior brick façade. The roof hatch finish was rusted. Facility staff reported vandalism on the roofs with access possible from pipes, canopies, ledges and other exterior infrastructure.</p>		Poor

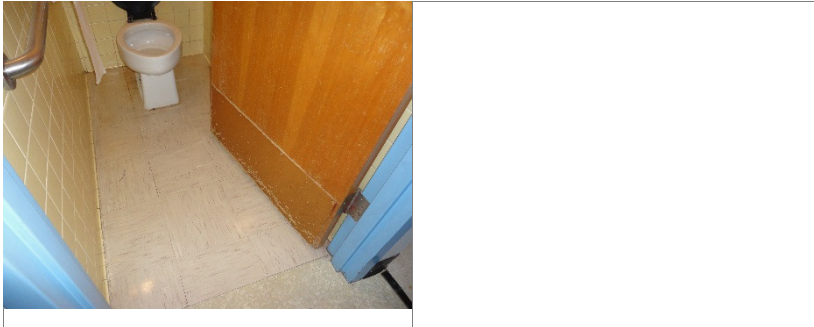
#### Interior Doors

System	Subsystem	Condition and Deficiency Overview	System Condition Rating
		condition with a few areas of wear, specifically at the bottom of the doors at the classroom restrooms.	
	Interior Specialties	System not present.	N/A
<b>Stairs</b>	Exterior Stairs	The exterior stairs on the southeast side of the building are concrete with a painted metal railing. There is an adjacent concrete ramp also with a painted metal railing.  The exterior stairs appeared to be in good condition.	Good
	Interior Stairs	There are rubber-covered steps at the stage leading into the cafeteria and at each side exit from the stage area.  The interior stairs appeared to be in good condition with no visible issues.	Good
<b>Interior Finishes</b>	Interior Wall Finishes	The majority of the interior wall finish is paint. The restrooms have ceramic wall tiles on the lower half and paint above. The movable walls along the corridors have a chalkboard surface inside the classrooms and a fabric finish in the corridor. Between classrooms, the movable wall finish is fabric. There is wood paneling on classroom walls as well.  The movable walls were observed to be in poor condition with torn fabric and scratched finish. The movable walls were significantly dated. The paint finish throughout the school appeared to be in average condition due to age, excluding the areas that were under construction at the time of the assessment. An isolated area of the walls finishes were removed down to the studs in classroom 400 due to the recent roof leaks. A portion of the drywall paper was removed as well. The library walls had already been repaired at the time of the assessment.	Average

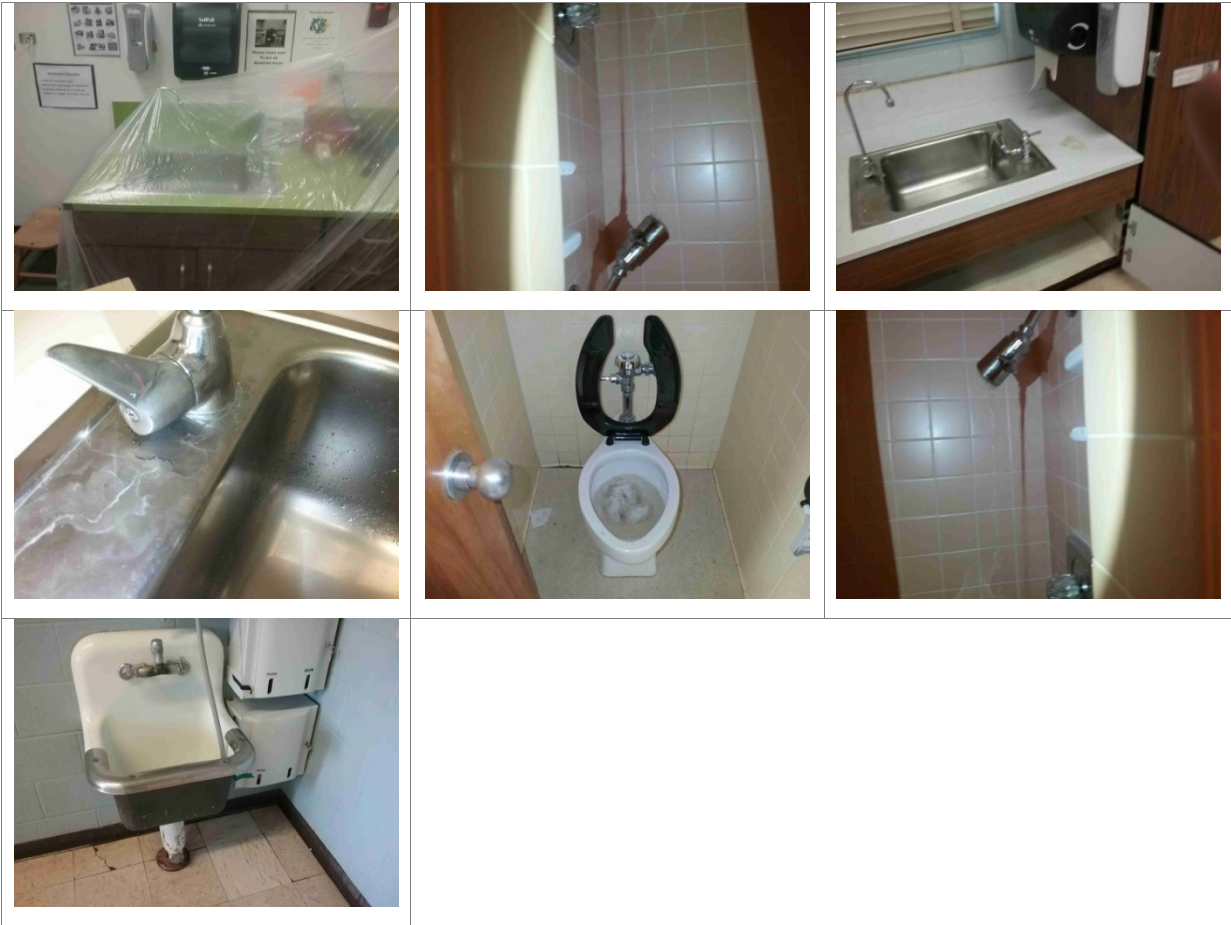
Plumbing Fixtures

System	Subsystem	Condition and Deficiency Overview	System Condition Rating
		<p>assessment, and as a result, the water was turned off to the kitchen, so functionality of the fixtures could not be assessed. The sink in LIBLIT was covered in plastic due to construction and was not able to be assessed for functionality.</p> <p>Plumbing fixtures were observed to be in average condition, showing minor signs of deterioration due to age. The drinking fountain in room 204 was observed to stick in the on position. The sink in room 205 was leaking from the faucet. The restroom off 100 had a clogged water closet. The shower in the restroom off the gymnasium office had low flow. The janitorial mops sinks were observed to be in average condition, with some showing signs of corrosion around the base.</p>	
	Domestic Water Distribution	<p>Domestic hot water to the kitchen is provided by a 99-gallon GWH (gas water heater) stored in the main mechanical room (MAINMECH). No other water heaters are in the building. Domestic hot water is not supplied to the classroom plumbing fixtures.</p> <p>The GWH was observed to be newer and in good condition but was reported in the facility interview to be undersized. Distribution plumbing appeared to be in average condition with minor signs of corrosion and deterioration due to age. The sinks in rooms 204, 303 and 503 were emitting a musty smell from underneath and had evidence of water damage, potentially due to leakage. It was noted that recent rain had caused certain areas of the building to flood, possibly causing the damage.</p>	Average

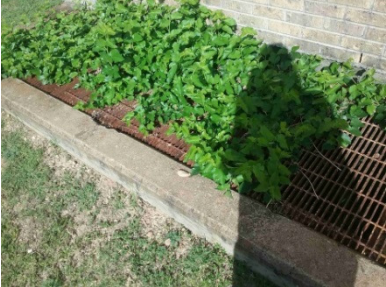
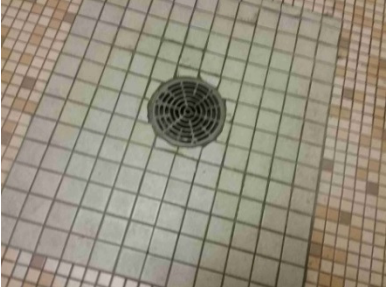
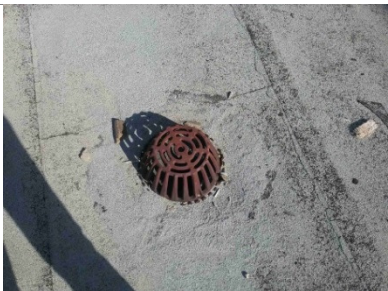
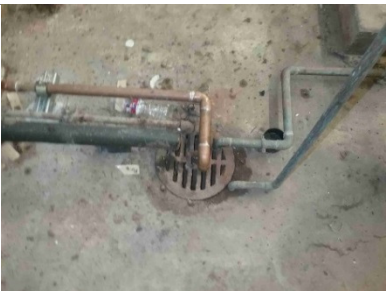
Other Plumbing	<p>Other plumbing is in average condition with signs of degradation associated with age. The restroom off room 508 was emitting a musty smell, potentially coming from the drain. It was noted that some areas had flooded recently, and cleanup was still underway. No evidence of flooding was observed in this restroom but could potentially be the source of the smell. The male restroom off the gymnasium (BHRRGYM) was emitting a smell from the floor drain.</p> <p>Roof drain grates were excessively rusted and corroded. Storm drains had signs of corrosion and rust. Kitchen and restroom floor drains were observed to be in good to average condition. Floor drains in mechanical and electrical rooms were degraded and had signs of corrosion.</p>	Average

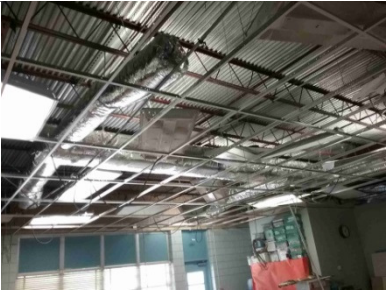
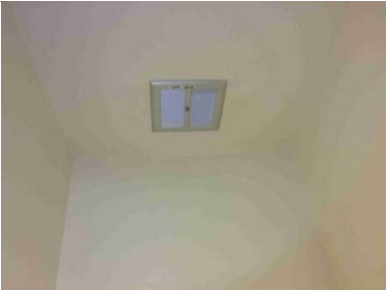
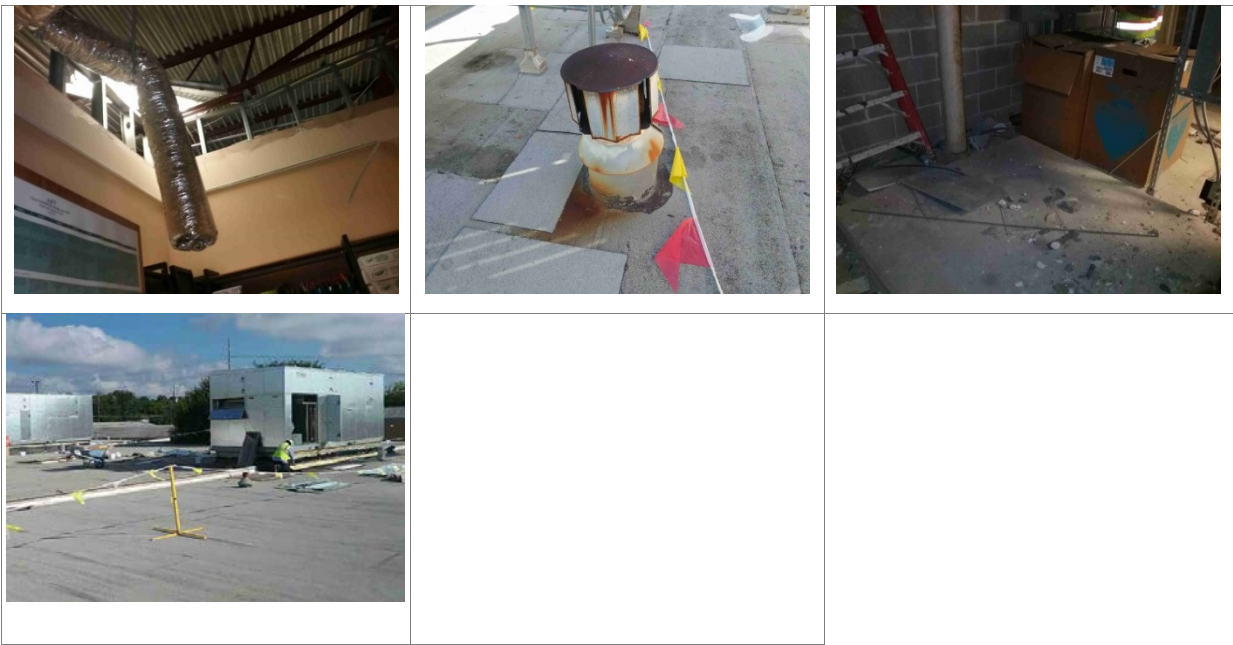
Mechanical/HVAC System Deficiency Examples

System	Subsystem	Condition and Deficiency Overview	System Condition Rating
<b>Mechanical/ HVAC</b>	<p>The majority of the building's HVAC system was in the process of being removed and replaced with new equipment at the time of assessment. The main mechanical room (MAINMECH) only contains a hot water pump and a chilled water pump. Two newer chillers are mounted on the roof above the main mechanical room. Two new makeup air units and a RTU (roof top unit) are located on the roof. During the assessment, multiple other packaged air conditioning RTUs and AHUs (air handling units) were being installed. An older cabinet fan is located on the roof. Rooms marked as AHU rooms on the floorplan were found to be empty, as their units were being removed as part of the renovation. Ductwork is being rerouted and replaced as part of the new HVAC system. Various sized EFs) (exhaust fans) feed the building. A large ventilation unit located on the roof was found with damaged conduit, but also appeared to be disconnected and abandoned in-place.</p> <p>Make up air units, chillers and RTUs were observed to be in excellent to good condition. The cabinet fan on the roof was original to the building and appeared to be no longer in operation. The EFs in the restrooms off rooms 502, 503, and 508 were excessively loud. Roof top vents and EFs were aged and rusted. At the time of assessment, the system appeared to be in poor condition due to multiple units not yet installed or partially installed, with ductwork still being replaced. It is expected when the renovations are complete the system will be in good condition.</p>		Poor

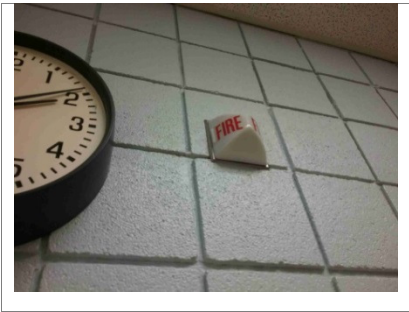
**Fire Alarm**

<b>Fire Protection</b>	Fire Alarm	<p>The building has a fire alarm system that consists of alarm and signaling devices such as strobes, horn/strobe combinations, pull stations, and detectors. Detection and indication are present throughout the building. Due to active on-site construction, several classroom areas and corridors could not be properly assessed due to missing ceiling tiles which typically hold end devices.</p> <p>The fire alarm system appeared to be in average condition. Many of the fire alarm end devices appeared to be reaching their end of service life expectancy. There were some end devices that appeared to be original to the school's construction.</p>	Average
	Fire Protection/ Suppression	<p>A fire suppression system is present for the range hood in the kitchen with a tank mounted to the wall at the ceiling. No other fire suppression system is present in the building. Fire extinguishers are located throughout the building.</p> <p>Visual assessment showed these appeared to be in average condition. The fire extinguishers off the 100-, 200- and 500-wings, gymnasium and MAINMECH and in the art room were out of date on their annual inspection.</p>	Average

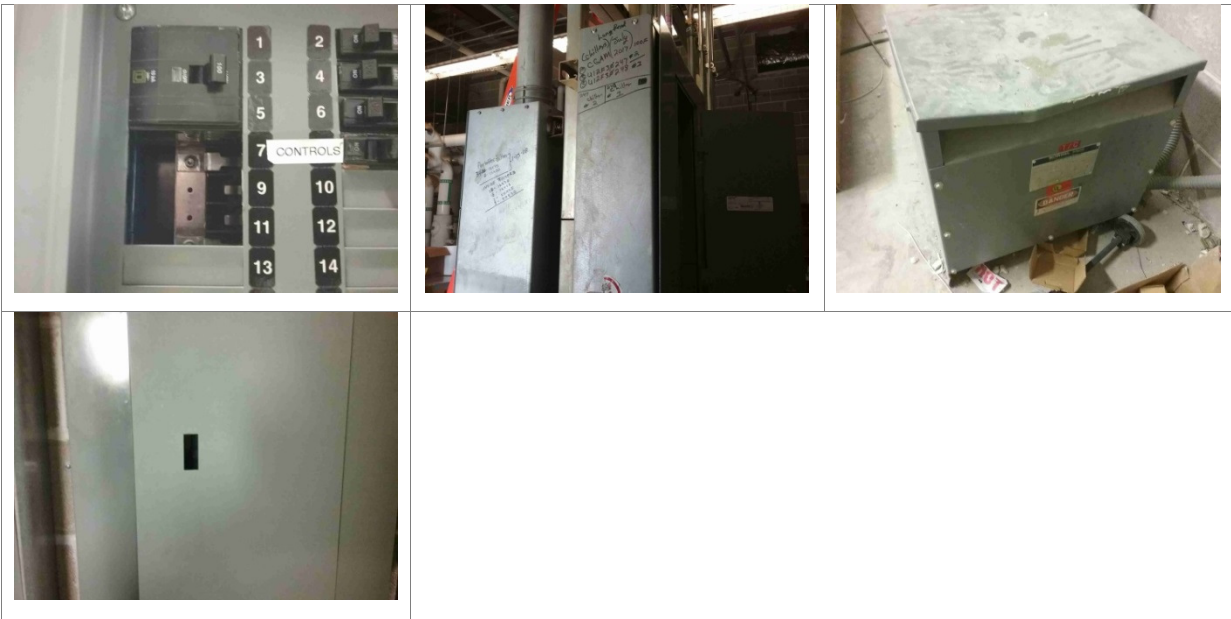
**Electrical Distribution**

System	Subsystem	Condition and Deficiency Overview	System Condition Rating
		<p>volt, 1600-amp main switchboard located outside room MAINMECH, on the east side of the building. The service feeds transformers and high-voltage panelboards located in various electrical rooms throughout the building. The building does not have a lightning protection system.</p> <p>The electrical distribution equipment appeared to be in average condition. The majority of the electrical panelboards and transformers throughout the building were original to construction with roughly 15 years remaining on their service life expectancy.</p> <p>Panel K had several missing breaker covers. This condition should be considered a life safety hazard, and breaker covers should be installed immediately. Panel K also had a loose front cover due to several missing screws. Panel H/A, located in AHU5MECH, had a missing door latch. A few transformers were observed with cosmetic damage to their housings, but this should not affect operation.</p> <p>School faculty reported that the recently installed MCC (motor control center) tripped the main panel of the school. It was reported that this was a problem within the equipment programming and that AISD Service Center staff could not make the necessary repairs. Faculty have requested the installation of a main disconnect for the electrical service, along with a service upgrade. Faculty have reported that a majority of the building's panelboards had circuits at full capacity and would require upgrades for future electrical additions.</p>

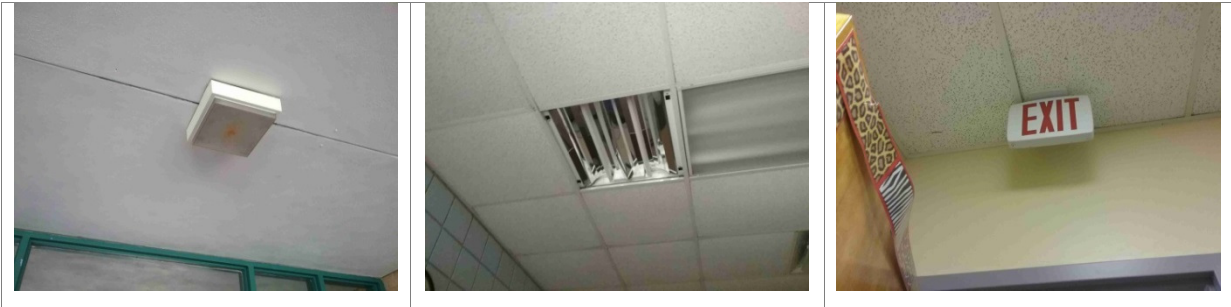
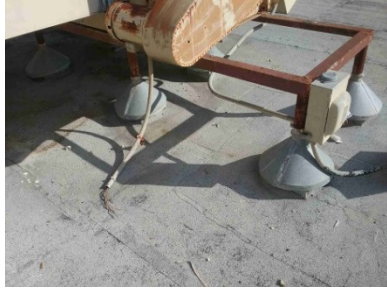
**Lighting**

System	Subsystem	Condition and Deficiency Overview	System Condition Rating
		<p>deficiencies included non-functional luminaires, burned-out lamps, or missing luminaire covers. Some classrooms had non-functional lighting, but this was attributed to the ongoing construction. No major deficiencies were observed with the building's branch wiring. Several exit sign luminaires were found dim or non-functional.</p> <p>Faculty requested additional electrical outlets throughout the building, especially within computer rooms. It was reported that the majority of the interior luminaires were original to the building and had exceeded service life expectancy.</p> <p>Faculty reported that the covered walkway canopy luminaires were damaged from water infiltration from the direct mounting through the metal roofing. It was requested that these luminaires be replaced with installation to prevent water infiltration. The covered walkways also need to be repaired.</p> <p>Emergency lighting battery packs above the covered walkways were reported to be in poor condition due to direct exposure rain. Faculty reported that several wall-mounted exterior luminaires were blocked by trees around the building. Faculty requested that exterior wall-mounted metal-halide luminaires be upgraded to LED luminaires. Faculty also report that there is not enough lighting in the building.</p>

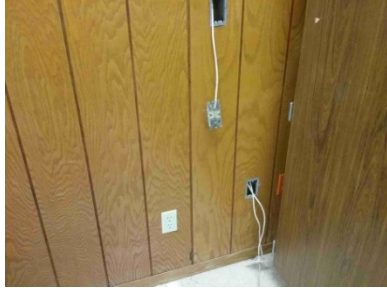
#### Communications & Security

System	Subsystem	Condition and Deficiency Overview	System Condition Rating
		<p>The communications and security systems were observed to be in average condition. The majority of the building's classrooms have new networking cable being installed, and as a result, receptacles were loose or removed.</p> <p>Faculty requested additional networking receptacles in the computer room. Faculty reported a number of issues with the building's security. The faculty requested a controlled entry access to the school. The building is typically under lockdown due to neighborhood issues. It was reported that the cafeteria surveillance camera had poor resolution and needed to be upgraded. Faculty requested additional surveillance cameras throughout the interior and exterior of the building, especially around covered walkway areas that adjoin the buildings. Faculty requested a surveillance camera and an intercom system for the kitchen unloading area.</p>

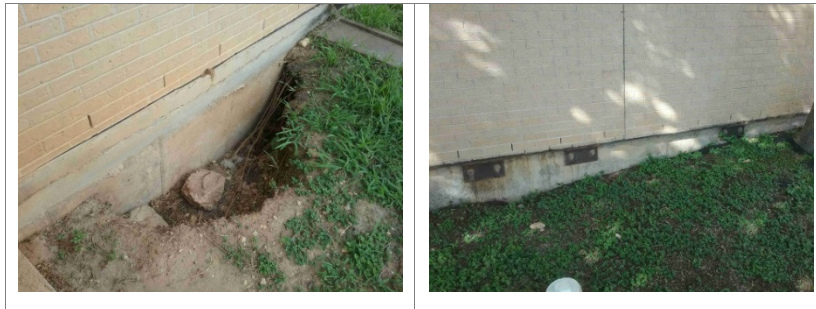
#### Exterior Walls

System	Subsystem	Condition and Deficiency Overview	System Condition Rating
Exterior	Exterior Walls	<p>The exterior walls are a brick façade with control joints spaced evenly along the perimeter. The north and south walls extend above the roof slope, creating a parapet. The east and west walls meet the roof edge with a painted stucco soffit. There is a small portion of painted stucco above the exterior windows.</p> <p>The exterior walls were observed to be in average condition due to age. There was a hole in the soil at the foundation on the northwest corner. This either was a bush or plant that was removed or an erosion problem associated with the nearby downspout. There were three angles bolted to the foundation on the north side, possibly to remedy a brick support or foundation issue in the past. No current issues were reported by facility staff.</p>	Average
	Exterior Windows	<p>The exterior windows are aluminum frames with single-pane glazing. The lower portions of the windows have translucent film applied to the interior of the glass.</p> <p>The exterior windows were observed to be in average condition due to age. The translucent film had minor scratches.</p>	Average

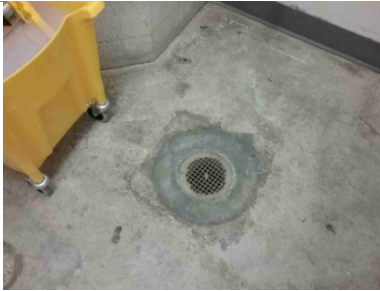
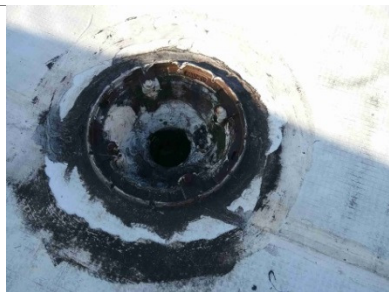
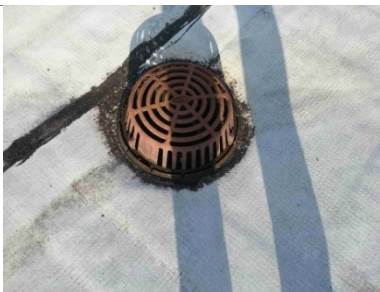
### Other Plumbing

Other Plumbing	<p>Other plumbing appears be in average condition with signs of degradation.</p> <p>Floor drains were observed to be in average condition, showing minor signs of deterioration and corrosion. Roof drains had rusted grates; one roof drain was missing the grate, allowing for potential blockage.</p>	Average
<b>Mechanical/ HVAC</b>	<p>The building's HVAC system is composed of a roof top AHU, split systems for the individual rooms with roof top condenser units and through-wall indoor heat pump units.</p> <p>The HVAC equipment is 6 years old and was observed to be in good condition. No deficiencies were observed.</p>		Good
<b>Fire Protection</b>	Fire Alarm	<p>The building has a fire alarm system that consists of alarm and signaling devices such as strobes, horn/strobe combinations, pull stations, and detectors.</p> <p>The fire alarm system appeared to be in good condition. No deficiencies were observed during the assessment.</p>	Good

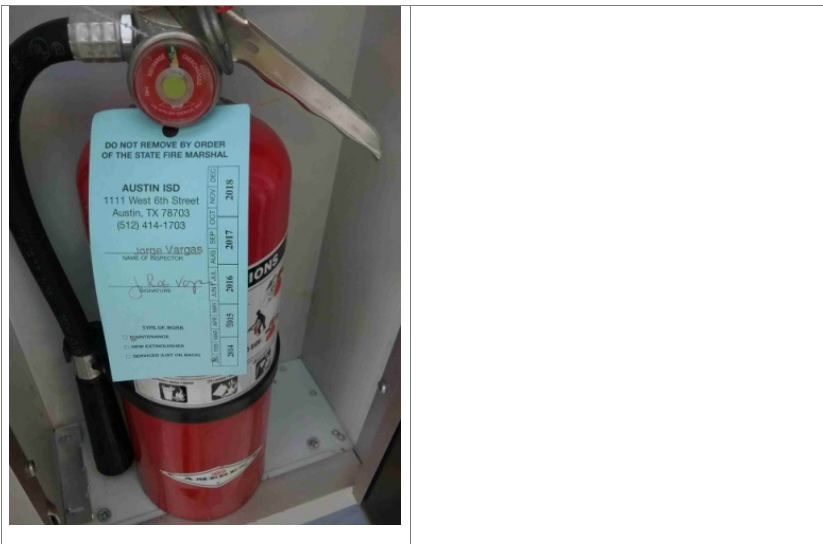
**Fire Suppression System Deficiency Examples**

Fire Protection/ Suppression	<p>A fire suppression system does not exist in the building.</p> <p>Two fire extinguishers were present and appeared to be in average condition. Both were out of date on their annual inspection.</p>	N/A
<b>Electrical</b>	Electrical Distribution	<p>Electrical distribution for the building is located in room ELEC700.</p> <p>The electrical distribution equipment appeared to be in good condition.</p> <p>Faculty reported that undersized occupancy sensors control the building's HVAC equipment and were causing the equipment power packs to fuse together. As</p>	Good

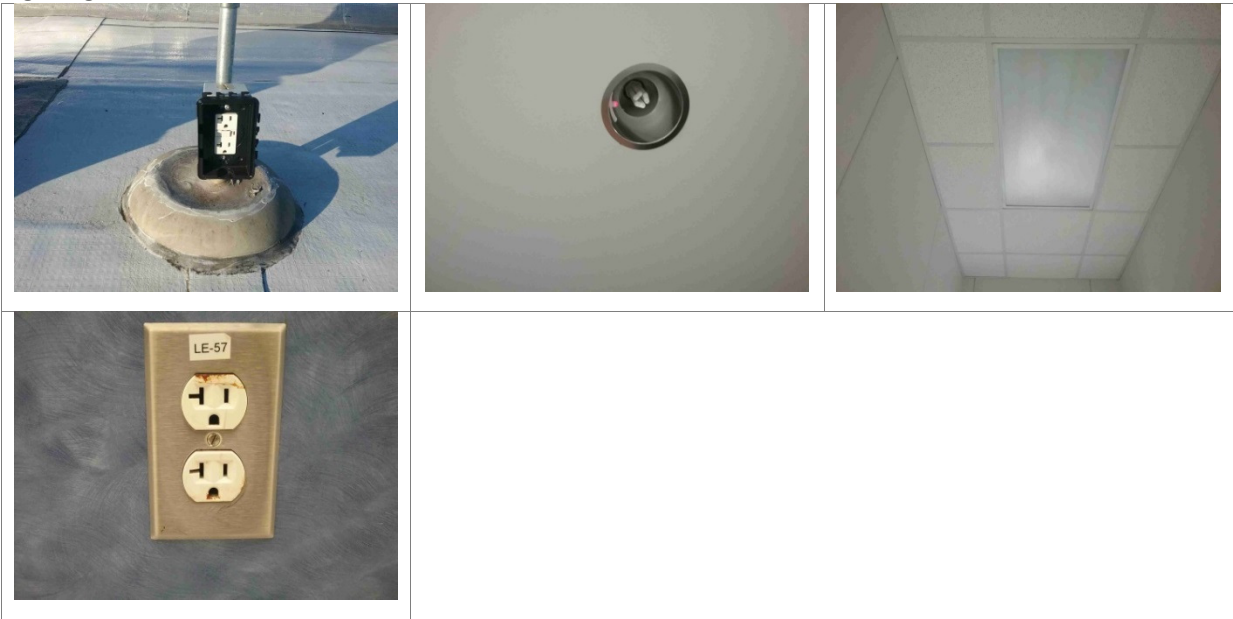
**Lighting**

System	Subsystem	Condition and Deficiency Overview	System Condition Rating
		a result, the HVAC equipment would not function or it ran continuously. Faculty requested that the occupancy sensors be upgraded.	
	Lighting	<p>The building's exterior lighting is primarily composed of wall-mount metal-halide luminaires on the building walls. Exterior egress lighting is canopy luminaires, but it could not be determined if they are metal-halide or LED lamps. The interior lighting consists primarily of recessed troffer and recessed downlight fluorescent luminaires. Interior lighting is activated by occupancy sensors.</p> <p>The lighting for the building appeared to be in good condition. All classrooms had at least one recessed downlight that was non-functional. The luminaire for the C14 restroom vestibule between rooms 704 and 702 was non-functional. The faculty restroom was found to have extremely dim lighting.</p> <p>The building had two exterior electrical receptacles with broken covers, one on the roof and one on the rear egress of the building. Also, several interior corridor electrical receptacles appeared to have corrosion, possibly due to water infiltration.</p> <p>Faculty reported a similar problem to the HVAC system's for undersized occupancy sensors that activate classroom lighting. Faculty requested that exterior wall-mounted metal-halide luminaires be upgraded to LED luminaires.</p>	Good
