Lee Elementary School Site Summary

Address	3308 Hampton Road Austin, TX 78705
Number of Permanent Campus Facilities	4
Original Year of Construction	BLDG-121A – 1939 BLDG-121C - 1998 BLDG-121B – 1939 BLDG-PS006 - 1939
Total Campus Building Area (combined)	46,328 SF

Main School Building – BLDG-121A

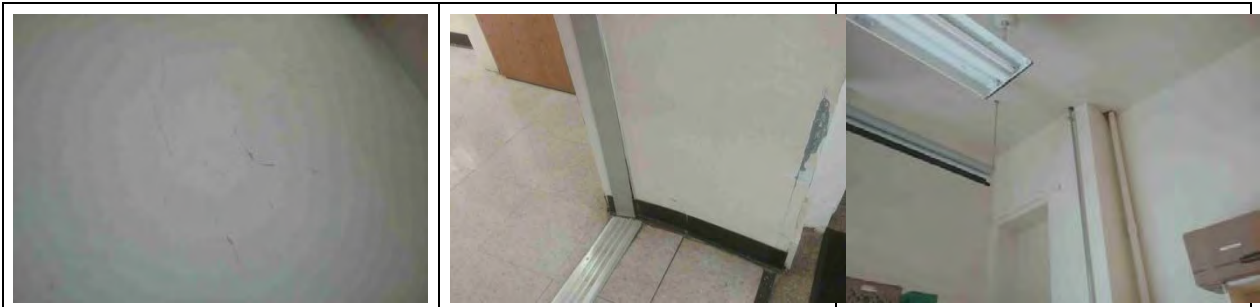
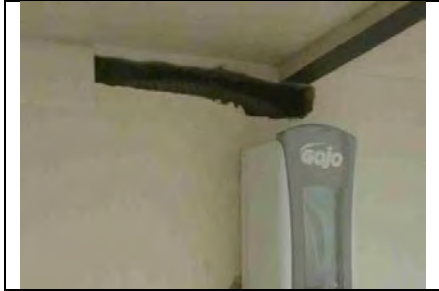
System	Subsystem	Condition and Deficiency Overview	System Condition Rating
Interior Construction	Interior Walls	<p>The interior walls are a mixture of masonry systems with plaster applied and a limited amount of gypsum board construction.</p> <p>The average condition assessment for this system is the result of the quantity and quality of conditions noted. Deficiencies observed were limited to cracking in the plaster systems indicating movement in the masonry behind, and damage to the gypsum board wall system around an expansion joint between the original building and an addition in corridor C2. While not a wall system, the millwork on the second floor at the bathrooms was observed to be in poor condition along with holes in the wall system at the backsplash area.</p>	Average
	Interior Doors	<p>The interior doors are wood hung in wood frames in the original building and wood doors hung in hollow metal frames in the addition. Doors original to the construction of the building are painted, while in the building addition the door finish is a stained veneer.</p> <p>The interior doors were observed to be in average condition. Two doors were observed as catching on the floor inhibiting their ability to open fully. Doors, particularly those in the gymnasium had significant damage to the paint on them. In the gymnasium the door hardware is mismatched with one door in a pair have a modern crash bar type panic hardware while the other had the older bar type exit hardware.</p>	Average

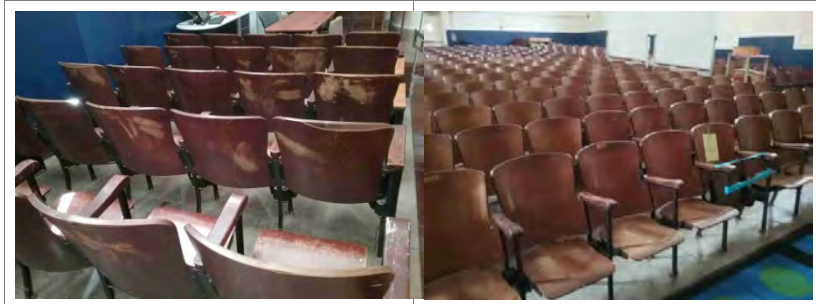
Interior specialties

Interior Specialties	<p>While there were no lockers in the facility, the auditorium fixed seating should be addressed. The existing seating is original to the building and wooden with fold up seats.</p> <p>These seats were noted to have significant aging and finish issues. In one instance noted the seat was missing.</p>	Average
Stairs	Exterior Stairs	<p>The exterior stairs are cast-in-place concrete left raw or with a terrazzo finish place on top. Railings are exclusively painted metal pipe type construction.</p> <p>The exterior stairs are of average condition. The complexity of matching the 1939 construction and materials will provided a challenge to their repair along with the effort to correct other conditions led to this rating. Cracking and damage to the stairs particularly to the original terrazzo covered elements dominate the condition issues with the stairs. Some cracking observed will create potential long term issues and the</p>	Average

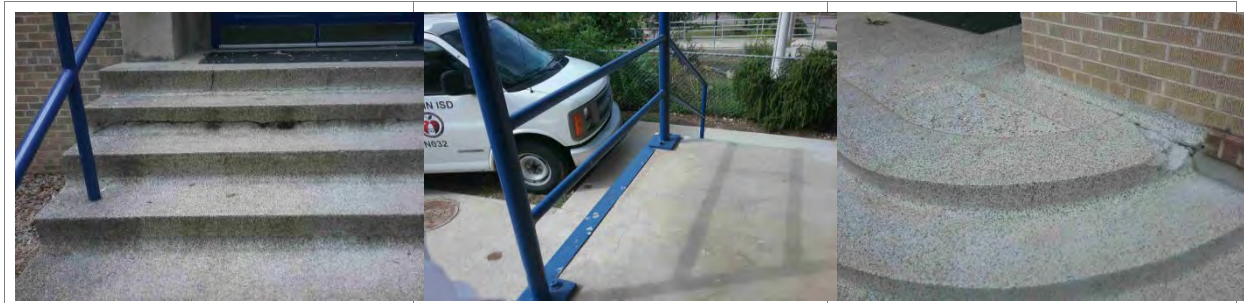
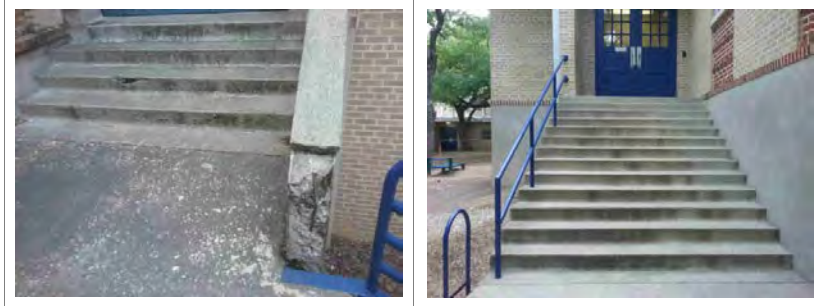
Exterior Stairs

System	Subsystem	Condition and Deficiency Overview	System Condition Rating
		potential for water infiltration into the cracks during a freeze thaw cycle could lead to more damage. In a limited number of locations the railing configuration was cause for concern. At the loading dock the guardrail portion of the railing is set below 42". At the auditorium exterior exit the concrete railing is damaged where the stair transitions, leaving reinforcing exposed along with a 6" to 8" gap between the concrete and metal railings. Railings on stairs on the west side of the building were observed to have 18" openings in them regardless of the height of the stair.	
	Interior Stairs	The interior stairs are cast-in-place concrete with a terrazzo topping. Railings serving these stairs are wall mounted wood with a round cross section. The stairs were observed to be in good condition. The wood railings were observed to not meet the current code standards; however, these are not required to do so due to the age of the structure. The terrazzo treads were noted to lack any anti-slip material at the tread edge.	Good

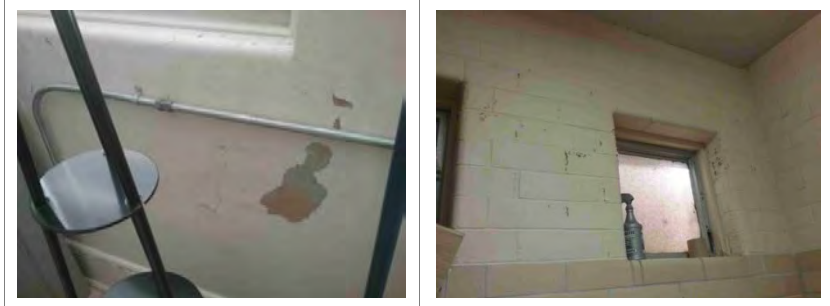
Interior Finishes	Interior Wall Finishes	The interior wall finishes are paint systems over gypsum board, plaster or masonry units in most areas. In bathrooms, ceramic wall tile is used. The interior wall finishes were in average condition. At window sills, it appeared that glazed masonry units were used and not properly prepared to accept the paint. On plaster portions of the walls the paint was observed to be peeling or blistering. In some cases this failure of the paint system was thought to be the result of the number of paint layers that were present. Alternatively, the lack of adhesion may have been caused by the application of latex paint to a masonry wall system with a strong vapor drive to the inside of the building as a result of modern air-conditioning.	Average
	Interior Floor Finishes	The interior floor finishes include vinyl composition tile (VCT) installed over a wood substrate or concrete, terrazzo, quarry tile and ceramic tile. A wood strip floor is installed at the stage while sheet vinyl is installed in the gymnasium. The interior floor finishes were in good condition. Despite being installed over a wood substrate the VCT in the classrooms appeared to have little telegraphing or condition issues that was observed in other schools of a similar era. At the exterior exit from corridor C2 minor	Good

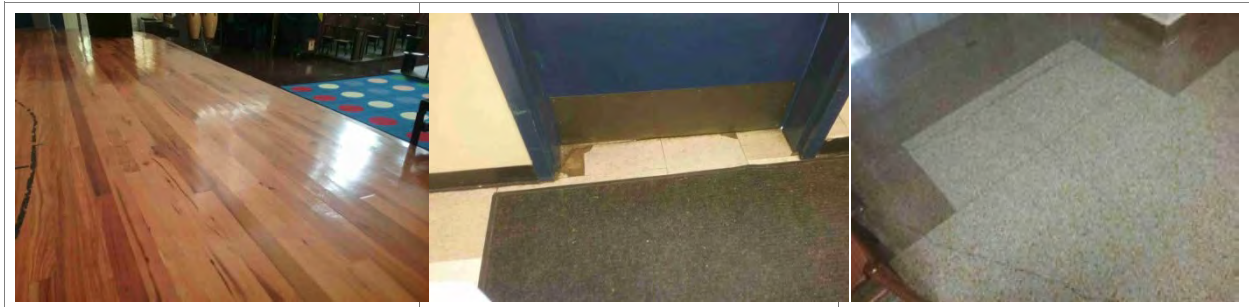
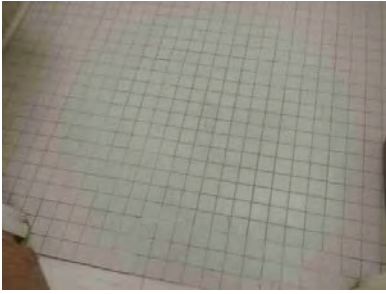
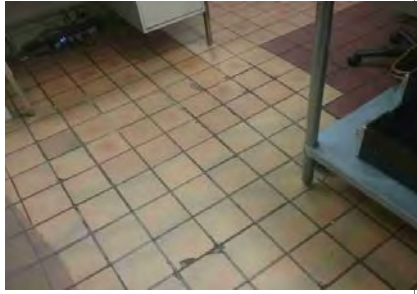
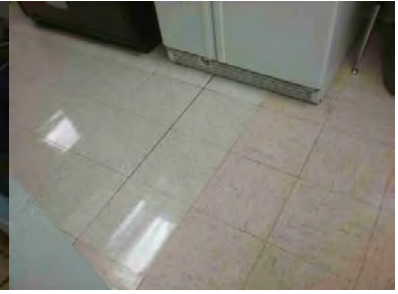
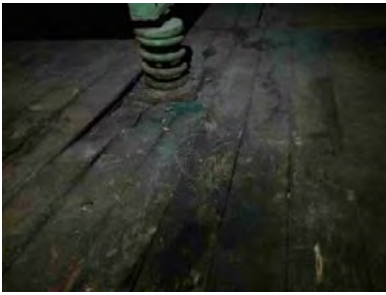
Interior Floor Finishes

System	Subsystem	Condition and Deficiency Overview	System Condition Rating
		damage was observed along with lifting of the floor tile at the expansion joint in the same hallway. In the bathroom at the lounge the ceramic floor tile was observed to be damaged. In the same area a hump in the floor of the lounge was observed. Terrazzo cracks were noted traversing the corridors. The stage appeared to have been expanded and the new section exhibited cupping suggesting moisture underneath the flooring. Also on the stage the mechanical units mounted on north and south sides were observed to be mounted on damaged flooring. This suggested that there is insufficient structural support under the units.	
	Interior Ceiling Finishes	<p>The interior ceiling finishes are a mixture of 12" by 12" and 12" by 24" tiles adhered to the ceiling structure and 2x4 suspended ceiling systems. A limited amount of gypsum board ceilings are used in the building as well. The gymnasium contains a suspended ceiling system with an wood fiber type acoustical panel infill.</p> <p>The interior ceiling finishes were observed to be in poor condition. A significant portion of the adhered tiles were observed to be releasing from their substrate. Evidence of past issues was also observed. Humidity damage was noted in corridor C2 and the 100-wing classrooms. A significant amount of water or moisture damage was observed on the ceiling system materials.</p>	Poor

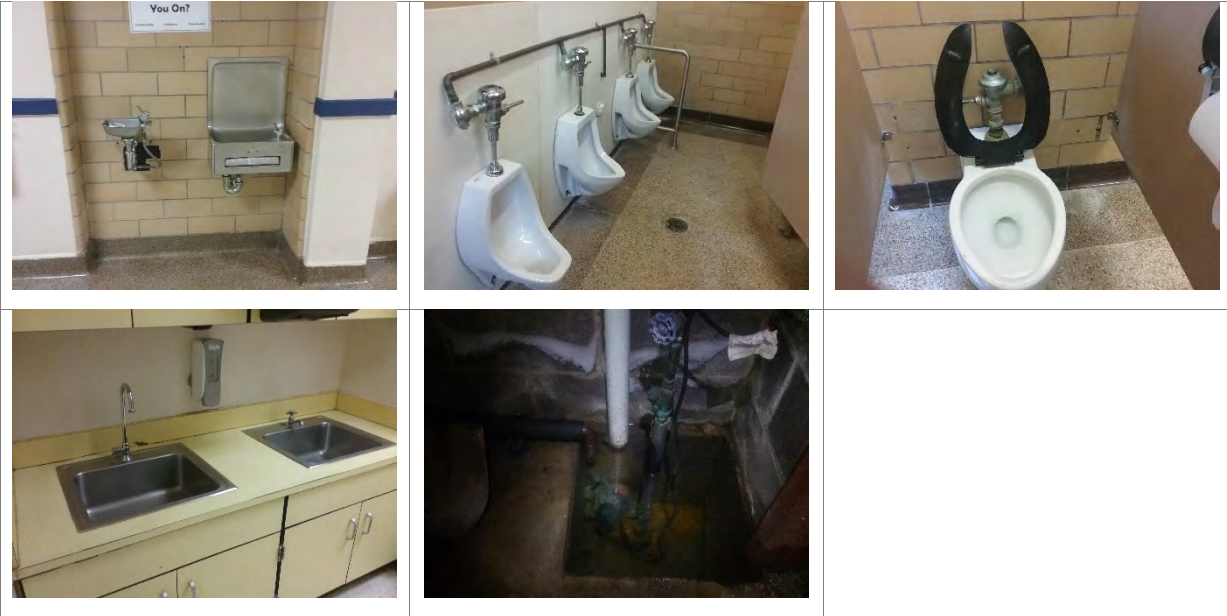
System	Subsystem	Condition and Deficiency Overview	System Condition Rating
		sinks in the faculty rest room on the second floor are pieced together with different faucets and do not have hot water. There is a sump pump in the basement mechanical room that was not working. At the time of observation, the floor had several inches of standing water.	
	Domestic Water Distribution	<p>All of the plumbing fixtures are serviced with domestic cold water. There is a gas water heater within the kitchen space.</p> <p>In the boy's restroom adjacent the auditorium the urinals were not able to flush correctly due to the fact that they were not served with the correct size water line. In addition to the urinals, there were other water closets that were not flushing correctly. This also appeared to be due to low water pressure at the valve.</p> <p>Most of the other observed fixtures appeared to be serviceable. Due to the age of the fixtures as well as the quantity of deficiencies observed the system is rated as poor.</p>	Poor

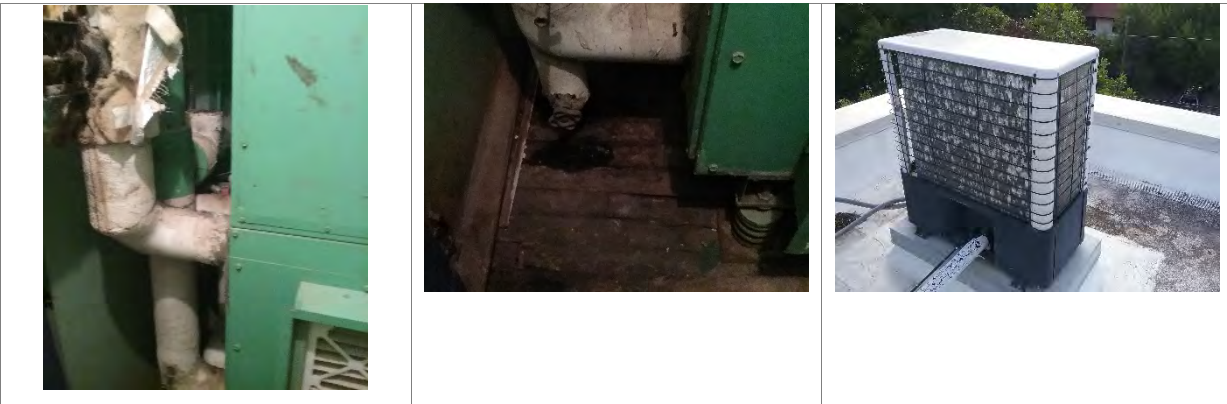
Mechanical/HVAC System Deficiency Examples

Other Plumbing	<p>The roof drains are equipped with metal grate covers to prevent debris from entering the drainage system.</p> <p>The roof drains appeared to be in good condition. However, the floor drain in the basement mechanical room was not draining at the time of observation.</p>	Average
Mechanical/ HVAC	<p>The major mechanical equipment consists of indoor chilled/hot water single zone air handling units, an air cooled chiller and gas fired boilers. In addition to the items above, the building utilized ground source heat pumps (GSHP). All AHUs (air handling units) are located in mechanical closets. They are located on the stage of the auditorium and in the basement to the outside of the auditorium and gymnasium.</p> <p>The AHUs in the stage closets were observed to be aged and in excess of their service dates as well as exhibiting multiple water leaks. The AHU in the basement mechanical room was in similar condition. The GSHPs serving the classrooms on both levels were also aged. One GSHP (HP-2) on the first level has been recently removed from the ground loop and replaced with a new DX console unit. A condensing unit on the roof of the multi-story part of the building was observed to have considerable hail damage.</p> <p>The kitchen was reportedly served by a packed DX unit mounted on a platform outside of the kitchen. This unit was unable to be observed due to its location.</p> <p>The gymnasium was reportedly served by two RTUs that were not accessible</p> <p>Outside air for the classrooms was understood to be served from a chilled water AHU located on the roof of the second story.</p>		Average

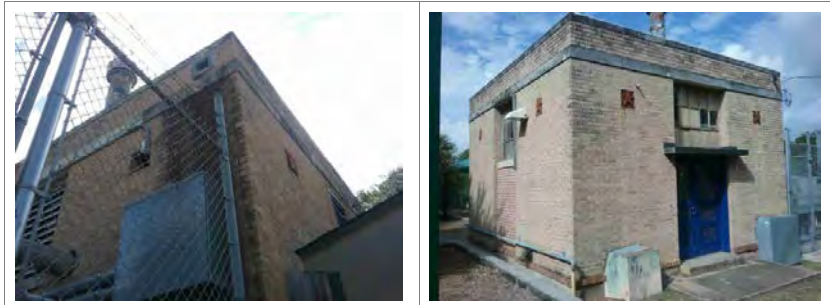
System	Subsystem	Condition and Deficiency Overview	System Condition Rating
Exterior	Exterior Walls	<p>The exterior walls are masonry in the form of brick with stone banding and decorative metal tiles.</p> <p>The exterior walls are in average condition. The condition of this system is the result of the wear and tear of a structure from the 1930's. While deficiencies noted are few, limited to the lack of a collector head and downspout for roof drainage, the structure could use some cleaning and attention.</p>	Average
	Exterior Windows	<p>The exterior windows are steel frame type construction likely original to the structure.</p> <p>The exterior windows were observed to be in poor condition. Although limited to two units, both these units exhibited rust on the metal frame and glazing replaced with fiber glass panels which have aged to the point of showing a fuzziness that is the result of breakdown of the base material.</p>	Poor

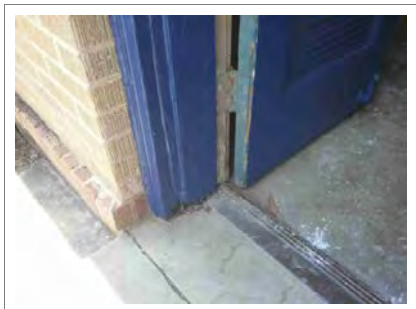
Exterior Doors	<p>The one exterior double door unit is a wood door slab with glass lites and louvers set in a wood frame.</p> <p>The door system was observed to be in poor condition due to rot at the base of the frame, aged hinges, and damage at the base of the astragal.</p>	Poor

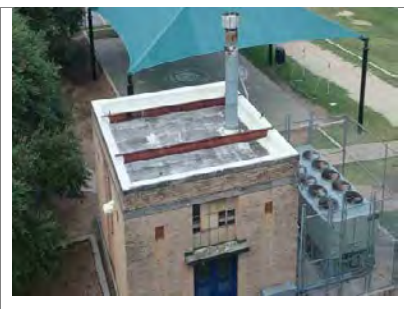
Roofing Deficiency Examples

System	Subsystem	Condition and Deficiency Overview	System Condition Rating
Roofing	<p>The roofing system is a modified bitumen type installation. The roof surface is inaccessible due to the lack of a roof scuttle or exterior ladder system.</p> <p>This roofing system was observed to be in poor condition This roof was observed from the adjacent building. This system appears to be aged out. The cap sheet of the system was separating at the joints between sheets. Ponding was evident throughout the roof area. The condition of the interior ceiling finishes was suggestive of significant water infiltration at some point.</p>		Poor
Interior Construction	Interior Walls	System no present.	N/A
	Interior Doors	System no present.	N/A
	Interior Specialties	System no present.	N/A
Stairs	Exterior Stairs	System no present.	N/A
	Interior Stairs	System no present.	N/A
Interior Finishes	Interior Wall Finishes	<p>The interior wall surface is the exposed brick of the exterior wall system.</p> <p>The interior wall finishes were observed to be in average condition due to age. No deficiencies were noted.</p>	Average

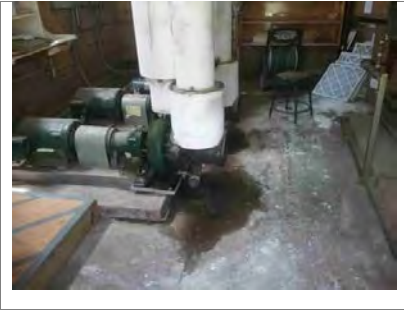
Interior Floor Finishes	<p>Only exposed concrete floors are present in the building.</p> <p>The interior floor finishes were observed to be in average condition due to age and abuse. The floors were observed to be in functional condition. The presence of water from mechanical equipment was noted on the floor surface but did not appear to causing damage.</p>	Average
	Interior Ceiling Finishes	<p>The interior ceiling is comprised of a plaster and lath system.</p> <p>The interior ceiling finishes were observed to be in poor condition. The ceiling finish system was observed to have significant portions missing exposing the underside of the roof and the structural elements. The bar joist construction appeared to have rust developing on it and the precast concrete panel that is used as the substrate for the roofing appeared cracked.</p>	Poor
Conveying	System not present.		N/A
Plumbing	Plumbing Fixtures	None	Good

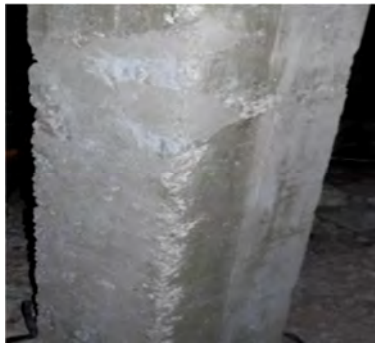
Honeycombing/chopping in column

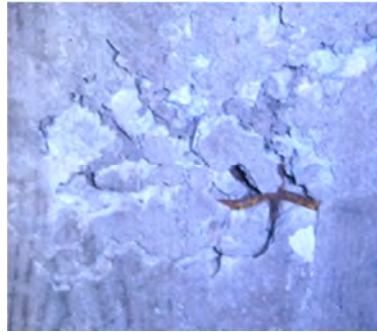
<p>Honeycombing in slab at exposed formwork chair</p>

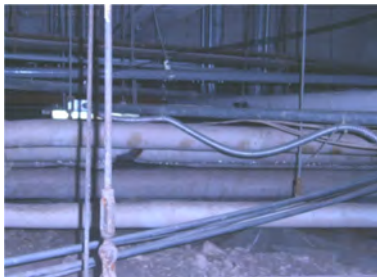
<p>Large cluster of sweating pipes</p>

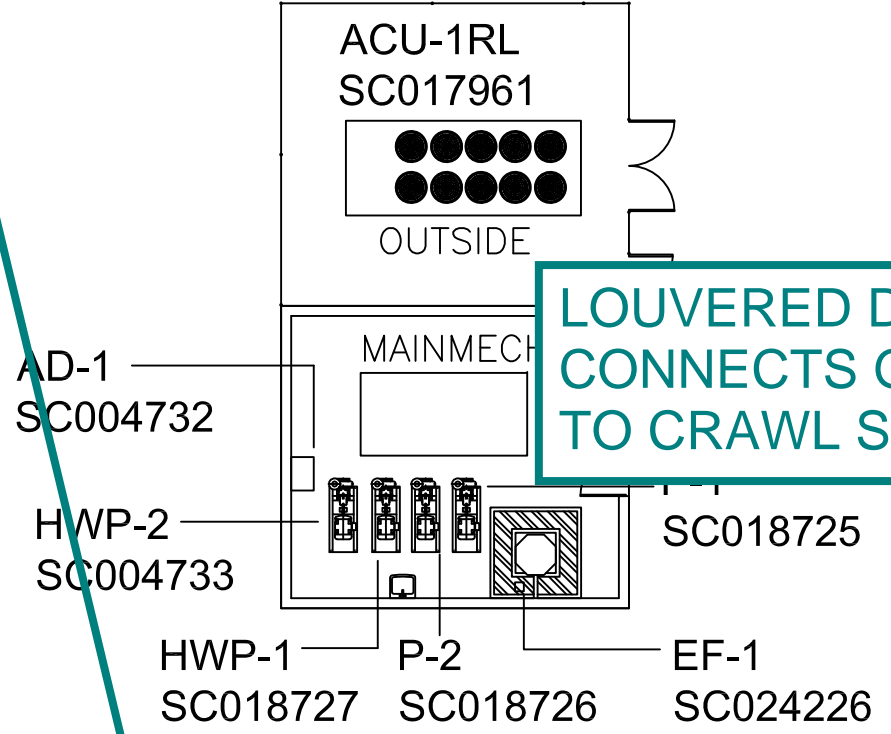
FLR-121B-01

LOUVERED DOOR CONNECTS GYM STORAGE TO CRAWL SPACE HERE.

ACCESS THROUGH SMALL DOUBLE DOOR HERE
