Linder Elementary School Site Summary

Address	2800 Metcalf Road Austin, TX 78741
Number of Permanent Campus Facilities	2
Original Year of Construction	1972
Total Campus Building Area (combined)	69,544 SF

CRAWL SPACE – Linder ES – Main School Building (BLDG-160A)

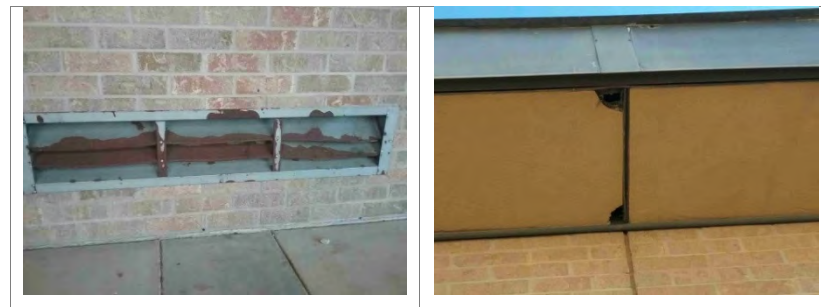
System	Subsystem	Condition and Deficiency Overview	System Condition Rating
Exterior	Exterior Walls	<p>The exterior of the building consists of a brick façade with concrete columns.</p> <p>The exterior of the building appeared to be in good condition. There were louver vents about one foot from the sidewalk area around the entire building that were chipped and rusted. There were two holes in the soffit on the southwest corner near BLDG-160B.</p>	Good
	Exterior Windows	<p>The windows are single-paned aluminum metal frames inset into the brick façade.</p> <p>The windows at the side lite next to the northwest entry doors were heavily scratched. The remainder of the windows appeared to be in good condition. It was reported by staff that the windows are leaking and may need to be replaced however this was not viewed during the assessment.</p>	Good
	Exterior Doors	<p>There are many double exterior metal doors with lites throughout the building. Some exterior doors are solid metal with no lites.</p> <p>The exterior doors appeared to be in good condition. It was reported by staff that water and dirt come in through the thresholds but this was not evident during the assessment.</p>	Good

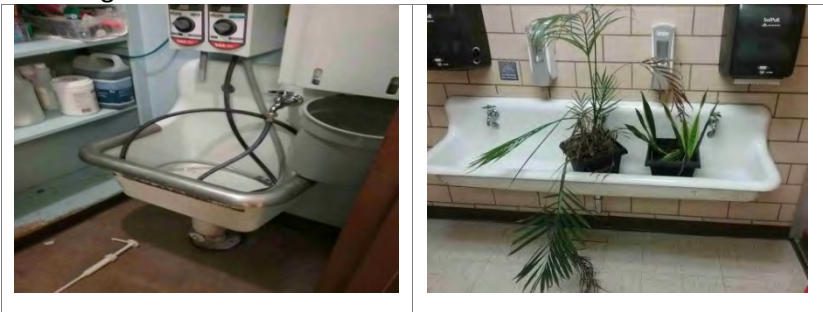
Conveying	System not present.		N/A
Plumbing	Plumbing Fixtures	The facility contains multiple plumbing applications that service one level, consisting of in-classroom student restrooms, staff restrooms, student gymnasium restrooms, janitorial closets with service sinks, and one commercial kitchen. The restrooms located inside classrooms have vitreous china floor-mount toilets with manual flushing valves. The classroom restrooms are not equipped with sinks; however, the classrooms have laminated particle board vanities with stainless steel sink/bubbler combinations mounted inside the vanities. The remainder of the facility's restrooms have vitreous china sinks with manual or metering faucets, along with vitreous china floor/wall-mount toilets and urinals with manual flushing valves. There are also wall-mounted service sinks in the janitorial closets. The restroom plumbing fixtures were observed to be fairly aged but were in good working condition. The commercial kitchen plumbing fixtures were also observed to be in good condition. The Staff reported that new drinking fountains, sinks, and toilet fixtures throughout the campus were	Good

System	Subsystem	Condition and Deficiency Overview	System Condition Rating
		<p>requested and that the drinking fountain in the 200-wing is scheduled to be replaced. The Staff went on to report that the floor sinks in custodial closets, KITMOPRM, CCCAFE, CC100, CC310, and CC300 were requested to be replaced. It was also reported by the Staff that the gymnasium's female and male restroom (GRRGYM and BRRGYM) fixture partitions were rusting and needed to be replaced. In addition, the Staff requested that female and male restrooms in the 200-wing be renovated, specifically, GRR200 and BRR200. Lastly, the Staff stated that the kitchen floor sink did not have enough capacity to handle the three-compartment sink.</p> <p>The only deficiencies recorded were in regards to extremely aged fixtures observed in the building, specifically, the porcelain wash sink located outside the cafeteria and the porcelain janitorial closet sinks located in the custodial closets.</p>

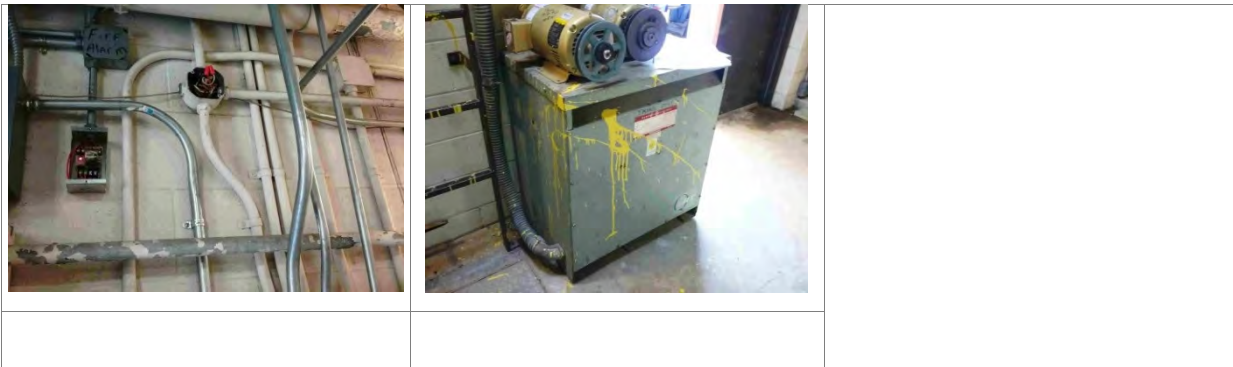
System	Subsystem	Condition and Deficiency Overview	System Condition Rating
Electrical	Electrical Distribution	<p>The electrical service (utility transformer, exterior switchboard, and capacitor bank for the facility) appear to be located on the east side of the complex, north of the main mechanical room. The main mechanical room houses an untagged switchboard and a main distribution panel that feeds transformers powering subpanels throughout the building. Additional subpanels in the main mechanical room exist for various building services and feed end users that appear to have been added as demand increased.</p> <p>The electrical distribution equipment appeared to be in average condition. The main switchboard "SG" in the mechanical room was nearing the end of its typical design service life. Oxidation on the enclosure was a concern. Transformer "DIST A" located in the main mechanical room appeared to have been used as a workbench. Heavy corrosion and splattered paint covered the enclosure. Panelboard "LVA" located in the main mechanical room was missing a breaker void cover or breaker. This is a life safety issue. A junction/pull box located in the main mechanical room above Panel LBA was missing a conduit plug and enclosure cover, leaving energized wires exposed. Panelboard "LAC" located in the basement was missing a breaker void cover or breaker. This is a life safety issue.</p>	Average
