## Norman Elementary School Site Summary

## Main School Building – BLDG-150A

## CRAWL SPACE – Norman ES – Main School Building (150-A)

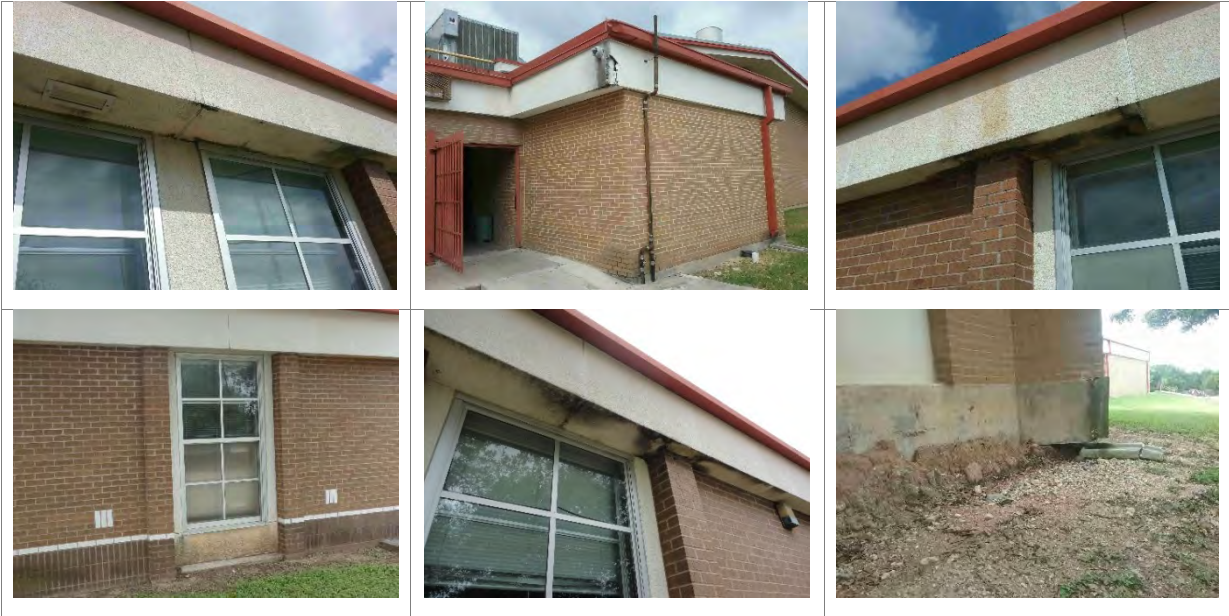
### Exterior Walls

System	Subsystem	Condition and Deficiency Overview	System Condition Rating
Exterior	Exterior Walls	<p>The exterior of the building consists of a brick façade with a painted stucco finish surrounding the windows on the original building and the 200-wing addition. There were multiple locations on the exterior brick where graffiti had been removed. There was some graffiti located on the southeast corner of the 200-wing. The stucco on the 200-wing was discolored and stained. The small soffit at the stucco fascia did not appear to have an adequate drip edge to prevent water infiltration. There was evidence of water infiltration along the east side of the 200-wing.</p> <p>There was soil erosion on the east side of the 100-wing and cracking of the foundation surrounding the downspouts. Erosion was reported on the east elevation of the 100-wing as well. There was damage to the stucco fascia on the northeast corner of the freezer.</p>	Average

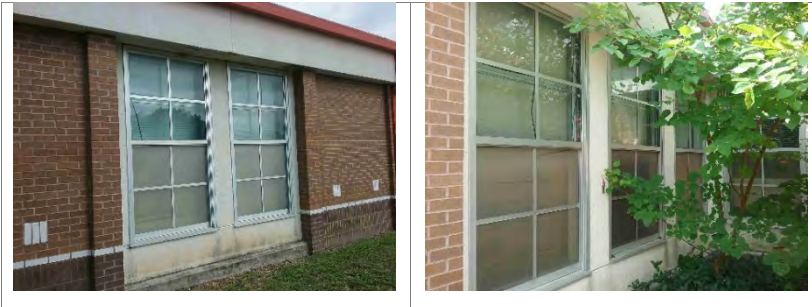
### Exterior Windows

Exterior Windows	The window units are aluminum frames with single pane glazing that are original to the respective construction date per wing. The seals were deteriorated on the window units in the 100- and 200-wings.	Average
	Exterior Doors	<p>The controlled main entrance on the west side is painted metal with glazing lites included in a window system, also of painted metal. All school exterior doors are painted metal with glazing lites. There are no automatic doors present in the facility.</p> <p>A majority of the doors were not plumb to the frame and</p>	Average

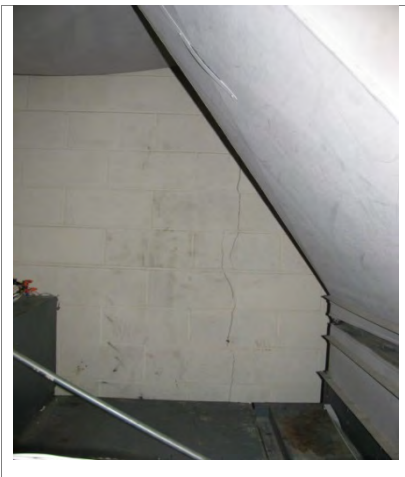
#### Interior Walls

<b>Interior Construction</b>	Interior Walls	The interior walls consist mainly of painted concrete masonry units. There was a crack in the wall adjoining the mechanical AHU-2 room and computer room near the cafeteria.	Average
	Interior Doors	<p>The interior doors are wood veneer with painted metal frames. There is an electric/motorized rolling gate separating the 200-wing from the rest of the school with a keyed on/off switch.</p> <p>There were several locations near restrooms where the metal frames of the doors were rusted and deteriorated in the 200-wing and the restrooms near the gymnasium. The paint finish was damaged and is peeling on various doorframes and some of the wood veneer doors had discoloration.</p>	Average
	Interior Specialties	There are six painted metal lockers located in the kitchen that were installed in the last five to six years. They appear to be in average condition.	Average

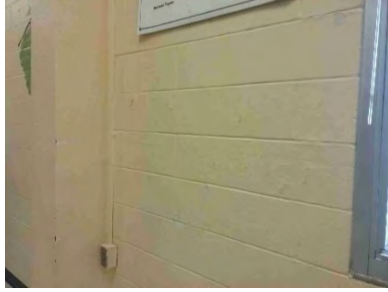
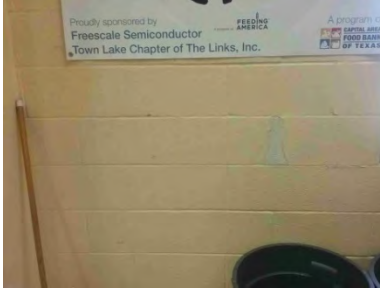
### Interior Wall Finishes

System	Subsystem	Condition and Deficiency Overview	System Condition Rating
<b>Interior Finishes</b>	Interior Wall Finishes	The interior wall finishes consist of paint throughout the school with ceramic tile in the restrooms and kitchen.  There were various locations of replaced tiles throughout the administration areas, 100-wing, and 200-wing. The paint finish was peeling on the interior of the cafeteria west wall. There was also visible peeling paint in the gymnasium.	Average
	Interior Floor Finishes	The interior floor finishes are made up of vinyl composition tile with vinyl base throughout with ceramic tile in the restrooms. There is vinyl strip flooring in the gymnasium and wood flooring on the stage in the cafeteria.  The flooring was in average condition due to age, but has been well maintained. There were instances of minor deterioration and patching and repair work.	Average
	Interior Ceiling Finishes	The ceiling finish is acoustic ceiling tile and metal grid throughout the facility with painted gypsum board in restrooms and various locations in the 200-wing atrium and library. The gymnasium has acoustic panels at the roof structure. The ceiling tile in the kitchen is vinyl faced. The cafeteria is not vinyl faced.  There was visible evidence of water damage in the storage area across from the gymnasium. It was reported that a pest issue exists, damaging the ceiling tile. There was evidence of this in the 100-wing storage closet.	Average

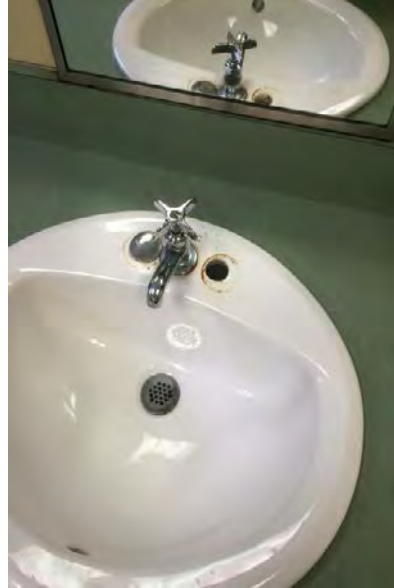
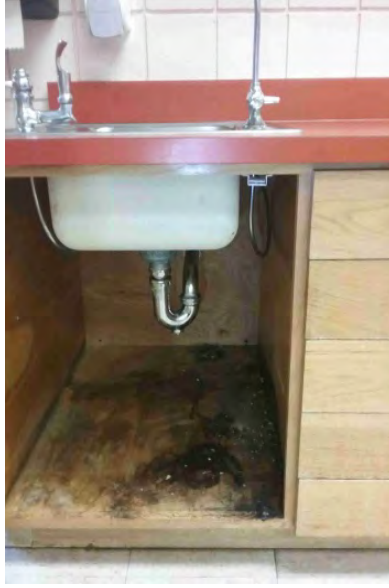
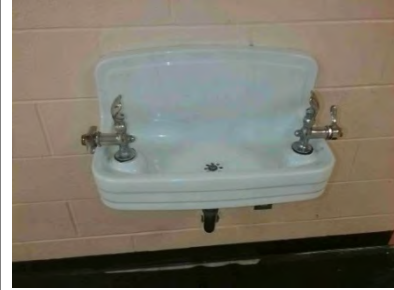
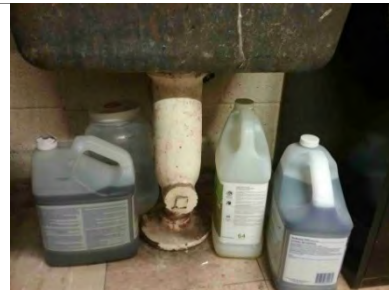
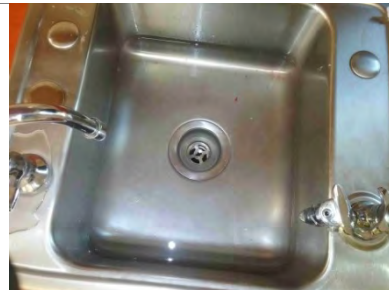
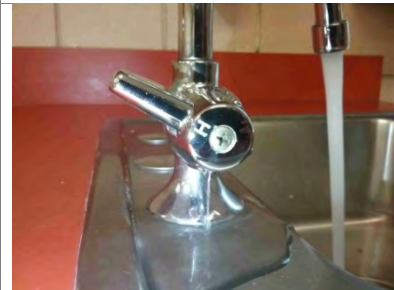
### Plumbing Fixtures

<b>Conveying</b>	System not present.		N/A
<b>Plumbing</b>	Plumbing Fixtures	The building contains predominantly single-use restrooms throughout the facility, with multi-use restrooms located near the gymnasium. Typical restrooms have floor- and wall-mounted vitreous china water closets with manual flush valves. Additionally, wall-hung vitreous china urinals with manual flush valves are located in the dedicated male restrooms. Typical classrooms contain a single basin stainless steel sink with a drinking fountain attached. Stainless steel and vitreous china drinking fountains can be found throughout the buildings, typically in the corridor close by to the hall restroom facilities.  A commercial kitchen, which was upgraded in the last five to six years, is located in the school's cafeteria. The kitchen contains stainless steel kitchen equipment, including a three basin prep sink. It also has various wall-mounted vitreous china sinks for personal use. The	Average

System	Subsystem	Condition and Deficiency Overview	System Condition Rating
		<p>building also has service sinks located in various janitorial closets.</p> <p>The restroom plumbing fixtures were in average condition. The fixtures were typically aged, but still operational. There was evidence of small leaks under some of the classroom sinks. The sink in classroom 204 made a rumbling sound when on and showed evidence of leaks underneath. The sink in room 203 appeared to be clogged and the faucet leaked at the connection to the sink when turned on. Some sinks were observed to have a hot and a cold valve, but only the cold delivered water (classroom 205 and 202). Multiple drinking fountains and sinks were observed to have low or no flow. Janitor's sinks were in average to poor condition, some showing signs of leaks and corrosion around the base.</p> <p>Majority of plumbing fixtures were in working condition, but show minor signs of deterioration. Multiple plumbing fixtures showed signs of corrosion around their base. Plumbing and fixtures in the 100-wing of the building were reported by staff to be original to the building, with some not functioning properly.</p>

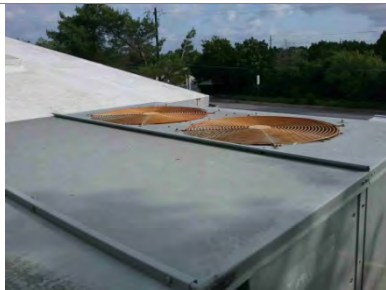
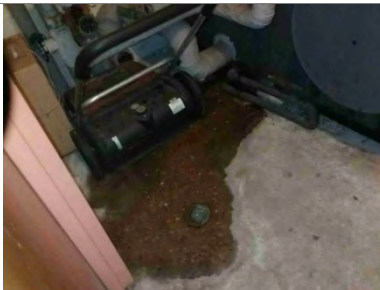
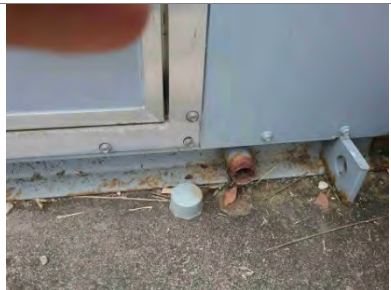
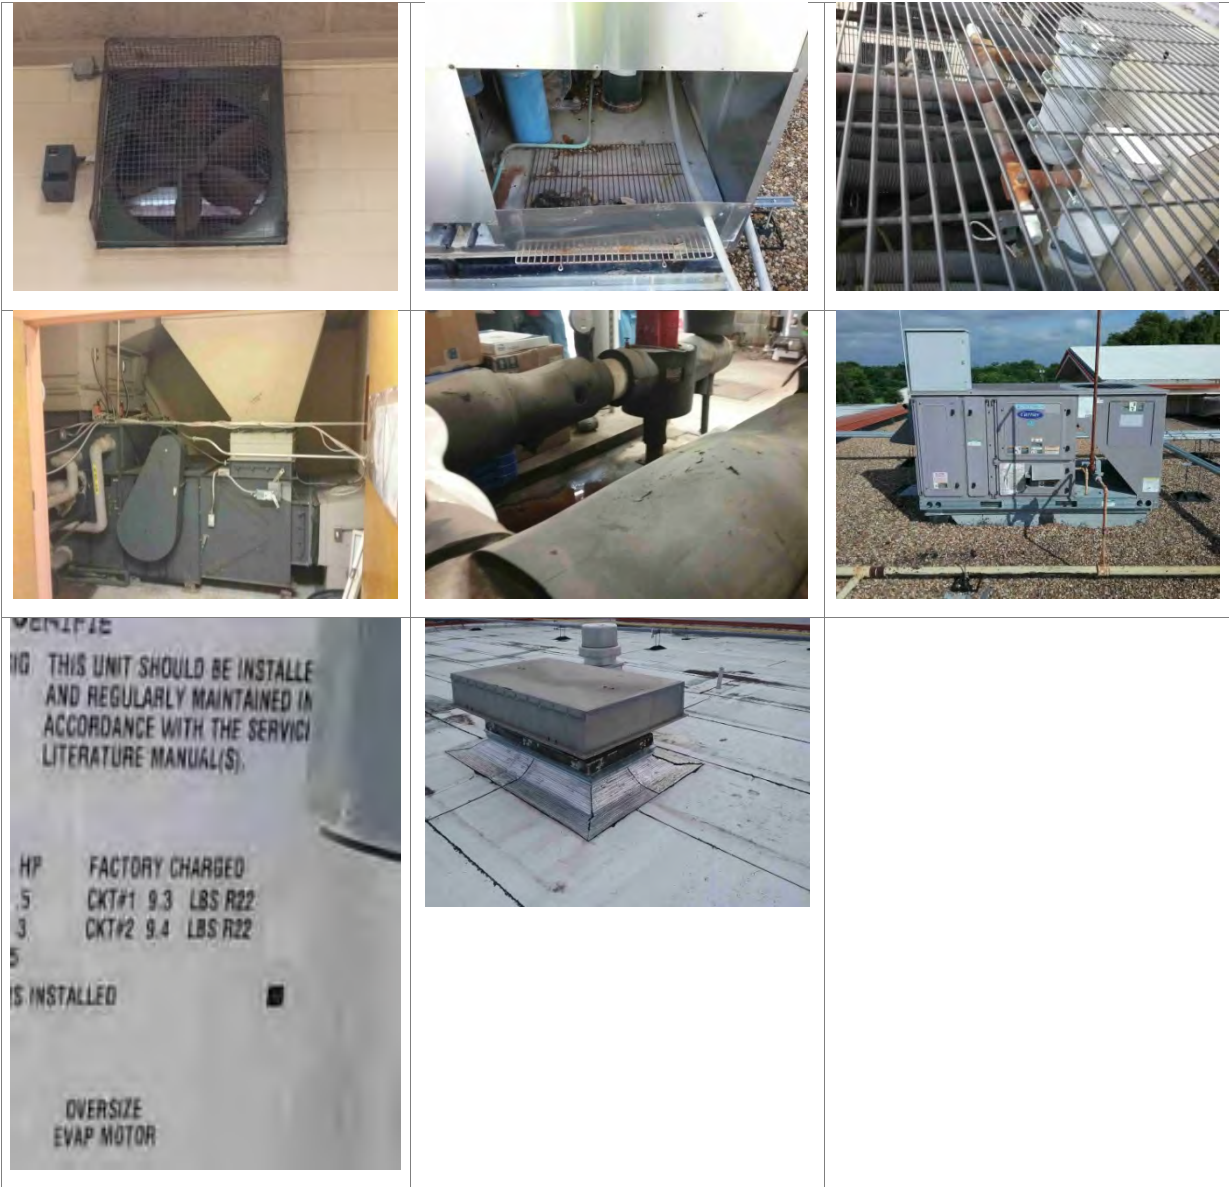
Mechanical/HVAC System Deficiency Examples

<b>Mechanical/ HVAC</b>	The building's HVAC (heating, ventilating, and air conditioning) system is composed of geothermal heat pumps, RTUs (roof top units), roof top and indoor		Average

System	Subsystem	Condition and Deficiency Overview	System Condition Rating
		<p>AHUs (air handling units) and split systems for individual zone temperature controls. The temperature control systems designated for the individual classrooms are determined by the date they were constructed. The original building containing the administration office, gymnasium, cafeteria, and 100-wing classrooms are controlled using RTUs, and roof top and indoor AHUs.</p> <p>Classrooms in the 200-wing were constructed in 1998, and are temperature controlled partially using a geothermal heat pump system designated for each classroom and partially using heating and cooling air handling system located outside the building on an enclosed slab (OAU 2-06). Water source heat pumps in each classroom were not accessible, assumed to be in the ceiling and working properly. The HVAC system in the 200-wing was reported to be having functionality issues and the geothermal well system is approaching end of useful life.</p> <p>AHUs appeared to be in average working condition. AHU-2 was making a loud vibration and knocking noise and appeared to have fluid leaking from underneath the unit. This unit has also been reported by staff to have operational issues. RTU-4 was reported to be making a loud grinding noise when in operation. Additionally, several of the AHUs use R-22 refrigerant, which is an outdated refrigerant that is being phased out of use.</p> <p>Multiple roof top exhaust fans ranging in size serve the building and appear to be in average working condition, but show signs of age. The exhaust fan supporting the kiln room could not be accessed due to blocked access.</p> <p>The HVAC system was in average condition; however, some pieces of equipment were past their expected design life and show signs of degradation and minimal signs of rust and corrosion.</p>

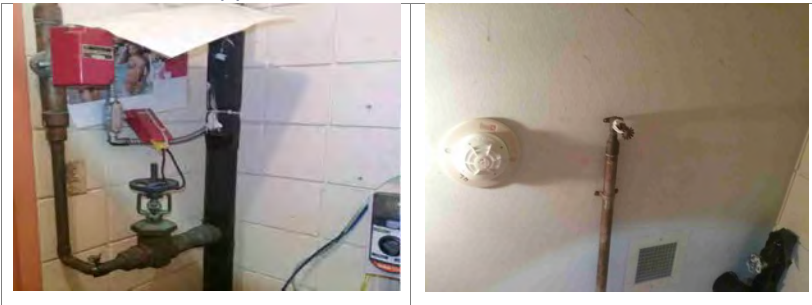
#### Fire Protection/Suppression

Fire Protection	Fire Alarm	<p>The building's fire alarm and detection system consists of pull stations, smoke detectors, strobe lights, annunciators, and a control system. The control system was reported to be in an inaccessible room. Detection and indication is present in all major living areas.</p> <p>No major deficiencies were observed during inspection.</p>	Average
	Fire Protection/Suppression	<p>A single sprinkler head was found in the janitorial closet (CC200). Remaining fire suppression system consists of fire extinguishers throughout the building.</p> <p>Visual inspection showed these were in average condition.</p>	Average
Electrical	Electrical Distribution	<p>The electrical service entrance for the facility is located on the north end of the complex, outside of the BLDG-150A MAINMECH room. 208Y/120-volt power appears to enter the facility through a 1600-amp switchboard located near the utility transformer. This switchboard feeds the original 1200-amp motor control center (MCC) for the facility along with two newer panels for the kitchen, installed 5-6 years ago. Power is distributed</p>	Average

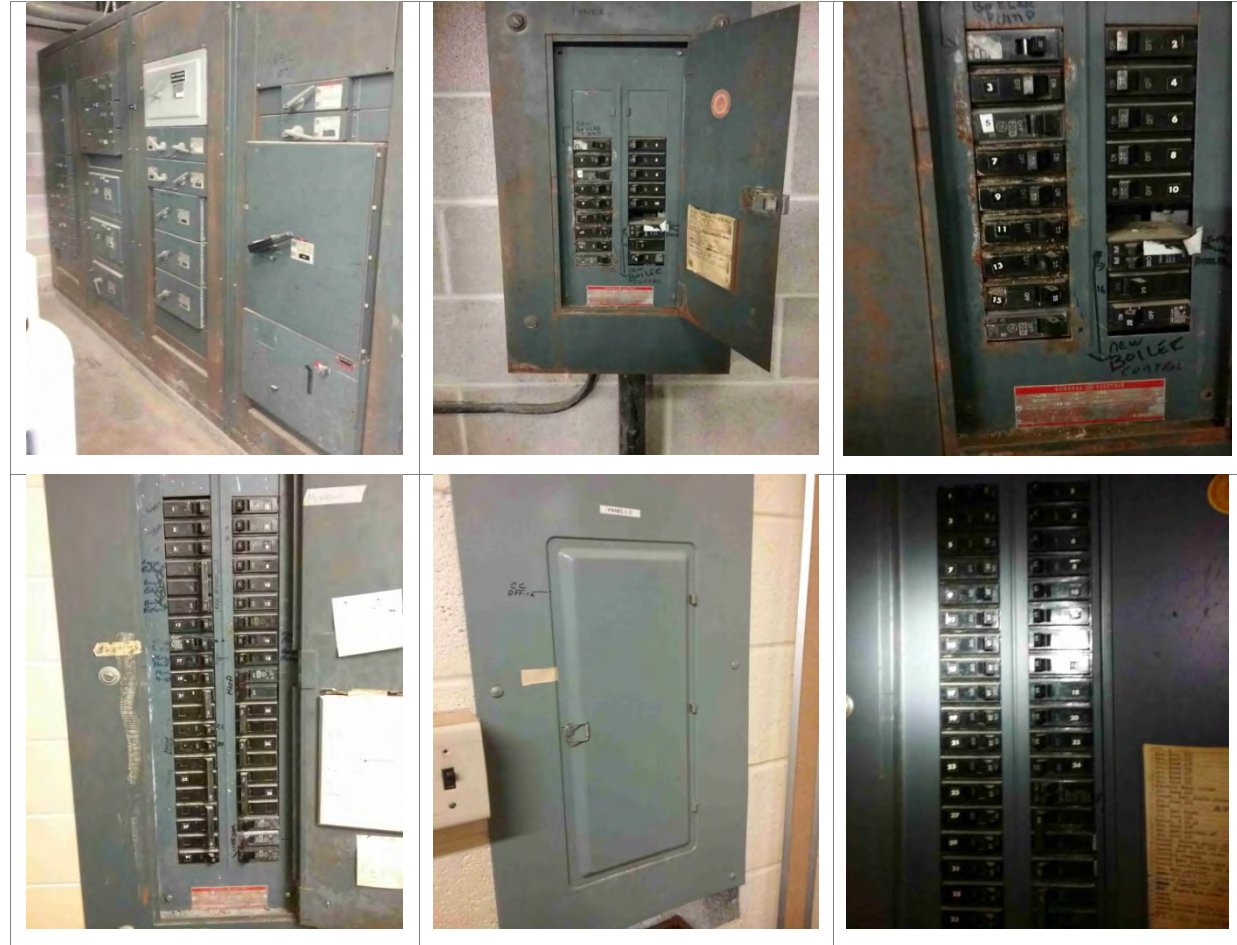
### Electrical Distribution

System	Subsystem	Condition and Deficiency Overview	System Condition Rating
		<p>from these main panels to smaller 225-amp main lug panel boards and larger 400-amp/800-amp main panels through the facility.</p> <p>The electrical distribution equipment throughout the facility was in average condition. The building featured a variety of switchboards and panelboards, most of which were replaced or added in the past ten to 20 years. Several panels are considered to be past their life expectancy or in poor condition. The original MCC, located in BLDG-150A's MAINMECH room was in poor condition and has a life expectancy of zero years. Panel P, a 100-amp panel, is located next to the original MCC. Panel P was missing a breaker cover plate and has severe corrosion located on the main housing and the breakers. If corrosion exists within the breakers, it is possible their overload protection was compromised and could be a major safety issue. Panel K, a 225-amp panel, located within the kitchen area on the west end. This panel appeared original to the building. Faculty also reported issues with the breakers tripping in this panel during rain events due to water infiltration. An original GE 225-amp panel was located within the MECH room in the C1 corridor. Panel LC was located in the CUSTOFC room and was beyond its typical service design life. This panel appeared to be manufactured by QC, but had no data plate or circuit information available. Panel A, located in the administration office next to the AHU-3 MECH room, appeared original.</p> <p>There was a small 3-circuit panel, labeled 'Fire Alarm Circuit Breaker', next to the original MCC in the MAINMECH room. The panel breaker was in the off position and believed to be decommissioned.</p>

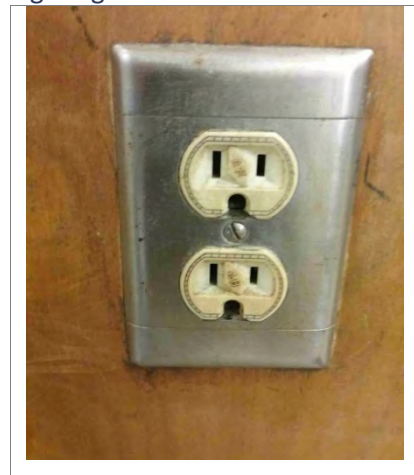
### Lighting

System	Subsystem	Condition and Deficiency Overview	System Condition Rating
	Lighting	<p>The interior lighting is comprised of a variety of fluorescent fixtures. Exterior lighting for BLDG-150A is limited to building entrances.</p> <p>The lighting for BLDG-150A was in average condition. The interior lighting in the majority of mechanical and storage rooms was found to be inadequate. Faculty reported the exterior lights on the south façade of the 200-wing were not functioning. The power feed for these lights was reported to have been cut during previous building renovation work and never restored. Norman faculty reported that the electrical outlets within the 100-wing had corrosion in various spaces. During the facility condition assessment, several outlets were found to have corrosion present on the contacts.</p>	Average
	Communications & Security	<p>BLDG-150A is equipped with tele/data/cable systems with the main backbone equipment located in MDF-A. BLDG-150A has a variety of older coaxial and phone-networking systems throughout the building that appear no longer in use. The building utilizes a VOIP (Voice Over Internet Protocol) telecommunication system that was reportedly installed in the last year. The timeclock system was reported to be functioning well.</p> <p>BLDG-150A has interior surveillance cameras located in all corridors. Exterior surveillance cameras are located near all building egresses.</p> <p>The communication and security systems equipment within BLDG-150A was in good condition. Several areas of the building exterior lacked surveillance coverage. The faculty also reported that some of the existing cameras did not fully cover some of the entrances to the building.</p>	Good

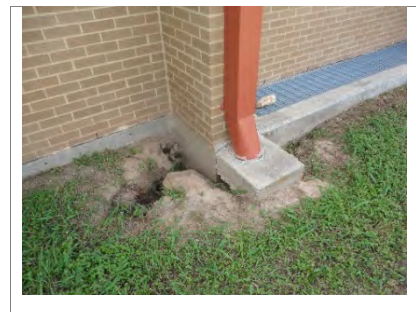
#### Exterior Walls

System	Subsystem	Condition and Deficiency Overview	System Condition Rating
<b>Exterior</b>	Exterior Walls	The exterior of the building consists of a brick façade on the 300-wing addition. There are multiple locations on the exterior brick where graffiti has been removed. There was evidence of erosion and soil deterioration at the north side of the 300-wing.	Good
	Exterior Windows	The window units are aluminum frames with double pane glazing that are original to construction of 2008. There were no observed deficiencies.	Good
	Exterior Doors	All exterior doors are painted metal with glazing lites. The doors were not plumb to the frame and the weather stripping was in poor condition leaving gaps around the frames and astragals. The interior doors at the vestibules did not have weather stripping.	Average
<b>Roofing</b>	The roof covering is modified bitumen roofing over the 300-wing. The roof was cracked and deteriorated throughout and was in poor condition due to age, sun exposure, and reports of leaks throughout the facility.		Poor

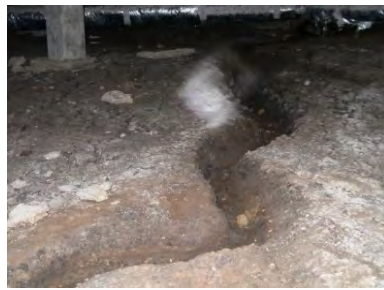
Damp soil, water intrusion from building perimeter

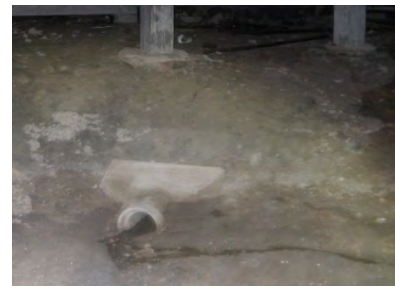
Partially clogged drain

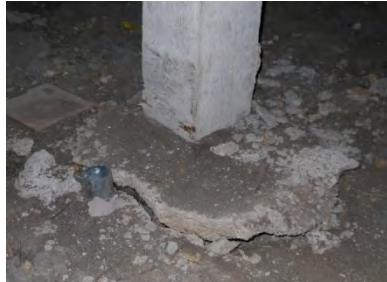
Concrete mushroom at top of pier

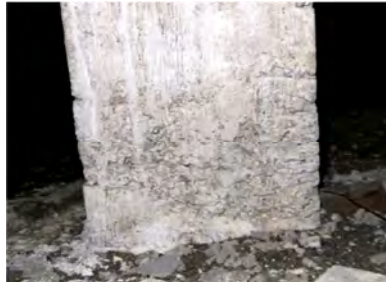
Honeycombing on column
