Pecan Springs Elementary School Site Summary

Address	3100 Rogge Lane Austin, TX 78723
Number of Permanent Campus Facilities	2
Original Year of Construction	1957
Total Campus Building Area (combined)	56,992 SF

Main School Building – BLDG-129A

Classrooms and Library – BLDG-129B

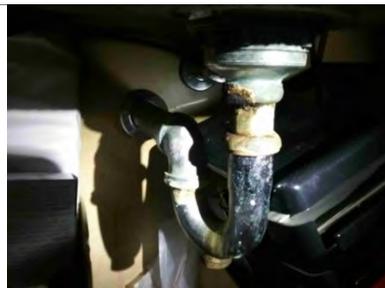
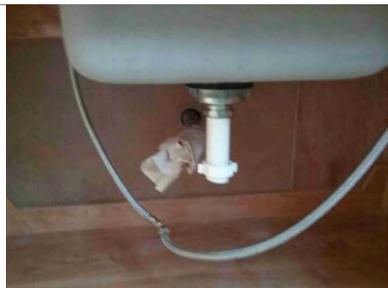
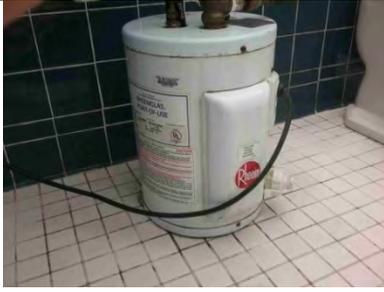
Domestic Water Distribution

System	Subsystem	Condition and Deficiency Overview	System Condition Rating
		<p>building to provide heated domestic water to specific locations in the school (i.e., the Nurse's office and gymnasium shower). Domestic hot water is not supplied to the classroom plumbing fixtures.</p> <p>The plumbing distribution equipment was observed to be in average condition with damaged insulation and corrosion and rust observed on piping throughout the building. Several sinks in the 100-wing were observed to have corrosion and rust in the connecting piping to the sink. The sinks in rooms 101, 203, 206, 302, 313 and 310 were observed to have a musty smell coming from beneath them and signs of leaks. room 303 was observed to be missing the connecting piping from the drain on the sink. It was reported in the facility interview that this classroom recently had a pipe burst, but repairs had already been completed.</p> <p>The EWH (electric water heater) in CC300 Unit shows signs of fire damage and smells charred. The building staff later noted that the unit caught fire earlier in the day. The unit has been disconnected and is not operational. Smaller EWHs in the administration office and nurse's office are aged and out of date. Corrosion was noticed on piping running along the ceiling in the kitchen storage. The domestic water system is in average condition with typical wear and tear associated with the system's age and general daily use.</p>

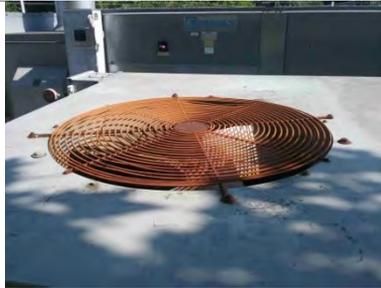
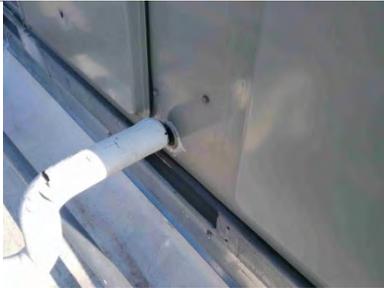
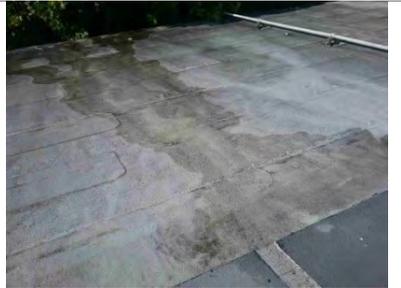
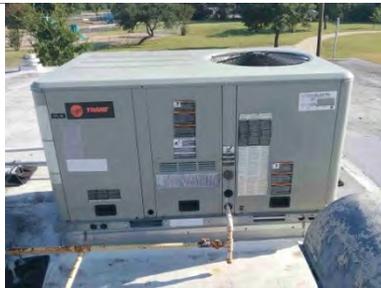
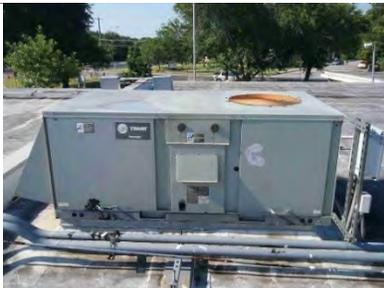
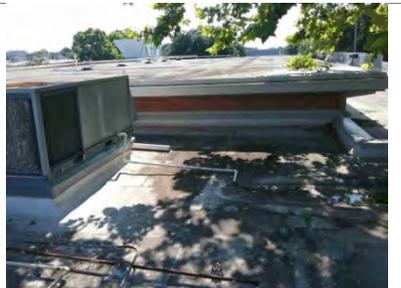
Mechanical/HVAC System Deficiency Examples

System	Subsystem	Condition and Deficiency Overview	System Condition Rating
		<p>RTUs feeding the 300-wing were in average condition with signs of deterioration due to exposure to the elements. RTU-310 was observed to have its condensate line cut and leaking across the roof. RTU-313 was observed to also have a condensation drip coming off the back of the unit. RTU-311 was observed to be making a rattling noise. The 300-wing has been noted to have excessive condensation in the rooms associated with the RTUs.</p> <p>RTUs for the administration office and cafeteria areas ranged in installation date from 1995 to 2010, with supporting AHUs as old as 1990. RTU-1 over the stage and RTU-4 were observed to be making a rattling noise when operating. RTU-1 over the kitchen had a condensate line that was draining onto the roof. A packaged AC system in the corridor outside the cafeteria is old and out of date and does not appear to be operational. When the unit is turned on, it makes a loud humming noise, and then shuts off. A thunderous sound was observed in the cafeteria when the air conditioning unit started. The source vent in the ceiling over room ADMIN2 was noisy.</p> <p>The geothermal water pump units are approaching end of useful life and have been reported to leak. The unit in the corridor between the 200- and 300-wings is not operational, resulting in the surrounding corridor being very warm. Heat pump systems observed in the gymnasium are aged and out of date and show signs of significant condensation or leakage around the associated AHUs. They were also reported in the facility interview to need frequent maintenance. Multiple HVAC units were observed to be using R-22 refrigerant, which is an outdated refrigerant that is being phased out of use. Exhaust fans on rooms 305, 308, 311 and over the gymnasium corridor were observed to be loud. The exhaust fan for the male restroom outside the gymnasium did not work. Aged vents were found on top of the roof with excessive wear and tear and signs of corrosion and rust. The HVAC system is in poor condition due to the number of repairs that need to be completed; the majority of the equipment is past expected design life and show signs of degradation, rust, and corrosion.</p>

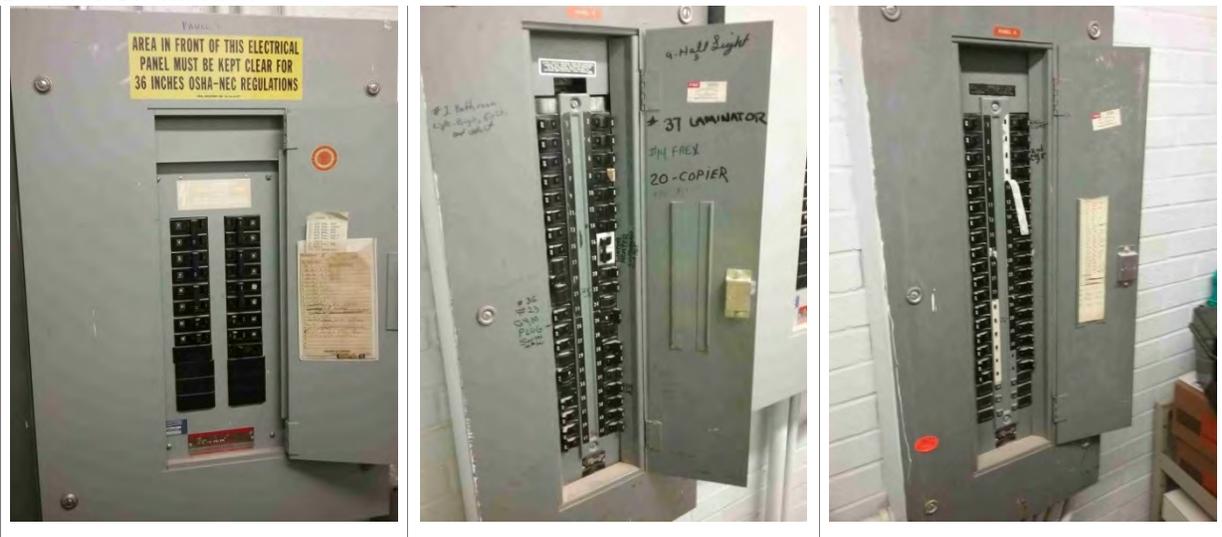
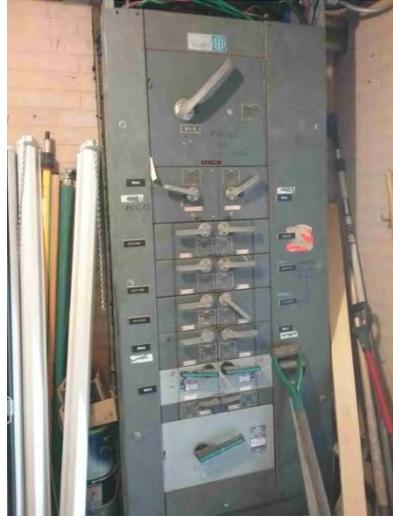
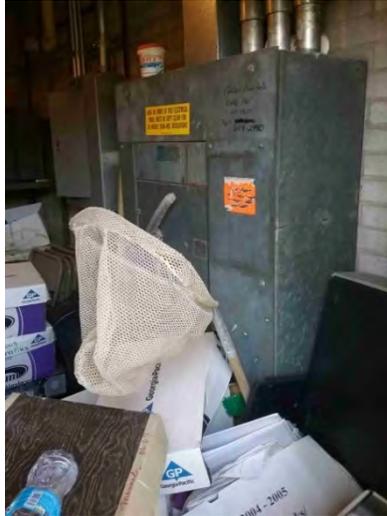
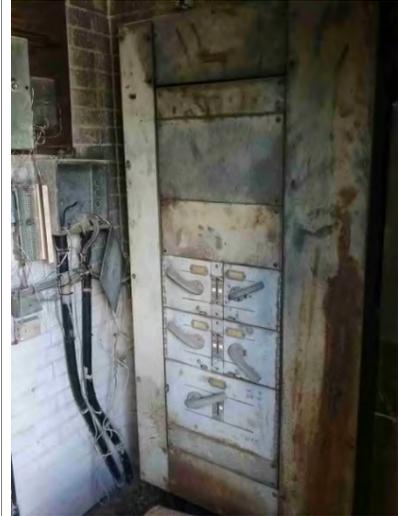
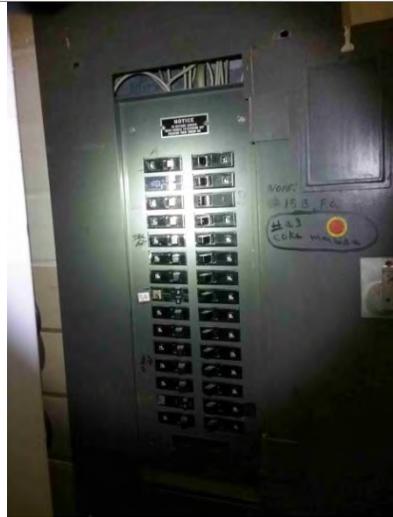
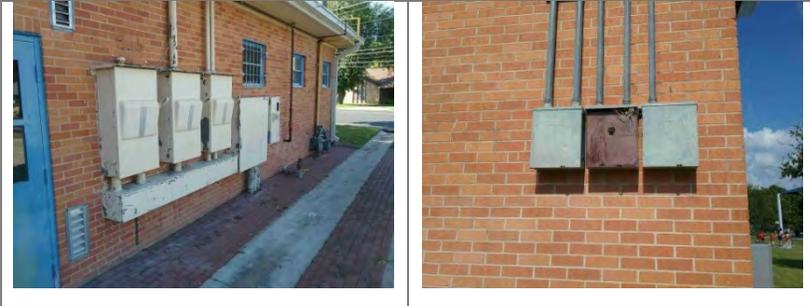
Electrical Distribution

System	Subsystem	Condition and Deficiency Overview	System Condition Rating
		<p>access to the panel. Lastly, panels located within the GYMSTO were partially blocked by gymnasium equipment. There are also several dated electrical shutoff switches serving BLDG-129A that have exceeded their life expectancy.</p>	
	Lighting	<p>Exterior lighting is comprised of metal-halide and LED (light-emitting diode) luminaires. LED luminaires are mainly installed in the major exterior areas of the building: the main entrances, kitchen loading area, the north side of the building near the playscape, the 200-wing covered walkway, and the ends of the 200/300-wings for portable building lighting. Interior lighting predominantly consists of fluorescent luminaires.</p> <p>The building has battery-operated emergency lighting luminaires throughout that were in good condition.</p> <p>The lighting for BLDG-129A was observed to be in average condition. Interior lighting deficiencies typically included burned-out lamps, non-functional luminaries, or missing/ damaged lens covers. This was observed in in several student bathrooms, GYMELEC, BKRM, and SUPPLYADM. Several exit sign luminaires were found to dim or partially visible. Many exterior metal-halide luminaires were found to be aged and may be reaching their end of life expectancy.</p> <p>BLDG-129A had a number branch wiring deficiencies. Several areas were found to have dated or poor condition conduit. In particular, the roof has a significant amount of corroded conduit. Several interior conduit junction boxes were exposed due to missing knockout plugs, missing covers, or broken covers. Many of the light switches throughout the building are severely dated and have exceeded their life expectancy. There are also older electrical receptacles in the classrooms that are worn and have exceeded their useful life. Worn light switches and electrical receptacles can create life safety issues due to internal arcing when used. Faculty has reported that several rooms in the 300-wing have electrical receptacles that spark when plugging in devices. It was also reported that the building has areas where the original braided wiring is still in use.</p> <p>An additional deficiency was found with an AC adapter used to power unknown panels within room SUPPLYADM, over the door entrance. The adapter appears to be aged and is discolored from possible</p>	Average

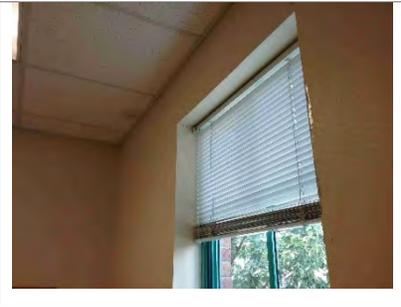
Interior Stairs	System not present.	N/A
Interior Finishes	Interior Wall Finishes	The interior wall finishes are plastic laminate wainscoting with wood trim and painted gypsum board above in the corridors. The classrooms are painted gypsum board throughout with tack boards surrounding the chalkboard and other locations along the walls. The library has painted gypsum board with strips of acoustic panels along the ceiling. The restrooms have ceramic tile wainscot and gypsum board above. The interior wall finishes were observed to be in good condition with a few isolated areas of deterioration, specifically around the windows.	Good
	Interior Floor Finishes	The interior floors are VCT throughout the corridor and classrooms. The library has carpet throughout, and the restrooms have ceramic tile. The floor finishes were in good condition. A few areas in the entrance corridor have been replaced, possibly due to high traffic to and from the library.	Good

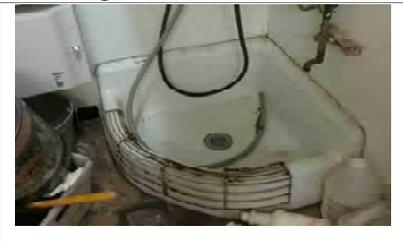
System	Subsystem	Condition and Deficiency Overview	System Condition Rating
Conveying	System not present.		N/A
Plumbing	Plumbing Fixtures	<p>Typical classrooms in BLDG-129B contain a single-basin stainless steel sink with a drinking fountain attached. Each pair of classrooms has two single-use restrooms containing floor-mounted vitreous china water closets in the connection between the classrooms. The library office contains a stainless steel basin sink. The corridor contains two single-use restrooms with floor-mounted vitreous china water closets and vitreous china wall-mounted sinks. A single stainless steel drinking fountain was observed in the corridor. A janitorial mop drain was located in CC400.</p> <p>The majority of plumbing fixtures are in good working condition with some showing minor signs of deterioration but still operational. The mop drain in CC400 was in average working condition with signs of corrosion and rust on the metal grate. It was reported during the facility interview that water closets in this building occasionally overflow; this was not observed during the assessment.</p>	Good

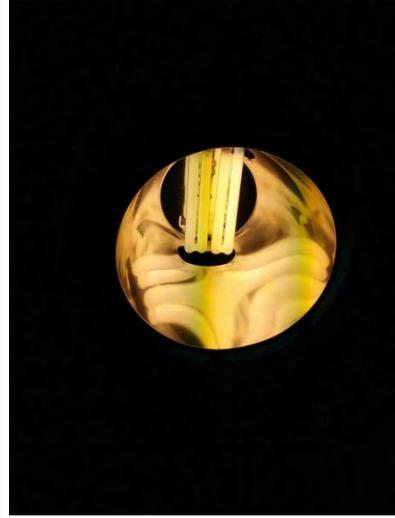
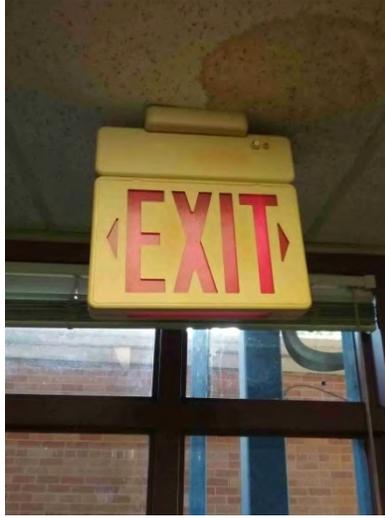
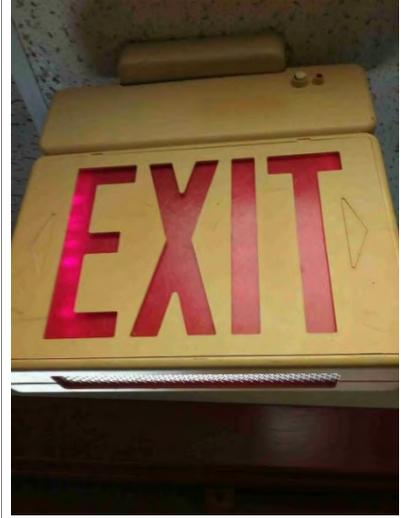
Lighting	The building's exterior lighting consists of metal-halide and LED luminaires. The interior lighting primarily consists of fluorescent luminaires flush mounted in the ceiling. The building has battery-operated emergency lighting luminaires throughout which were found to be in good condition. BLDG-129B's lighting system was found to be in good condition. One deficiency was noted due to a strobing luminaire in the female restroom that connects rooms 400 and 401. The building exit luminaires were found to be dim and appeared discolored. No deficiencies were found with the branch wiring.	Good
	Communications & Security	BLDG-129B is equipped with telecommunication systems. room LIBAVSTO houses server equipment for building distribution. The classrooms and library also have Wi-Fi modules present. Each classroom has a hardwired telephone fixture and receptacle. Interior security cameras are located in the building corridors, and the classrooms have motion detectors. The timeclock system appears to be in good condition. BLDG-129B's communications and security system was found to be in good condition. The north entrance that connects to the C5 corridor was found to have networking cable (assumed) running through a hole in	Good
