Pillow Elementary School Site Summary

Main School Building – BLDG-151A

CRAWL SPACE – Pillow ES – Main School Building (BLDG-151A)

PILLOW ELEMENTARY SCHOOL

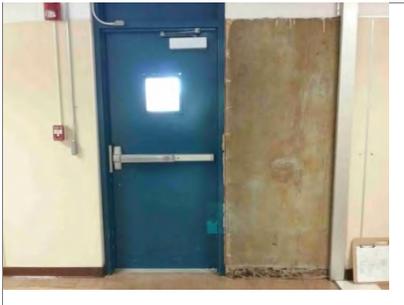
Interior Construction	Interior Walls	The interior walls are gypsum board in the classrooms, administration area, and lobby. There are CMU (concrete masonry unit) in the gymnasium and	Average

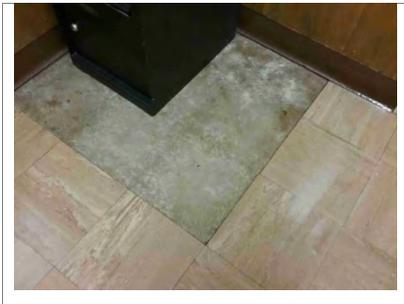
Interior Stairs	System not present.	N/A
Interior Finishes	Interior Wall Finishes	<p>The interior walls are painted gypsum board in the classrooms, administration area, and lobby. There is painted CMU in the gymnasium and cafeteria areas. The corridors are gypsum board or CMU at the top and plastic laminate from the floor upward of eight feet. The classroom wings, music room and councilor offices are wood paneled.</p> <p>They were all observed to be in good condition. The CAC and Principal Brian Hill believe asbestos may be in materials found in the gymnasium and in the corridor walls. Independent verification through Jason Buster, with TASB, could not be performed. These surfaces should be investigated prior to future renovations.</p>	Good
	Interior Floor Finishes	<p>The interior floor finishes are mainly suspected asbestos floor tile in administration offices, cafeteria, corridors, and classrooms. There is VCT (vinyl composition tile) in the 300-wing classrooms. Ceramic tile is in the restrooms and kitchen. The flooring is new carpet tiles in the library. There is a rubber sport court in the gymnasium and wood flooring on the stage.</p> <p>All were observed to be in good condition. The corner of the administration open area had missing tiles.</p>	Good

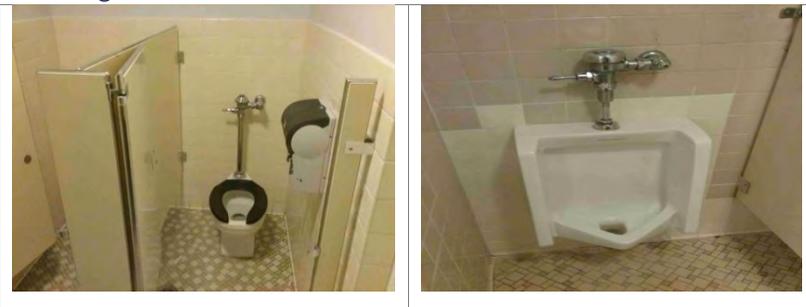
Plumbing	Plumbing Fixtures	<p>The facility contains multiple plumbing applications that service one floor level, consisting of: student restrooms, staff restrooms, janitorial closets with service sinks, and one commercial kitchen.</p> <p>The restrooms that are located inside of the classrooms have vitreous china floor mount toilets with manual flushing valves and some are equipped with auto sensing flushing valves. The classroom restrooms are not equipped with sinks; however, the classrooms all have laminated particle board vanities with stainless steel sink/bubbler combinations mounted inside of the vanity. The remainder of the facility's restrooms have vitreous china sinks with manual or metering faucets, along with vitreous china floor/wall mount toilets and urinals with manually operated flushing valves. There are also wall-mounted service sinks in the janitorial closets.</p> <p>This building's plumbing fixtures were observed to be in average condition. All of the classroom and gymnasium restrooms had old fixtures that were originally installed when the school was built. Staff reported that the divider walls between the urinals in the male restrooms are breaking away from the walls. In addition, it was reported that there were old mop sinks in the janitorial closets that need to be replaced with floor sinks and that the water fountains near the gymnasium had low water pressure.</p> <p>The plumbing fixtures observed throughout the building were either from when the facility was</p>	Average

System	Subsystem	Condition and Deficiency Overview	System Condition Rating
		<p>originally constructed or had been installed recently. Though there were fixtures that were aged and required maintenance, all of the fixtures assessed at the time of assessment were functional.</p>	
	<p>Domestic Water Distribution</p>	<p>The plumbing fixtures that are serviced by domestic water distribution equipment are located in the commercial kitchen. The fixtures in the commercial kitchen are serviced by four tankless gas-fired water heaters that are located in the main mechanical room. The tankless water heaters have the ability of producing 199 MBH.</p> <p>The staff reported that the sewer piping associated with the restrooms located in the crawl space was cracked and broken. It was also reported that the original galvanized water distribution piping was in need of replacement.</p> <p>The domestic distribution system was observed to be in good condition at the time of assessment.</p>	<p>Good</p>

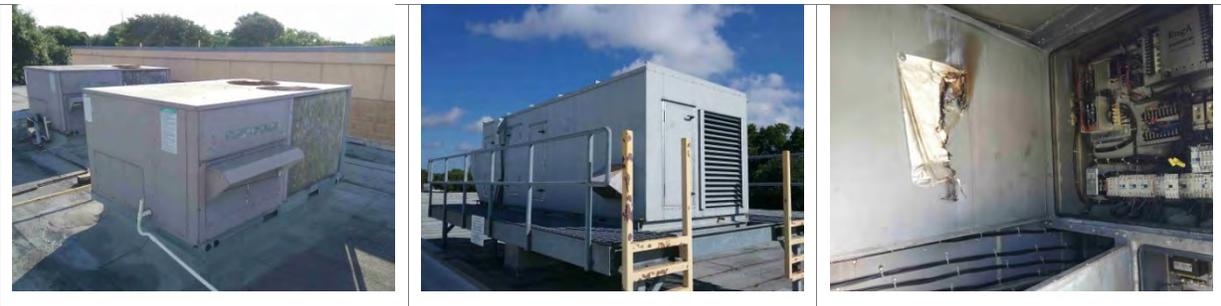
Mechanical/HVAC System Deficiency Examples

System	Subsystem	Condition and Deficiency Overview	System Condition Rating
		<p>The staff also reported that the large roof top-mounted HRUs were aged and needed to be replaced, because they consistently required maintenance. Additionally, the roof top-mounted EFs that serviced the kitchen were reported to be aged and not working efficiently.</p> <p>Of the 31 pieces of HVAC equipment observed, only four had noted deficiencies. The deficiencies consisted of general aging of equipment, enclosure/compressor fin damage due to excessive wear and tear, and the utilization of outdated R-22 refrigerant.</p> <p>The roof top-mounted HRU-2 was observed to be in a failed state of operation at the time of observation because of an electrical fire that took place inside of the unit. HRU-1 was also being worked on by HVAC technicians at the time of observation. The CAC and Principal Brian Hill reported that the HVAC system is experiencing issues related to air flow, humidity, and heating.</p>

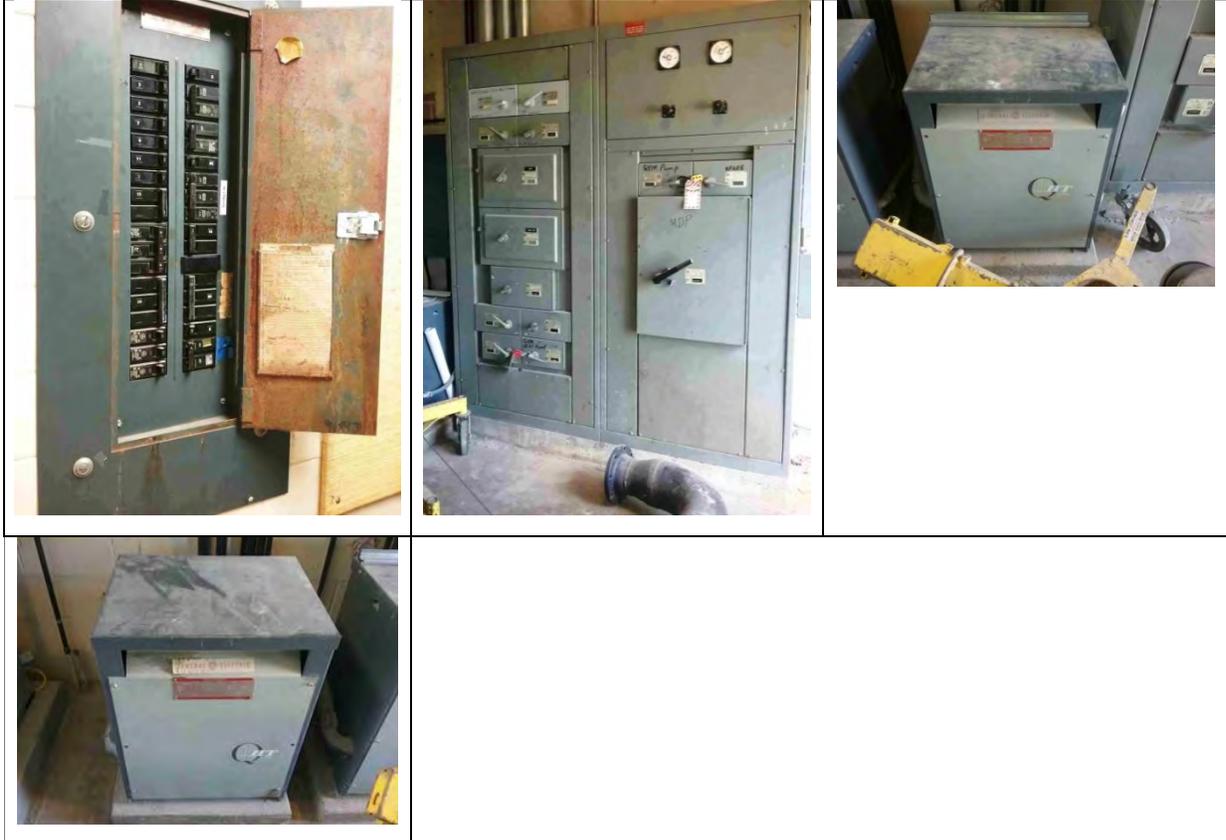
Electrical Distribution

System	Subsystem	Condition and Deficiency Overview	System Condition Rating
		<p>enclosure.</p> <p>The facility reported that there was an electrical panel located in the MDF (main distribution frame) room. This panel was not accessible due to the MDF security requirements. Additional equipment had been requested in the administration area.</p>	
	Lighting	<p>The exterior of the building is outfitted with what appears to be wall-mount HID (high-intensity discharge) fixtures and screw-type flood fixtures located near the roofline of the building. Covered walkways are illuminated by surface-mounted ceiling fixtures.</p> <p>The interior lighting consists of fluorescent troffer fixtures in classrooms and hallways. The stage is equipped with a specific designed lighting to support stage productions. The gymnasium is equipped with hanging fluorescent style fixtures and there are screw type fixtures in closets, mechanical rooms, and electrical rooms.</p> <p>The exterior lighting was observed to be in average condition due to a mixture of fixtures nearing their life expectancy and newer fixtures that had been recently replaced.</p> <p>The facility reported that exterior lighting was required in the circle drive and in pathways leading to the portable classrooms.</p> <p>The interior lighting was observed in average condition. There were exit signs at every exit; however, various signs were not illuminated.</p> <p>The facility reported that lighting in the hallways and classroom restrooms was dim and insufficient.</p>	Average
