## Pleasant Hill Elementary School Site Summary

## Main School Building – BLDG-130A

Building Purpose	Administration Offices, Classrooms, Cafeteria, and Gymnasium
Building Area	65,298 SF
Inspection Date	July 28, 2016
Inspection Conditions	90°F - Sunny and hot
Facility Condition Index

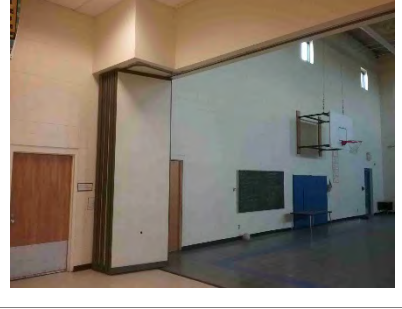
### **Interior Walls**

<b>Interior Construction</b>	Interior Walls	<p>The interior walls are primarily CMU. In the classroom wings, framed gypsum board partitions create the restroom cores and separate pairs of classrooms. The light wells walls located at the classroom wing corridors are constructed of framed gypsum board. Large common spaces such as the library, gymnasium, and auditorium have CMU walls. Interior windows found throughout the school are single-glazed with hollow metal frames. A folding wall separates the cafeteria and gymnasium.</p> <p>The interior walls and windows were observed to be in good condition. The folding partition at the cafeteria/gymnasium was reported to be deteriorating, and a replacement was requested.</p>	Good
	Interior Doors	<p>The interior doors are solid core wood with hollow metal frames. The doors located in classroom wings have vision panels and some have a side-lite.</p> <p>The interior doors and hardware were observed to be in good condition.</p>	Good

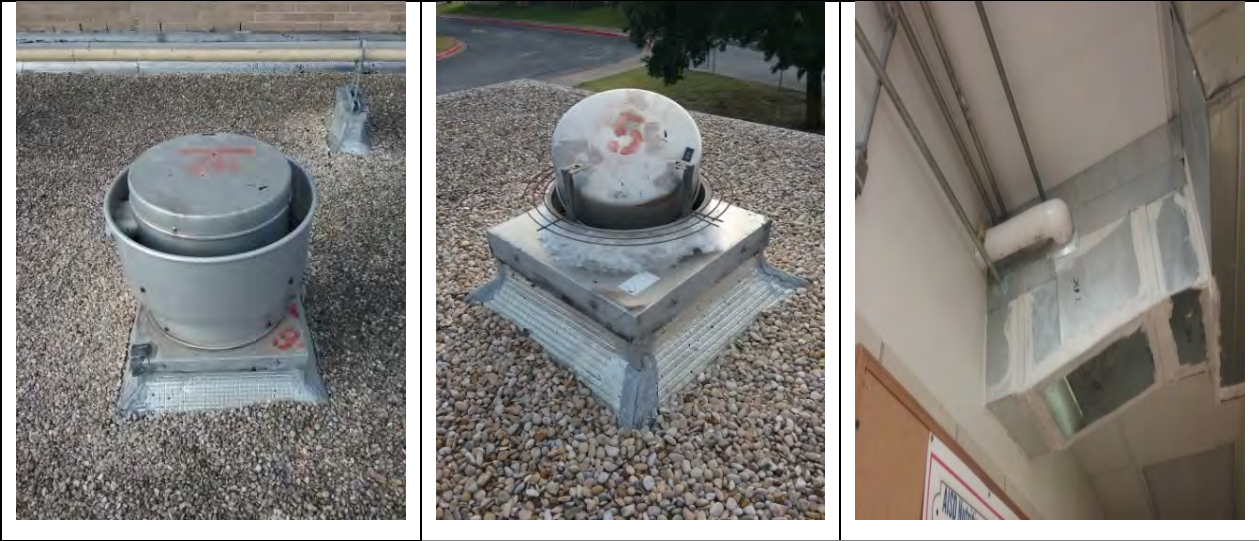
Mechanical/HVAC System Deficiency Examples

System	Subsystem	Condition and Deficiency Overview	System Condition Rating
		<p>reported that 15 WSHPs were being replaced this summer and that the remaining 55 WSHPs need replacement as well. Portable coolers were observed in select areas of the building at the time of assessment. The cooling tower appeared to have been installed within the last three years and appeared to be in good condition. The heat exchanger and distribution pumps appeared aged and need replacement. A new boiler was being installed at the time of assessment. A condensing unit located on the exterior of the building was aged and appeared to be in poor condition. The RTU located above the kitchen for the kitchen exhaust hood make-up air appeared to be in poor condition due to age. The electrical disconnect was rusted and needed replacement. Electrical conduit was penetrating the ductwork located in the kitchen.</p> <p>The EFs serving restroom exhaust appeared to be in average condition. The kitchen EF and nearby EFs appeared to be in poor condition due to their age. A nonfunctioning EF was observed on the roof near the kitchen. It was reported that the electrical rooms and janitorial closets throughout the building need EFs.</p> <p>It was reported that the mechanical units in the K-wing were unique to the building. The outside air is ducted to each unit through the exterior wall of each classroom. This requires that the maintenance staff change more filters than a typical combined outside air unit, and the additional building penetrations lead to pest management issues.</p> <p>It was also reported that the HVAC controls run on a Microsoft XP operating system that is no longer supported for security upgrades by Microsoft. The AISD Service Center staff is concerned that this situation can become a security threat.</p>
