Sanchez Elementary School Site Summary

Main School Building – BLDG-127A

CRAWL SPACE – Sanchez ES – Main School Building (BLDG-127A)

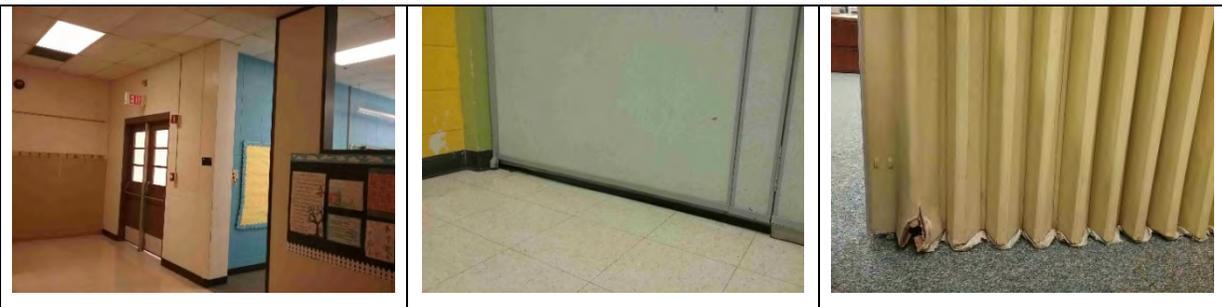
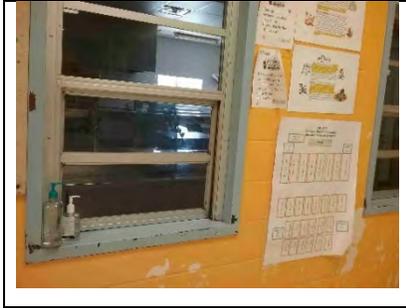
Interior Walls

System	Subsystem	Condition and Deficiency Overview	System Condition Rating
		<p>units dividing the main entrance corridor area from the public administration area.</p> <p>The interior walls appeared to be in good condition. The campus staff requested the partial height partitions in the north classroom wing to be full height in order to eliminate the noisy environment. The staff also requested more wall closure in classroom 208 and 218 in order to create more useable spaces. The moveable partition system between the gymnasium and cafeteria was reported to be used by the staff. It proved to be difficult to operate and the bottom seal was broken. The campus staff requested that this system be replaced. The accordion curtain in room 214 appeared to be functional and in good condition. The curtain in room 123, however, was worn and difficult to operate. The campus staff requested that it be replaced. The interior windows are in good condition but the hollow metal frames require paint. The windows appeared to be in good condition at the administration suite.</p>

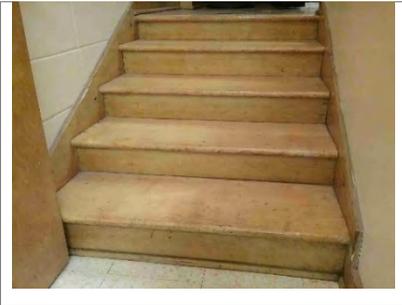
Interior Stairs

System	Subsystem	Condition and Deficiency Overview	System Condition Rating
		<p>installed for the walking surface. Two additional short run, wood stairs flank the rear sides of the cafeteria stage. Carpeted steps form the front edge of the stage in the cafeteria.</p> <p>All stairs appeared to be in good condition. The two stairs flanking the stage, however did not have handrails. These two stairs were well finished, but were scarred.</p>	
<p>Interior Finishes</p>	<p>Interior Wall Finishes</p>	<p>Paint on either CMU, gypsum wallboard, or concrete structure is the most prevalent finish. A painted mural occupies the upper areas of three library walls. Vinyl-clad panels on a partial height partition system are installed in the north classroom wing areas at both the first and second levels. FRP (fiber reinforced plastic) panel wainscots on painted gypsum board walls are installed in the library, in corridors of the same north classroom wing area, and in corridor 4. Ceramic tile is installed in restrooms as wainscots and full-height in the kitchen. Acoustic panels are installed on the upper wall areas in the gymnasium and music 100.</p> <p>The campus staff reported that paint peels on the walls in the cafeteria, gymnasium, restroom WFRR100, classroom 7 and at the open space at classrooms 5 and 8 even though there were no moisture problems and paint failed soon after application. Paint was also observed peeling from the CMU walls in the stair wells. The north wing corridor corners were chipped and marred, mostly at the exposed concrete column corners. The vinyl-clad wall system appeared to be in good condition as were the FRP panels. The older ceramic wall tile installations appeared to be in good condition but the campus staff requested the tile be replaced in the student restrooms.</p>	<p>Average</p>

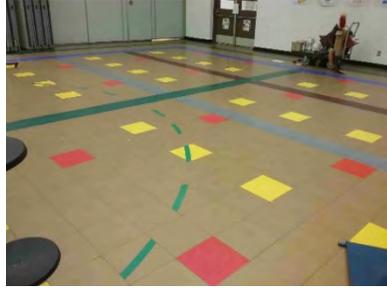
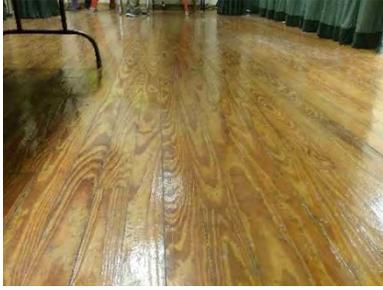
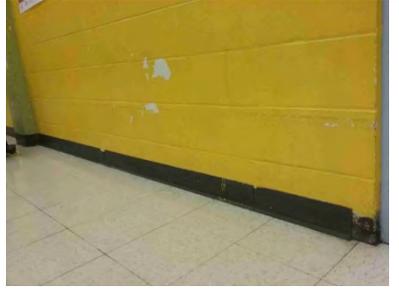
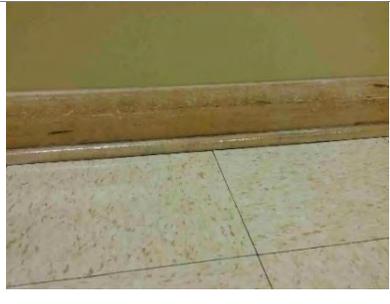
Interior Floor Finishes

System	Subsystem	Condition and Deficiency Overview	System Condition Rating
		<p>guardrail (above the library), and at the cafeteria stage; elsewhere vinyl base is installed.</p> <p>All floor finishes appeared to be in good condition. The campus staff requested that carpet in the library, classrooms, stage stair, and elevator be replaced; but these did not appear to be in poor condition. Though the gymnasium floor is in good condition, it requires cleaning. The wood stage floor is in good condition but the wood surface is rough and should be well sanded before the next finish. The campus staff reported that the kitchen tile around a floor drain was sinking. This condition was not observed but could have been hidden by equipment and not available for visible assessment. All vinyl wall base appeared to be in good condition except in the cafeteria where it was in poor condition and partially missing. Most all of the wood base is scratched and dented.</p>

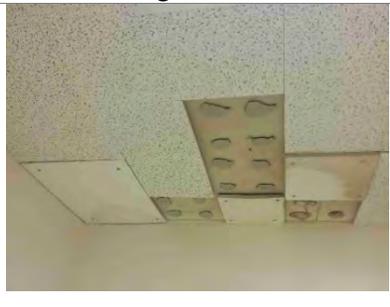
Interior Ceiling Finishes	<p>A 2'x4' acoustic tile in a suspended grid system is installed throughout most of the building. A 2'x4' vinyl-clad tile and suspended grid system is installed in the kitchen. The bottom side of the roof deck forms the ceiling above the gymnasium and cafeteria stage. There are 6"x6" acoustic tiles adhered to the restroom ceilings. Painted gypsum board ceilings are installed in the newer east classroom wing.</p> <p>Ceilings appeared to be in good condition even though the cafeteria acoustic tile installation was beginning to show age. The adhered tile in the restrooms was damaged or missing.</p>	Good
Conveying		<p>The building is equipped with a two-stop, 2,000-pound elevator for second floor accessibility. The elevator's certificate of compliance is current.</p> <p>The conveying system was found to be in good condition. The elevator hydraulic equipment data plate was original to the building's construction, but all components appear to be in good working order. Campus faculty reported that the elevator gets stuck occasionally, leaving occupants trapped inside. Campus staff also requested a wheelchair lift for stage accessibility.</p>	Good

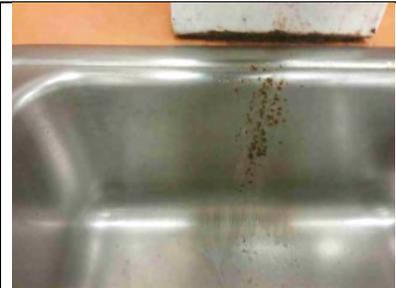
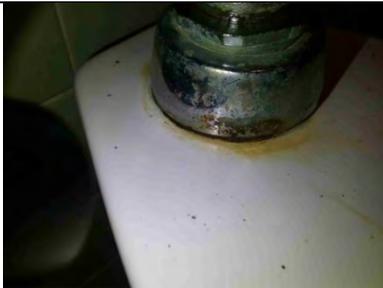
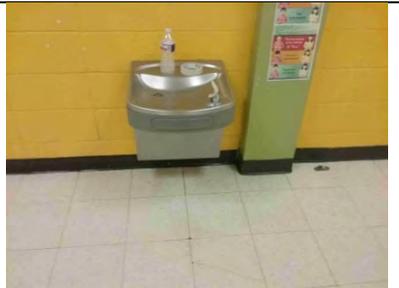
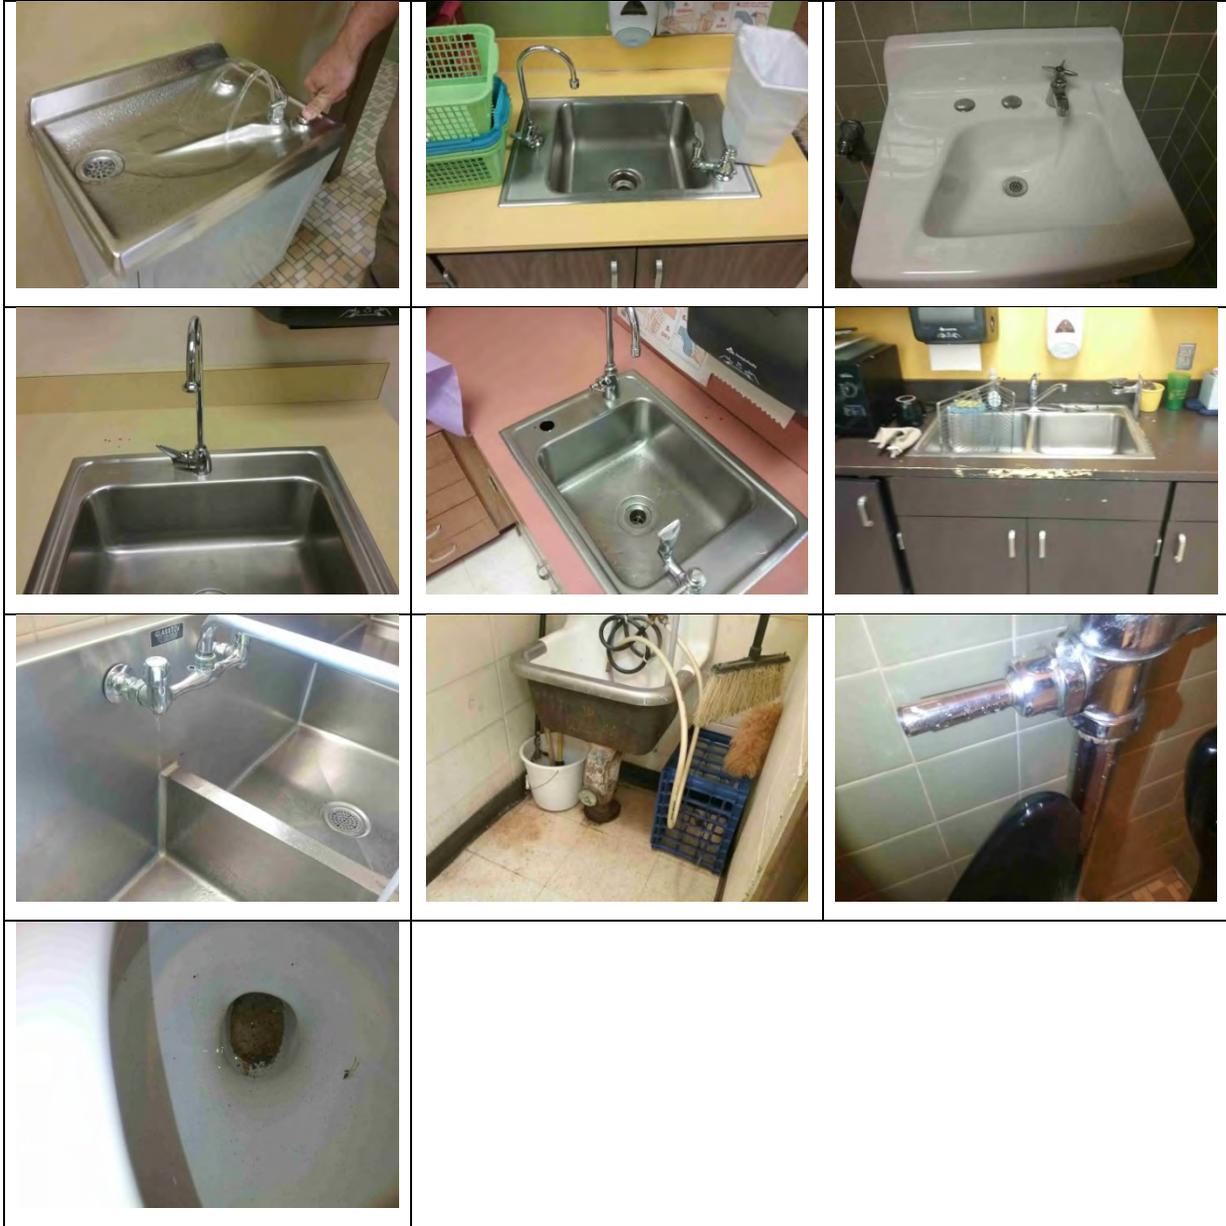
Plumbing Fixtures

System	Subsystem	Condition and Deficiency Overview	System Condition Rating
		<p>mounted vitreous china or stainless steel handwashing sinks. Typical classrooms contain a single basin stainless steel sink with a drinking fountain attached. Stainless steel and vitreous china drinking fountains are found in the corridors of the building. Various additional vitreous china and stainless steel sinks can be found throughout the building in areas such as the kiln room, lounge, and library. Additionally, a single-use shower stall is located in the restroom off of the gymnasium office.</p> <p>There is a stainless steel handwashing basin sink outside of the cafeteria. The kitchen contains stainless steel kitchen equipment, including one triple basin and one double basin prep sink. It also has various wall-mounted vitreous china sinks for personal use. Service sinks are also located in various janitorial closets.</p> <p>The majority of plumbing fixtures were in average working condition, but were aged and show minor signs of deterioration. The drinking fountain in the cafeteria was observed to have no flow. The drinking fountain outside of the 100-wing multi-use restroom was observed to have a split flow from the nozzle. The drinking fountain in classroom 102 was observed to have low flow. The sink and drinking fountain combination in classroom 111 was observed to have low flow coming from both fixtures. The sink in the male restroom (BRR101) sticks in the "ON" position. The sink in room 122COPY was observed to have no flow. The sink in classroom 101 was observed to be missing a faucet plug. The male faculty restroom (MFRR100) was observed to have low flow to the sink. The sink in classroom 210 was observed to be emitting an odor when turned on. The double basin prep sink in the kitchen was observed to have a leaky handle. The sinks in the janitorial closets were in average condition showing signs of deterioration and rust associated with age.</p> <p>The water closets in classrooms 2 and 103 were observed to leak when flushed. The water closets off of both classrooms 3 and 4 were observed to have pests in them, with classroom 4 having indications of buildup. The shower in the nurse's restroom had items stored in it and could not be assessed for operation; visual assessment did not yield any deficiencies.</p>

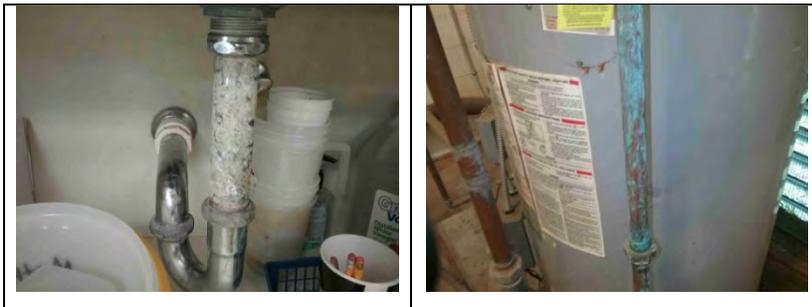
System	Subsystem	Condition and Deficiency Overview	System Condition Rating
	Domestic Water Distribution	<p>Domestic hot water to the kitchen is provided by a 70-gallon water heater stored in the main mechanical room (MAINMECH). A smaller point of use water heater is in STO1. The floor plan noted a water heater would feed the shower in the gymnasium office, but no water heater was detected. Domestic hot water is not supplied to the classroom plumbing fixtures.</p> <p>The water heater feeding the kitchen was aged and was reaching its end of typical design service life. The unit was observed to have signs of corrosion and rust. The point of use unit in STO1 was newer and in good condition. Corrosion and rust observed on distribution piping throughout the building. The plumbing distribution to equipment was observed to be in average condition with typical wear and tear associated with the system's age and general daily use.</p>	Average

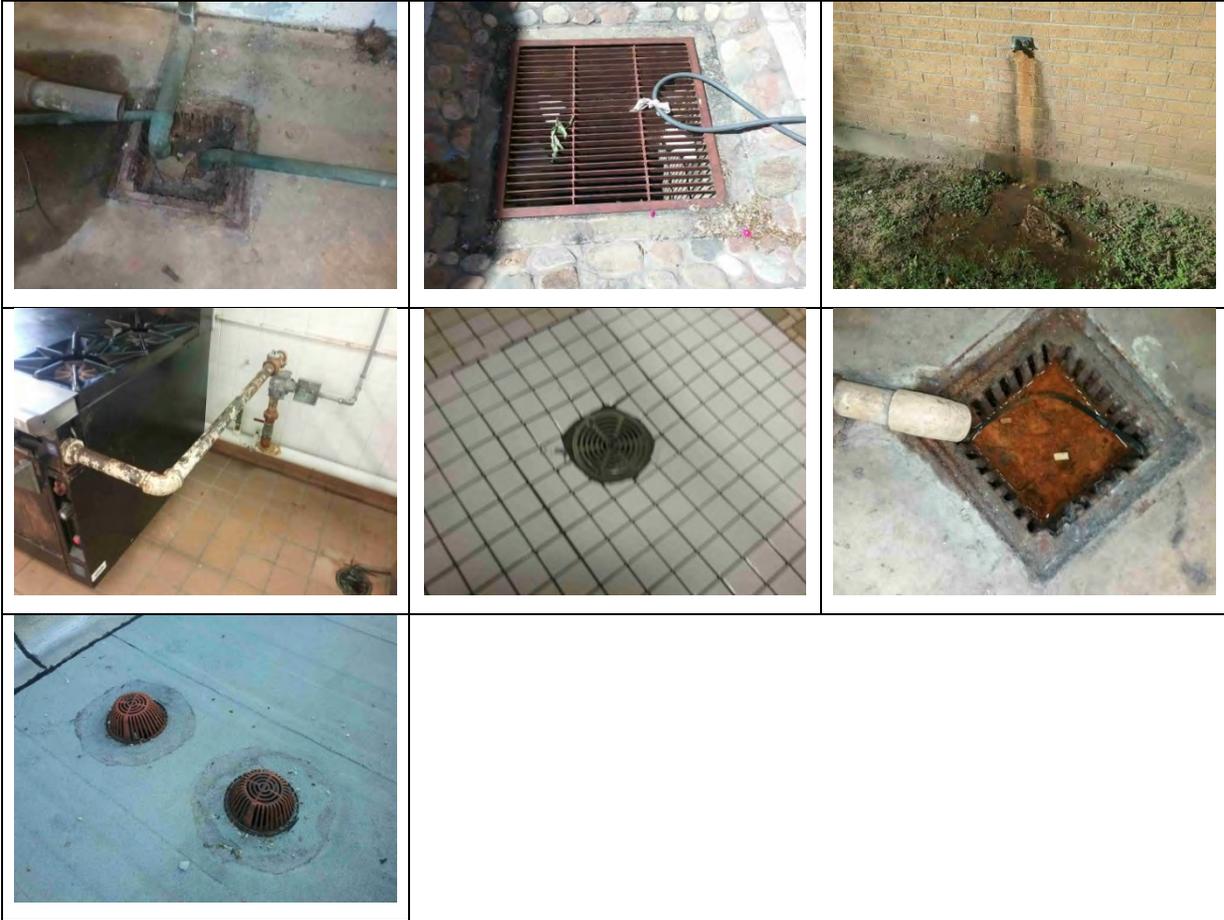
Other Plumbing	<p>There are roof, storm, and floor drains present in the facility.</p> <p>Rooftop drains were observed to be rusted. There was an exterior water spigot that was observed to be dripping. The storm drain found in the courtyard was heavily rusted. Gas lines in the kitchen were observed to be rusted. One of the floor drains in the kitchen was observed to be broken and rusted. Floor drains in the MAINMECH and AHU rooms were observed to be rusted and corroded. The male faculty restroom was observed to be emitting an odor. The restroom off of classroom 217 was observed to be emitting an odor.</p>	Average
Mechanical/ HVAC		<p>The building's HVAC (heating, ventilating, and air conditioning) system is composed of WSHPs (water source heat pump units), a boiler, two chillers, AHUs (air handling units), and roof top condenser air conditioner units. A separate WSHP unit was designated for classrooms 1-12. Pumps for these units were not accessible, but assumed to be stored within the unit and working properly. Multiple roof top EFs (exhaust fans), ranging in size, serve the building.</p> <p>The HVAC system was in average condition; however, some pieces of equipment were past their expected design life and show signs of degradation and minimal signs of rust and corrosion. There was aged ductwork observed in the GYMSTO.</p> <p>The boiler was aged and had signs of corrosion. It was in average condition but was observed to have a drain pipe that had been disconnected. The chillers and associated pumps were observed to have leakage around the equipment. Chillers were newer but had signs of corrosion and rust on the connections. CH-2R was observed to be missing insulation from the connections. Roof top cooling unit CU-5R was observed to have condensate drip off the back of the unit. The condenser air conditioner unit in the courtyard was observed to have vegetation overgrown</p>	Average
