Sims Elementary School Site Summary

Address	1203 Springdale Road Austin, TX 78721
Number of Permanent Campus Facilities	6
Original Year of Construction	1956
Total Campus Building Area (combined)	44,337 SF

Classroom and Gymnasium Building – BLDG-139A

Classroom and Library Building – BLDG-139B

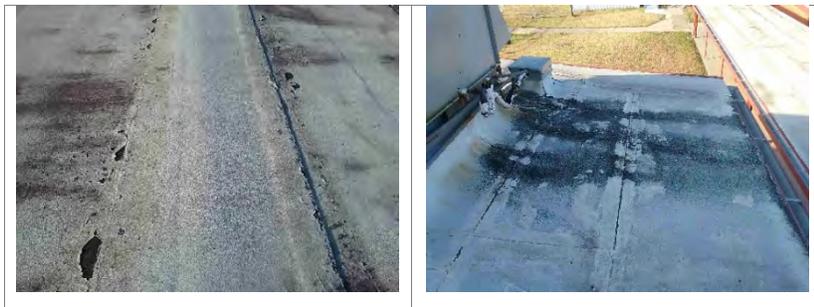
Roofing Deficiency Examples

System	Subsystem	Condition and Deficiency Overview	System Condition Rating
		hardware appeared to be operational. The staff reported that the fiberglass panels surrounding the entrance doors are scratched and that visibility through these panels is desired.	
Roofing		<p>There are three roof surfaces on this building. The largest roof surface of approximately 12,300 SF (square feet) covers the classroom wing. The next largest surface of approximately 1,940 SF covers the gymnasium. A third, smaller roof area of approximately 220 SF covers the gymnasium office on the north side of the gymnasium.</p> <p>A modified bitumen roof system is installed on all three surfaces. Painted metal gutters and downspouts discharge to concrete splash blocks.</p> <p>The three roof surfaces appeared to be of a similar age and appeared to have approximately ten years of life remaining. An area of membrane degradation is located at the center ridge of the gymnasium roof. There is also some ballast aging adjacent to the roof-mounted AHU (air handling unit) caused by condensation dripping from the uninsulated refrigerant line. Sheet metal, including gutters and downspouts, appeared to be in good condition.</p>	Average

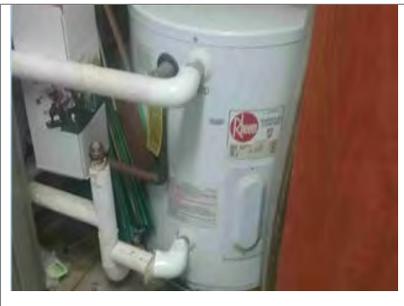
Domestic Water Distribution

System	Subsystem	Condition and Deficiency Overview	System Condition Rating
		<p>classroom plumbing fixtures.</p> <p>The domestic water system was in average condition with typical wear and tear associated with the system's age and general daily use.</p>	
	Other Plumbing	Exterior downspouts appeared to have minor debris that could cause blockage; these should be cleaned periodically to ensure proper drainage when needed.	Average
Mechanical/ HVAC		<p>The building's HVAC (heating, ventilating, and air conditioning) system is primarily composed of geothermal heat pumps for both heating and cooling the classrooms and a single split system feeding one of the classrooms. The gymnasium contains RTUs (roof top package units), and a packaged in-wall system in the gymnasium office for individual zone temperature control. Room 203 appeared to have an updated geo-thermal heating unit with an AC system feeding from outside the building, working in average condition. Individual geothermal heat pump systems used for each remaining classroom were reported to be 25 to 30 years old. Water source heat pumps in each classroom were not accessible, assumed to be inside each individual unit and working properly.</p> <p>Multiple units were making screeching or loud vibration noises upon start-up and shutdown.</p> <p>The building's RTUs were aged and out of date, showing signs of corrosion and rust. One of the units (RTU-4) had insulation falling off the refrigerant lines and had a condensation drip onto the roof. Many roof top vents showed signs of age and deterioration. Additionally, the electric room at the front of the building's MDFA (main distribution frame A) was inaccessible. The following were reported to be housed inside the closet: exhaust fan EF-SC014228 and PU-SC014229 (possibly the fire pump, but unable to verify as the area was not accessible).</p> <p>A boiler is stored in the MECH room off the gymnasium (MECHGYM). It appeared to have the inlet and outlet lines cut and was no longer in operation. Additionally, two heating units reside in the corridor of the gymnasium entrance, one on either side, that appear to be original to the building and were no longer in operation. Each single-use restroom inside the classroom contains an exhaust fan. Additionally, the gymnasium had its own set of exhaust fans. All were reported and observed to still be in working condition, but were out of date and should be replaced. The HVAC system was in average condition; however, some pieces of equipment were past their expected design life and showed signs of deterioration.</p> <p>Sr. Architect Florence Rice reported that the abandoned fan coil units in the 200-wing classrooms were removed during Summer 2016.</p>	Average

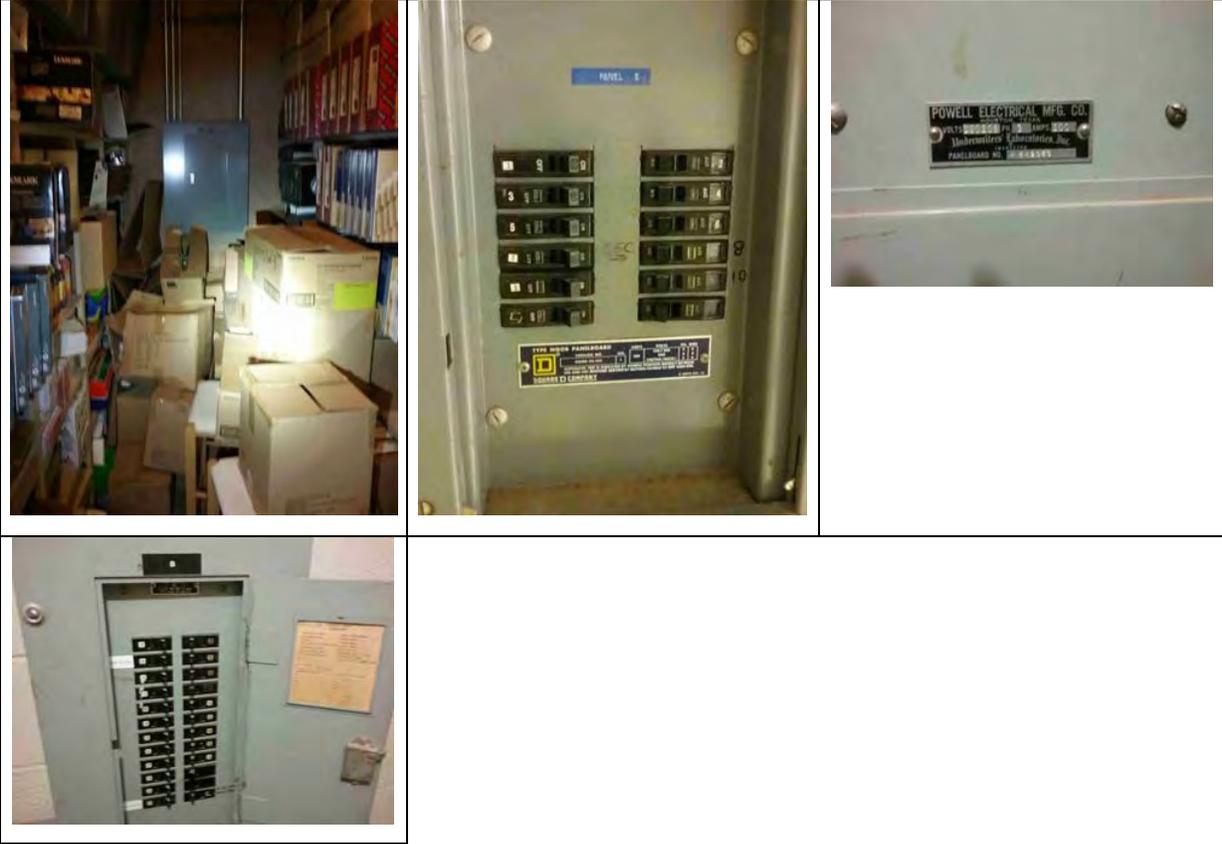
System	Subsystem	Condition and Deficiency Overview	System Condition Rating
		to the fire system. Electrical equipment could not be assessed. No major deficiencies were observed during the assessment.	
	Fire Protection/Suppression	No sprinkler systems were detected in the building. Visual assessment of the fire extinguishers determined they were in average condition.	Average
Electrical	Electrical Distribution	<p>The main distribution panels (greater than 200-amp) were in average to good condition and had been replaced in the past ten to 20 years. The building has several smaller 100-amp panels that were near or at their end of life. Panel E located in the main classroom corridor on the gymnasium side appears to be from the late 1970s / early 1980s and should be considered for replacement due to age. Panel B, located in the 'ELECGYM' room, appears to be from the early 1970s and should be replaced due to its overall age. Panel TP1B, located in 'STO200', was in good condition but its access was blocked by cardboard boxes.</p> <p>One common deficiency was the lack of access to panels located in the 'ELECGYM' and 'STO200' rooms. These rooms appeared to serve as storage and required moving several items to access the panels.</p>	Average

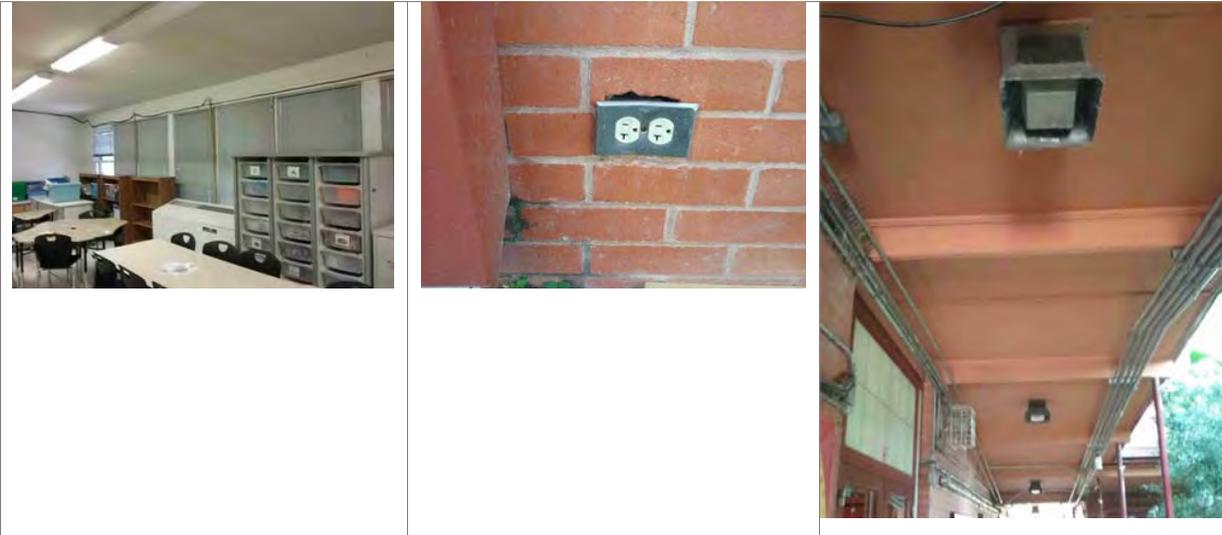
Lighting	<p>Interior lighting is predominantly ceiling-mounted fluorescent fixtures. Some bulbs were burned out and need replacement. Interior lighting was in average to good condition.</p> <p>Exterior lighting is halide fixtures that are installed on the covered walkways adjoining the facility buildings. These fixtures varied in age and were in average to poor condition.</p> <p>The exterior of the gymnasium has a branch wiring deficiency due to an interior electrical outlet installed on the brick wall. This outlet also has an exposed gap into the wall. This outlet should be replaced with a new weatherproof, exterior-grade outlet, and the gap sealed.</p>	Average
	Communications & Security	<p>The building has a variety of previous communication systems throughout the classrooms, e.g. coaxial (CATV), telephone, and modern networking. The school also features VOIP (voice over internet protocol) phones through networking. Sr. Architect Florence Rice reported that the abandoned CATV and telephone receptacles were removed during Summer 2016.</p> <p>The building has five interior security cameras, located in the main classroom corridor, the gymnasium corridor,</p>	Average

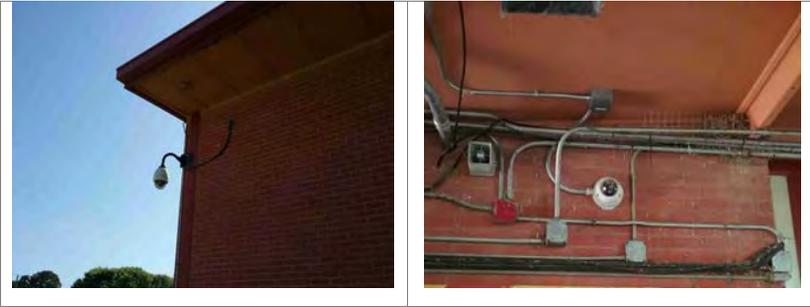
Communications & Security

System	Subsystem	Condition and Deficiency Overview	System Condition Rating
		<p>and inside the gymnasium. Four cameras are located near each entrance (two for main corridor and two for gymnasium corridor) and one inside the gymnasium.</p> <p>There was one motion detector at the front entrance to the building on the courtyard side. There were two exterior cameras, one facing the courtyard and one on the rear corner of the gymnasium. The exterior security had inadequate coverage as reported by facility staff.</p> <p>Clocks throughout the building are battery powered.</p> <p>Staff reported that clocks do not keep accurate and consistent time.</p>

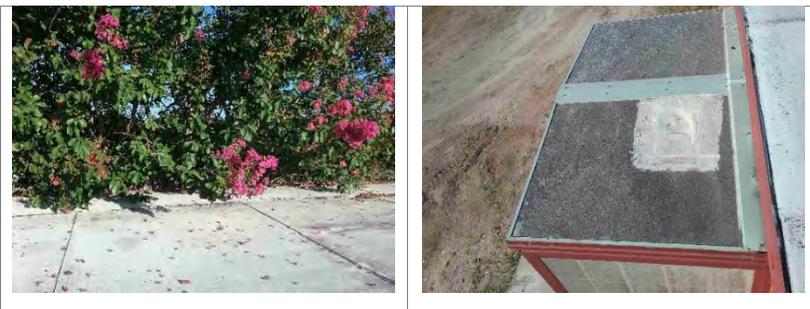
Roofing Deficiency Examples

System	Subsystem	Condition and Deficiency Overview	System Condition Rating
	Exterior Windows	<p>All but the library windows are single-hung, single-glazed and are made of aluminum. The library windows are fixed, single-glazed and are also made of aluminum. All windows are retrofit on the interior with newer single-hung, single-glazed windows.</p> <p>The retrofit interior units appeared to provide insulation properties to the exterior windows that they are fitted against. All assemblies appeared to be in good condition.</p>	Good
	Exterior Doors	<p>Exterior doors are painted, hollow metal doors set in painted, hollow metal frames. All of the doors except one have single-glazed view panels.</p> <p>All doors and door hardware has chipped paint and signs of wear, but appears to be operational.</p>	Average
Roofing	<p>There are three roof surfaces on this building. The largest roof surface of approximately 18,190 SF covers the classroom wing. This is a modified bitumen roof system. The next largest surface of approximately 1,500 SF covers the library. The library roof is a built-up roof system. A third, smaller roof area of approximately 24 SF covers the east entry doors.</p> <p>Roofs consist of two, flat fiberglass panels trimmed with painted aluminum angles at the edges and a ridge cap covering the panels down the middle. The largest classroom wing roof drains to painted metal gutters and downspouts that discharge to concrete splash blocks. The other two roofs do not have drains or gutters but instead are sloped for sheet flow over the perimeter edges. The staff reported that at least one of the roofs on this building has been replaced within the last ten years.</p> <p>The large, modified bitumen roof over the classroom wing appeared to be in good condition with approximately ten years of life remaining. Gutters, downspouts, and splash blocks appeared to be in good condition. There were several trees, however, that were in contact with the south edge of the roof. The built-up roof above the library addition also appeared to be in good condition with approximately 12 years of life remaining. The small, east entry roof appeared to have been patched and aged. The staff reported roof leaks at this entry.</p>		Average

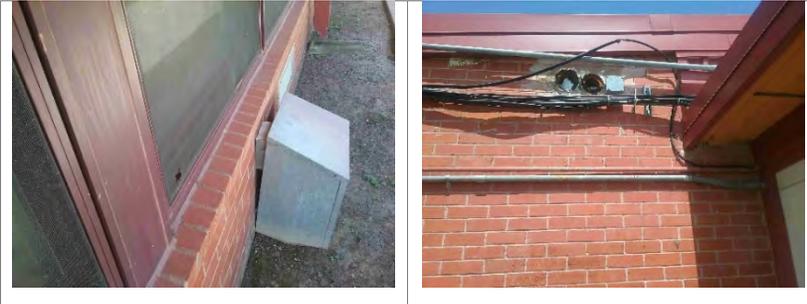
System	Subsystem	Condition and Deficiency Overview	System Condition Rating
Exterior	Exterior Walls	<p>The exterior of the building consists of the original, single-story brick façade. Double-walled, translucent fiberglass panels surround the entrance doors. The brick terminates above at a 24-inch to 36-inch-wide painted panel soffit.</p> <p>There were six sheet metal housing boxes located at the base of the wall that serve to cover ground-level utility lines penetrating the base of the exterior wall. These housings have become detached from the face of the wall, and the penetrations may not be properly sealed. Elsewhere, there were abandoned wall penetrations that were not properly sealed. It was recently reported that rodents are prevalent, and these penetrations could serve as the source of entry.</p>	Good
	Exterior Windows	<p>The exterior windows are single-hung, single-glazed and are made of aluminum. All windows have been retrofit on their interior sides with newer single-hung, single-glazed windows.</p> <p>The retrofit windows appeared to have been installed to provide insulation properties. All assemblies appeared to be in good condition.</p>	Good

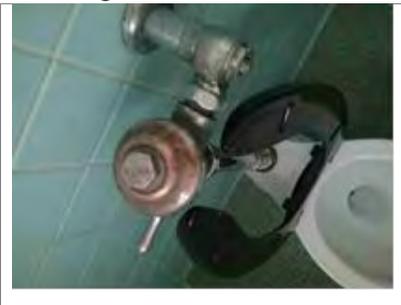
System	Subsystem	Condition and Deficiency Overview	System Condition Rating
		determined. The area of roof adjacent to this damage did not appear to have been compromised.	
Conveying	System not present.		N/A
Plumbing	Plumbing Fixtures	<p>The building contains in-classroom, single-use restrooms. Typical restrooms have floor-mounted vitreous china water closets with manual flush valves. Typical classrooms contain a single-basin stainless steel sink with a drinking fountain attached. Stainless steel drinking fountains can be found in the corridor.</p> <p>The majority of plumbing fixtures were in working condition, but showed minor signs of deterioration. Some plumbing fixtures showed signs of corrosion; this should be addressed to avoid further deterioration.</p>	Average
	Domestic Water Distribution	Domestic hot water is not supplied to the classroom plumbing fixtures. Supply water fixtures appeared to be in average condition.	Average

1. Replace aged plumbing fixtures to maintain a functioning system.
2. Repair or replace drinking fountains delivering no or low flow.
3. Repair minor leaks under sinks.

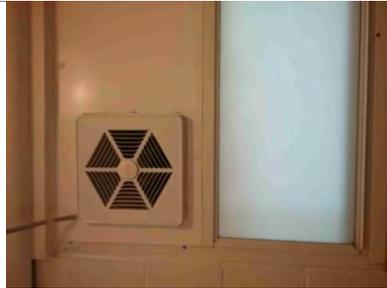
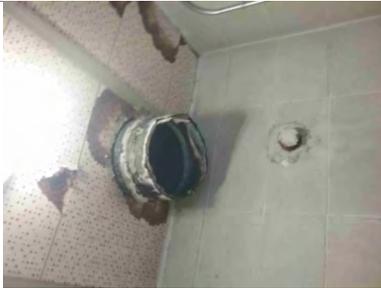
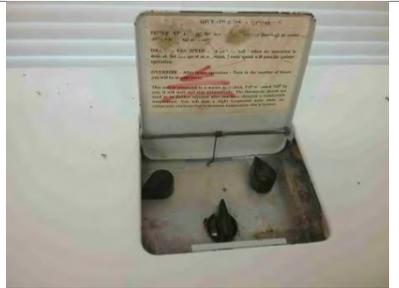
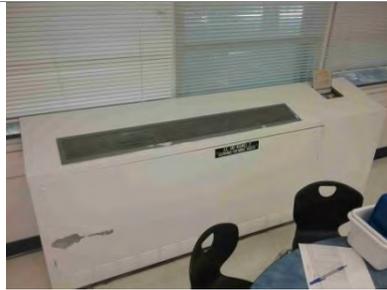
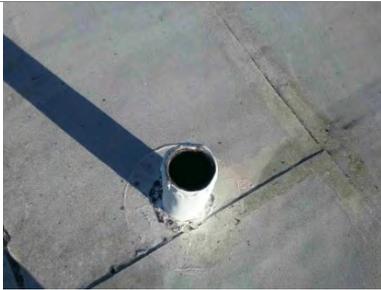
Mechanical/HVAC System Deficiency Examples

Other Plumbing	Multiple restrooms were emitting an unpleasant odor. The plumbing should be more thoroughly inspected and flushed, cleaned or repaired as necessary.	Average
Mechanical/ HVAC	<p>The building's HVAC system is composed of geothermal heat pumps feeding the classrooms. The individual geothermal heat pump system used for each classroom is reported to be 25 to 30 years old. There is concern about the useable life remaining for these systems. Water source heat pumps in each classroom were not accessible, assumed to be inside each individual unit and working properly. Controls on the unit were slightly different than those observed in BLDG-139A, but the units were thought to be similar in age and condition. Multiple units made screeching or loud vibration noises upon start-up and shutdown. They should receive regular maintenance until they are able to be replaced to maintain functionality. If significant repair is needed to an individual system, it should be replaced with a more modern system.</p> <p>Evidence of water damage was noted around a ceiling duct in the storage room (OSSTO). It is not clear whether this duct is still part of the current HVAC system. If it is still functional, repairs should be made to prevent further damage. If it is not operational, it should be removed, and the surrounding ceiling should be repaired.</p> <p>Each single-use restroom inside the classroom contains an exhaust fan. The exhaust fan in the restroom off room 104 was working but made a screeching noise when on. The fan should be repaired to maintain functionality of the system. Exhaust fans were reported and observed to still be in working condition, but were out of date and should be replaced. Roof vents showed signs of degradation due to age. The HVAC system was in average condition; however, some pieces of equipment were past their expected design life and showed signs of degradation.</p> <p>Sr. Architect Florence Rice reported that the abandoned fan coil units in the 100-wing classrooms were removed during Summer 2016.</p>		Average

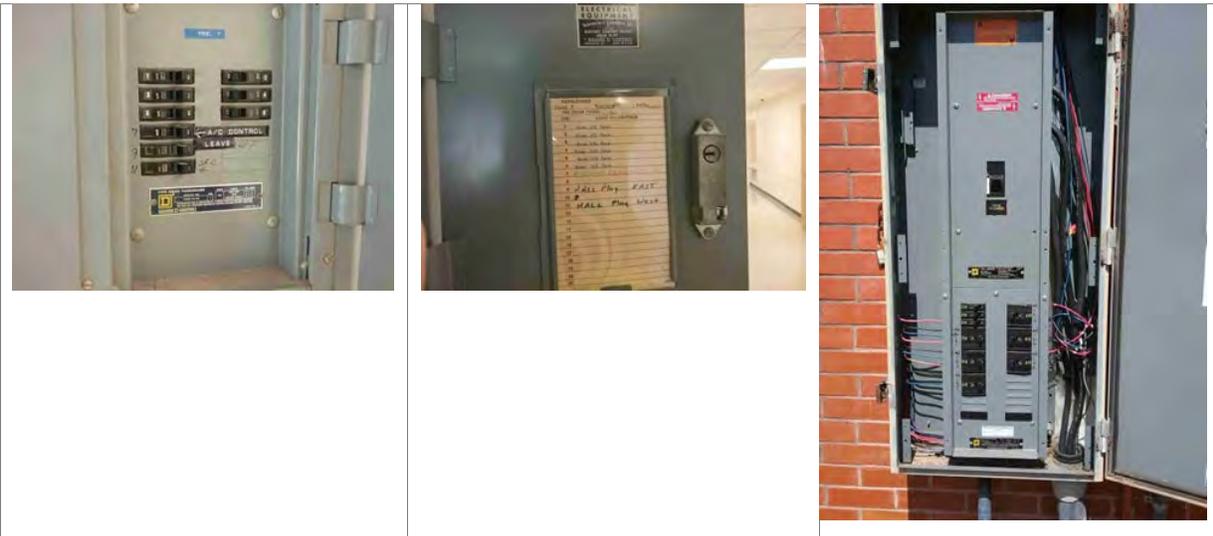
System	Subsystem	Condition and Deficiency Overview	System Condition Rating
Fire Protection	Fire Alarm	The building has fire detection and indication (strobes and annunciators) in all classrooms and the corridor. Pull stations are located at the building exits. No deficiencies were found during the assessment.	Good
	Fire Protection/Suppression	No sprinkler systems were detected in building E. Visual assessment of the fire extinguishers determined they were in good condition	Average
Electrical	Electrical Distribution	The electrical distribution was in average condition. Two panels are recommended for replacement due to age or deficiencies. Panel F, located in the main corridor, was estimated to be 35 years old, and should be replaced due to its age. There is an exterior panel that feeds each classroom's AC system that was missing the front cover to hide wiring terminations and is approximately 30 years old. Although replacement is recommended, installation of the correct front cover would make this panel acceptable.	Average

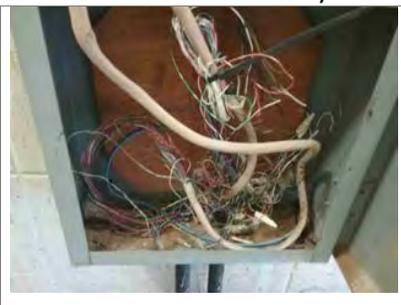
Lighting	Interior lighting is typically fluorescent fixtures throughout the building. Exterior lighting is limited to the covered walkway areas. The front entrance to the building has an interior exit light that is hanging by the wiring and was found to be deficient.	Average
	Communications & Security	The building has modern network distribution throughout the building and appears to utilize VOIP for phone service. The building also has existing phone service lines which could not be assessed for functionality. The exterior room space 'OSSTO' has a junction box for the phone cabling, which was found to be in poor condition. Sr. Architect Florence Rice reported that the abandoned CATV and telephone receptacles were removed during Summer 2016. Security for the building was in poor condition. There are two interior security cameras at the end of the corridor near the two entrance/exits. Interior classrooms appear to have motion detectors installed. No exterior security cameras were observed during the assessment. Exterior cameras should be installed for additional security coverage. Clocks throughout the building are battery powered.	Average
