## Sunset Valley Elementary School Site Summary

<b>Address</b>	3000 Jones Road Austin, TX 78745
<b>Number of Permanent Campus Facilities</b>	2
<b>Original Year of Construction</b>	1971, 1996
<b>Total Campus Building Area (combined)</b>	64,766 SF

## Main School Building – BLDG-158A

## CRAWL SPACE – Sunset Valley ES – Main School Building (BLDG-158A)

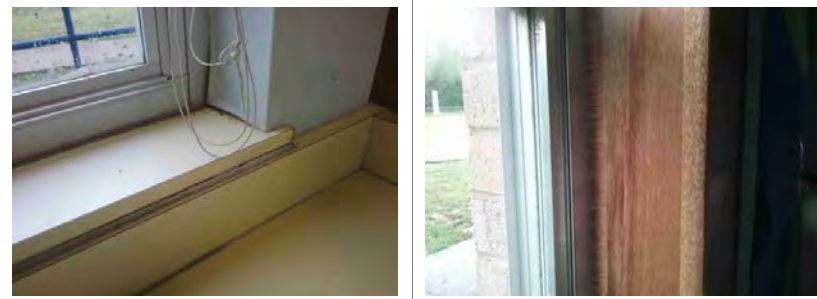
### Exterior Windows

Exterior Windows	<p>The window systems are an older aluminum single-hung single-type unit. Some of these are above brick, and in other locations, the system extends to the floor and contains a solid panel at the bottom.</p> <p>Given the lack of thermal performance of this type of</p>	Average

System	Subsystem	Condition and Deficiency Overview	System Condition Rating
		unit, degradation of the finishes around the windows was observed. In the 300-wing, the vinyl wall covering was delaminating. In the 200- and 100-wings, the veneer on the wood paneling was delaminating. In the 300-wing, the laminate sills and backsplash showed signs of movement, which may have been due to moisture absorption by the wood substrate. Given the age of the structure, window sealants have aged to the point that they will fail in the near term. Also noted were a number of window panes replaced with acrylic panels. In some cases, these were scratched or aging and turning opaque. These should be surveyed and replaced.	
	Exterior Doors	<p>The exterior doors are older hollow metal doors mounted in hollow metal frames.</p> <p>These elements were observed to be in average condition. It was reported that the thresholds and hardware needed to be replaced. None of this hardware was ADA (Americans with Disabilities Act) compliant, panic hardware tended to be the bar type rather than a crash bar, and none of the thresholds were a saddle type that would direct water out of the building.</p> <p>With the exception of some classroom doors, the exterior doors were under a canopy or overhang. As such, only those without protection appeared to need replacement thresholds. A significant number of doors and sidelights were noted to have acrylic installed, as was the case with the exterior exit at the 300-wing. In addition to the door at AHU-1 having rust, it was noted that there was rust at the exterior door frame for ART.</p>	Average

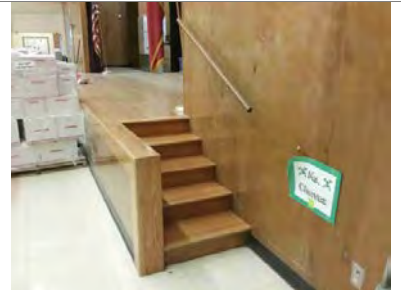
#### Interior Stairs

System	Subsystem	Condition and Deficiency Overview	System Condition Rating
	Interior Stairs	Interior stairs only appear at the stage. Consistent with the age of the facility, these were not code compliant with regard to handrails.	Good
Interior Finishes	Interior Wall Finishes	The facility has a variety of finishes that are designed to be durable but are beginning to show their age in some cases. The facility includes exposed brick, vinyl-wrapped panels that have been painted, wood paneling, and ceramic tile.  In the 300-wing and adjacent spaces, the painted vinyl wall covering exhibited adhesion issues at joints. In other locations, these issues appeared to be greater. Some of the vinyl had been painted to the point that the paint system appeared to be failing, and the original wall covering was visible as in corridor C6.  In contrast, the wood wall paneling appeared to have fared better over time. The 100-wing and 200-wing are primarily wood paneling in the classrooms. In these areas, the walls next to sinks showed signs of needing a waterproof material to prevent further damage. In the 300-wing, the drywall bulkhead above accordion doors exhibited damage to the finish at the metal corner bead. This was primarily caused by the flexure of the wall system when the accordion door was operated. As a result, the drywall mud on the corner bead cracked and fell out. In LITLIB of the 300-wing, the vinyl wall covering had a residue on the wall that should be sampled and the cause of its presence diagnosed.	Average

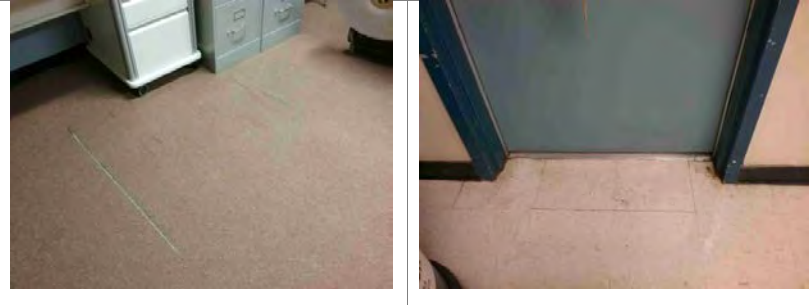
#### Interior Floor Finishes

Interior Floor Finishes	Due to construction, much of the flooring was covered with protection and therefore not reviewed. The majority of the floor finish surface is VCT (vinyl composite tile). The stage is wood, the gymnasium is covered in a sheet vinyl system, and the kitchen has quarry tile, while restrooms have ceramic tile. Carpet was noted in the administration area, the library, and a few other locations.  From what could be seen, the floor appeared to be in good condition. It was not new but has been well maintained and was free of pitting and other damage. In LITOFB, the carpet is in poor condition and damaged. At one exterior door, the VCT was buckling.	Good
	Interior Ceiling Finishes	The facility has an older 2'x4' suspended ceiling system with drywall accents in the 300-wing. In the 100- and 200-wings, the ceilings have exposed structure with Tectum-type panels. This is similar to the corridors and	Average

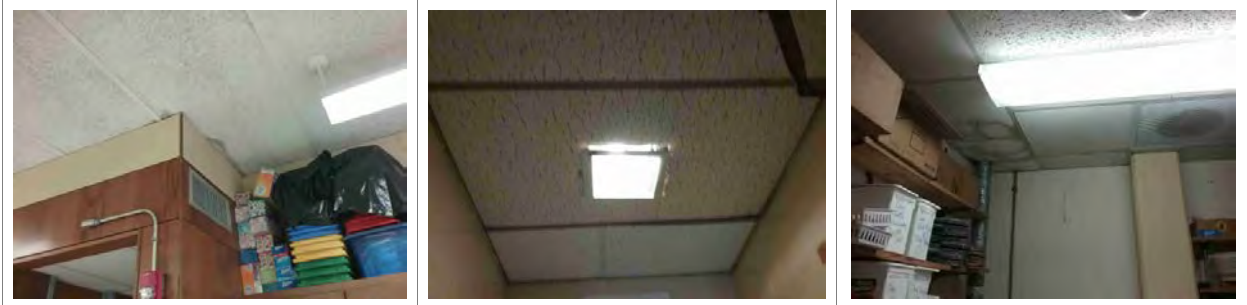
#### Interior Ceiling Finishes

System	Subsystem	Condition and Deficiency Overview	System Condition Rating
		<p>high-bay spaces.</p> <p>A portion of the drop ceiling tiles had been replaced with a different tile type. This was not extensive but was such that it would suggest past water damage. This appeared clearest in the art room. Damage to a ceiling finish system is typically from water infiltration.</p> <p>Other issues that were consistently observed were damage to ceiling tiles in single restrooms as a result of unsupported light fixtures in the suspended system relying on the tile to support them. As a result, the tiles were cracked from the weight. In addition to this, the grid in several of the male restrooms was rusted.</p>	
<b>Conveying</b>	System not present.		N/A
<b>Plumbing</b>	Plumbing Fixtures	<p>The building has public restrooms for men, women, and students, and separate staff restrooms located throughout the facility. These restrooms typically have vitreous china hand sinks in counters with manual faucets, along with vitreous china, floor-mount/wall toilets with manual flushing mechanisms, and vitreous china, wall-hung urinals in the male restrooms with manual flushing mechanisms. There are service sinks in the janitorial closets, and water coolers located throughout the facility, typically near the public restrooms.</p> <p>The restroom plumbing fixtures were observed to be in average condition as the fixtures were typically aged but still operational.</p>	Good

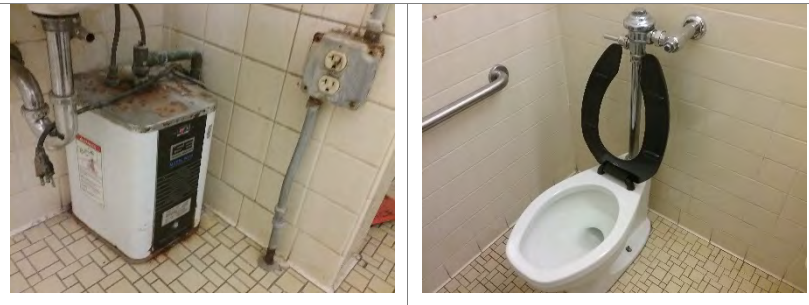
##### Domestic Water Distribution

Domestic Water Distribution	<p>All of the plumbing fixtures are serviced with domestic cold water. There is a gas water heater adjacent to the kitchen in the main mechanical room.</p> <p>The water heaters near the kitchen spaces were in new condition with no identified or reported deficiencies.</p> <p>There is an additional EWH (electric water heater) in the stand-alone classroom building that serves janitorial closets, which were observed to be in good condition.</p> <p>The plumbing distribution equipment appeared to be in good condition.</p> <p>There is an electric water heater in the admin that is not serviceable.</p>	Good
	Other Plumbing	The roof drain is a scupper system. An internal drainage system is not present.	N/A

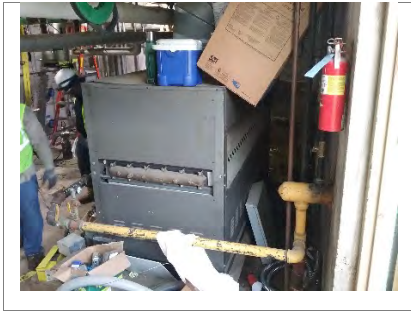
### Mechanical/HVAC System Deficiency Examples

System	Subsystem	Condition and Deficiency Overview	System Condition Rating
<b>Mechanical/ HVAC</b>		<p>The major mechanical equipment consists of indoor chilled/hot water multi-zone AHUs (air handling units), an air-cooled chiller, and gas-fired boilers. There are three DX (direct expansion) HRUs (heat recovery units) that are located on the roof and provide outside air to the building.</p> <p>All AHUs were located in mechanical closets. All AHUs were being replaced as new and had not been started up at the time of assessment.</p> <p>The HRUs were original and have exceeded their useful life expectancy.</p> <p>The air-cooled chiller was new and had not been started up at the time of assessment. The chilled water pumps were replaced at the same time.</p> <p>The existing boiler was still in place and had passed its service date. It was understood that this boiler was to be replaced as new along with the heating water pumps.</p> <p>Since the majority of the mechanical equipment had been replaced as new, except the HRUs, the system appeared to be in good condition. <a href="#">PM Andrew Miller reported that testing and balance is scheduled to occur for the new HVAC equipment that was replaced in Summer 2016.</a></p>	Good

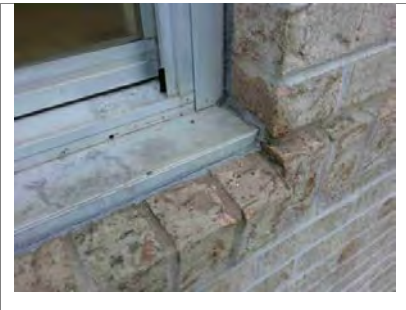
System	Subsystem	Condition and Deficiency Overview	System Condition Rating
Exterior	Exterior Walls	This building has brick exterior walls with windows inset over brick sills.  On the east side of the building, there a was vertical crack observed in the masonry through the brick.	Average
	Exterior Windows	The exterior window system is comprised of aluminum frames with single-pane glazing similar to the main building.  As a result of moisture, likely the result of condensation, the sills of the exterior windows showed water damage. The sealant around the windows was in a state of failure and needed to be replaced. Acrylic was present in a number of the operable sashes of the windows and should be replaced.	Average
	Exterior Doors	Exterior doors are hollow metal door panels with windows set in hollow metal frames.  One pair of doors appeared to have sagged and was repaired with a pivot hinge at the top of the doors. These types of hinges are not durable, and the doors will continue to sag inward.	Average

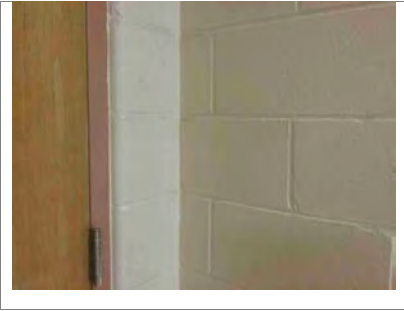
### Interior Walls

System	Subsystem	Condition and Deficiency Overview	System Condition Rating
<b>Interior Construction</b>	Interior Walls	CMU and drywall partitions appeared to be performing consistent with their design.  Accordion doors exist between classroom pairs. This was not noted on the floorplans. In one location in the corridor, a crack in the CMU wall was observed.	Average
	Interior Doors	Interior doors consist of solid core wood veneer with hollow metal frames.  These doors generally had minor surface damage and were observed to be in average condition due to the volume of damage.	Average
	Interior Specialties	System not present.	N/A
<b>Stairs</b>	Exterior Stairs	System not present.	N/A
	Interior Stairs	System not present.	N/A
<b>Interior Finishes</b>	Interior Wall Finishes	Interior wall finishes are primarily paint on drywall or CMU.  The surfaces of the 400-wing appeared to have taken more abuse than the other wings of the facility. In the corridors, the paint on the CMU has a substance that should be sampled and the cause of its presence addressed. This is apparent at rooms 402 and 404.	Average
