Travis Heights Elementary School Site Summary

Main School Building – BLDG-140A

Building Purpose	Administrative, Classrooms
Inspection Date	August 26, 2016, (Afternoon)
Inspection Conditions	92° - Sunny & Dry

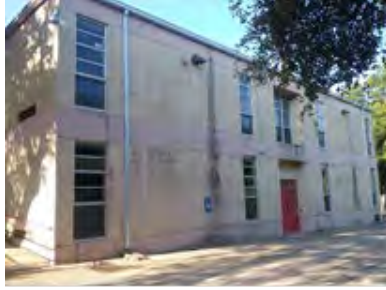
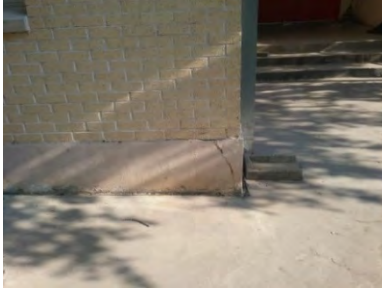
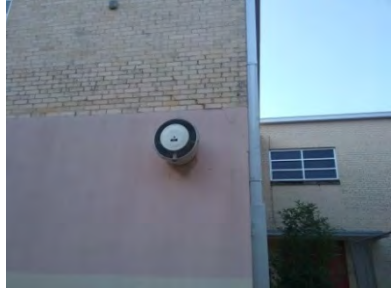
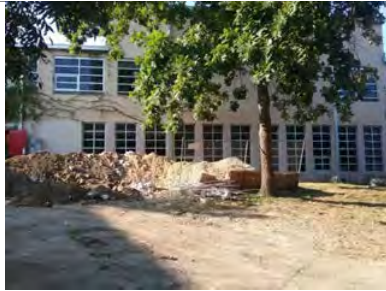
System	Subsystem	Condition and Deficiency Overview	System Condition Rating
Exterior	Exterior Walls	<p>The exterior of the building consists of a brick façade with a concrete structure.</p> <p>The exterior walls were observed to be in good condition, with isolated areas in need of cleaning due to organic growth. It was observed that rodents may enter the building by following HVAC (heating, ventilating, and air conditioning) penetrations at condenser units. Foundation cracks were observed near the corners of the Main School Building mostly in the rear elevations. Some minor mortar cracks appear around the brick directly above these cracks. Expansion joint sealant was deteriorated or missing in several places but generally in good condition. Due to active construction of a new addition, the entire façade was not observed.</p>	Good
	Exterior Windows	<p>The exterior windows consist of single-pane glazing units with clear anodized aluminum storefront frames. All windows have been replaced throughout the building except in the stairway of the 300-wing, the south side of 100-wing and the south side of the kitchen. It was reported that the window adjacent to the library office was leaking; however, no evidence of this was observed. Some lower basement windows have expanded metal covering the glass to minimize unauthorized access.</p>	Good

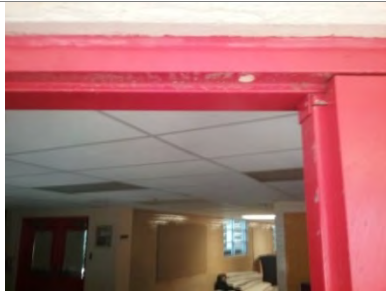
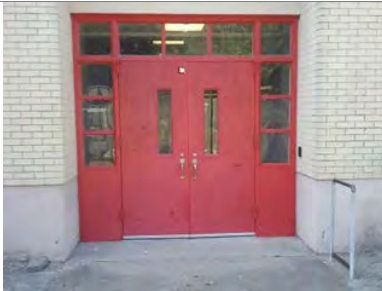
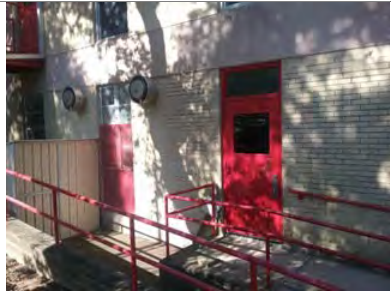
System	Subsystem	Condition and Deficiency Overview	System Condition Rating
	Exterior Doors	<p>There is one main public entryway located at the northeast side of the building. All exterior doors are hollow metal with mostly original hollow metal frames.</p> <p>The exterior doors were observed to be in good condition with minor paint finish issues fading primarily those facing the sun. All of the doors observed lacked the proper weather stripping or silencers which caused air infiltration between the frame and door. This also created noise when the door closed. Many of the exterior light kits in the doors have been replaced with acrylic over the years. These have been severely scratched due to cleaning procedures. The kitchen door did not close properly and the doorframe showed signs of rust.</p>	Good
Roofing		<p>The roof material covering the majority of the building appears to be PVC/TPO (polyvinyl chloride/thermoplastic membrane) and a couple of older areas of modified bitumen. There is a connecting covered walkway with a corrugated metal roof between the Main School Building and the Gymnasium Building.</p> <p>The building has a couple roof systems installed at different times. The majority of roof surfaces were observed to be in average condition. The isolated areas of the modified bitumen roofs where the top sheet was deteriorated to the point that the cover board was exposed, were over the 200- and 300-wings. The east side of the building, over the 200- and 300-wings were observed to be in poor condition. Leaks were reported in the 300-wing and ceiling damage was visible in this area. There was rusting observed on the flashings of these wings. The corrugated metal roof over the walkway appeared to be in good condition.</p>	Average

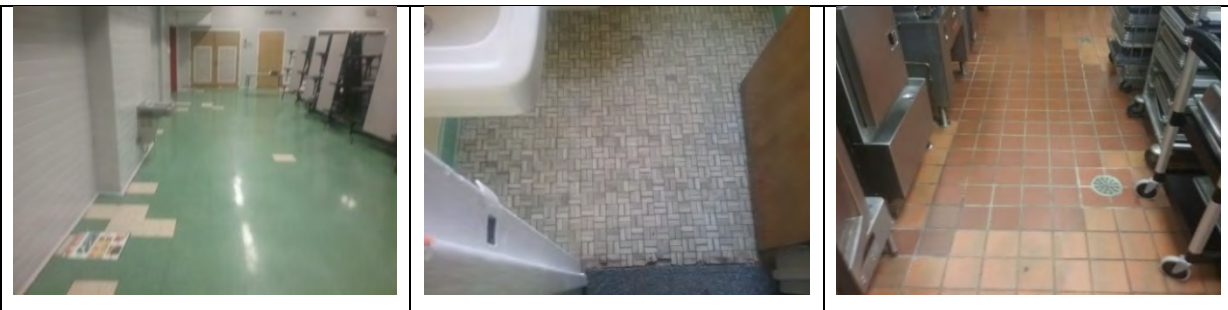
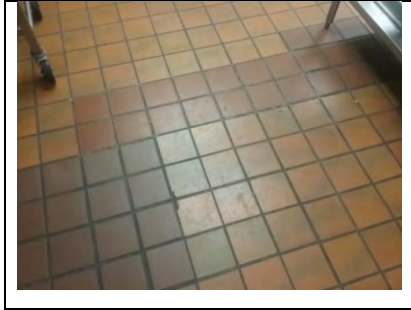
Interior Finishes	Interior Wall Finishes	The building has undergone multiple renovations since its original construction in 1938. Most spaces were updated and appear to be in good condition. Plaster and structural glazed tile walls are in good condition from the original construction. Painted gypsum walls inside the library and administration are also in good condition. The restroom walls appear to be original to the construction of 4"x4" tile, but in average condition. The corridor walls are wainscot of tile or SGT. Building staff reported the persistent odor of urine in the basement restrooms and this condition was observed during the assessment. These surrounding walls were in average condition otherwise.	Good
	Interior Floor Finishes	There is 12"x12" resilient floor tile throughout the building which is not original construction. Original ceramic tile floor is present in the restrooms. The cafeteria and building extension floors have multiple areas patched with various colored tiles. The administration offices and library are finished with carpet that was observed to be in good condition. It appears there have been multiple renovations and patches to the quarry tile flooring in the kitchen. The flooring appeared to be in good condition throughout the building.	Good

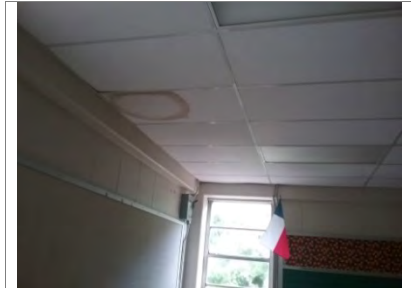
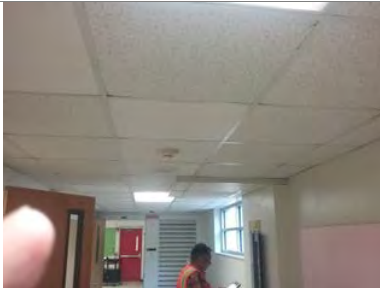
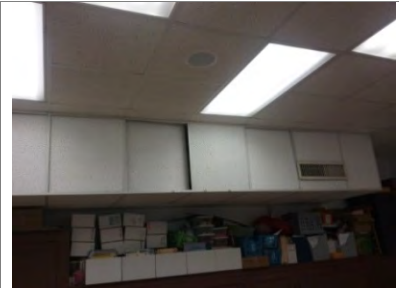
System	Subsystem	Condition and Deficiency Overview	System Condition Rating
	Interior Ceiling Finishes	<p>The building consists of predominately 2x4 acoustical lay-in ceiling tile. Some areas of plaster or a hard ceiling were present in the utility areas. Most of the ceiling tile in the building has been replaced over time. A mix of old and new tiles was observed in many of the spaces. The ceiling in room 11 consisted of exposed beams with acoustical spray insulation.</p> <p>No damaged ceiling tiles were observed in the kitchen though this area has been reporting roof leaks. The corridor adjacent to room 104 has reported damaged ceiling tile but this was not observed at this visit. Reports of leaks in the 300-wing may be confirmed by water damaged tiles in the area. The ceiling system was observed to be in average condition.</p>	Average
Conveying	System not present.		N/A
Plumbing	Plumbing Fixtures	<p>The building has public restrooms for students and separate staff restrooms located throughout the facility. These restrooms generally have vitreous china hand sinks with manual faucets, along with vitreous china toilets with manual flushing mechanisms. There are service sinks found in the janitorial closets, trough-style stainless steel handwashing sinks located in the corridor, and water fountains located throughout the facility, typically near the public restrooms. The restroom plumbing fixtures were observed to be in average condition as the fixtures were aged but still operational with noticeable wear. Building staff reported repeated toilet flushing and backup issues in several restrooms throughout the building. It is unknown if the issues are caused by the sanitary piping lines or by malfunctioning fixtures.</p> <p>The kitchen included additional plumbing fixtures such as stainless steel wash sinks and a small restroom equipped with a vitreous china wall toilet and sink. These plumbing fixtures were observed to be in average condition. There appears to be a sink that was removed from room 35. The cabinet was observed to contain water lines and drain plumbing that was capped off, but no sink was observed.</p>	Average

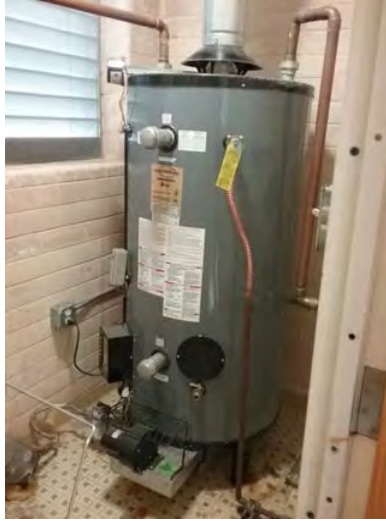
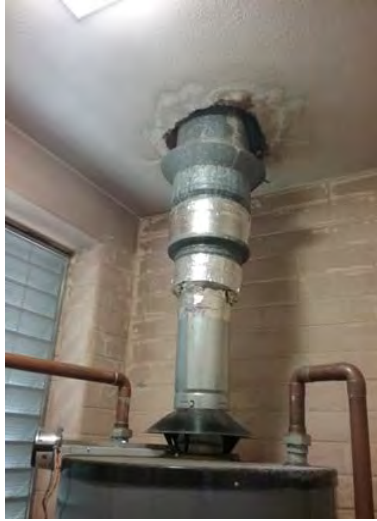
System	Subsystem	Condition and Deficiency Overview	System Condition Rating
	Domestic Water Distribution	<p>The sinks located throughout the facility, with the exception of the kitchen are not equipped with hot water. The sinks located in the kitchen are serviced with hot water from a gas water heater GWH-1 that was located in the kitchen mechanical room. The water heater was observed to be functioning, however nearing the end of its useful life due to age and use. The flue collar appeared to be disassembled and hanging from the flue duct exposing the penetration to the concrete deck above.</p> <p>The plumbing distribution equipment was observed to be in average condition based upon the deficiencies of the water heater mentioned above, and with damaged insulation and corroded piping observed in some areas.</p>	Average
	Other Plumbing	<p>There were no roof drains observed. Floor drains were observed in the interior portion of the building. An area drain appeared to be clogged and had standing water on the northwest side of the building. The condensate lines associated with the RTUs (roof top units) appeared to be aged and damaged. The condensate line associated with RTU-4 was observed to be cut and disassembled. The gas lines associated with the RTUs appeared to be rusting. It was reported that wastewater backed into the kitchen multiple times in the last month. It is suspected that the line from the grease trap is clogged downstream causing the reoccurring problem.</p>	Poor

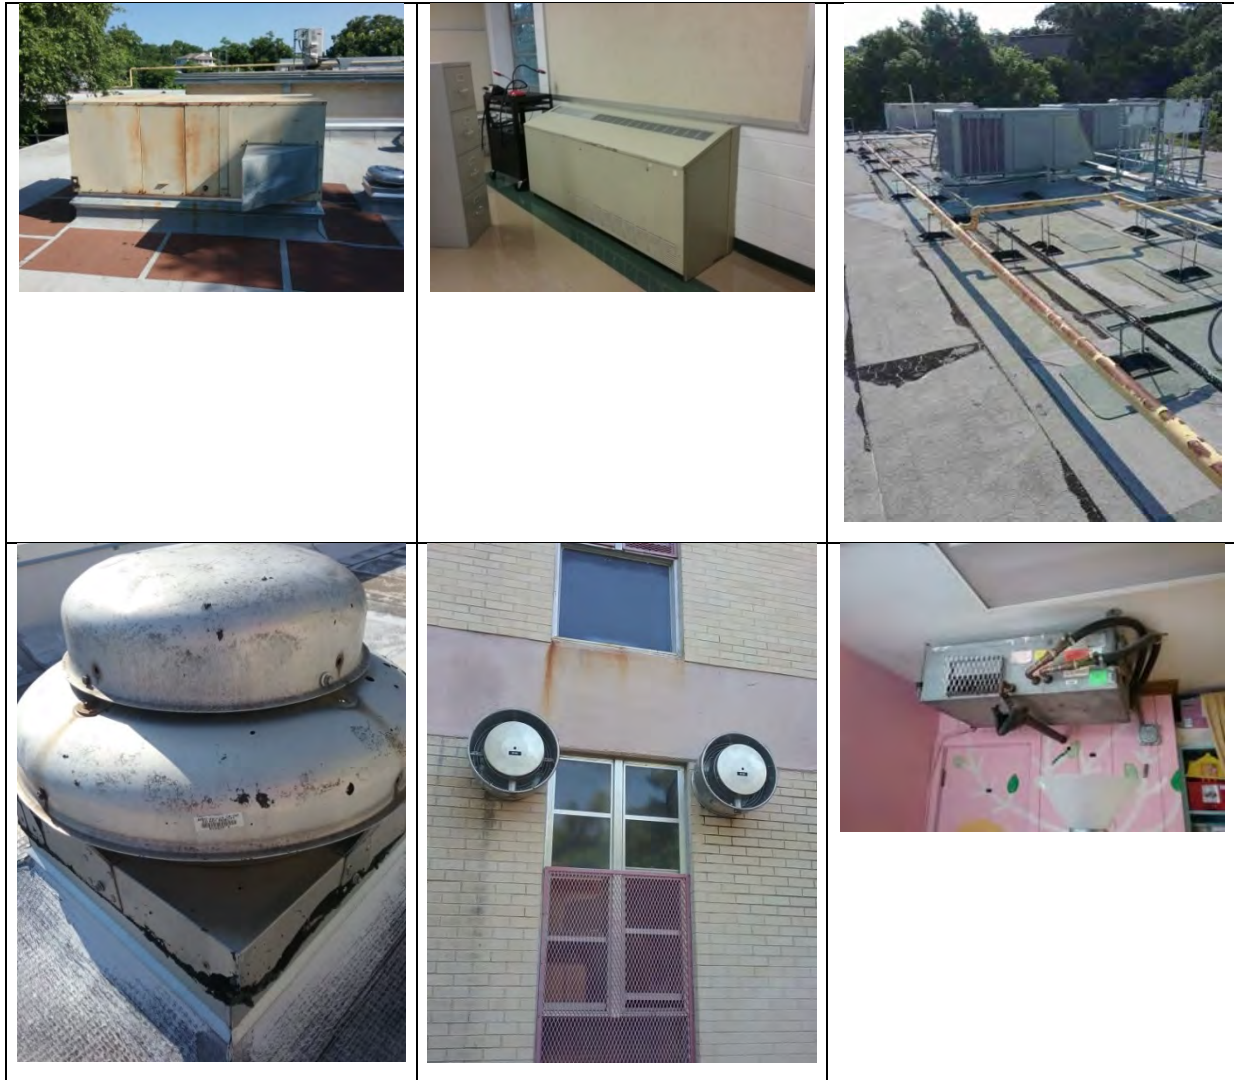
Mechanical/HVAC System Deficiency Examples

Mechanical/ HVAC	<p>The major mechanical equipment consists of package RTUs located on the roof, floor mounted units which appear to be ground source heat pumps, as well as split systems providing cooling in select areas of the building. These serve the HVAC system along with roof-mounted and wall-mounted exhaust fans. It was reported that all new air conditioning units are being installed this summer with the exception of the following units which were estimated to be approximately five years in age:</p> <ul style="list-style-type: none"> • Cafeteria; • Kitchen; • Gymnasium; and • Office. <p>Eight RTUs, ranging in capacity from an estimated 5 to 18 tons, are located on the roof. Twenty-six ground-mounted units that appeared to be ground source heat pumps were located in the classrooms and select other areas. The RTUs and ground mounted units appeared to be aged and needing replacement. Eight other split-system AHUs (air handling units) are located throughout the interior of the facility and range from an estimated 2 to 5 tons in capacity. These AHUs appeared to provide supplemental cooling in locations throughout the facility. They</p>		Poor

System	Subsystem	Condition and Deficiency Overview	System Condition Rating
		<p>were observed to be in good condition as most of them appeared to be installed in 2008. Additional deficiencies observed included general aging of the equipment, as well as damaged insulation on condensate piping.</p> <p>Supplemental mechanical equipment for the HVAC system also includes exhaust fans and wall-mounted FCUs (fan coil units). Roof top and wall-mounted exhaust fans generally appeared to be outdated. The wall-mounted exhaust fans appeared to serve bathroom exhaust. The roof top exhaust fan over the kitchen was much larger and vibrated excessively. The wall mounted FCUs were observed to serve supplemental cooling for rooms PTAOFC and CUSTOFC. The FCUs were observed to be in good condition and were replacements for aged FCUs that were abandoned in place.</p> <p>The HVAC system was observed to be in poor condition with all of the prior mentioned deficiencies.</p>

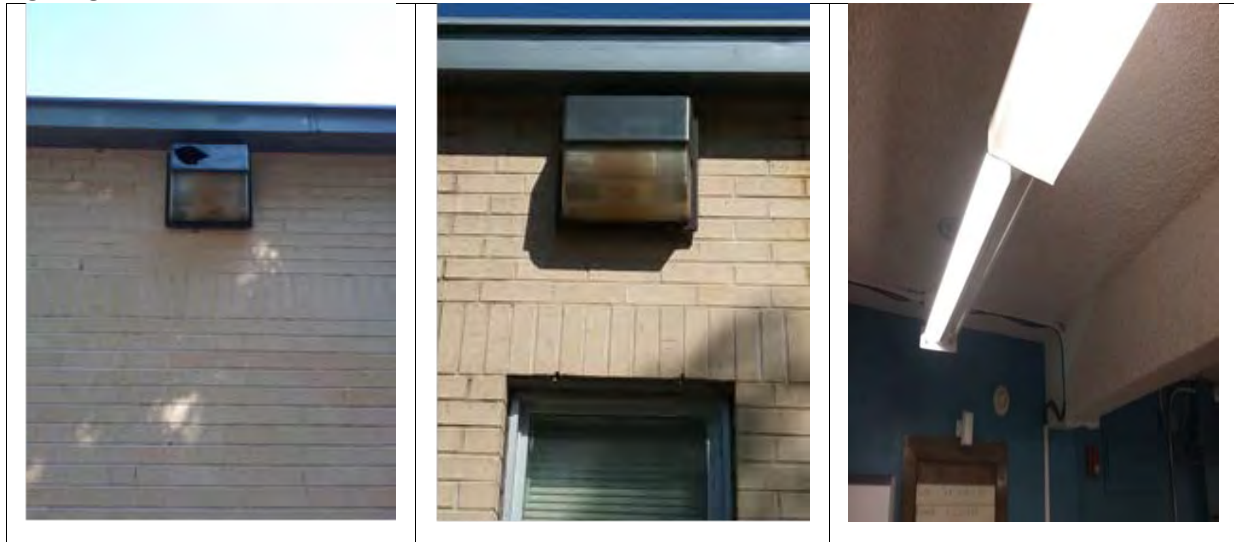
System	Subsystem	Condition and Deficiency Overview	System Condition Rating
	Lighting	<p>The building's exterior lighting consists of wall mounted HID (high-intensity discharge), and surface mounted incandescent fixtures with cracked or missing lenses. The interior lighting consists of primarily 2x4 acrylic lay-in fixtures with T8 fluorescent luminaires and some offices and classrooms have indirect pendant mounted fluorescents.</p> <p>The lighting for the building was observed to be in poor condition. Many interior and exterior luminaires appeared to be aged and past their design life; observed deficiencies include broken lenses, inconsistent color temperatures, missing bulbs, and exposed conduit to light fixtures in restrooms. There are exit signs present in the building; however several appeared to be aged. It was observed that some of the corridor lighting utilized emergency battery packs for emergency lighting.</p>	Poor

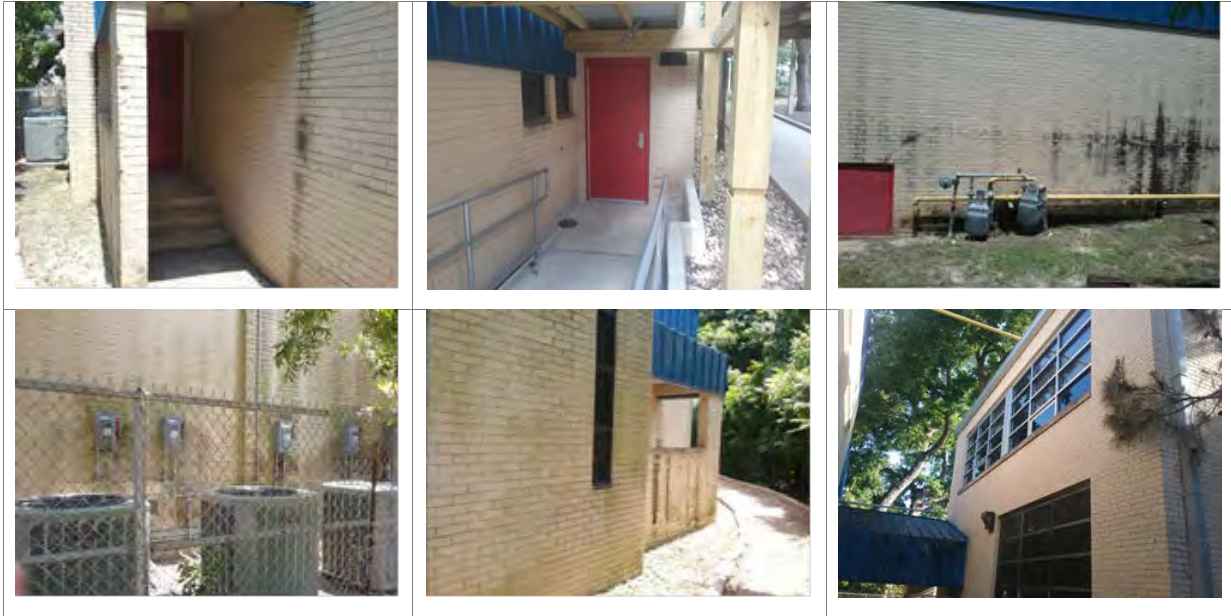
System	Subsystem	Condition and Deficiency Overview	System Condition Rating
Exterior	Exterior Walls	The exterior of the building consists of a brick/metal panel façade with concrete structure. The exterior walls were observed to be in average condition, with the majority of north and east facing walls in need of cleaning due to stains from organic growth. Metal panels appear to be in average condition but are very dirty.	Average
	Exterior Windows	The exterior windows consist of single-pane glazing units with bronze aluminum window frames. Some windows are opaque. All windows are original throughout the building and were observed to be in average condition. All were observed to be very dirty.	Average

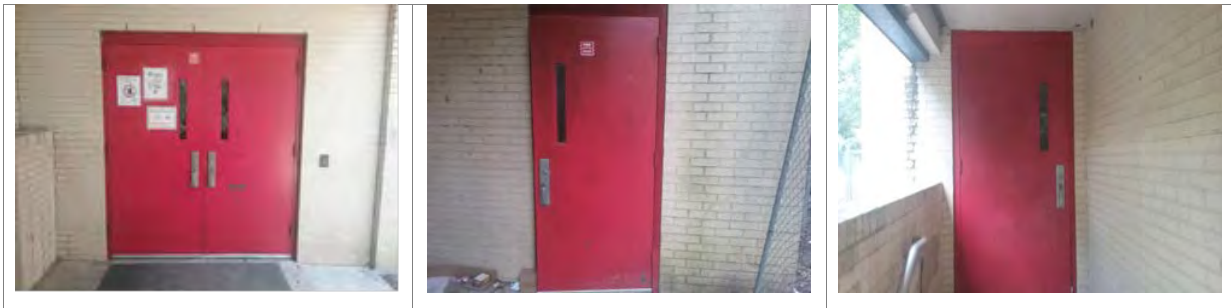
System	Subsystem	Condition and Deficiency Overview	System Condition Rating
	Exterior Doors	<p>There are two main public entryways located at the north east and south west sides of the building. All exterior doors are hollow metal with original hollow metal frames. Many of these doors have had the window glazing replaced with acrylic panels which have been severely scratched over time.</p> <p>The exterior doors were observed to be in average condition with minor fading paint finishes on primarily those facing the sun. All of the doors observed lacked the proper weather stripping or silencers which caused air infiltration between the frame and door. These created noise when the door closed. Some doorframes were observed to show signs of rust.</p>	Average
Roofing	The low slope roof was inaccessible to the team. The sloped metal roof elements appear to be in good condition as observed from grade. The ladder to the roof was pad locked and was not accessible.		N/A

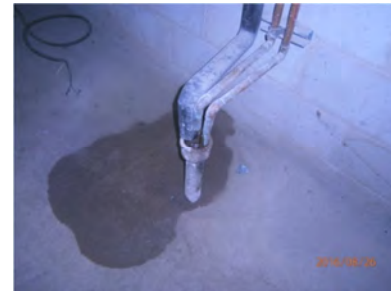
<p>Air gap near Boiler Room</p>

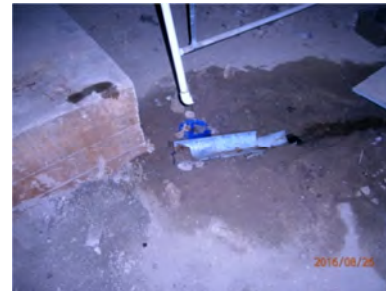
<p>PVC draining onto ground and makeshift drainage channel with running water</p>

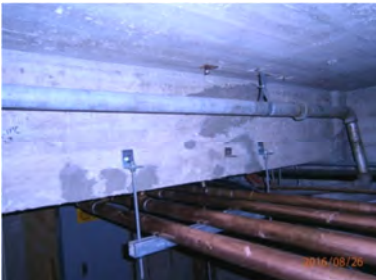
Patches in interior beam at Access Point 3 near Computer Lab

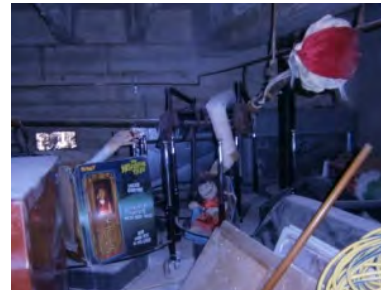
Scary items stored on piping near boiler room – **inappropriate for children**

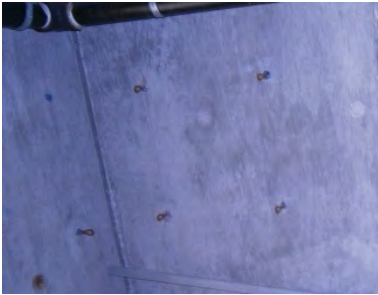
Formwork accessories left in place in walls
