Walnut Creek Elementary School Site Summary

Address	401 West Braker Lane Austin, TX
Number of Permanent Campus Facilities	2
Original Year of Construction	1961, 1999
Total Campus Building Area (combined)	79,223 SF

Introduction

Main School Building – BLDG-141A

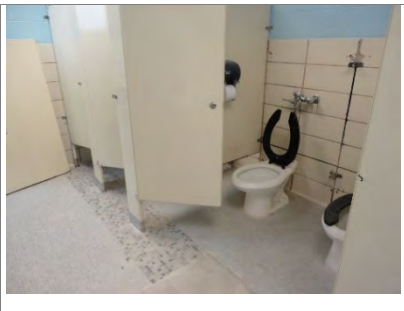
Interior Floor Finishes	The interior floor finishes include vinyl composition tile throughout the classrooms and corridors. The 100-wing and administration areas were remodeled in 2015 with new floor finishes. The remaining areas have older vinyl composition tile, which is well maintained. There is carpet in the conference room and administration offices, and the restrooms have ceramic tile floors. The interior floor finishes were in average condition due to age and wear in the majority of the school. The male restroom BRRGYM was discolored and worn. The restroom appeared to be in the process of being renovated as the toilet partitions were partially removed.	Average

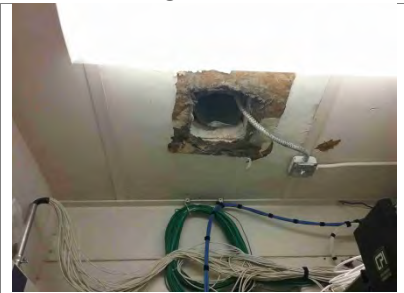
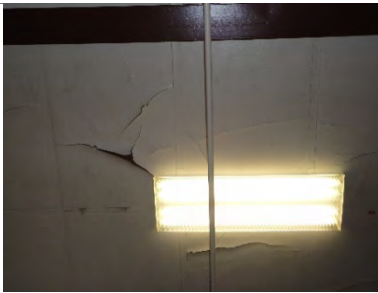
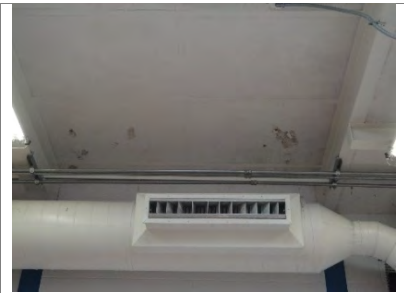
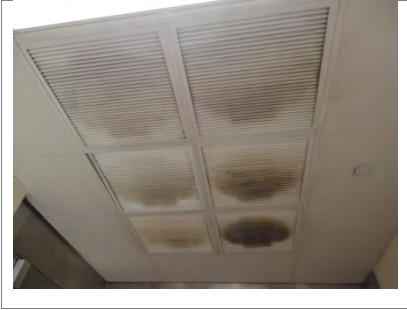
System	Subsystem	Condition and Deficiency Overview	System Condition Rating
	Interior Ceiling Finishes	<p>The interior ceiling finish includes acoustic ceiling tile in the administration area with vinyl ceiling tile in the restrooms. The majority of classrooms and corridors have Tectum ceiling panels above the painted steel structure. The panels are smooth and painted in the corridors, 200-wing, 600-wings, and gymnasium. The panels in the 100-wing are textured.</p> <p>The ceiling finishes were in average condition due to age. There was a damaged ceiling panel around the EF (exhaust fan) in the IDF B room in the conference room. The ceiling finish was peeling in the cafeteria and the vents was discolored in the kitchen. There were several visible holes in the gymnasium.</p>	Average
Conveying	System not present.		N/A
Plumbing	Plumbing Fixtures	<p>The building predominantly contains single-use restrooms throughout the facility for each classroom. Additionally multi-use restrooms for the gymnasium and cafeteria areas with single use faculty restrooms in the cafeteria, administration, and nurse areas. Typical restrooms have floor-mounted vitreous china water closets with manual flush valves. Vitreous china urinals with manual flush valves are located in the dedicated male restrooms. Restrooms that were not located inside classrooms had wall-mounted vitreous china sinks for handwashing. Personal use stainless steel sinks with a drinking fountain attached are located in each classroom. Stainless steel and vitreous china drinking fountains can be found in the corridors of the building.</p> <p>A commercial kitchen is located in the school's cafeteria. The kitchen contains stainless steel kitchen equipment, including one triple basin prep sink and one double basin prep sink. It also has various wall-mounted sinks for personal use. The art room contains two stainless steel basin sinks, and a single deep basin stainless steel rinse sink. The building also has service sinks located in various janitorial closets. Various other rooms such as the library and lounge have basin sinks for personal use.</p> <p>Majority of plumbing fixtures were in average working condition, but were aged and were original to the building and showed signs of deterioration. The drinking fountain in the corridor of the 100-wing was observed as non-functioning. The drinking fountain in room 600 was observed to have low flow. A drinking fountain outside</p>	Average

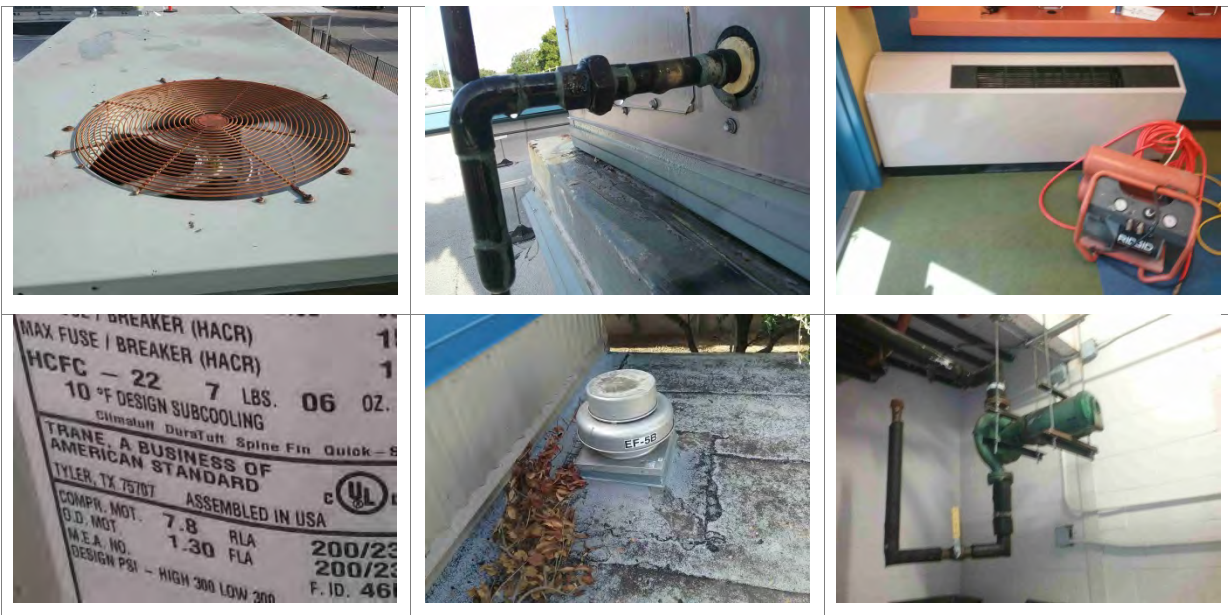
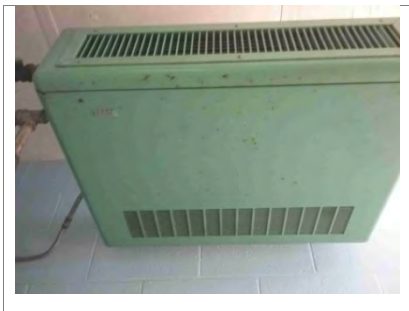
Mechanical/HVAC System Deficiency Examples

System	Subsystem	Condition and Deficiency Overview	System Condition Rating
		There was standing water observed on the floor of the kitchen indicating a possible plumbing issue but no leaks were observed during assessment. No source of the water was determined, but reported as a known issue during the facility interview. One floor drain had a grate that was not properly secured and had slight build-up in the drain. A floor drain in the kitchen was missing a grate.	
Mechanical/ HVAC	<p>The building's HVAC system is primarily composed of heat pumps, RTUs (roof top units), rooftop AHUs (air handling units), vertical unit ventilators, and air conditioner condenser units. Various sized exhaust fans feed the building.</p> <p>Majority of the RTUs were observed to be brand new and in excellent condition. There were several older RTUs that were observed to be aged and have corrosion and rust. RTU-3A and RTU-6 were observed to have a condensation drip off the back of the units. Additionally majority of the vertical unit ventilators were also brand new and in excellent condition. Heat pumps found in the library and administration areas were aged and out of date. Cooling units in rooms 100 and 101 were newer and reported to be replaced in 2014 after the 100-wing had a fire causing damage to the previously existing units. Roof top AHUs were newer and in good condition. Majority of the condenser air conditioner units were brand new and in excellent condition. CU-1 outside room 205 was observed to be older and using R-22 refrigerant.</p> <p>The HVAC system was in average condition with wear associated with the age of the associated units. Exhaust fan EF-5B was observed to be making a loud vibration noise. Roof top exhaust fans were in average condition with some units observed to be making a loud whirring noise. Exhaust fans were aged and were approaching the end of their typical design service life. There were various pieces of HVAC equipment that were no longer functional and were abandoned in place. Multiple HVAC units were observed to be using R-22 refrigerant, which is an outdated refrigerant that is being phased out of use.</p>		Average

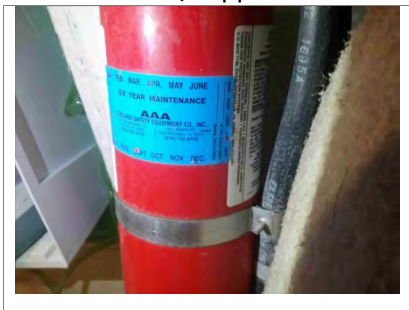
Fire Protection/Suppression

System	Subsystem	Condition and Deficiency Overview	System Condition Rating
		<p>ceiling. Additionally, a fire suppression sprinkler system is found in the kitchen. Fire extinguishers are located throughout the building.</p> <p>The over range and sprinkler fire suppression systems appeared to be in good condition, but were not tested for functionality. Visual assessment showed the fire extinguishers were in average condition. Majority of the extinguishers were observed to be up to date with their inspections. The fire extinguishers in 200 and CAFEECC were observed to be out of date on their annual inspections.</p>	
Electrical	Electrical Distribution	<p>The electrical service enters the building at the 277/480-volt, 2,500-amp switchboard located at the northwest exterior corner of the building. The service feeds transformers and 277/480-volt panelboards, which are located in various electrical rooms throughout the building. The building does not have a lightning protection system.</p> <p>The electrical distribution equipment was observed to be in average condition. The building had several panelboards that had exceeded their typical design service life and should be considered obsolete. Those obsolete were manufactured by Wilson Electric, Federal Pacific, and ITE. Obsolete panelboards were found in rooms STO200, GYMSTO, ADMIN, CAFEELEC, CAFESTO, and KITCHEN. ADM3STO was found with several items blocking the access to a panelboard and should be considered a life safety hazard. The building had a roof-mounted transformer that was observed to have severe corrosion due to weather exposure. The building also had a number of safety switches and motor control panels that appeared to have exceeded their typical design service life.</p> <p>Faculty expressed concern over the outdated panelboards and safety switches that were at the end of their typical design service life and requested replacements.</p> <p><i>It was reported by AISD construction management staff that electrical disconnects were replaced on the exterior wall of the kitchen during the summer of 2016.</i></p>	Average

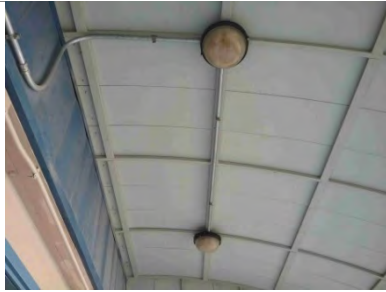
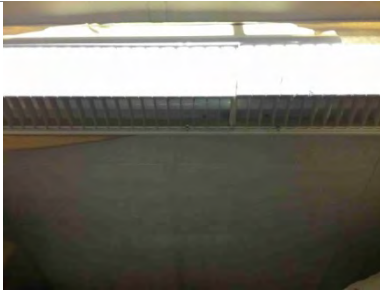
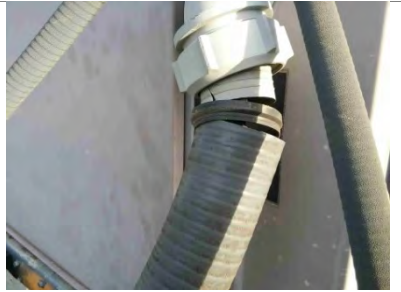
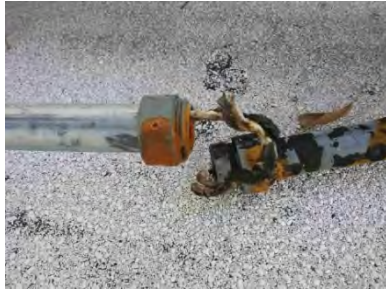
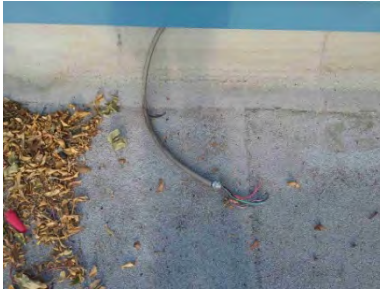
Lighting

System	Subsystem	Condition and Deficiency Overview	System Condition Rating
		<p>building and within the courtyard area. Exterior luminaires include high pressure sodium/metal halide, fluorescent, LED, and screw-in incandescent flood lamps. The interior lighting consists of primarily recessed troffer and surface-mounted fluorescent luminaires although some storage/janitorial rooms have various downlight luminaires present. The 100-wing has suspended LED fixtures that were added in the past year.</p> <p>The lighting for the building was observed to be in average condition. Many exterior luminaires were discolored or aged past their typical design service life. Observed interior lighting deficiencies were limited to burned-out lamps. A large portion of the roof top had been replaced from the recent HVAC renovations, but the existing roof top conduit was damaged in several areas. Much of the existing HVAC equipment was observed with open conduit. Roof top conduit was found damaged in several areas. One section of conduit was loose on the roof with wiring exposed, possibly from the ongoing construction project. The kitchen area roof top had a section of conduit with a disconnected union, exposing severely twisted cabling. The twisted cabling within this section of conduit was observed with exposed copper wiring. The open conduit area could lead to water infiltration into end devices and panelboards.</p> <p>Faculty requested additional luminaires to improve parking lot lighting.</p>

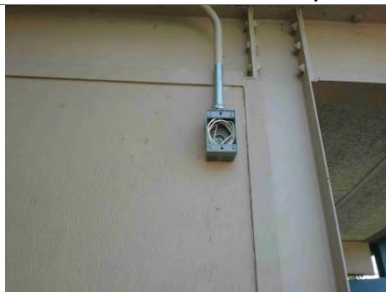
Communications & Security

System	Subsystem	Condition and Deficiency Overview	System Condition Rating
		<p>be in good condition. One junction box was observed without a cover plate and appeared to have networking cabling present.</p> <p>Faculty reported that the Wi-Fi signal is poor within the administration office area. Faculty reported that the security alarm system did not function properly and could be activated while windows were open. Faculty also reported that the interior surveillance cameras were poor quality and requested higher resolution replacements. Faculty also requested a secured access to the west-side of the building.</p>
