Widen Elementary School Site Summary

Introduction

Main School Building – BLDG-175A

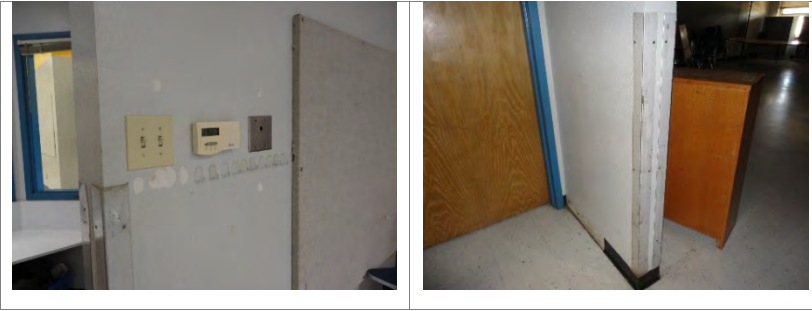
Interior Wall Finishes

Interior Construction	Interior Walls	<p>The majority of the interior walls are gypsum board on studs. The cafeteria and gymnasium are CMU with a manual movable partition separating the two spaces.</p> <p>The interior walls appeared to be in good condition. Facility staff reported the movable partition between the café and gymnasium is not functional.</p>	Good
	Interior Doors	<p>The interior doors are wood veneer with wire glass vision lites and painted metal frames.</p> <p>The interior doors appeared to be in good condition with issues on the frames and hardware. The painted doors and frames in the A-wing rooms have peeling paint. The doors stops and hold-open hardware at the bottom of the doors appeared to be in poor condition throughout the school. They function appropriately, but were loosely attached to the doors.</p>	Good
	Interior Specialties	System not present.	N/A
Stairs	Exterior Stairs	<p>There are exterior stairs for access to the loading dock at the kitchen. There is a painted metal railing.</p> <p>The exterior concrete stairs appeared to be in average condition. There are cracks and wear due to high use, but they were still fully functional.</p>	Average

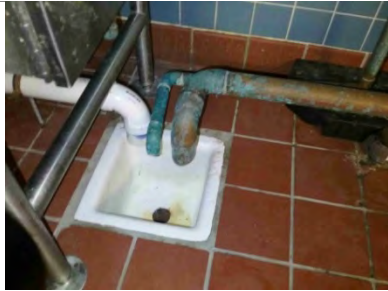
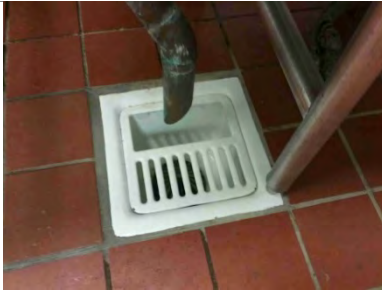
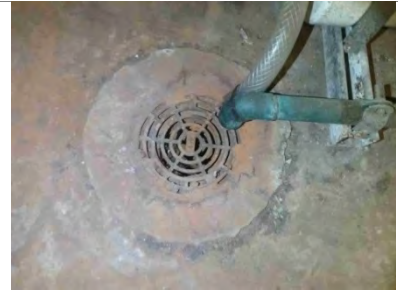
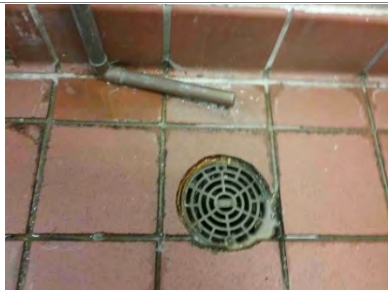
System	Subsystem	Condition and Deficiency Overview	System Condition Rating
		<p>(i.e., nurse's office and administration area). Domestic hot water is not supplied to the classroom plumbing fixtures.</p> <p>The GWH feeding the cafeteria was aged and out of date. It also had corrosion and rust and was in poor condition. The smaller units installed for specific hot water use were in good to average condition. Some were showing signs of age deterioration and rust.</p> <p>The plumbing distribution equipment was in average condition with damaged insulation and corrosion and rust piping throughout the building. Several sinks had corrosion and rust in the piping connecting to the sink.</p>	
	Other Plumbing	<p>Associated other plumbing was in average condition. The kitchen drain pipes had corrosion and rust. A floor drain in the kitchen was emitting a rotten smell. Leakage was seen in the MAINMECH room; floor drains had corrosion and rust on them. There was a pipe in the kitchen that was leaking. The restrooms in rooms A4, K2, and K4 were emitting a foul odor. It was reported by a maintenance worker that the building is known to have plumbing issues underneath the floor.</p>	Average

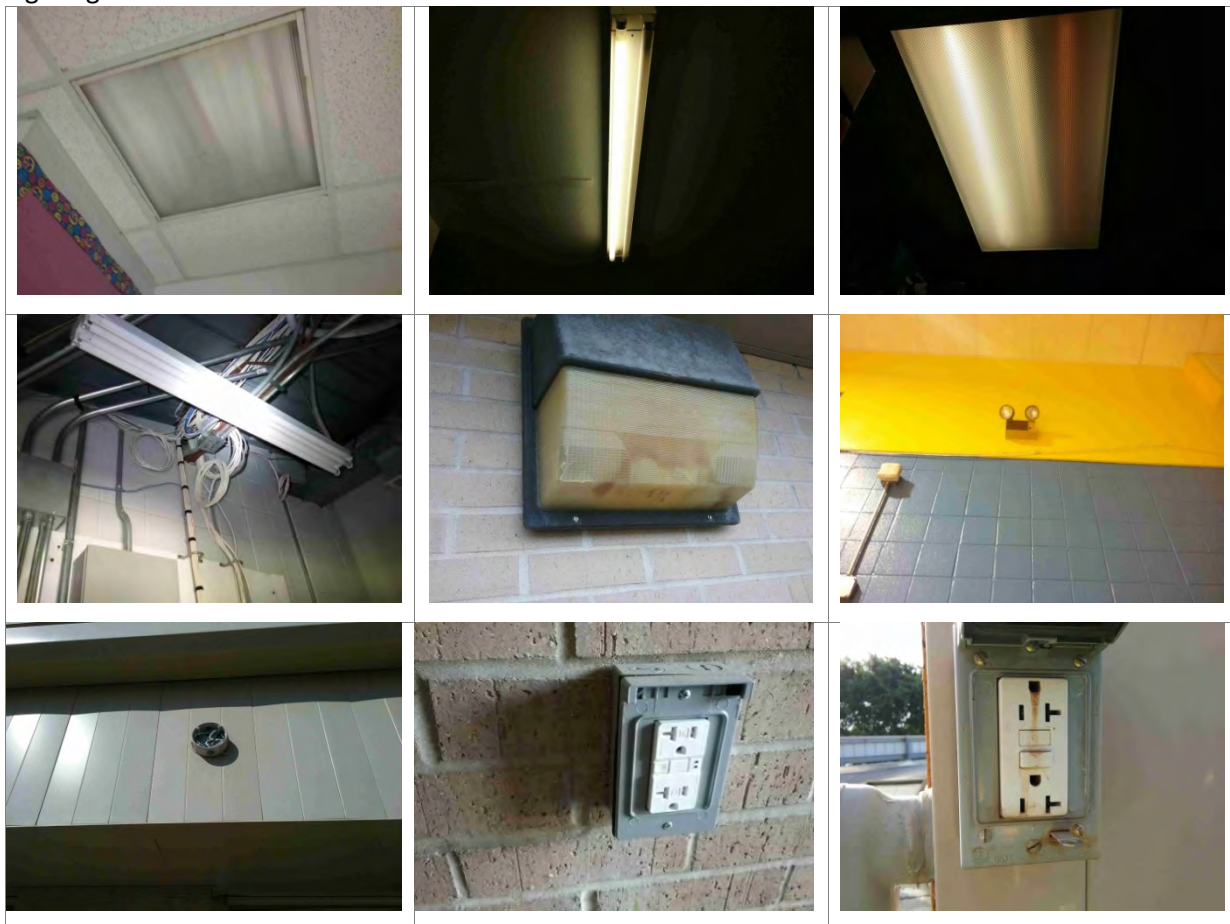
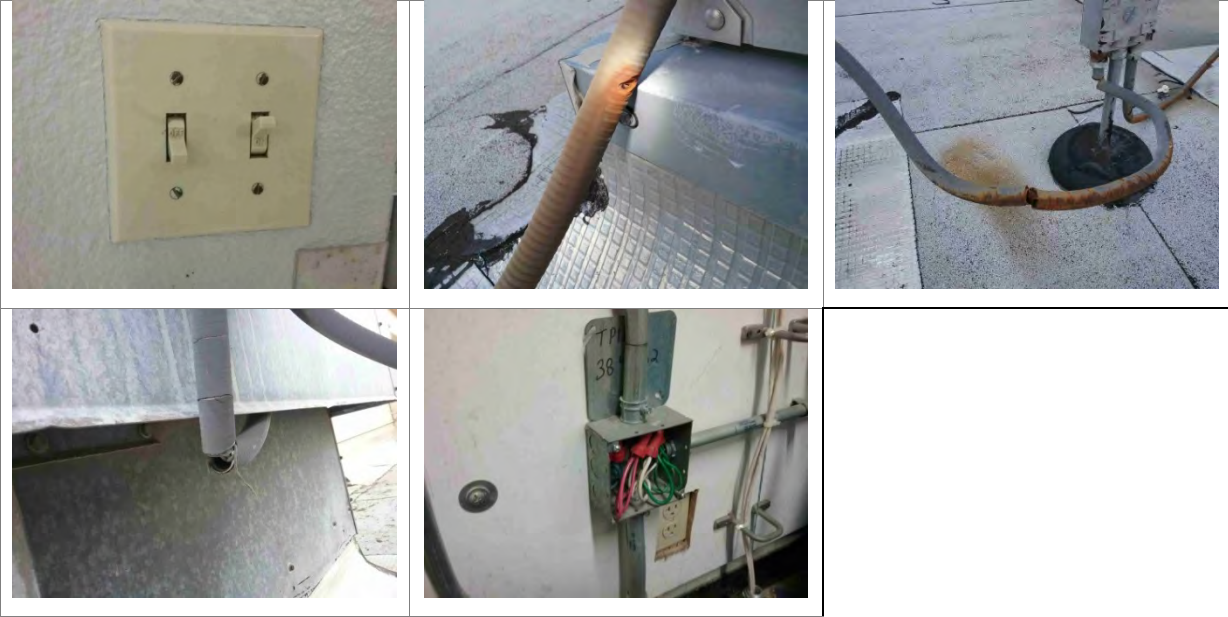
System	Subsystem	Condition and Deficiency Overview	System Condition Rating
		<p>One roof top panel was found to have a damaged seal, which could allow for water infiltration. There are several storage rooms where items are blocking proper access to the panels and should be moved due to safety concerns. There are also several storage rooms where items are being stored on top of transformers, which could create a fire. Items should never be stored on top of or against any transformers. There are several safety switches for HVAC equipment on the roof that are heavily corroded or have holes that will allow for water infiltration into electrical conduit.</p> <p>The facility staff reported that there are not enough circuits throughout the cafeteria and kitchen area. Faculty has also reported that several facility circuits trip due to corroded conduit within the foundation.</p>	
	Lighting	<p>The building's exterior lighting consists of metal-halide and LED (light-emitting diode) luminaires that are located near parking lots, playground, covered/non-covered walkways, and building egresses. The interior lighting primarily consists of T8 fluorescent luminaires.</p> <p>The lighting for the building was in average condition. Many interior and exterior luminaires appeared to be aged past their design life. Observed deficiencies included broken lenses, inconsistent color temperatures, and non-functional fixtures. There are exit signs and emergency lighting present in the building that appeared to be in good working order. There are two original emergency lighting luminaires that are original to the building in the cafeteria and the gymnasium.</p> <p>There were several issues in the branch wiring, including damaged or loose conduit and missing junction box covers. Several exterior receptacles were found with broken covers. Some classroom light switches were beginning to arc. Faculty has requested additional lighting at building exits and around the exterior, along with additional emergency lighting luminaires for the corridors. Faculty also reported that water infiltrates the kitchen lights during rain.</p>	Average
