## Winn Elementary School Site Summary

## Main School Building – BLDG-157A

## Stand-Alone Classroom Building – BLDG-157B

## CRAWL SPACE – Winn ES – Main Building (BLDG No. 157A)

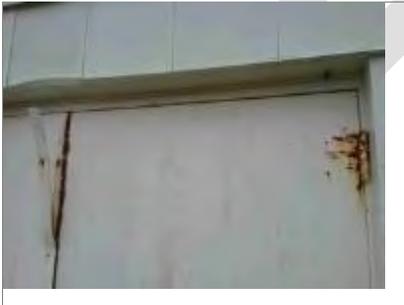
#### Exterior Doors

Exterior Doors	<p>There is a secure main entry located along the west elevation of the building. The remaining exterior doors around the facility are metal. The exterior doors were observed to be in average condition showing signs of wear and use. The metal doors at the rooftop penthouse are corroded and the hardware is bent and damaged.</p>	Average
<b>Roofing</b>	<p>The roof is constructed of built-up asphalt with a granular topping. The roof was estimated to be original construction.</p> <p>The roof was observed to be in average condition. Areas of ponding water were observed. The gravel topping appeared thin or missing in areas leaving the</p>		Average

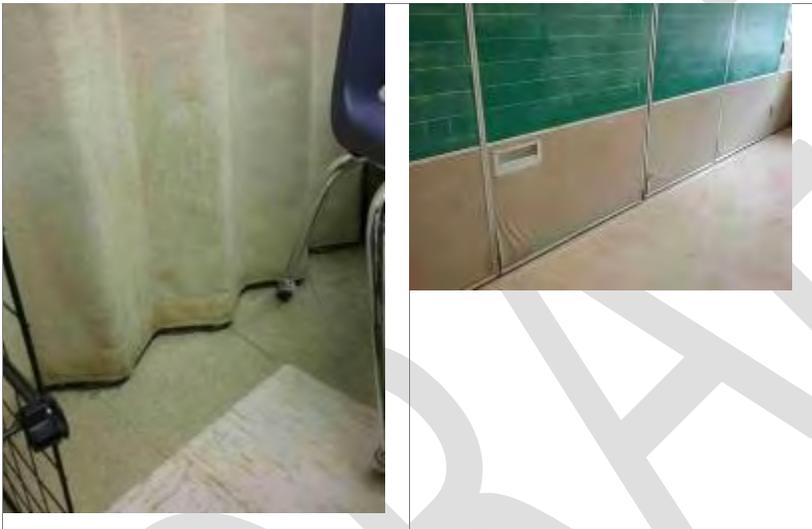
asphalt membrane exposed. The membrane and flashing appeared dried and cracked in various areas.	
<b>Interior Construction</b>	Interior Walls	<p>The interior partitions vary throughout the building and consist of stud construction finished with GWB, brick walls, or CMU walls. The classrooms are separated from one another by a series of accordion style or folding panel partition walls. There is a full height folding panel partition separating the gym area from the cafeteria area.</p> <p>The folding panel partitions dividing the classrooms were observed to be aged, deteriorated and in poor condition. The full-height folding partition in the gym appeared to be in good condition showing typical signs of wear.</p> <p>AISD staff indicated that the main building will undergo a partial renovation in the summer of 2016. The funded project includes the complete renovation of the administrative office suite and the library area. A new building will be constructed on the campus housing a counseling center. Another reported and funded project that will occur in the summer of 2016 is the removal of the existing folding panel partitions dividing the classrooms. The folding panel partitions will be replaced with permanent GWB partitions.</p>	Average

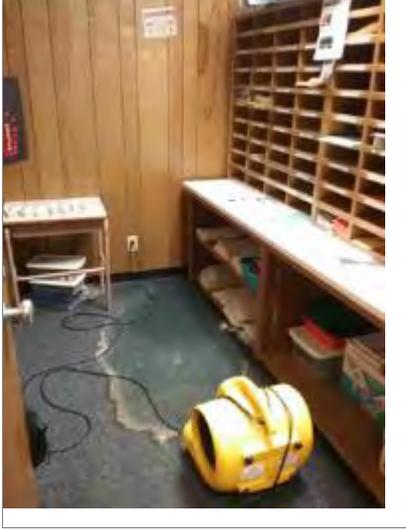
Interior Floor Finishes

<p>tile. The restrooms are finished with ceramic tile.</p> <p>The floor finishes were observed to be in average condition. The carpet in the administrative office area was observed to be damaged from water leaking from malfunctioning HVAC equipment. The floor tile in the restrooms appeared to be chipped in various areas.</p>	
	Interior Ceiling Finishes	<p>The interior ceiling finish is predominately ACT in the corridors, classroom areas, administrative area, and kitchen. The gym does not have a finished ceiling and is open to the structure above. The interior finishes appeared to be original and in average condition showing signs of age and wear. The existing ACT system throughout the building was observed to be aged, damaged, stained, or missing in several areas.</p>	Average
<b>Conveying</b>	<p>The staircase in the corridor of the main school utilizes an automatic wheelchair lift. No major deficiencies were observed during inspection.</p>		Average

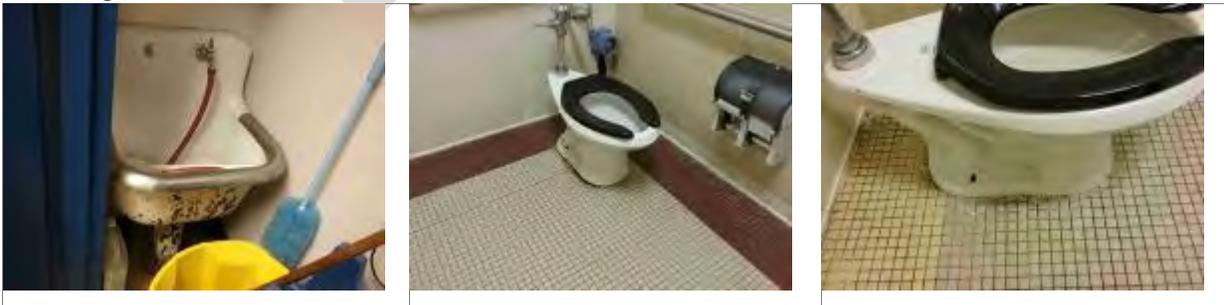
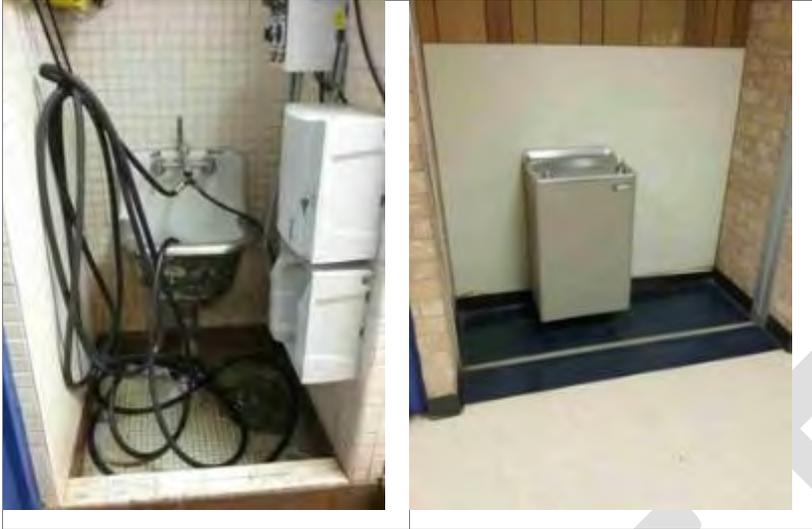
<b>Plumbing</b>	Plumbing Fixtures	<p>The building has both single-user and multi-user restrooms for students and staff located throughout the facility. Typical restrooms have floor mounted, vitreous china water closets with manual flush valves along with wall hung, vitreous china lavatories with manual faucets or single bowl stainless steel sinks located adjacent to the restroom's entrance. There are wall hung, vitreous china urinals with manual flush valves in dedicated men's restrooms. The building also has multiple janitors' closets with vitreous china utility sinks. Typical classrooms have a single bowl stainless steel sink with a drinking fountain attachment. The facility has a multi-station stainless steel sink directly outside of the cafeteria for hand washing. Water coolers can be found throughout the main corridors of the building, typically near multi-user restrooms. A subset of the water coolers includes a rapid bottle filler combination.</p> <p>There is a commercial kitchen that serves the school's cafeteria in the building. The kitchen has wall mounted vitreous china sinks for personal use and stainless steel kitchen equipment throughout including one, two and three basin dish/prep sinks.</p> <p>Many fixtures appear to be dated and staff has reported issues with poor seals causing minor leaks around the plumbing fixtures. Most of the utility sinks in the janitor closets and some of the water coolers in the corridors are past their expected design life. The janitor utility sinks are also corroded. There is evidence of leaking around many of the water closet basins, particularly water closets missing their flange bolts. The building staff reported issues with clogged pipes and poor water pressure. All pipes should be cleaned and flushed in order to remove buildup.</p>	Average

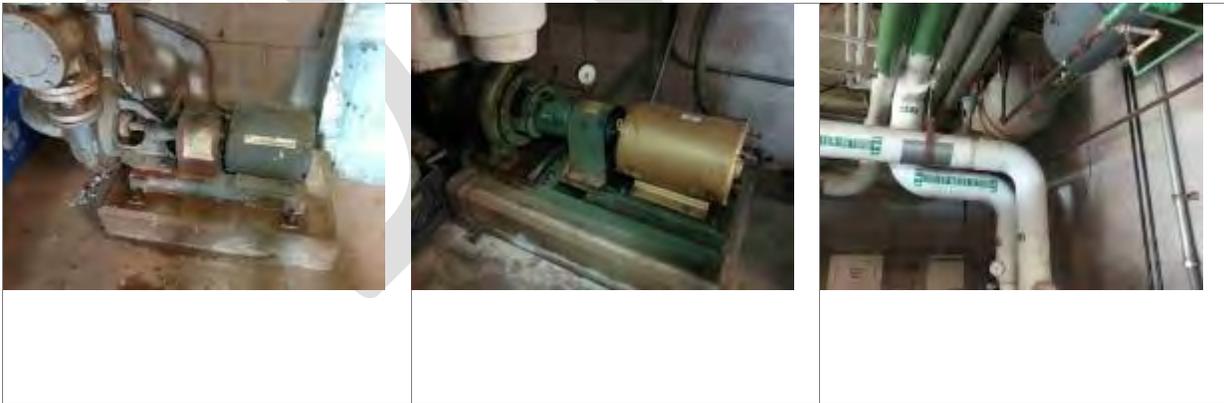
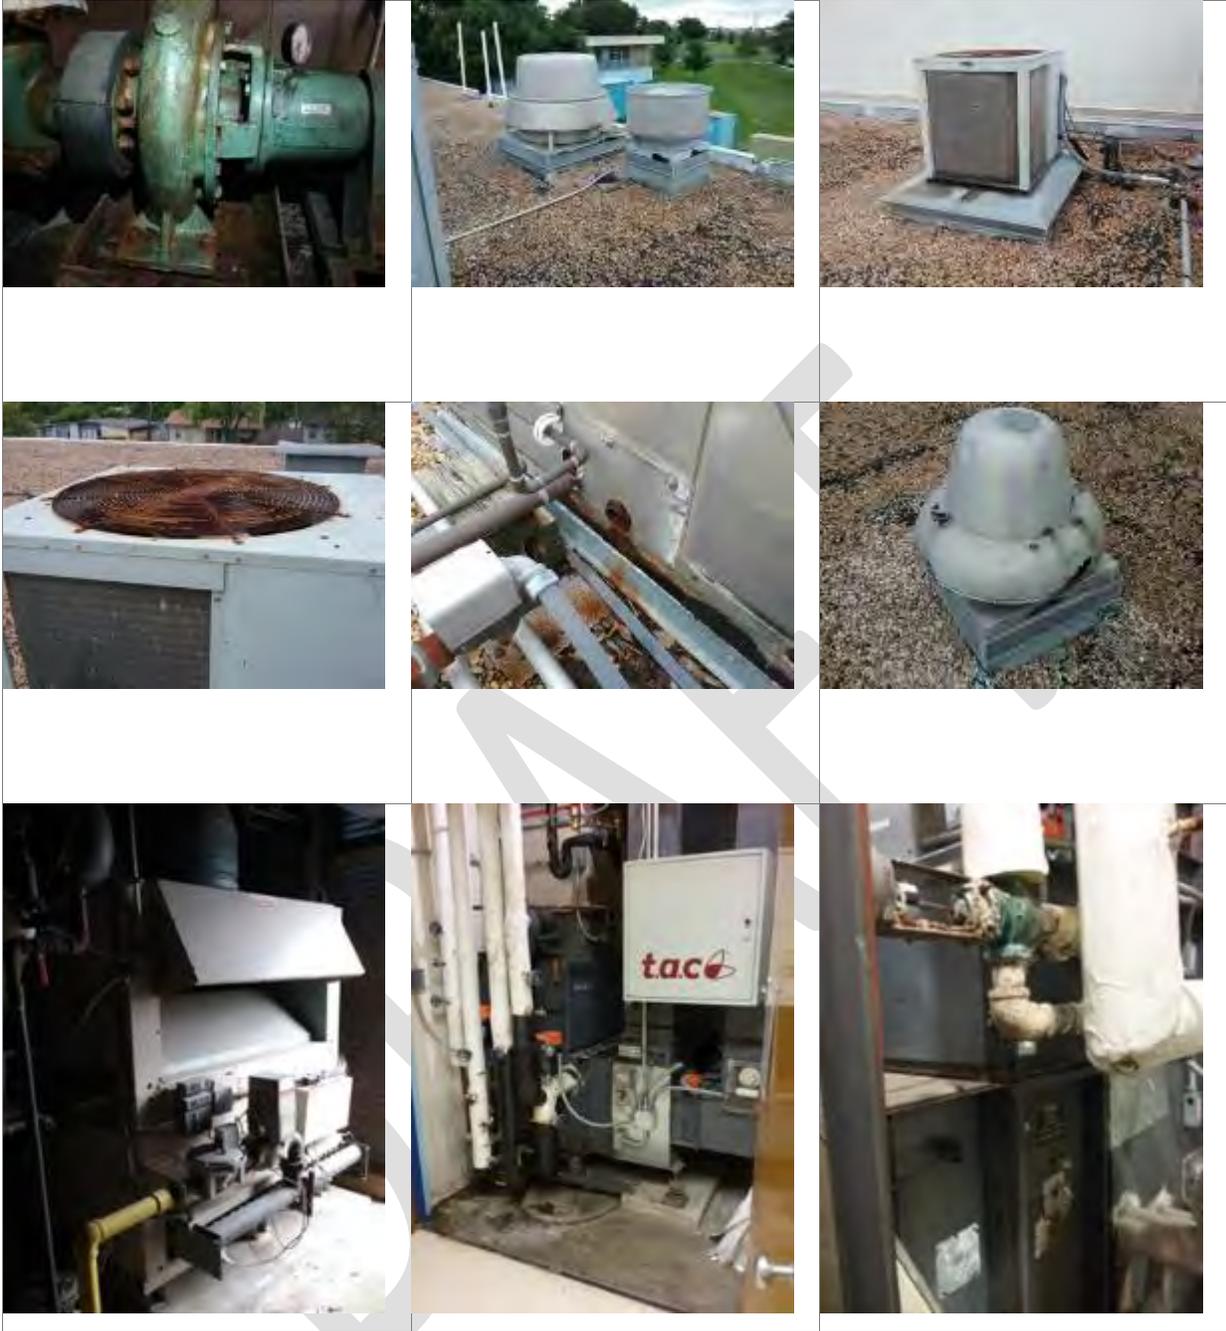
**Mechanical/HVAC System Deficiency Examples**

Distribution	<p>gallon, 390 MBH gas water heaters in the main mechanical room. Smaller electric how water heaters are located throughout the building to provide domestic hot water to specific locations. Domestic hot water is not supplied to classroom plumbing fixtures and other assets throughout the facility.</p> <p>The domestic water system was observed to be in average condition with typical wear and tear associated with general daily use.</p>	
	Other Plumbing	System not present.	N/A
<b>Mechanical/ HVAC</b>	<p>The building's HVAC system is composed of a central hot water and chilled water system in conjunction with eight air handling units. The system uses a 2100 MBH natural gas boiler and two 125 TON rotary liquid chillers with remote condensers. The remote condensers are located on the roof directly above the main mechanical room. The eight air handling units throughout the building range in size, but there was limited nameplate information available for the units. It appears the only spaces not served by the centralized system are the administrative area, the MDFA room, the kitchen, and the cafeteria. These areas are serviced by a combination of split systems, rooftop package units, and evaporative coolers. The building has multiple rooftop exhaust fans ranging in size and condition.</p> <p>The HVAC system is in average condition with assets ranging from good to poor condition. The chillers and their condensing units appear to have been recently replaced and are in good condition, however they use R-22 refrigerant, which is an outdated refrigerant that is being phased out of use. The boiler has exceeded its expected design life and should be replaced in the near future. Both the hot water and chilled water circulation pumps and some associated piping are corroded and show signs of minor leaks. The pumps were manufactured in 1999, but the motors have been replaced. The pumps should be replaced and the surrounding piping should be further inspected to see the extent of the corrosion. A portion of the air handling units appears to have been replaced in the last five years. The remaining air handling units throughout the building are aged and show signs of excessive wear. The two air handling units, AHU 2 and AHU 3, in Boiler Room 1 are in poor condition. AHU 2 makes excessive noises and has extreme vibrations, which may be caused by improper tension, condition, or alignment of the unit's belts. The unit's vibrations are causing the associated piping to rattle intensely. AHU 3's pipes have excessive vibrations and minor leaks, which are causing build up to occur on the pipes and unit. AHU 2 and AHU 3 need to be serviced immediately to prevent further degradation, but all five aged AHUs should be scheduled for replacement. The split systems, rooftop package units and evaporative cooler are in average to poor condition. Both rooftop package units and the administrative area's condensing unit use R-22 refrigerant, which is an outdated refrigerant that is being phased out of use. The condensing unit is also corroded and has damaged coil fins, which may affect its functionality. The piping to the evaporative cooler has corroded all the way through causing the drain pipe to break and disconnect from the unit. It is unclear if the unit is currently operational as the unit's disconnect appears to be in the tripped position. Further inspection of the unit is required, but the unit's piping needs to be replaced at a minimum. The building staff reported heating and cooling issues in the east classroom area of the building. Further investigation is required to determine the proper repair. Exhaust fans should be installed in all restrooms throughout the building. The exhaust fan on the northwest roof is degraded and needs to be replaced. The exhaust fan next to "Admin CU-1" is severely degraded, vibrates</p>		Average

excessively and is noisy. This exhaust fan needs to be replaced.	
<b>Fire Protection</b>	Fire Alarm	The buildings fire alarm and detection system consists of a fire alarm control panel, pull stations, smoke detectors, strobe lights, and annunciators. No major deficiencies were observed during inspection.	Good
	Fire Protection/ Suppression	The facility has a wet pipe fire sprinkler system serving the janitor closets and dry chemical portable fire extinguishers throughout the rest of the school. The kitchen has a dedicated chemical fire suppression system for the exhaust hoods designed for grease fires. The fire protection system is in good condition. The observed portable fire extinguishers have up-to-date inspection tags and the chemical fire suppression system in the kitchen is in proper working order.	Good
<b>Electrical</b>	Electrical Distribution	<p>The electrical service entrance equipment is located on the exterior of the main school. A metered 3000-amp enclosure supplies power to a 3000-amp switchboard located in an attached enclosure. This switchboard serves both chillers and the 600-amp main panelboard (Panel MTDP) which in turn serves smaller distribution panels throughout the building. The north addition has several distribution panels, which are fed from the main building service.</p> <p>The electrical service is in average condition. Many of the panels including Panel K, Panel D, Panel B, and Panel C, in the main school appear to be original to the building and have exceeded their expected design life. In addition to the dated electrical equipment, a flexible conduit on the exterior of the building had a hanger strap break causing part of the conduit to split apart allowing rain water to pull in the conduit. The conduit should be repaired immediately, before significant water damage occurs.</p>	Average

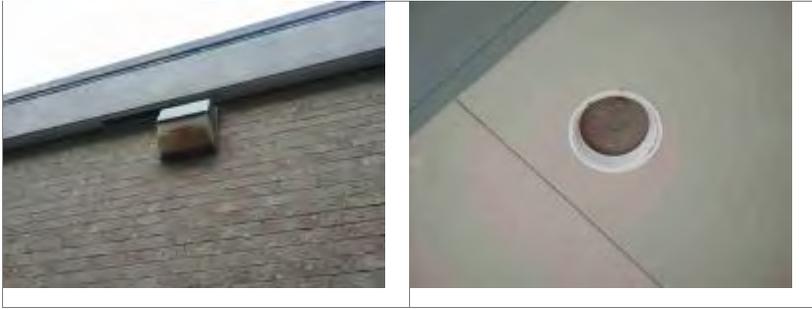
Lighting	The interior lighting throughout the main school is predominantly T8 fluorescent fixtures. Most corridors, offices, and classrooms had two foot by four foot lensed troffers. Emergency and exit lighting is located throughout the building. Exterior lighting was metal halide wall mounted fixture. Common issues with the lighting were broken or missing covers and lamps that were either missing or inoperable. The building staff reported that the exterior lighting of the main school was inadequate.	Average
	Communications & Security	The security system consisted of cameras, proximity card readers, keypads, and control panels. The building staff reported the security system does not provide sufficient coverage and additional cameras need to be installed.	Good

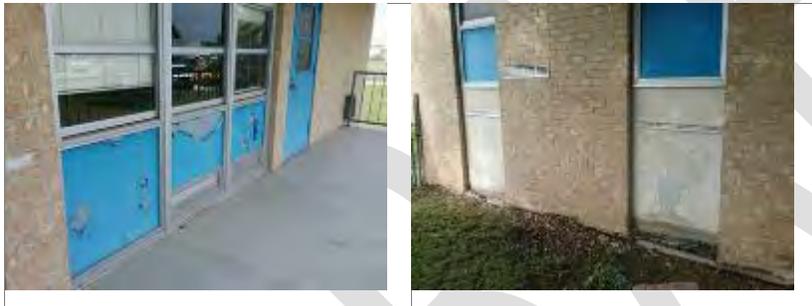
System	Subsystem	Condition and Deficiency Overview	System Condition Rating
Exterior	Exterior Walls	<p>The exterior consists of brick masonry walls. Below the windows, there are two types of decorative panels; painted spandrel panels, and plaster-cement finished infill panels. The building is connected to the Main Building by a concrete ramp and aluminum canopy structure located along the south elevation of the building.</p> <p>The exterior masonry walls appear to be in good condition. The windows were estimated to be original, and observed to be in good condition with the exception of some of the painted spandrel panels and infill panels. The painted spandrel panels located below the window units were observed to be chipped and peeling. The plaster-cement finished infill panels were observed to be cracked and crumbling at the east elevation of the building.</p>	Good
	Exterior Windows	<p>The exterior windows consist of single pane glazing in aluminum framing units. The exterior windows were observed to be in good condition. Some of the glazing lites in the window units were scratched and foggy obscuring the view to the exterior.</p>	Good

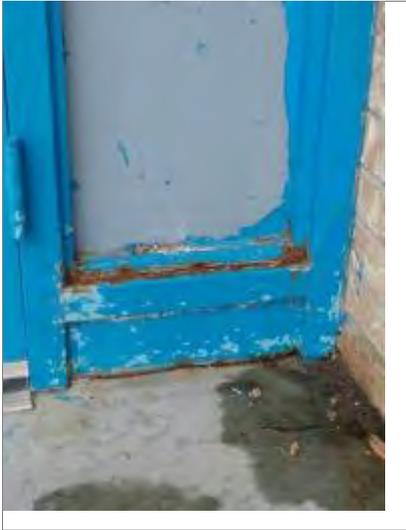
Exterior Doors	<p>There is a secure main entry located along the south elevation of the building. The remaining exterior doors around the facility are metal with metal frames. The exterior doors and frames were observed to be in average condition showing signs of wear and exposure to the elements. The exterior metal door frames were observed to be corroded from moisture exposure.</p>	Average
Roofing	The roof is constructed of built-up asphalt with a granular topping. The roof was		Average

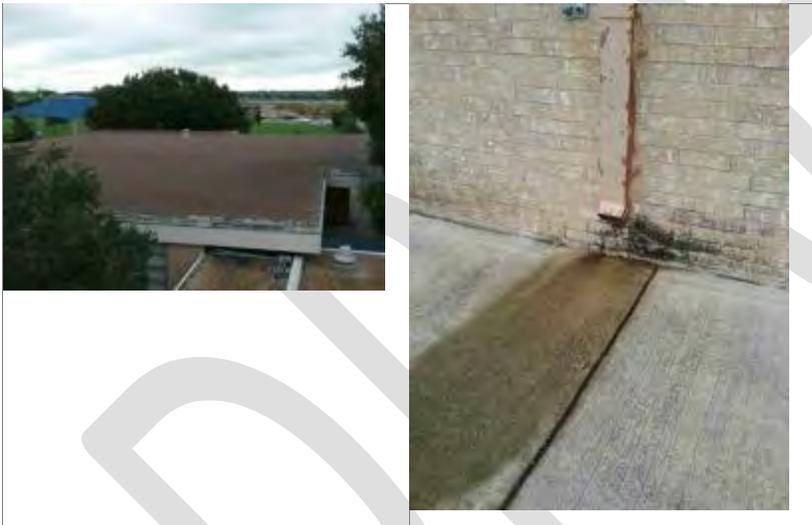
Roofing Deficiency Examples

<p>estimated to be original construction. The roof was not accessed and was observed from the roof of the adjacent Main School Building.</p> <p>The roof surface appeared to be in average condition. The metal coping edge on the perimeter of the roof was weathered and chipped. The downspouts were observed to drain directly onto the sidewalk causing a safety hazard at these areas.</p>		
<b>Interior Construction</b>	Interior Walls	The interior partitions in the building are stud construction finished with GWB. The partitions appeared to be in good condition as there were no deficiencies noted on site.	Good
	Interior Doors	The doors within the building are wood with metal frames. There are transoms located above the door frames. The doors were observed to be in good condition.	Good
	Interior Specialties	System not present.	N/A
<b>Stairs</b>	Exterior Stairs	There is an exterior concrete ramp structure with metal handrail/guardrail system that connects the Main School Building to the Stand-Alone Classroom Building. The ramp structure was observed to be in good condition.	Good

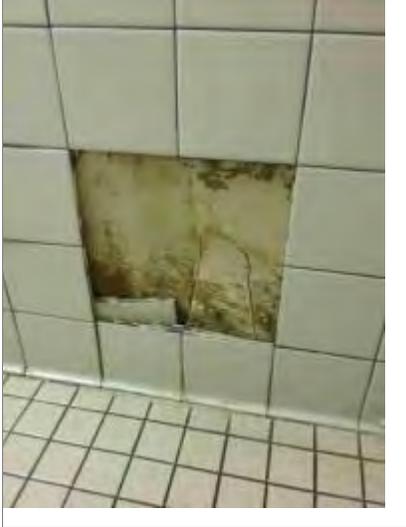
Interior Stairs	System not present.	N/A
<b>Interior Finishes</b>	Interior Wall Finishes	The interior partitions are finished with plastic laminate or painted GWB in the classrooms. The restrooms are finished with glazed ceramic tile on the walls.  The interior wall finishes were observed to be in good condition with a few minor deficiencies observed on site. The ceramic wall tile in the restrooms in rooms 123 and 125 was missing and broken in certain areas.	Good
	Interior Floor Finishes	The main interior common area of the building is finished with carpet. The classrooms are finished with linoleum floor tile while the restrooms are finished with ceramic tile.  The interior floor finishes were observed to be in good condition with a few minor deficiencies observed on site. The linoleum floor tile near classrooms 125 and 126 was observed to be cracked and broken.	Good
	Interior Ceiling Finishes	The classrooms and the main interior common area of the building are finished with ACT. The restrooms are also finished with ACT.  All of the interior ceiling finishes appeared to be in good condition with a few minor deficiencies noted. The painted tray ceiling trim was observed to be chipped and scratched. Several stained ceiling tiles were observed throughout the building from possible roof leaks or pipe leaks.	Good

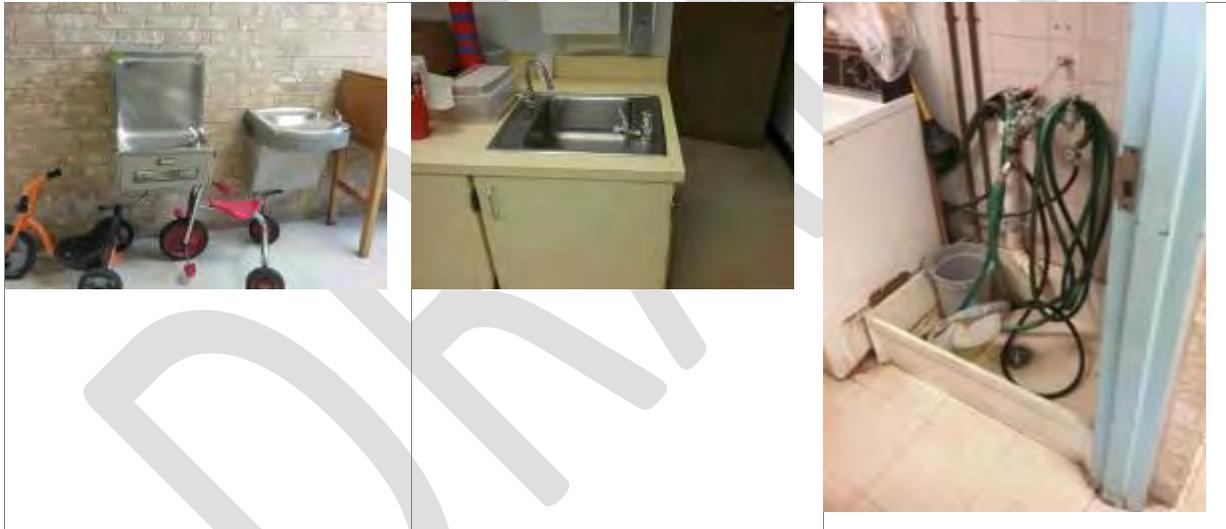
**Plumbing Fixtures**

<p>throughout the classrooms and one single occupancy restroom in the common area. The common area restroom has one wall mounted vitreous china water closet with a manual flush valve along with a wall mounted vitreous china lavatory with manual faucets. Typical classroom restrooms have a wall mounted vitreous china water closet with a manual flush valve and a stainless steel service sink with a drinking fountain attachment. In addition to the drinking fountains in the classrooms, there are four water coolers in the common space. There are also additional stainless steel sinks in the Art classroom along with a utility sink in the janitor's closet.</p> <p>The plumbing fixtures were observed to be in good condition. The only deficiency observed was one inoperable water cooler.</p>	
	Domestic Water Distribution	Domestic hot water for the building is provided by one water heater. The water heater is mounted above the drop ceiling in the janitor's closet and could not be accessed during the time of the survey. There were no reports of deficiencies with the water heater.	Good

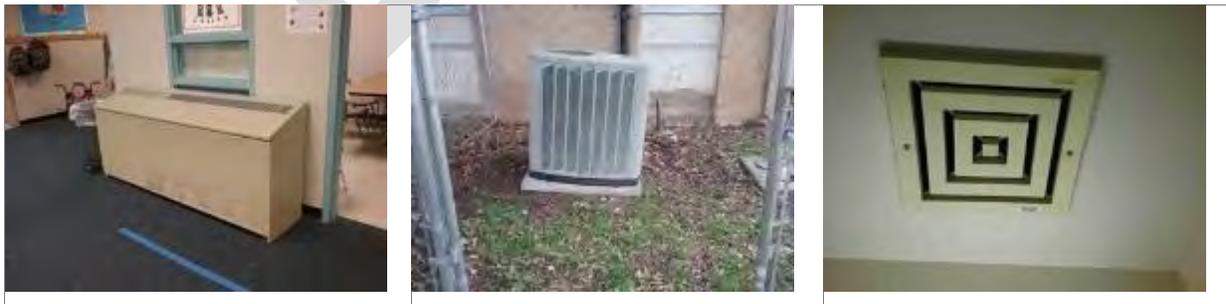
**Mechanical/HVAC System Deficiency Examples**

Other Plumbing	System not present.	N/A
<b>Mechanical/ HVAC</b>		<p>The building uses a series of water source heat pumps along and one split system for individual zone temperature controls. The water source heat pumps in each classroom are assumed to be three TON units, but limited nameplate information is available. The facility has exhaust fans in each restroom, the janitor's closet, the art storage room and the art kiln room.</p> <p>The HVAC system is in average condition. Staff did not report any complaints with the building's HVAC system, however the water source heat pumps are aged and approaching the end of their design life. The condensing unit on the exterior of the building is significantly tilted due to a settling concrete pad. The concrete pad and unit should be leveled to ensure optimum efficiency. Some restroom exhaust fans made excessive noise and should be serviced.</p>	Average

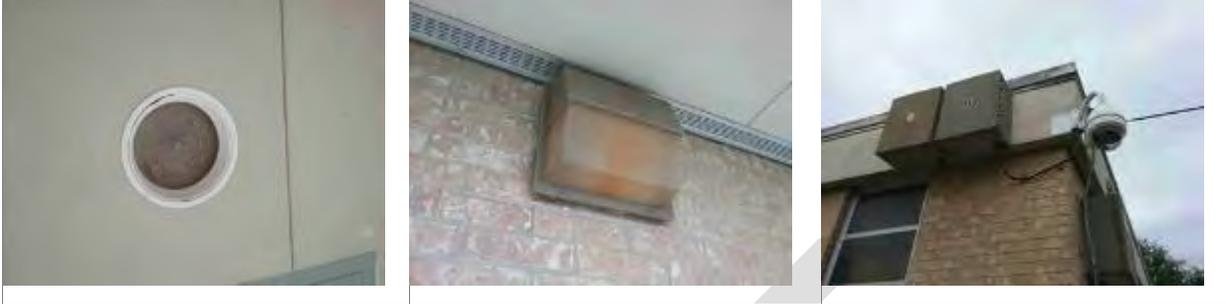
**Lighting**

<p>predominantly T8 fluorescent fixtures. Most corridors, offices, and classrooms had two foot by four foot lensed troffers. Emergency and exit lighting is located throughout the building. The exterior lighting was metal halide wall mounted fixtures. Common issues with the lighting were broken or missing covers and lamps that were either missing or inoperable. The building staff reported that the exterior lighting of the building was also inadequate. The exterior lighting should be upgraded by replacing degraded lenses and installing additional fixtures.</p>	
	<p>Communications &amp; Security</p>	<p>The security system consisted of cameras, proximity card readers, keypads, and control panels. No major deficiencies were observed during inspection. The building staff reported the security system does not provide sufficient coverage and additional cameras need to be installed.</p>	<p>Good</p>
