## Zilker Elementary School Site Summary

## Main School Building – BLDG-146A

Building Purpose	Administration Offices, Classrooms and Cafeteria
Building Area	42,029 SF
Inspection Date	August 15, 2016
Inspection Conditions	76°F – Cloudy and raining
Facility Condition Index

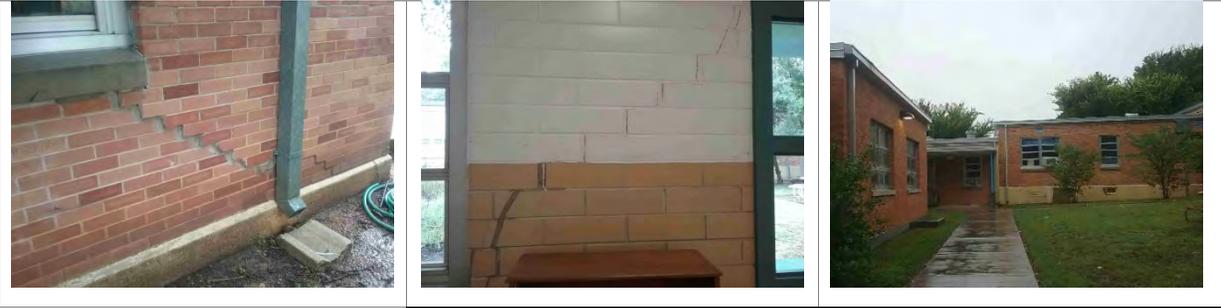
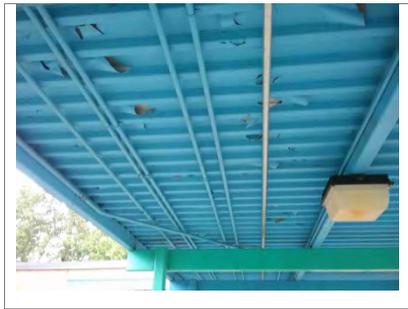
System	Subsystem	Condition and Deficiency Overview	System Condition Rating
Exterior	Exterior Walls	<p>The exterior walls are brick facade on structural concrete block. There are concrete sills at the exterior windows with painted stucco above that extends to the roof line. The 100- and 200-wings have concrete canopies at each exterior classroom door with painted metal support columns. The 300-, 400- and 500-wing classrooms have exterior covered walkways with painted metal support columns and corrugated metal soffit. The 500-wing has metal panels above the walkway that appear to have been transom windows at one time. The 400-wing has louvers at the top and bottom of the exterior wall that have been filled in with plaster and painted on the exterior. The foundation is painted outside Admin 5 and at the south end of the 300-wing.</p> <p>The exterior walls were observed to be in good condition with a few areas that required repair. There were step cracks and cracks through the brick and concrete block near the exterior door on the west side of corridor C4. There were also step cracks on the exterior brick on the west side of corridor C4 at the south end. The painted areas of the foundation were peeling outside Admin 5 and at the south end of the 300-wing. The paint was peeling on the metal covered walkway that leads to the Library from the 300- and 500-wings.</p>	Good

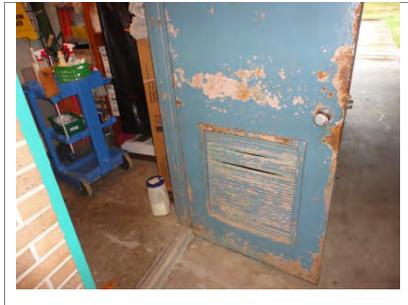
Exterior Doors	<p>The main entrance doors are aluminum frame with integral side lites and transom windows. The side lites appear to have a frosted film on the glass. The other exterior doors are painted hollow metal doors in painted hollow metal frames. The doors have wire glass vision panels and kickplates at the bottom. The exterior doors in corridor C4 have integral painted metal side lites with clear glazing on the upper half and solid metal panel on the lower half. The 400- and 500-wings have glazing on the upper half.</p> <p>The majority of exterior doors were observed to be in average condition due to age and exterior exposure in the 300-, 400- and 500-wings. The double doors at the south end of corridor C4 did not close properly. The door to CC500 was deteriorated and had peeling paint.</p>	Average
Roofing	<p>The roof includes a built-up roof covering with gravel surface and a metal gravel stop at the perimeter and a modified bitumen roof covering over the 200-wing, administration areas, and the west side of the cafeteria.</p> <p>The modified bitumen roof covering appeared to be in good condition. The gravel surfaced built-up roofing appeared to be in poor condition. There were large areas of ponding water observed on the surface. There was an active roof leak in room 400, the south wall of 502, and the bookroom. GRR500, CC500 and the west side of the cafeteria had evidence of previous roof leaks. Roof leaks were reported in rooms 200 and 206 by staff. The built-up areas are scheduled to be replaced in 2017 as part of the 2013 Bond Program.</p>		Poor

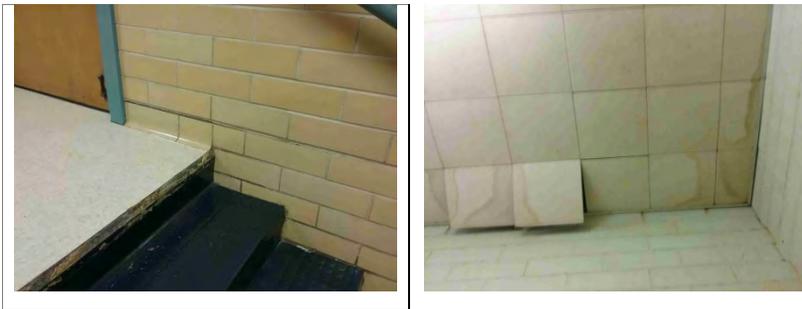
**Interior Walls**

System	Subsystem	Condition and Deficiency Overview	System Condition Rating
<b>Interior Construction</b>	Interior Walls	<p>The majority of interior walls are structural concrete glazed block with painted block above. There are select areas of gypsum board on metal stud framed walls in the cafeteria, lounge and at ceiling height transitions.</p> <p>The interior walls appeared to be in good condition with one area adjacent to the stairs in corridor C3 showing cracks in the mortar of the glazed block.</p>	Good
	Interior Doors	<p>The interior doors are wood doors with painted wood frames in the 100- and 200-wing classrooms. There are painted metal frames with hollow metal doors from the cafeteria to corridor C3.</p> <p>The metal interior doors were observed to be in good condition. The wood interior doors were observed to be in poor condition. The painted frames had peeling paint, and the door finish was worn, specifically at the classroom restroom doors. The louvers in the classroom restroom doors were also damaged and misaligned.</p>	Average

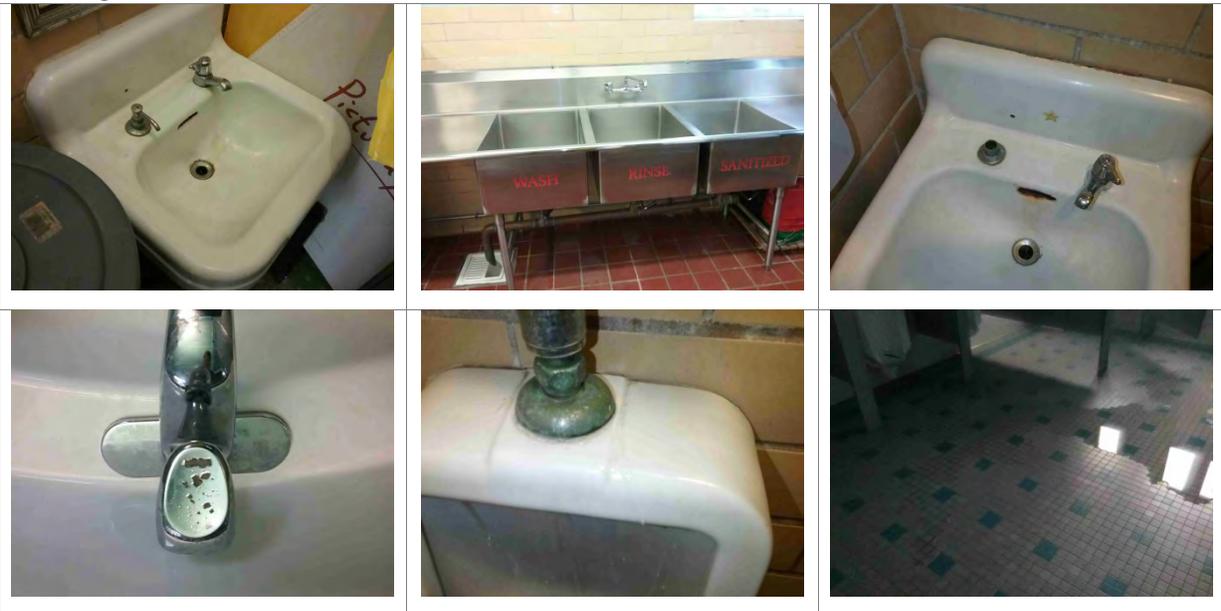
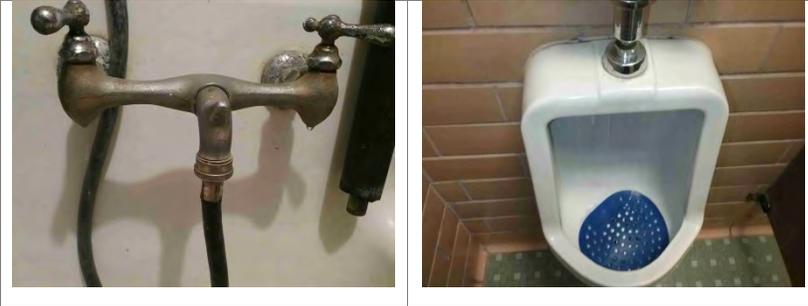
**Plumbing Fixtures**

Conveying		<p>The building is equipped with two wheelchair lifts. The first is a 750-lb lift for stage access. The second is a 495-lb lift for the elevated C3 landing.</p> <p>The conveying system appeared to be in good condition. Facility staff reported that the wheelchair lifts were inspected regularly and functioned well.</p>	Good
Plumbing	Plumbing Fixtures	<p>The building contains predominantly single-use restrooms throughout the facility. Multi-use restrooms are located outside the 200-, 300-, and 500-wings. Typical restrooms have floor-mounted vitreous china water closets with manual flush valves. Dedicated male restrooms contain vitreous china urinals with manual flush valves. Restrooms contain vitreous china sinks for handwashing. Some classrooms contain stainless steel basin sinks with drinking fountain attached. Stainless</p>	Average

System	Subsystem	Condition and Deficiency Overview	System Condition Rating
		<p>steel drinking fountains can be found in the corridors.</p> <p>A commercial kitchen is located in the school's cafeteria. The kitchen contains stainless steel kitchen equipment, including a triple-basin prep sink. It also has various wall-mounted vitreous china and stainless steel sinks for personal use. A coated cast iron trough handwashing sink with two faucets is located outside the kitchen.</p> <p>The building also has service sinks located in various janitorial closets. Various other rooms such as the lounge and Admin 4 have stainless steel basin sinks for personal use.</p> <p>The majority of the plumbing fixtures were observed to be in average condition, but were aged and showed signs of deterioration. The sink outside the restroom in room 200 had no water flow. Multiple sinks were observed to be rusted and original to the building. The sink in the restroom outside of room 206 was missing its soap pump handle. The triple-basin prep sink in the kitchen had no water flow. The faucet on the sink in GRR500 was damaged and peeling.</p> <p>Multi-use restroom BRR300 was observed to have a clogged urinal that caused leakage across the restroom floor. The janitorial sink in CC500 was leaking from the handles. The toilet in the restroom outside of room 102 had no water flow. The urinal in the male restroom outside of room 205 was leaking. The urinal in the restroom outside of room 101 was observed to have no water flow. Low flow was observed to the urinal in the restroom outside of room 206.</p>

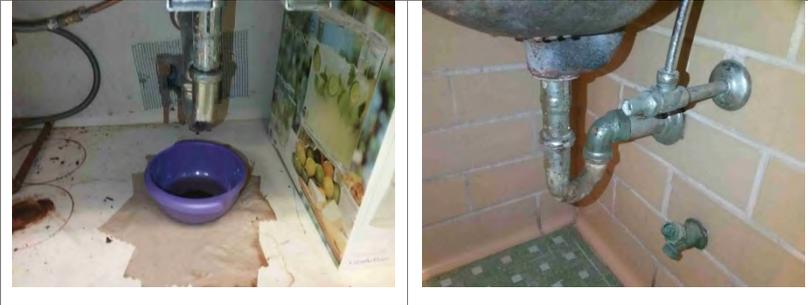
**Domestic Water Distribution**

Domestic Water Distribution	<p>Domestic hot water to the kitchen is provided by a 99-gallon gas-fired heater located in the KITMECH room. A smaller EWH (electric water heater) is located in the nurse's office to provide heated domestic water to the sink in the adjacent restroom. Domestic hot water is not supplied to the classroom plumbing fixtures.</p> <p>The gas water heater feeding the cafeteria and the EWH for the nurse's office were new and appeared to be in good condition.</p> <p>Distribution plumbing was observed to be aged and had signs of corrosion. The sinks in room 403, Admin 4 and the lounge had evidence of leaks underneath them.</p>	Average

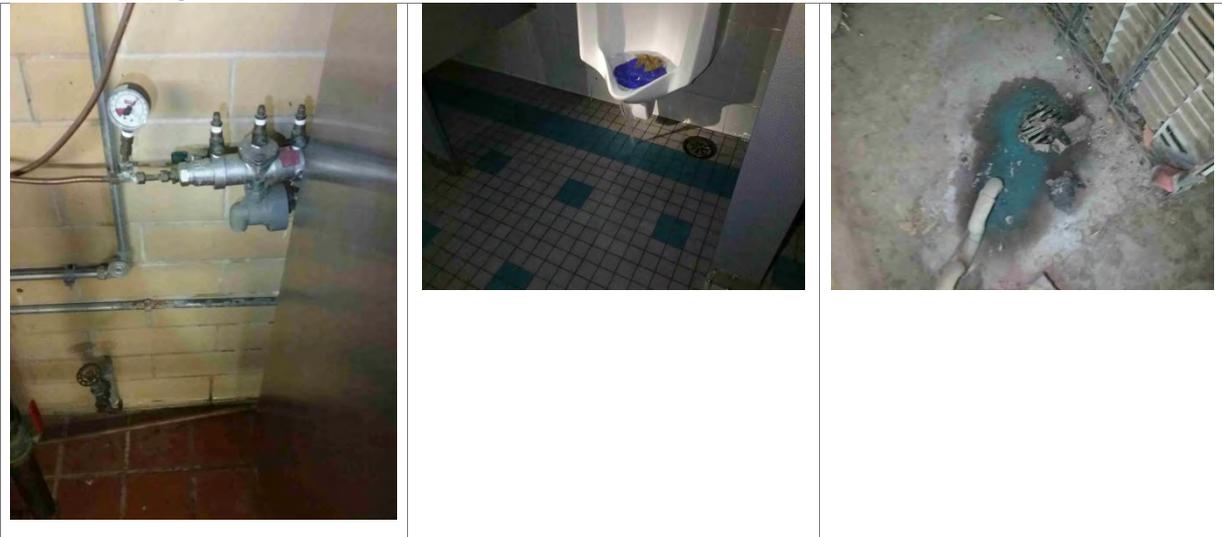
**Other Plumbing**

System	Subsystem	Condition and Deficiency Overview	System Condition Rating
	Other Plumbing	<p>Other plumbing consists of floor drains and a backflow preventer in the kitchen.</p> <p>Associated other plumbing appeared to be in average condition. Floor drains in the mechanical and electrical rooms were aged and corroded. The multi-use male restrooms BRR200 and BRR300 were emitting an odor, potentially coming from the floor drains. A backflow preventer in the kitchen leaked every time the toilet in the kitchen restroom was flushed.</p>	Average
<b>Mechanical/ HVAC</b>		<p>The building's HVAC (heating, ventilating, and air conditioning) system is primarily composed of air conditioner condensing units, AHUs (air handling units), heat pump systems, water source heat pumps, unit ventilators, RTUs (roof top units) and through-wall air conditioner units. Various-sized EFs (exhaust fans) vent the building.</p> <p>Unit ventilators had replaced water source heat pumps in some classrooms. The unit ventilators were newer and appeared to be in good condition. Room 401 had water stains in front of its unit ventilator, but this could have been from the previously replaced water source heat pump. Water source heat pumps were aged and reaching their end of expected design service life. Multiple water source heat pumps were making whirring or vibrating noises during operation. The water source heat pump in room 203 had a water line feeding it off the sink as an additional water source. This is not a typical design or operating condition for these units.</p> <p>Multiple pieces of equipment that were no longer in use and abandoned in place were observed throughout the building. Rooms ADMIN5 and ADMIN6 had heat pumps designated to them on the floorplan, but no units were observed during the assessment. It was assumed these units were in the ceiling.</p> <p>The HVAC system appeared to be in average condition with wear associated with the age of the units. Multiple HVAC units were using R-22 refrigerant, which is an outdated refrigerant that is being phased out of use. EFs throughout the building were reported in the facility interview to not be working properly.</p>	Average

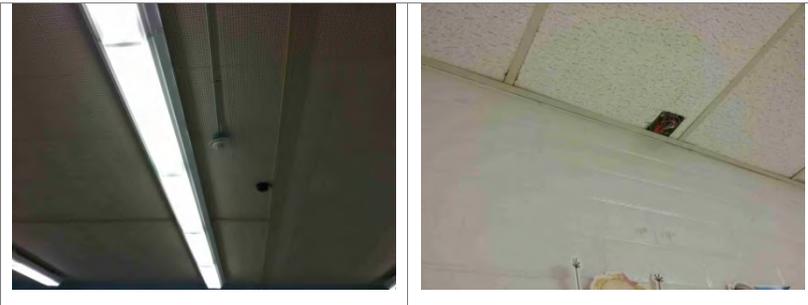
**Fire Alarm**

<b>Fire Protection</b>	Fire Alarm	<p>The fire alarm system consists of alarm and signaling devices such as strobes, horn/strobe combos, pull stations, and detectors. The fire alarm system is controlled by a Silent Knight control panel.</p> <p>The fire alarm system appeared to be in good condition. One detector end device was found improperly secured in room 303. Corridor C3 was observed with a missing end device.</p> <p>Facility staff reported that the fire alarm system was functioning properly.</p>	Good
	Fire Protection/ Suppression	<p>A fire suppression system is present for the range hood in the kitchen with a tank mounted to the wall at the ceiling. Fire extinguishers are located throughout the</p>	Average

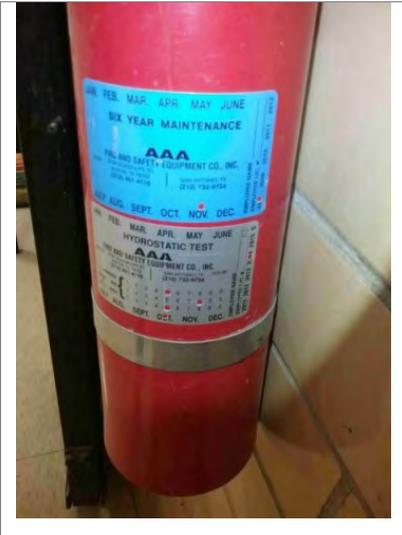
**Fire Protection/Suppression**

System	Subsystem	Condition and Deficiency Overview	System Condition Rating
		<p>building.</p> <p>Visual assessment showed the systems to be in average condition. The majority of the fire extinguishers were up to date with their inspections. The fire extinguisher in the corridor outside the cafeteria was out of date on its annual inspection.</p>	
<p><b>Electrical</b></p>	<p>Electrical Distribution</p>	<p>The building utilizes 120/240-volt panelboards for electrical distribution. The building receives electrical feed from BLDG-146D. The building does not have a lightning protection system.</p> <p>The electrical distribution equipment appeared to be in good condition. Panel 1P, located in the kitchen, was missing two breaker covers and should be considered a life safety hazard. Panel 1P was also installed within a decommissioned panel cabinet that had cabling exposed. Panel 2P, located in BKR300, was observed with a broken latch, and was inaccessible.</p>	<p>Good</p>

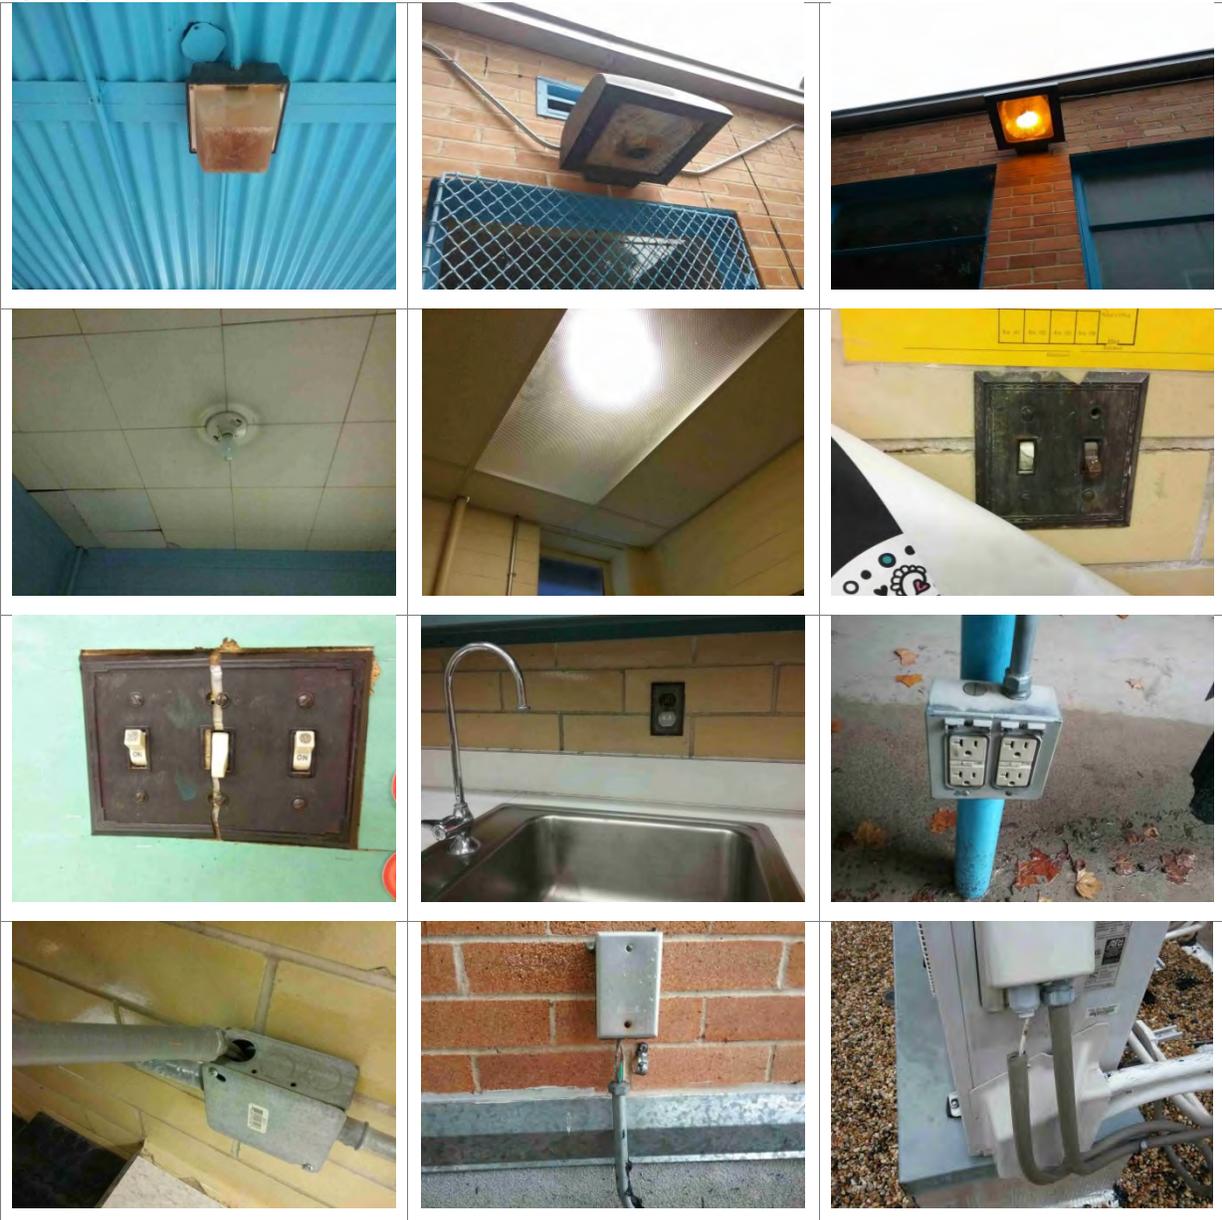
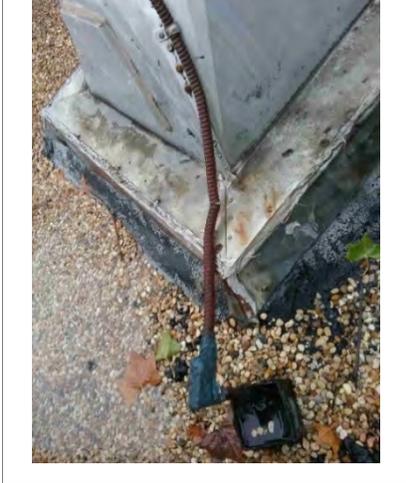
#### Lighting

<p>Lighting</p>	<p>The building's exterior lighting consists of wall-mounted and canopy fluorescent, metal-halide or high-pressure sodium luminaires. Exterior luminaires are located on the walls, egress points, and covered walkways. Interior lighting is predominantly recessed troffer, suspended, or surface-mounted fluorescent luminaires. Various downlights are in storage rooms, restrooms, and restroom vestibules, including screw-in fixtures with incandescent/CFL (compact fluorescent) lamps.</p> <p>The lighting system appeared to be in average condition. Several exterior luminaires were worn, discolored, or damaged. A few exterior luminaires had lamps nearing their end of design service life. Interior lighting deficiencies were limited to non-functional, burned-out lamps, or dim lighting. Branch wiring deficiencies included outdated or non-functional light switches, damaged faceplates, non-GFCI (ground fault circuit interrupter) electrical receptacles near sinks or water fountains, and exterior electrical receptacles with broken covers or no covers. Interior conduit was observed to be unsecured near the corridor wheelchair lift. Roof top conduit was damaged or unsealed in several areas.</p> <p>Facility staff reported that the lighting within the nurse's office was dim. Facility staff requested that future lighting replacements be LED (light-emitting diode) luminaires. Facility staff also reported that the current</p>	<p>Average</p>

System	Subsystem	Condition and Deficiency Overview	System Condition Rating
		<p>exterior lighting was dim and that additional or improved lighting for the portable area, playground area, and kitchen unloading area was required for exterior safety and security.</p>	
	<p>Communications &amp; Security</p>	<p>The building is equipped with telecommunications/data systems with the main equipment located in the inaccessible rooms MDF, IDF-B, and CUSTOFC. Networking Wi-Fi access points are installed throughout the building. The building utilizes traditional telephones for telecommunications.</p> <p>The building's security consists of surveillance cameras, motion detectors, and a proximity card access system. Exterior surveillance cameras overlook outdoor covered walkway areas, the main entrance egress, and the cafeteria egress. Interior surveillance cameras are located throughout corridors overlooking building egresses and within the kitchen. Motion detectors are installed throughout the building.</p> <p>The communications and security systems were observed to be in good condition. No deficiencies were observed during the assessment.</p> <p>Facility staff reported that the data/Wi-Fi system was functioning properly. Facility staff reported that the existing surveillance cameras had poor resolution and requested additional surveillance cameras for the interior corridors and near parking lots.</p>	<p>Good</p>

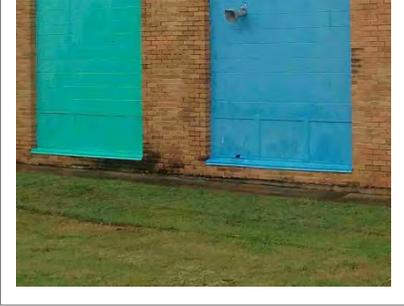
System	Subsystem	Condition and Deficiency Overview	System Condition Rating
<b>Exterior</b>	Exterior Walls	The exterior walls are brick and CMU (concrete masonry unit). There are louvers in the CMU walls that have been closed off and painted.  The brick façade and painted CMU appeared to be in average condition due to age. There were areas of the brick that were soiled due to water sheeting off the roof.	Average
	Exterior Windows	System not present.	N/A
	Exterior Doors	The exterior doors are painted metal doors and painted metal frames. The two entrance doors have vision panels with wire guards over them. The exterior door out of GYMSTO does not have a window.  The exterior doors appeared to be in good condition.	Good
<b>Roofing</b>	The main roof is a sloped modified bitumen roof covering with eight skylights. There is a lower roof area over the storage room and office that is a built-up roof covering. There are gutters on the north edge of the main roof and lower built-up roof. There is no gutter on the south side. There is no roof access ladder, but the majority of the roof is visible from the main school roof.  The modified bitumen roof appeared to be in good condition. The lower built-up roof was scheduled to be replaced as part of the 2013 Bond Program.		Good

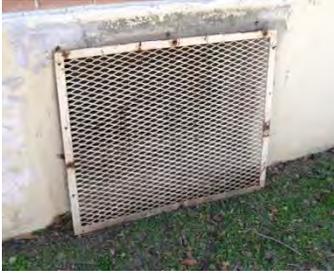
<p>Screwed shut access hatch</p>

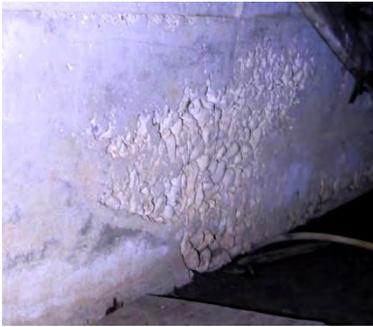
Exposed Structure

<p>Moderate honeycombing in suspended perimeter beam</p>

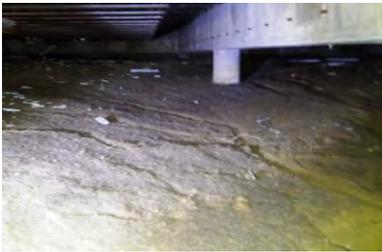
<p>Overturned soil retainers</p>

<p>Saturated soil &amp; drainage paths</p>

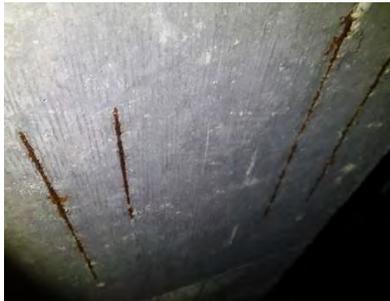
<p>Honeycombing on perimeter beam</p>

<p>Exposed reinforcement under beam</p>
