STRUCTURAL ASSESSMENT – Bryker Woods ES – Main Building (BLDG-110A)

Building Purpose	Administrative offices, Gym, Classrooms and Cafeteria
Inspection Date	September 23, 2016 (Morning)
Inspection Conditions	N/A - Indoors only

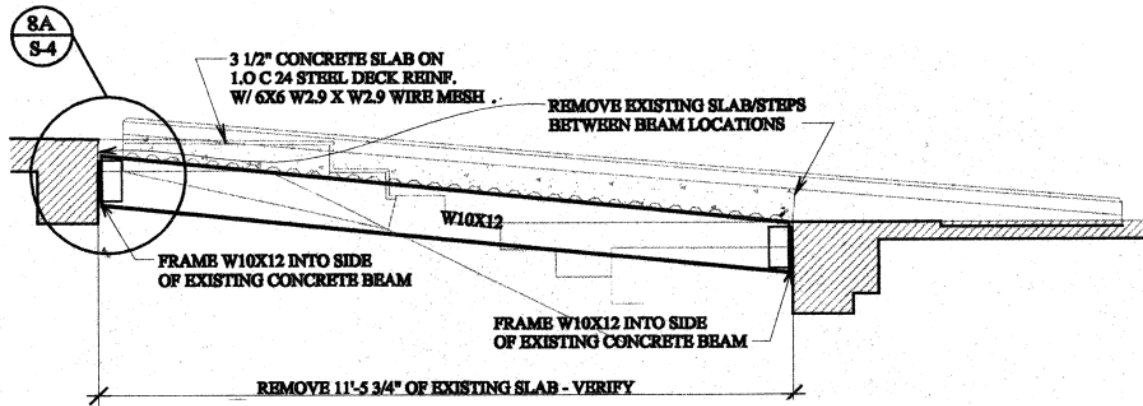
The east half of the 1939 stairs and 1948 slab were demolished in 1998 to install the ramp. The ramp consists of two sloping steel wide-flange stringers supporting galvanized steel conform deck. The stringers are supported by a 1948 concrete beam at the bottom and a 1939 beam at the top of the ramp. The top portion of the existing stairs was demolished to make room for the ramp slab.
