## STRUCTURAL ASSESSMENT – Burger Athletic Complex Stadiums (BLDG-951M&N)

| Building Purpose | Stadium Seating |
| Inspection Date | September 23, 2016 and<br>November 14, 2016 |

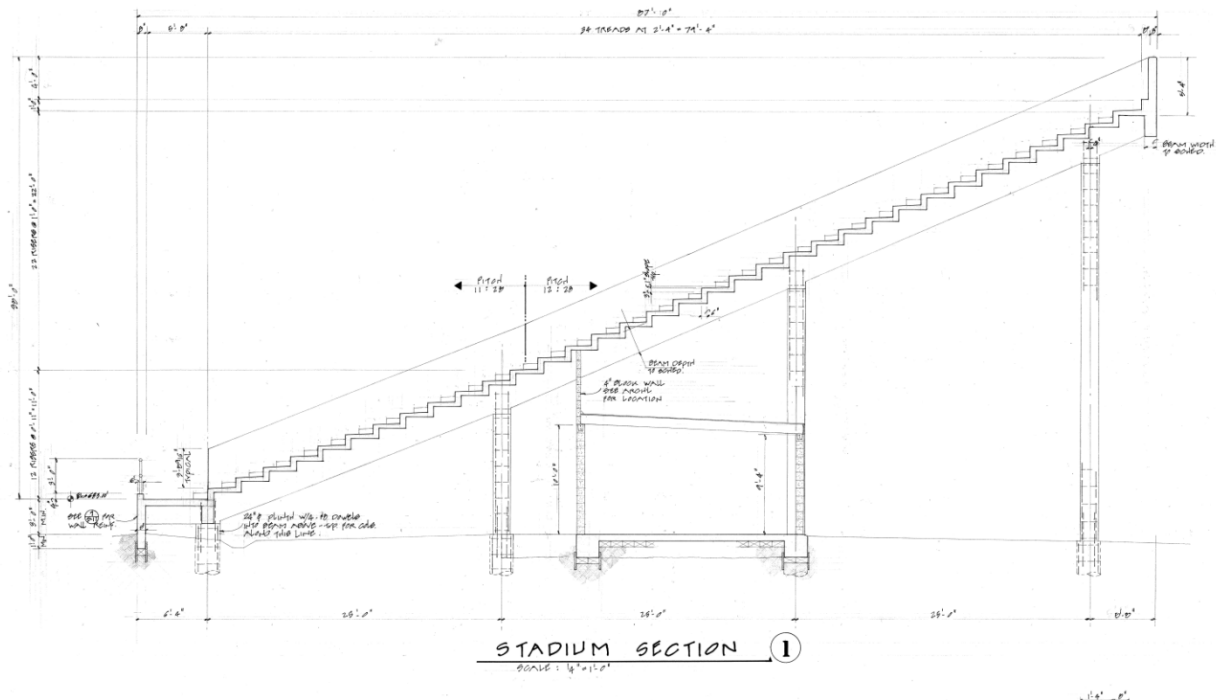
**Brief Description of Existing Stadium Seating Structure:** The east and west stadium structures consist of cast-in-place, suspended concrete framing. At ground-level, the concession area and other enclosed spaces are supported on a suspended flat slab and suspended edge beams. The low side of the stadium seats is supported on suspended foundation beams running north-south and span between piers. The low side beams are not connected to or braced by any ground-level framing in the east-west direction. Void spaces below beams and slabs are maintained by precast concrete soil retainers. The high side of the stadium seats is supported by tall 18" square cast-in-place concrete columns bearing directly on isolated drilled piers; no ground-level beams or slabs brace the top of piers/bottom of columns or connect them together. The stadium seats are framed with sloping beams that span between columns in the east-west direction (perpendicular to the seats). Cast-in-place concrete, stepped deck and vertical joists form the stadium seats and span north-south between beams. See typical section below from the original plans dated 5-26-1975:

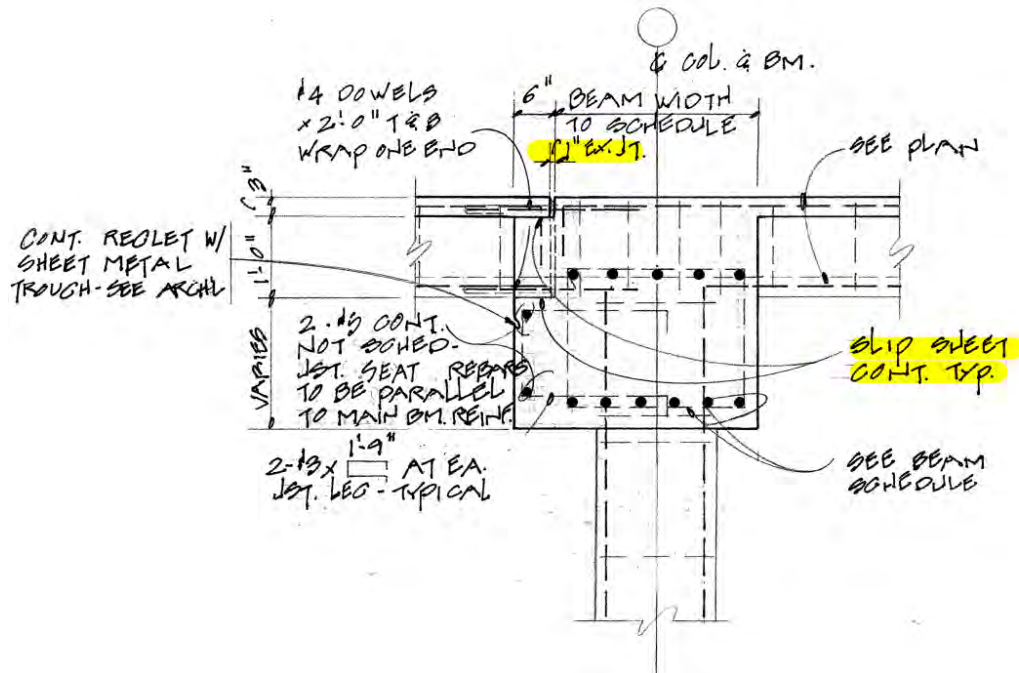
joint (the center section of the stadium) bear on top of the same beam but are isolated from the beam with slip sheeting to allow lateral movement. The detail below depicts the concrete framing at intermediate expansion joints:

- East Stadium Intermediate Expansion Joints:** Both the reported daylight visible through the east stadium structure and the cracking noted in the concrete framing and CMU walls are located near the south intermediate expansion joint. At this location, the deck/joists to the south of the expansion joint are cast integrally with the beam while the deck/joists on the north side are isolated from the supporting beam. At the north expansion joint, the deck/joists to the north of the expansion joint are cast integrally with the beam while the deck/joists on the

south side are isolated from the supporting beam. At the north intermediate joint, a horizontal separation of the deck/joists on either side of the joint ranged from 1" to 3" and a vertical upward displacement of approximately 1" was visible from where the isolated north deck was originally cast against the beam. At the south intermediate joint, a horizontal separation of approximately 1" and a vertical displacement of approximately 2" were measured from where the south deck was originally cast against the beam. For both intermediate joints in the east stadium structure, vertical separation was primarily found along the beam near where it intersected with the CMU wall; everywhere else along the beams had little to no vertical separation between the beam and the stand framing bearing on it. Where it could be measured, the bearing width of the isolated stand framing was measured as approximately 4" (measured near CMU walls). The beam was starting to spall on the top corners where the isolated stand above was bearing on the beam. The spalls appeared to be a mix of old and recent activity and spalled concrete was caught in the gutter. Severely cracked and spalled concrete was observed at the top of the deck near the horizontal expansion joint dowels that connect the deck on each side of the joint. The concrete in this area appeared to have been repaired in the past (presumably in 2006) but new damage has since developed. Water staining is prevalent on the vertical faces of the beams below the intermediate joints.

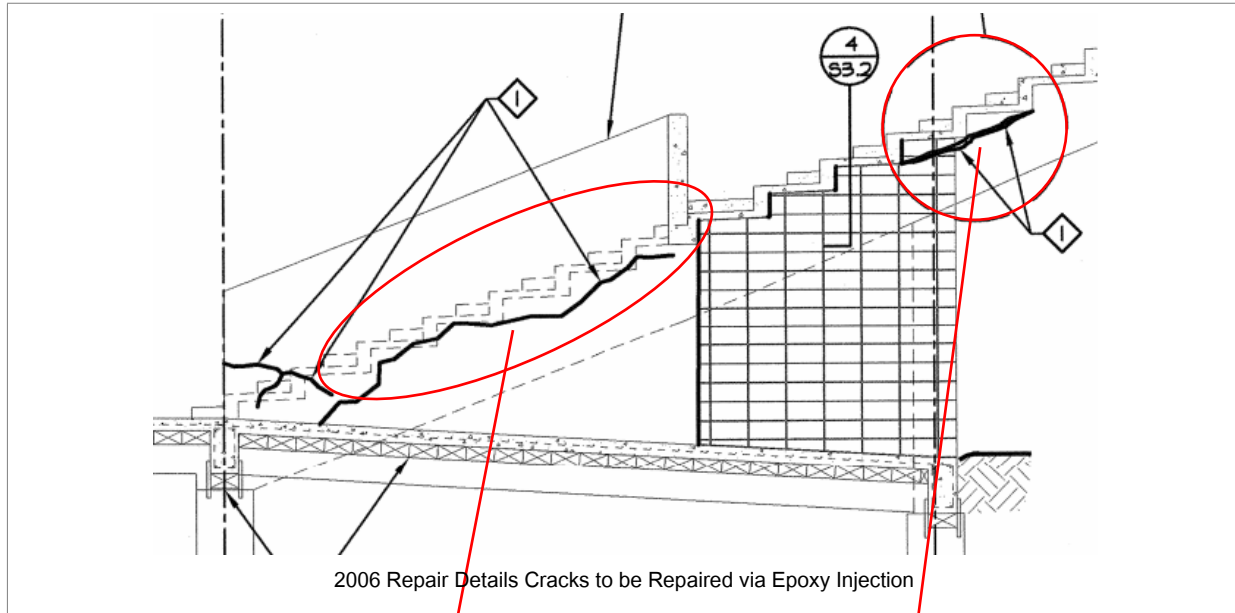
Cracks at south ramp wall do not appear to have been repaired via epoxy injection

Structural repair work required includes repairing spalled/cracked/honeycombed columns, beams, slabs and joists throughout both stadium structures. Exposed/corroded reinforcement needs to be cleaned and protected from further water exposure. Top of stadium decks require a waterproofing membrane to prevent further water infiltration.

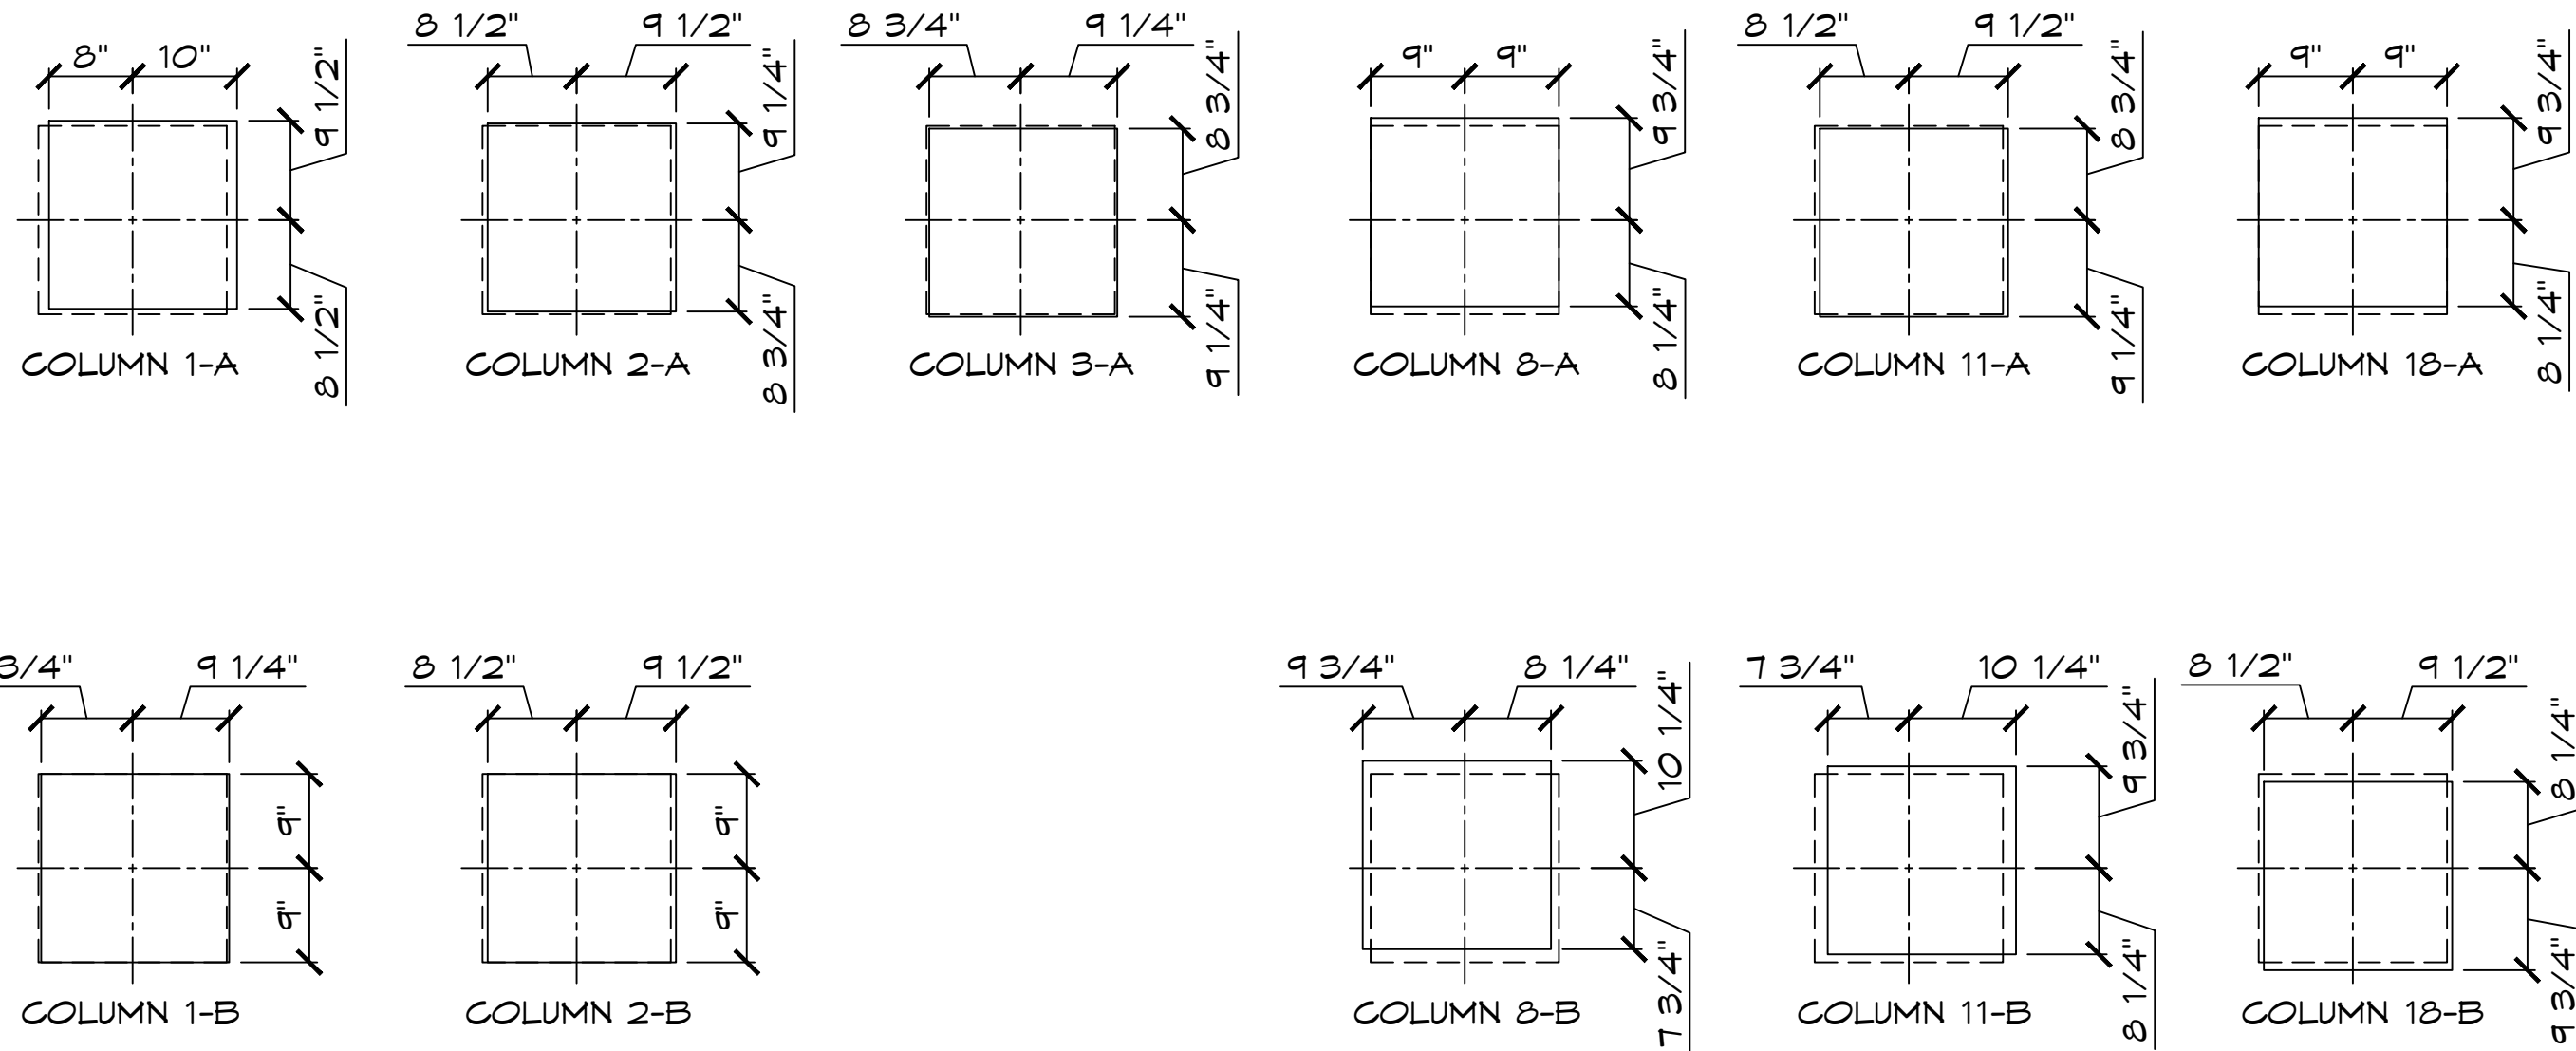
- **Columns:** Flexural cracks were observed near the base of several tall columns along the back side of both stadium structures. Similar flexural cracking was also observed at the tops of several tall columns; some of these cracks had been previously repaired and some of the repaired cracks have re-opened. Severity of the cracking at the top of the column roughly matches that of the cracking at the bottom of the column but the top cracks were typically on the opposite face from the bottom cracks. Additionally, several of the tall columns visually appeared to deflect laterally (i.e. appeared to be leaning). Generally, columns north of the north expansion joint deflect towards the north while columns south of the south expansion joint deflect towards the south.

- 1) THE DASHED COLUMN REPRESENTS THE POSITION OF THE COLUMN AT THE TOP OF THE COLUMN.
- 2) THE SOLID COLUMN REPRESENTS THE POSITION OF THE COLUMN AT THE BOTTOM OF THE COLUMN.
- 3) THE DASHED CENTERLINES ARE FOR THE TOP OF COLUMN.
- 4) MEASUREMENTS ARE FROM THE EDGES OF THE BOTTOM COLUMN TO THE CENTERLINE OF THE TOP COLUMN.
