ALC Ridgeview Special Campus Site Summary

Main School Building – BLDG-012A

CRAWL SPACE – Ridgeview ALC – Main School Building (BLDG-012A)

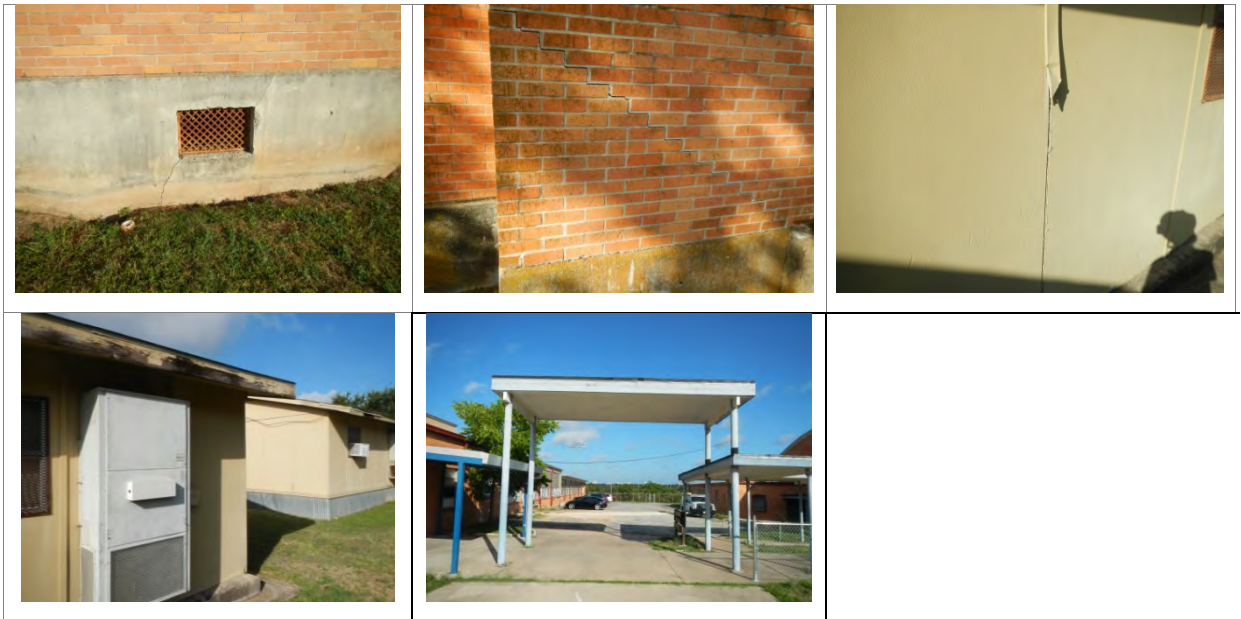
System	Subsystem	Condition and Deficiency Overview	System Condition Rating
Exterior	Exterior Walls	<p>The exterior of the building consists of a brick façade around the entire building with the upper portions of the southwest wall of the cafeteria, the library walls, and the courtyard walls southeast of the gymnasium, consisting of glass blocks. The walls for the wing for rooms 411-414 consist of wood paneling. The roof top penthouses consist of corrugated metal panels.</p> <p>The exterior walls were observed and reported to be in poor condition. It was reported that there was rotting wood in the rear canopy adjacent to the 100-wing. It was observed that there were angled cracks in a crawlspace vent on the southeast side of the 400-wing, as well as along the entire northeast end of the facility from room 534 to the gymnasium. Also observed was damage to the wall panel connection strip and corrosion</p>	Poor

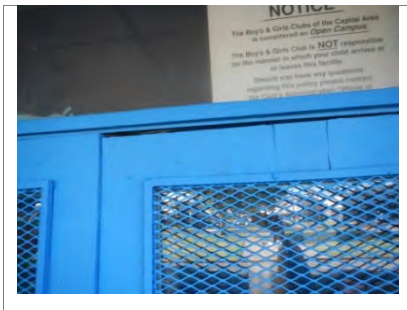
System	Subsystem	Condition and Deficiency Overview	System Condition Rating
		on the eaves, both on the northeast side of room 413. It was also reported that the wing that starts at the intersection of corridors C5 and C6 and encompassing all the 500-wing rooms along corridor C3 to the gymnasium have been condemned by the district.	
	Exterior Windows	<p>The exterior windows consist of single pane acrylic, corrugated plastic, and glass in metal frames throughout the facility. The bottom window panel is a casement window on the classrooms.</p> <p>The exterior windows were observed to be in poor condition. It was observed that the majority of acrylic windows were broken and cracked where openings to the facility were present. There was also damage to the corrugated plastic window frame in the gymnasium courtyard.</p>	Poor
	Exterior Doors	<p>The exterior doors consist of six public entryways located around the building. These entryways consist of metal doors with glass with glazing in metal frames, glass transoms, and storefronts. The access doors to the mechanical spaces are solid metal doors in metal frames. The exterior office spaces in the 400-wing have a solid metal door with glazing in metal frames.</p> <p>The exterior doors were observed to be in poor condition. The exit doors on the northwest end of the 100-wing and the northeast exit doors to the gymnasium have large gaps with visible daylight. It was reported that the exit doors on the northeast end of the 100-wing do not lock properly. The staff would like all exterior doors replaced.</p>	Poor

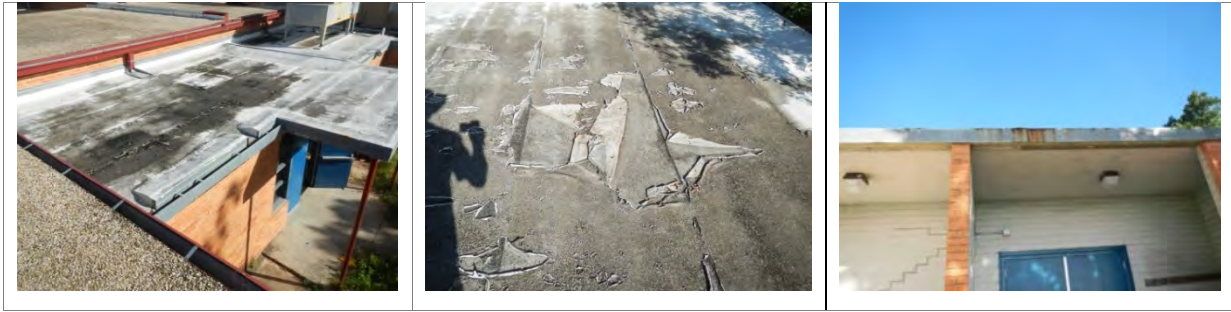
Roofing Deficiency Examples

Roofing	<p>The roof material covering the building consists of the following: a mix of built-up roof with a medium granular surface, primarily in the center of the facility; a modified bitumen roof on the southeast end and gymnasium and over a portion of the 100-wing and 400-wing; a metal roof on all mechanical penthouses located on the roof; and asphalt shingles on rooms 411 through 414.</p> <p>The roof was reported and observed to be in poor condition. It was reported that there were soft areas of roof above rooms 110 and 116. It was observed that the roof on the northeast side of the facility had many soft spots. There was evidence of ponding water on the majority of the roof where modified bitumen was present. The southeast side of the building had modified bitumen that was observed to be peeling. The gutters and down spouts have significant corrosion. The CAC and Principal Kathy Redondo have also reported that there are a number of roof leaks throughout the building.</p>		Poor

1. Further inspect and assess damaged sections of roofing and either repair damaged sections or replace roofing.

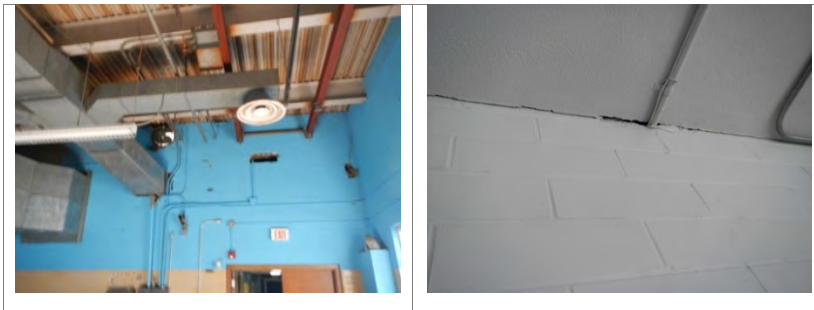
System	Subsystem	Condition and Deficiency Overview	System Condition Rating
Interior Construction	Interior Walls	<p>The interior partitions are predominately constructed of clay fired brick with gypsum board on the upper portions throughout the majority of the corridors and classrooms. The southeast and northwest ends of the 400-wing consist of wood paneling.</p> <p>The interior partitions were observed to be in average condition. It was observed that there were large holes in the walls in the northeast walls of the stage behind the gymnasium. A crack running along the ceiling and wall joint in the room GYMSTO5 was also observed.</p>	Average
	Interior Doors	<p>The building interior doors consist of wood doors and frames. There are metal doors in metal frames in the southeast 400-wing.</p> <p>The interior doors and frames were reported and observed to be in poor condition. It was observed that there were damaged double doors that access a storage room in the gymnasium. Damage to the door to room 413 was also observed.</p>	Poor

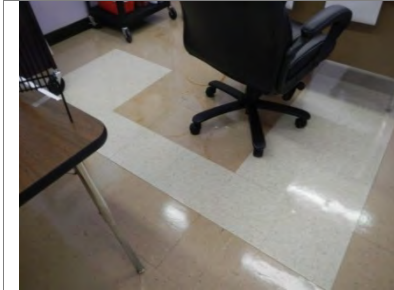
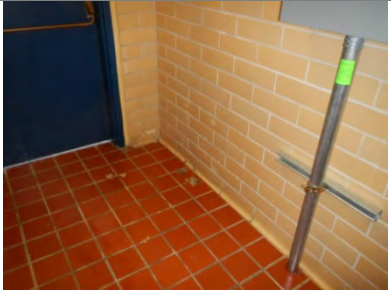
System	Subsystem	Condition and Deficiency Overview	System Condition Rating
		also observed. Water damage to the wall in the room GYMSTO4 was evident.	
	Interior Floor Finishes	<p>Vinyl floor tile is found throughout the classrooms, janitorial closets, southeast and northwest corridors, and cafeteria. The office space has carpeted flooring. Ceramic tile floor is present in the restrooms and old kitchen area. There is a wood stage located at the front of the cafeteria.</p> <p>It was observed that the flooring in all areas was in average condition. It was reported that there were soft spots in the gymnasium flooring. The kitchen floor un-level in places. It was reported and observed that the flooring had a slight drop along the corridor near the northwest end of the 400-wing. This was causing tiles to crack and floors to buckle. There was also chipped tile observed throughout the gymnasium locker room.</p>	Average

4. Level the flooring in the kitchen.
5. Re-level the classrooms 411- 414 and replace the damaged vinyl tile.

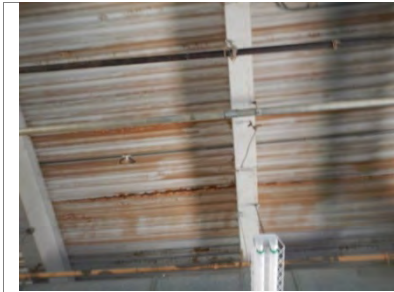
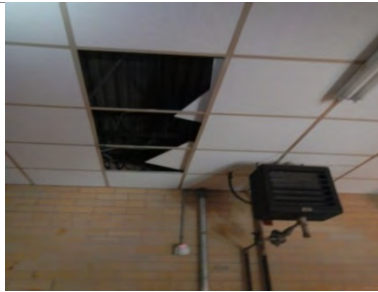
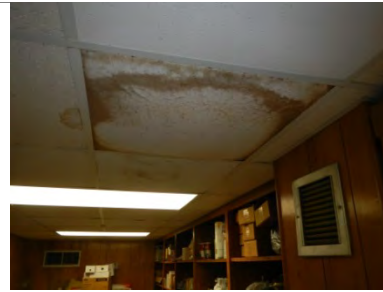
Interior Ceiling Finishes	<p>The ceiling consists predominantly of 2'x2' acoustic ceiling tiles throughout the classrooms, office spaces, restroom, and kitchen. The gymnasium has 2'x4' acoustic ceiling tiles. The gymnasium stage has exposed roofing and girders. The storage spaces have gypsum board.</p> <p>The ceiling finishes were observed to be in average condition. It was observed that the gymnasium stage ceiling is exhibiting signs of corrosion. There were missing and water damaged ceiling tiles throughout the facility.</p>	Average
Conveying	System not present.		N/A
Plumbing	Plumbing Fixtures	<p>The building has public male and female restrooms located throughout the facility. The male and female restrooms in public areas typically have triple basin acrylic polymer hand sinks in counters with automatic faucets for the students, along with vitreous china, floor-mount toilets with manual flushing mechanisms, and vitreous china, wall-hung urinals in the male restrooms with manual flushing mechanisms. There are pedestal mounted drain service sinks in the janitorial closets. Water coolers are located throughout the facility, typically near the public restrooms.</p> <p>The plumbing fixtures were observed to be in average condition. It was observed that the water fountain in room 413 was not functioning. The following deficiencies were also reported by facility staff: toilets and urinals throughout the facility were in need of</p>	Average

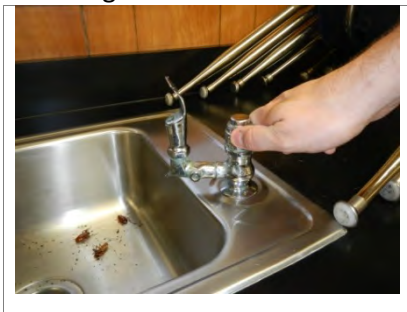
Plumbing Fixtures

System	Subsystem	Condition and Deficiency Overview	System Condition Rating
		replacement, with the exception of the gymnasium; fixtures in rooms 107 and 109 had frequent drain clogs; the kitchen grease trap and grease line were in need replacement.	
	Domestic Water Distribution	There are two boilers and a distribution network for the school. There is a gas water heater for the kitchen. The distribution for this system was observed to be in average condition. The water heater for the kitchen was reported to be too small for full time use. The sewer line to the street was also reported to be in need of replacement as it was beyond its design service life.	Average
	Other Plumbing	The other plumbing systems on this building consist of roof drains. The condition of the roof drains was observed and reported to be poor. It was reported that the roof drains had frequent clogs because of pea gravel from the roof, including the AC (air conditioning) roof drains above room 107 and 109. Roof drain filters were observed to be missing on the northeast side of the roof.	Poor

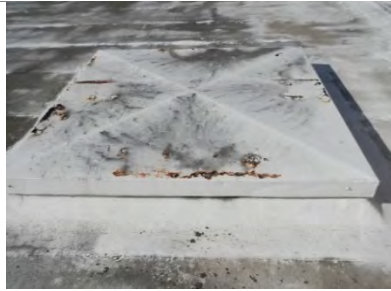
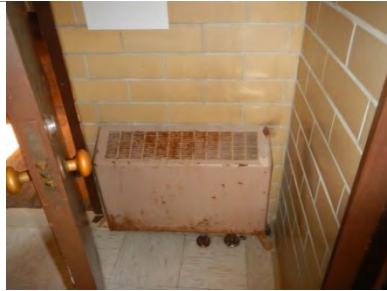
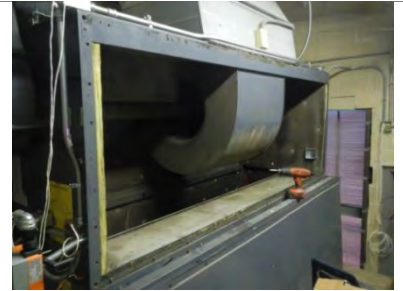
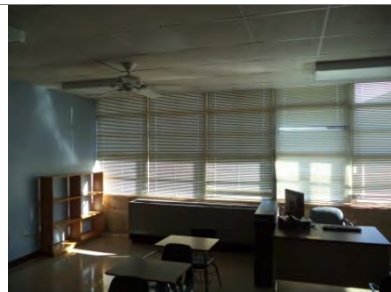
Mechanical/HVAC System Deficiency Examples

Mechanical/ HVAC	<p>The major mechanical equipment consists of seven AHUs (air handling units), three condenser units, and one heat pump) located on the roof of the facility. Eight AHUs are located throughout the inside of the facility. FCUs (fan coil units) are located in each classroom. These serve the HVAC system for the Main School Building. Supplemental mechanical equipment for the HVAC system also includes 23 EFs (exhaust fans) located on the roof of the building. The mechanical/HVAC system was reported and observed to be in poor condition. It was reported that the classroom FCUs will be reaching the end of their design service life in the next ten years. The humidity was inconsistent as the FCUs did not have climate controls. There was damage to the ceiling fans in rooms 110 – 116. The boiler hot water pipes branch lines had heave corrosion and leaks in the crawl space. The school hot water pipes were in need of replacement. The EFs for the restrooms were not functioning properly. The roof top EFs will need to be replaced in the next ten years. It was observed and reported that the 400-wing does not have a fully functioning air conditioning system. It was observed that there was corrosion on the mechanical equipment cover in the east corner of the roof section A-35. There was abandoned mechanical equipment located adjacent to the room GYMSTO5. The AHU11 and AHU12 were at the end of their design service life.</p> <p>It was reported that a current project is in place to repair existing problems. The scope of work includes: a new mechanical/electrical plant building; two new 180-TON air cooled chillers and chiller yard; replacement of two boilers with new piping and venting; controls for new equipment and the five existing AHUs; a new chilled water system, including cold water pumps, chillers and motors; a new heating system, including boilers, hot water pumps and motors; and replacement of the electrical system. PM Rick Kaven reported that during Summer 2016</p>		Poor

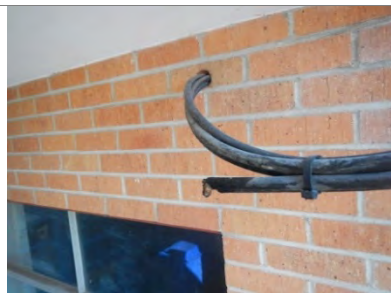
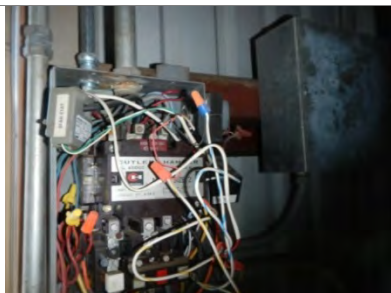
System	Subsystem	Condition and Deficiency Overview	System Condition Rating
		installation of two air cooled chillers, two boilers, hot and chilled water pumps with corresponding pipe was completed. The CAC and Principal Kathy Redondo reported that there are still ongoing heating, cooling, and humidity issues with the HVAC system.	
Fire Protection	Fire Alarm	The building has a fire alarm system that consists of alarm and signaling devices such as horns/annunciators, pull stations, and detectors. The fire alarm system is controlled by a control panel. The fire alarm system was reported and observed to be in average condition. It was reported that the fire alarm in the gymnasium was not loud enough.	Average
	Fire Protection/ Suppression	The building has a series of fire extinguishers for fire protection. There were no reported or observed concerns with the fire protection system.	N/A
Electrical	Electrical Distribution	The electrical service enters the building at the 480V/277-volt 3 phase 4 wire to main switchboards located in the main electrical room. The service steps down to 277V/120 system secondary transformers and panelboards, located in various electrical rooms throughout the building which branches into all circuits. The building does not have a lightning protection system. The electrical distribution equipment was reported to be in average condition. It was reported that the sub panels in the 100-wing adjacent to the janitorial closet were in need of replacement. It was observed that there was exposed wiring that was not properly capped and removed adjacent to the cafeteria. There was exposed and unkempt wiring located in penthouse A-07. PM Andrew Miller reported that the electrical distribution at the stage in the 500-wing should be considered for replacement.	Average

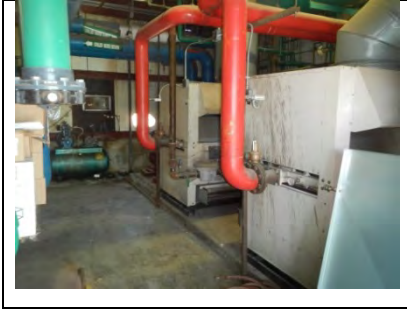
Mechanical/HVAC

System	Subsystem	Condition and Deficiency Overview	System Condition Rating
Interior Finishes	Interior Wall Finishes	System not present	N/A
	Interior Floor Finishes	The flooring consists of unfinished concrete flooring. It was observed that the flooring in all areas was in good condition.	Good
	Interior Ceiling Finishes	The ceiling consists of exposed roofing. The ceiling finishes were observed to be in poor condition. It was observed that corrosion is occurring on the exposed metal roof decking.	Poor
Conveying	System not present.		N/A
Plumbing	Plumbing Fixtures	System not present.	N/A
	Domestic Water Distribution	The only distribution is for chill water to the boiler system to the Main School Building. The distribution system was reported and observed to be in poor condition. This equipment was aged beyond its useful life.	Poor
	Other Plumbing	System not present.	N/A
Mechanical/ HVAC	The major mechanical equipment in this building consists of chillers and two boilers. The mechanical/HVAC system was reported and observed to be in poor condition. It was reported that boilers were scheduled to be decommissioned. The chillers and boilers were aged and reaching the end of useful life.		Poor
