Akins High School Site Summary

Address	10701 S. 1 st Street Austin, TX 78748
Number of Permanent Campus Facilities	7
Original Year of Construction	2000
Total Campus Building Area (combined)	346,839 SF

Introduction

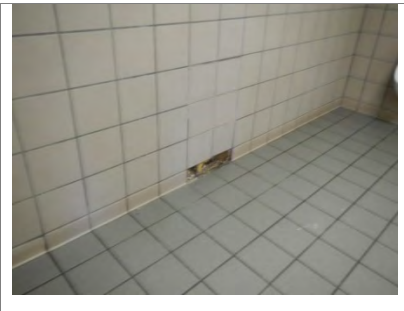
System	Subsystem	Condition and Deficiency Overview	System Condition Rating
		length along each corridor. The stairs are metal pan stairs with poured concrete steps and vinyl non-slip surfaces. The interior stairs were observed to be in good condition. The stair handrails were observed to have deteriorating paint with exposed metal railing.	
Interior Finishes	Interior Wall Finishes	The school entry foyer and corridors consists of painted interior surfaces of CMU, shotcrete, and gypsum board. The classrooms and office spaces consist of gypsum board. Restrooms consist of ceramic tile walls. The interior wall finishes were observed to be in good condition. Instances of minor cracking, chipping, and scraping were observed throughout all wall surfaces due to normal use and wear.	Good
	Interior Floor Finishes	VCT (vinyl composition tile) flooring is present throughout the common areas along common corridors, classrooms, and janitorial spaces. The VCT is original to construction. There is carpeting in the library, office spaces, conference rooms, and elevator. The restrooms have ceramic tile flooring. The floor finishes were observed and reported to be in good condition. Missing tile was observed in the male restroom adjacent to room 256.	Good

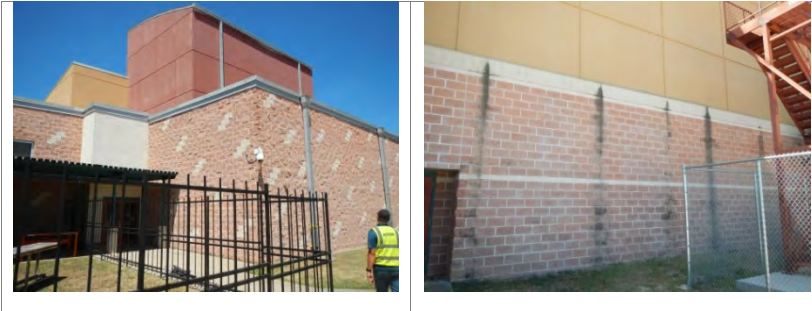
System	Subsystem	Condition and Deficiency Overview	System Condition Rating
Exterior	Exterior Walls	The exterior of the building consists of a CMU and shotcrete panel façade. The exterior walls were observed to be in good condition and had normal wear due to age and use of the facility. Minor wall stains were observed around the facility.	Good
	Exterior Windows	The exterior windows consist of single-pane glazing units with metal frames. Classroom windows typically have an upper fixed pane and a lower casement pane. Other windows observed include fixed pane and single pane with metal muntins. The windows are original to construction. The windows were observed to be in good condition and had normal wear due to age and use of the facility.	Good
	Exterior Doors	There is one main public entryway located at the west side of the building. These doors consist of two pairs of double doors that are metal with interior glazing and a metal frame and glass transom. The remaining access doors are metal double doors with interior glazing and metal frames with the exception of the mechanical and electrical room service doors, which are solid single metal doors in metal frames. Mechanical open-air spaces enclosed by CMU walls have a wood picket door access. The doors were observed to be in good condition and had normal wear due to age and use of the facility.	Good

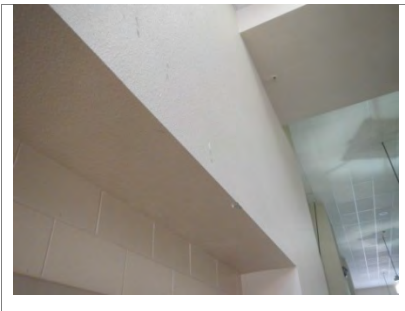
Interior Wall Finishes

System	Subsystem	Condition and Deficiency Overview	System Condition Rating
		<p>grade splash blocks.</p> <p>Based on reports and observations, the roof condition was rated as average. Water leaks were reported in the ceiling above the Band Hall. The sheetrock above the ceiling tiles in these locations had not been replaced. It was observed that the roof downspouts and gutters around the facility were experiencing leakage. It was observed that the modified bitumen roofing throughout the facility was experiencing bubbling.</p>	
Interior Construction	Interior Walls	<p>The walls consist of CMU on the lower portion of the walls and gypsum board on the upper sections of the wall. Corridors consist of gypsum walls. Theater space has gypsum board walls. Restrooms consist of ceramic tile walls. Music rooms contain gypsum and acoustic fiber wall tiles.</p> <p>Based on reports and observations, the interior walls were rated as average. Damage was observed throughout the school with minor cracks, chipping, and scraping in the walls due to normal wear and use.</p>	Average

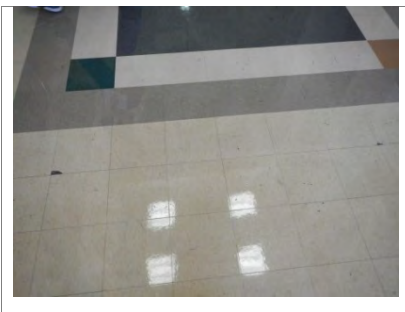
Interior Doors	<p>The portions of the building original to construction have wood doors with metal frames and metal-framed interior windows.</p> <p>Based on reports and observations, the interior doors were rated as good.</p>	Good
	Interior Specialties	System not present.	N/A
Stairs	Exterior Stairs	System not present.	N/A
	Interior Stairs	System not present.	N/A
Interior Finishes	Interior Wall Finishes	<p>Corridors consist of painted gypsum and CMU walls. Restrooms consist of ceramic tile walls.</p> <p>The interior wall finishes were observed to be in average condition. Instances of minor cracking, chipping, and scraping were observed on all wall surfaces due to normal use and wear.</p>	Average
	Interior Floor Finishes	<p>VCT flooring is present throughout common areas along the common corridors, classrooms, and janitorial spaces. The VCT is original to construction. There is carpeting in the choir, music spaces, and theater. The dance rooms and theater stage have hardwood flooring. The restrooms have a floor tile. The floors in the art rooms and directly under the theater seating are polished concrete.</p> <p>The floor finishes were in good condition based on reporting and observation. It was reported and observed that there were minor chips in the VCT.</p>	Good

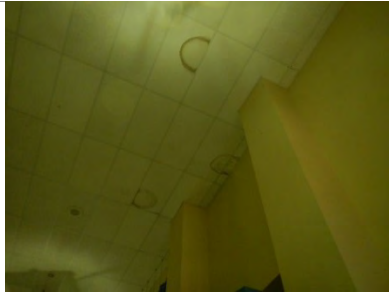
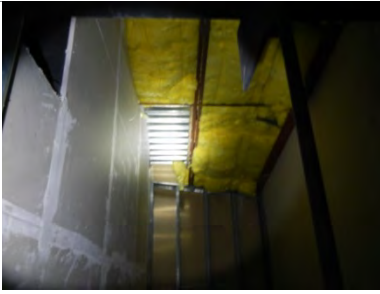
System	Subsystem	Condition and Deficiency Overview	System Condition Rating
	Interior Ceiling Finishes	<p>The interior ceiling consists of standard 2'x4' acoustical fiberglass ceiling panels throughout the corridors, office space, and janitorial closets. Painted gypsum board is located in the mechanical closets.</p> <p>The ceiling overall was reported and observed to be in average condition. It was observed that 5% of the ceiling tile was exhibiting water damage. Insulation was missing behind the right hand of the stage.</p>	Average
Conveying	System not present.		N/A
Plumbing	Plumbing Fixtures	<p>The building has public restrooms for males and females, students, and separate staff restrooms located throughout the facility. These restrooms generally have counter-mounted vitreous china hand sinks with manual faucets, along with vitreous china floor-mount toilets with manual flushing mechanisms, and vitreous china wall-hung urinals in the male restrooms with manual flushing mechanisms. There are water coolers located throughout the facility, typically near the public restrooms.</p> <p>Based on reports and observations, the plumbing fixtures were rated in good condition. It was reported that toilets in this facility were loose fitting and required new flanges. It was reported that no hot water was installed in this facility. It was observed that the water cooler adjacent to room 105 was making a loud rattling noise.</p>	Good
