Anderson High School Site Summary

Address	8403 Mesa Drive Austin, TX 78759
Number of Permanent Campus Facilities	5
Original Year of Construction	1973
Total Campus Building Area (combined)	338,434 SF

Introduction

Main School Building – BLDG-009A

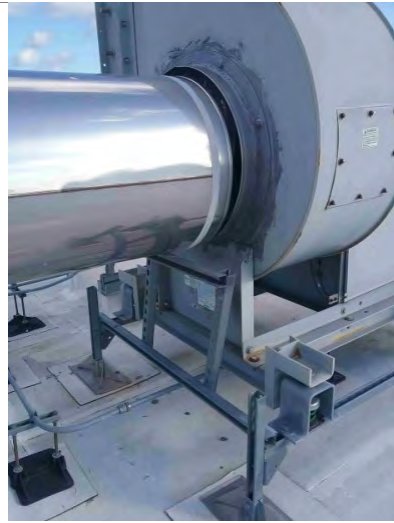
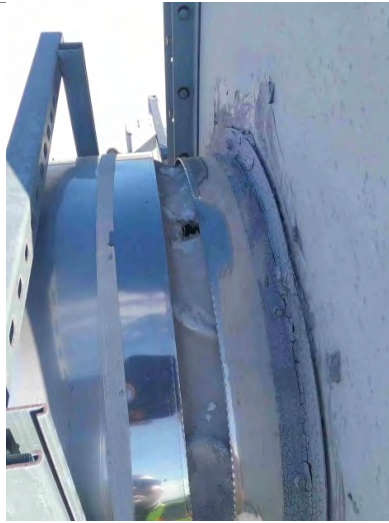
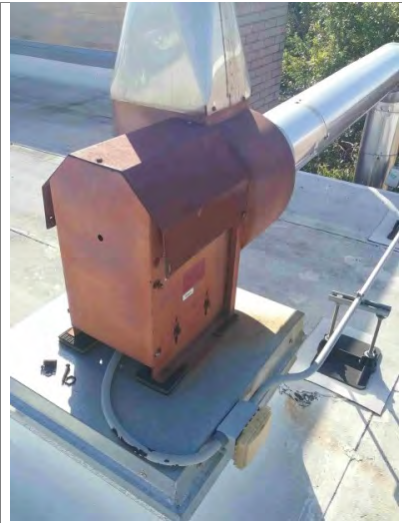
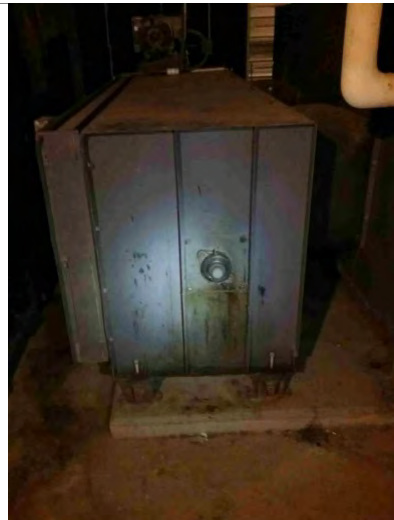
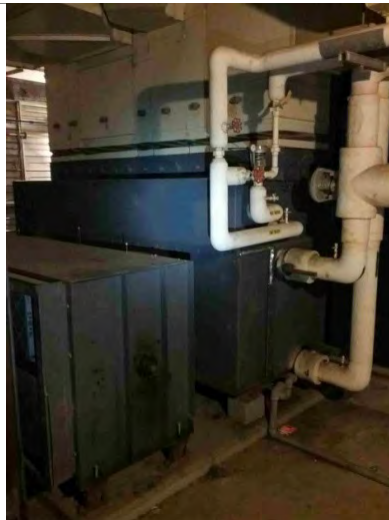
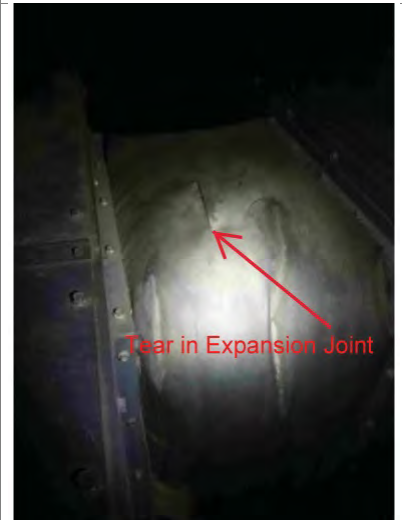
Mechanical/HVAC System Deficiency Examples

System	Subsystem	Condition and Deficiency Overview	System Condition Rating
		<p>These systems have capacities that range from 1,500-8,000 CFM (cubic feet per minute). The assessed roof top HVAC system's refrigeration capacities range from 3- to 250-TON and were installed within the last ten years. Ten EFs (exhaust fans) were assessed and the majority of the units were installed within the last ten years. Eighteen (18) indoor AHUs were assessed throughout the three level building. These AHUs range from 7,000-8,000 CFM and service multiple areas on their respected floor levels.</p> <p>The HVAC system is in average condition and has multiple deficiencies from the roof top down to the first level. Roof top mounted industrial centrifugal EFs-4, -5, and -10 were all found to have minor deficiencies. EF-4's discharge ductwork support is deformed; this ductwork support deformation is causing the discharge ductwork to sag. The sag in the discharge piping is causing the expansion joint to flex and could be possibly causing additional stress on the drive train. It was also noticed that the EF-4 had excessive noise and vibration. EF-5 and -10 both appear to be in a good operating condition, but both of their expansion joints have golf ball size holes in them from excessive wear and should be replaced. An unmarked small EF was also noticed to be in poor condition, missing hardware from housing and to have excessive corrosion damage. Only one packaged air condition unit, AISD Barcode- SC016727, was observed to have been potentially charged with outdated refrigerant type, R-22 in the year 2005.</p> <p>Building level three has three AHUs -11, -13, and -14 that are extremely aged and have excessive wear and tear. During the pre-facility condition assessment interview with Anderson High School staff, it was noted that the 3rd-floor level AHUs tend to run inconsistently hot/cold during all seasons. Building level two has two indoor AHUs-7 and -9 that are both generating excessive noise/vibration. It appears that the excessive noise/vibration is being generated from the drive train. Building level one AHU-3 is extremely aged and has excessive wear to exterior shell, and there are tears in the expansion joint material.</p> <p>The HVAC system is assessed to be in an average condition. Principal Sammi Harrison reported chronic HVAC issues on the 2nd and 3rd floors.</p>

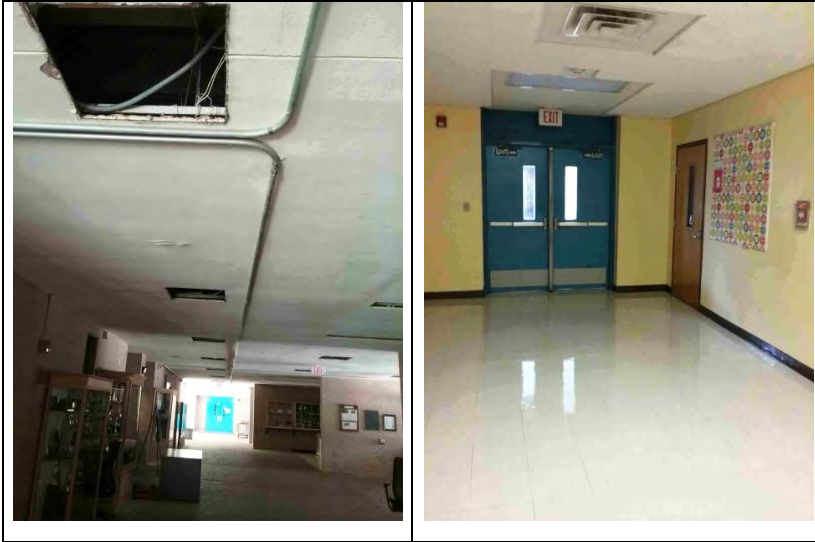
Lighting	<p>Numerous exterior fixtures are currently under construction and being replaced. The existing fixtures are HID (high-intensity discharge) style fixtures and observed to be in good condition.</p> <p>Throughout the interior areas of the building, it appeared that all damaged lighting is currently being replaced. The replacement lighting to be installed is reported to be LED (light-emitting diode) luminaires.</p> <p>The existing interior lighting is mainly fluorescent with screw type fixtures in closets and small rooms. The fixtures were observed to be in good condition.</p> <p>There are exit signs at every exit and at the end of the corridors on all three floors; however various signs were not illuminated.</p>	Good

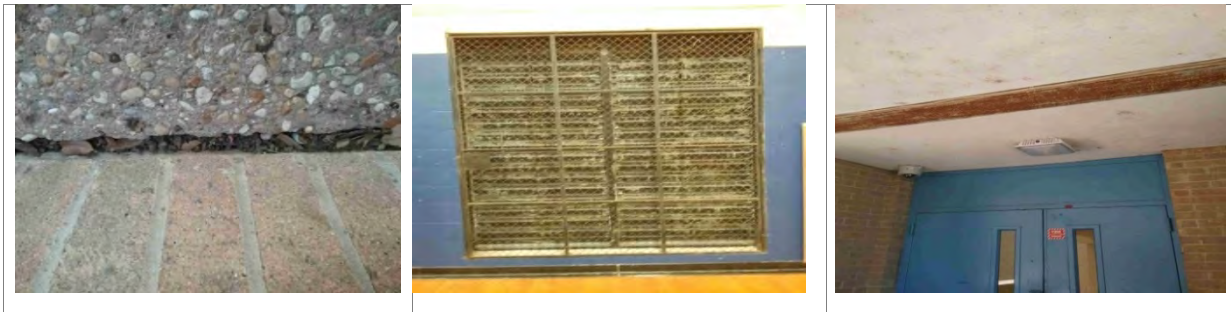
System	Subsystem	Condition and Deficiency Overview	System Condition Rating
Exterior	Exterior Walls	<p>The exterior of the building consists of a brick façade. The building is constructed on one level but because of the three gymnasiums, theater, and cafeteria, the building has two-story tall spaces in these areas. The big and small gymnasiums contain large louvers in the outside walls from a previous venting system which show outside daylight through them. . Investigate the ability to remove the vents and fill the void with adjacent wall material to match existing.</p> <p>Expansion joints at the pea gravel surfaced concrete sidewalk adjacent to the building walls were deteriorated.</p> <p>Steel lintels above brick openings along walkway from theater to art wing are rusted...</p>	Good
	Exterior Windows	Windows are metal framed and are in good condition.	Good
	Exterior Doors	The exterior doors were observed to be in average condition due to age and high usage. Door thresholds were observed to be deteriorated.	Average

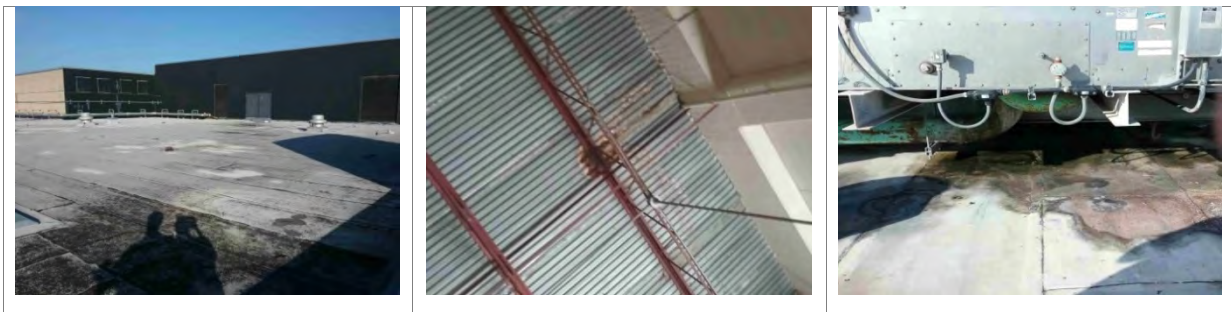
Roofing Deficiency Examples

Roofing	<p>The roof of this building contains approximately 14 different roof sections. Most roof areas are a single ply membrane system of differing ages. Some roofs have skylights or former roof hatches. The theater roof area is a steep sloping standing seam metal roof. Area of immediate concern is the roof under the cooling tower where the tower is continually dripping onto the roof. This could be causing the leak into the enclosed loading dock area where the roof deck and bar joists are rusting. Also, the roof area on the southwest corner of the big gymnasium where</p>		Average

System	Subsystem	Condition and Deficiency Overview	System Condition Rating
		there appears to be ponding, and has discolored insulation from the gymnasium below. Staff indicated this roof area leaks down the wall onto the bleachers. Leaks were reported over the exit doors of the small gymnasium. In addition, stained ceiling tiles were observed over the weight room The theater, band halls, cafeteria, and dance gymnasium roof areas are newer.	
Interior Construction	Interior Walls	The interior wall finishes are predominately painted gypsum board in theater, band halls and classrooms, CMU at the gymnasium and locker rooms, and ceramic tile wall finish in restrooms. The CMU, gypsum board, and ceramic tile wall finishes were observed to be in good condition.	Good
	Interior Doors	The interior doors consist of wood doors with vision lites in a metal frame and metal doors with vision lites in a metal frame The interior doors and frames were observed to be in good condition with typical signs of wear and use.	Good

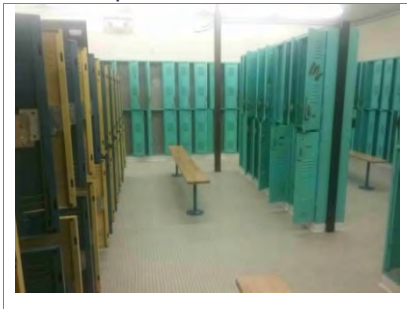
Interior Specialties	The lockers in the male and female athletic locker rooms are vented metal lockers. They are in good condition with some lockers bent and scraped. Band hall lockers are large wooden lockers and are in very good condition. Principal Sammi Harrison and the CAC have concerns regarding damaged (rusted, bent, and inoperable) lockers in the locker room.	Good
Stairs	Exterior Stairs	System not present.	N/A
	Interior Stairs	System not present.	N/A
Interior Finishes	Interior Wall Finishes	The interior wall finishes are predominately painted gypsum board in theater, band halls, and classrooms CMU at the gymnasium, and locker rooms and ceramic tile wall finish in restrooms. The CMU, gypsum board, and ceramic tile wall finishes were observed to be in good condition. The wall	Good
	Interior Floor Finishes	The floor finishes vary with wood floor in the gymnasiums, carpet in the theater area, ceramic tile in the restrooms/locker rooms, and vinyl tile in cafeteria, kitchen, and classrooms. They were all observed to be in good condition.	Good

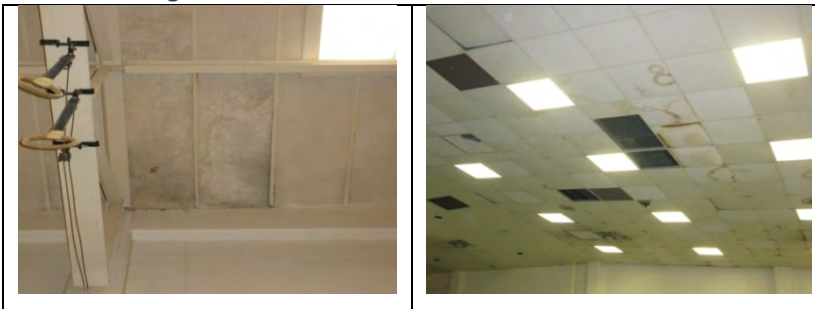
Interior Ceiling Finishes	The ceiling finishes are acoustical tile in cafeteria/kitchen and art classrooms that are currently under construction. New areas such as the renovated art wing, theater and band rooms are in good condition. Craig Estes, from AISD Project Management reported that 75% of the ceiling is new. Locker rooms and weight room areas appeared to show	Average

System	Subsystem	Condition and Deficiency Overview	System Condition Rating
		wear and stains from roof leaks. They were observed to be in poor condition. Several of the ceilings are open to the roof structure because they are gymnasiums. The big gymnasium insulation shows signs of heavy staining from roof leaks. The remainder of the building are gypsum board ceilings in the restrooms and locker/shower areas. They appeared to be in average condition.	
Conveying	System not present.		N/A
Plumbing	Plumbing Fixtures	<p>The facility contains multiple plumbing applications that service one level, consisting of: public restrooms, staff restrooms, janitorial closets with service sinks, locker rooms equipped with multi-unit type showers, and a commercial kitchen for cafeteria. It should be noted that during the building assessment the commercial kitchen was being completely renovated. Many of the kitchen plumbing fixtures are to be replaced.</p> <p>The building's fixtures are serviced by various vertical EWHs/GWHs ranging from 150-200 MBH and larger horizontal boilers ranging from 1,800-2,500 MBH. Many of the heat generating and cooling systems are original to this building's boiler/chiller main mechanical room, with the exception of an outdoor 120-TON chiller located on northwest corner of BLDG-009B's cafeteria.</p> <p>The building's restrooms typically consist of metal wall/floor mounted washstands with stainless steel sinks mounted in composite plastic countertops, vitreous china floor/wall mounted toilets, and wall mounted urinals. The restroom fixtures throughout the facility are equipped with manual push metering faucets and manual flush valves. The restroom fixtures in this building are typically aged, but all in good condition.</p> <p>This building has the following deficiencies: service closets contain old and out of date janitorial sinks (scheduled to be replaced with floor style sinks/mop basins), and the aged and out of date multi-unit type showers in the female/male restrooms are to be replaced with single/private showers.</p>	Good

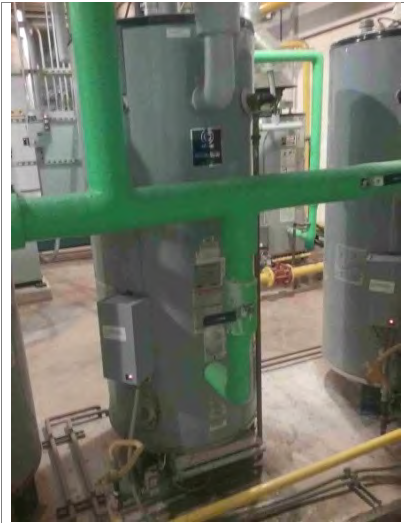
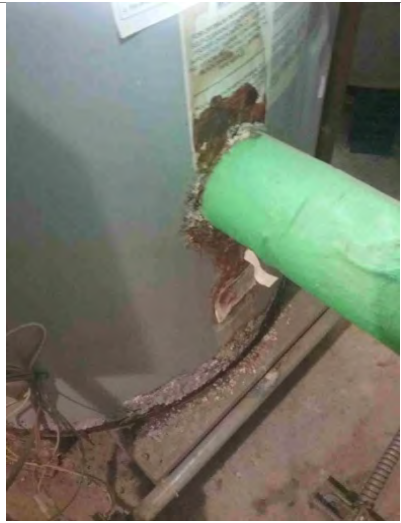
Domestic Water Distribution	<p>The Domestic Water Distribution system is predominately located in the main mechanical room. Six large vertical commercial GWHs were observed in the main mechanical room with input capacities ranging from 200 MBH to 500 MBH.</p> <p>The domestic water distribution piping original to this</p>	Average
