## Austin High School Site Summary

## Main School Building – BLDG-002A

## Theater Building – BLDG-002B

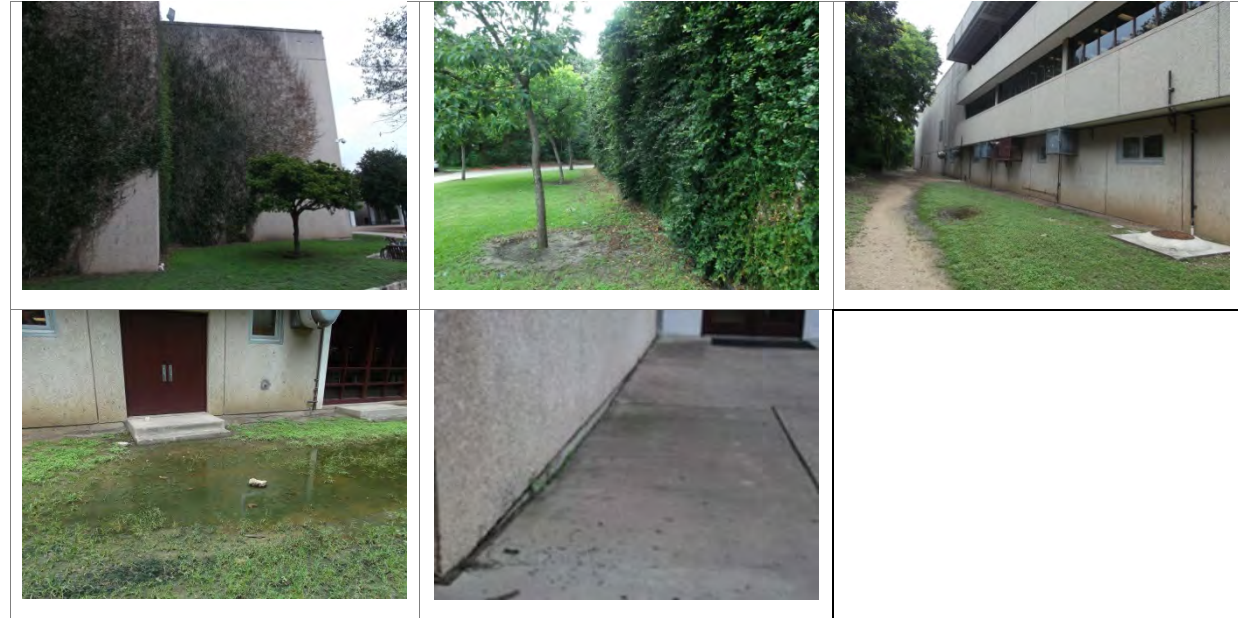
### Exterior Walls

System	Subsystem	Condition and Deficiency Overview	System Condition Rating
Exterior	Exterior Walls	The main building exterior consists of concrete walls with an exposed aggregate finish. The exterior walls of the Cohlmlia Chemistry Wing are clad with metal panels. The exterior façade was in good condition with few deficiencies. Substantial vine and plant growth was observed climbing the façade along the north and east elevation of the building. There was minor staining of the lower façade around the east elevation from backsplash during heavy rain. The sidewalk adjacent to the building was sagging west of the gymnasium. This may be indicative of water infiltration of the building foundation. The north penthouse exterior was stained, most noticeably on the north wall.	Good
	Exterior Windows	The main building windows are metal framed. The windows of the Cohlmlia Chemistry Wing have exterior window shades. The main building metal framed windows were observed to be leaking; they appeared to be original to construction and aged beyond their useful lives. The Cohlmlia Chemistry Wing exterior window shades were in good condition.	Poor

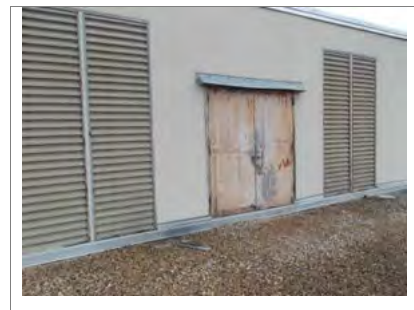
### Exterior Doors

Exterior Doors	There are two secure entries: one is located on the east side main entrance and the other is located at the administration and gymnasium entrance. The majority of the exterior personnel and roll-up doors around the facility are metal. There is a storefront door with glazing on the east side of the Chemistry Wing, and a pair of glazed doors on the west side. There are additional	Good

System	Subsystem	Condition and Deficiency Overview	System Condition Rating
		<p>exterior glazed doors leading out of the cafeteria.</p> <p>The storefront door with glazing on the east side of the wing and the pair of glazed doors on the west side were in good condition. The exterior metal doors and roll-up doors appeared to be in average to good condition showing signs of wear. The metal doors at the two roof top penthouses were corroded and the hardware bent and damaged.</p>	
<b>Roofing</b>	<p>The low slope roof section over the main building is constructed of built-up modified bituminous with a granular topping. There are two mechanical penthouses and clerestories located on the main building. These are constructed with a Thermoplastic Polyolefin (TPO) system. The penthouse and clerestory roofs appear to be original. The north penthouse roof has flashing, while the south penthouse roof utilizes rain gutters. There are two plaza decks located on the south side. There is a breezeway, which extends from the east entrance of the main building to the theatre.</p> <p>The low slope roof section over the main building is beyond its useful life. Areas of ponding water were observed, most noticeably at the north and east sides of the roof. There were signs of leaks within the structure's interior. The roof drain at the condensing unit just north of the north penthouse was clogged with the gravel resulting in ponding within the area. The chemistry wing roof appears to be maintained satisfactorily; however, water infiltration of the first floor has occurred along the interior of the west wall. There were no visible issues with flashing or signs of the infiltration source; however, further investigation is recommended. The upper and lower west roof sections had various areas of ponding, but appear to be regularly maintained. It was observed that the new roof ladders on all roofs were secure and in good condition. Both decks and canopies appeared to be in fair condition; however, the staff indicated there are pre-existing drainage and water infiltration issues. The breezeway roof was observed from the main school building, and appears to be at the end of its useful life. It was observed that some downspouts drain directly onto the sidewalk. There were several downspouts that did not have leaders, allowing the accumulation of water around the base of building.</p>		Poor

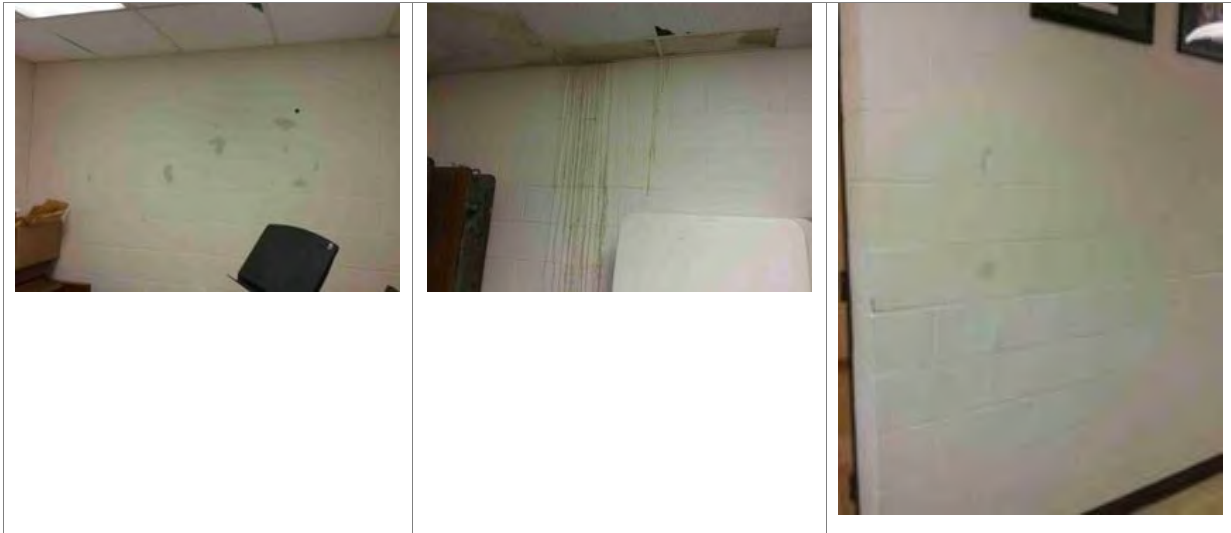
#### Interior Wall Finishes

<b>Interior Construction</b>	Interior Walls	<p>The classrooms are separated from one another by a series of CMU and partition walls.</p> <p>The CMU and partition walls separating the classrooms had typical wear and tear associated with general everyday use. There were some isolated areas observed with wall damage from water intrusion.</p>	Good
	Interior Doors	<p>The interior doors throughout the building include both metal and wood doors with metal frames.</p> <p>The majority of the metal and wood doors were in good condition.</p>	Good
	Interior Specialties	<p>There are metal lockers in the hallways and in the locker rooms. They appear to be in good condition.</p>	Good

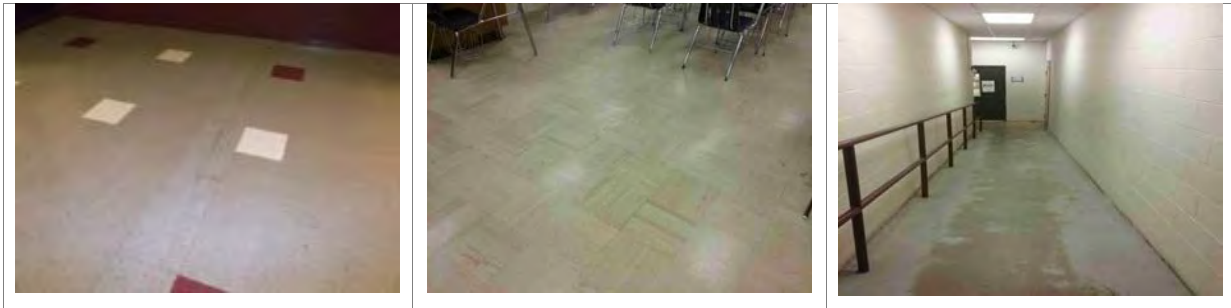
#### Interior Floor Finishes

Interior Floor Finishes	The interior floor finishes in the hallway and classroom areas are linoleum floor tile. The library area flooring is finished with carpet. The kitchen and cafeteria are finished with ceramic floor tile. The three gyms on the second level have hardwood floors. The restrooms have tile floor finishes. The interior finishes appeared to be in average condition showing signs of age and wear. Much of the VCT floor tile appears to be original construction and is well maintained; however, the flooring system was showing signs of age, deterioration, and uneven surfaces. The gym hardwood floors are in good condition. The restroom finishes were in good condition.	Average
	Interior Ceiling Finishes	The interior ceilings in the hallway and classroom areas are acoustical ceiling tiles (ACT). The kitchen and cafeteria ceilings are finished with ACT. The existing ACT system was observed to be aged, damaged, stained, and/or missing in some of the classroom areas. Water infiltration has damaged ceiling tiles throughout the building including classrooms, labs, corridors, mechanical/electrical rooms, the sports equipment storage area, and the Preas Theater and its orchestra office area. There were signs of water infiltration within the fire sprinkler riser room located on the south side, although the source of the infiltration was not known. It was observed that maintenance was performed in order to route the water to drain.	Average

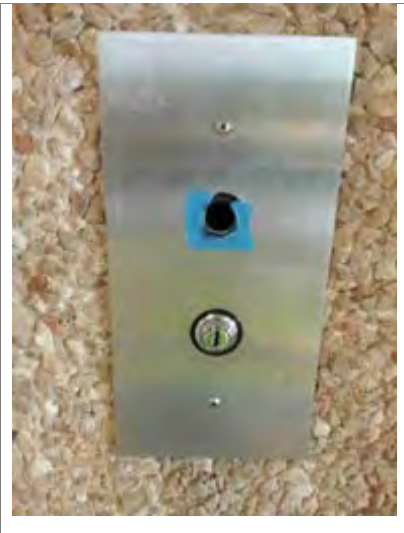
### Conveying System Deficiency Example

<b>Conveying</b>	The building has two passenger elevators that use hydraulic systems to service three floors, one was noted as having a maximum weight capacity of 2,100 pounds, and the other has a maximum weight capacity of 2,000 pounds.		Good

System	Subsystem	Condition and Deficiency Overview	System Condition Rating
		These elevators were in good condition and both were observed with an inspection certification within the last year as required. The only deficiency noted was the missing call button on the second floor. This elevator is only used by building staff and is key operated; therefore, the missing pushbutton is unnecessary. There is a hole where the button should be, which could be a safety hazard.	
Plumbing	Plumbing Fixtures	<p>The main building has dedicated student restrooms located on the first, second, and third floors with additional single occupant restrooms in the health services, administration offices, Special Education classroom, and in the arts studio. The school also has male and female locker rooms to support athletics and the Physical Education department. The typical plumbing fixtures, including toilets, urinals and sinks, are vitreous china with manual controls. Adjacent to the gymnasium is a male and female restroom that was recently renovated for sporting event use. Within these restrooms, the fixture hardware has been upgraded to automatic control. The locker rooms also have single and multi-occupant showers. The single occupant showers have manual controls, and the multi-occupant stainless steel shower terminals have push button "timed" controls. The kitchen has a mix of wall mounted vitreous china hand wash sinks and stainless steel kitchen equipment that includes one, two, and three basing dish/prep sinks. The student lab and faculty break rooms have molded in-counter sinks with manual faucets.</p> <p>The girls' coaches' office has a water tempering valve for shower temperature control that is leaking and has caused water damage to the surrounding wall. The tempering valve appears to be recently installed.</p>	Good

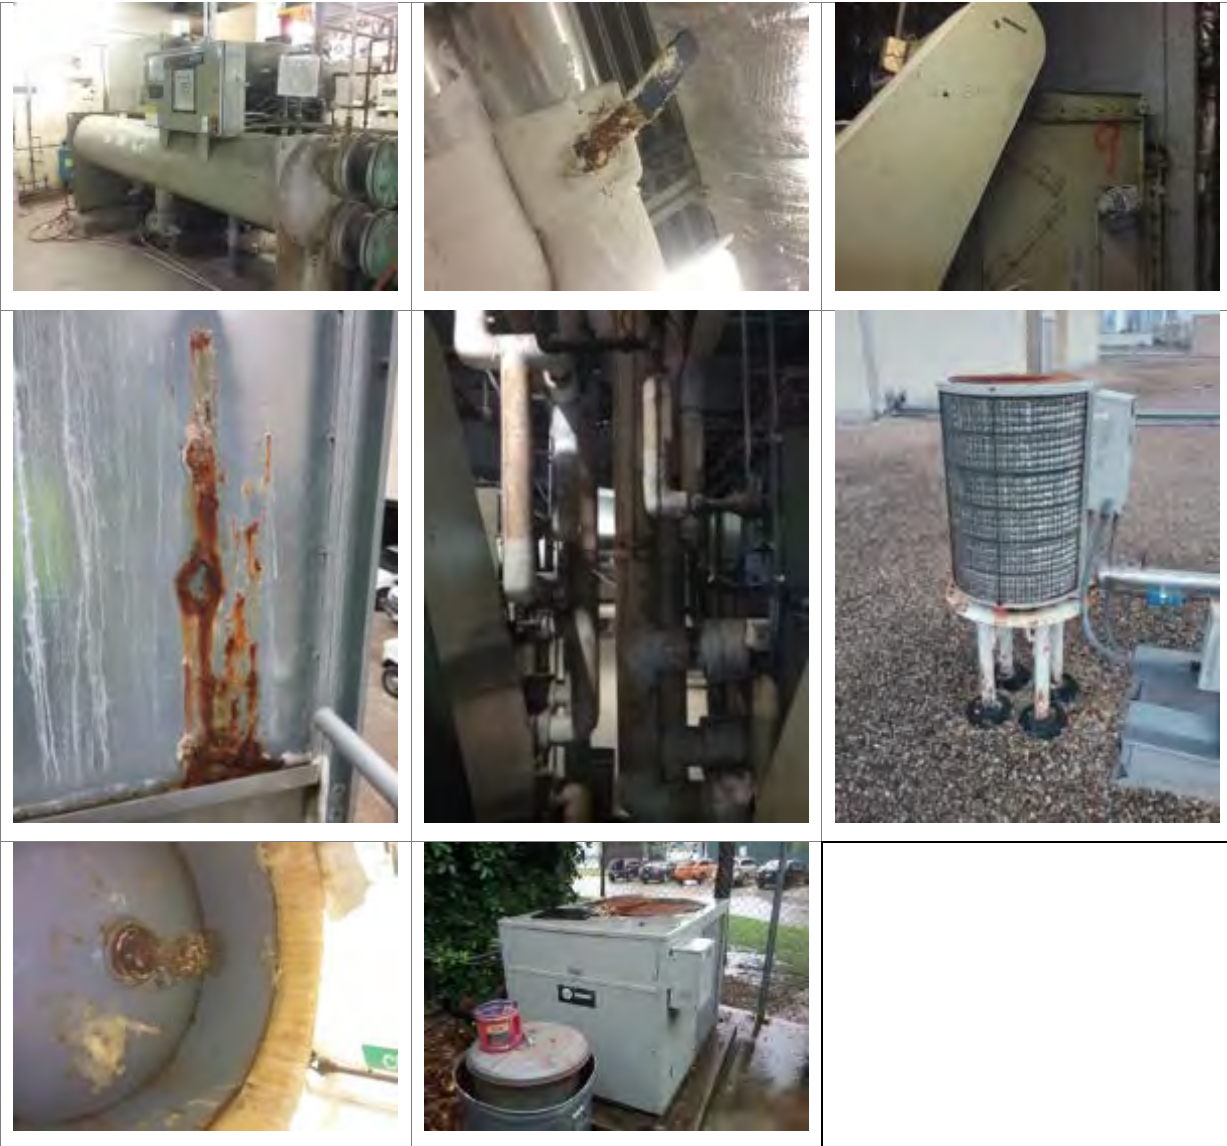
**Mechanical/HVAC System Deficiency Examples**

System	Subsystem	Condition and Deficiency Overview	System Condition Rating
	Other Plumbing	The low slope roof sections have single inlet roof drains with three inch to four inch diameter pipe depending on location and area served.	Average
<b>Mechanical/ HVAC</b>	<p>Austin High School utilizes a mixture of heating and cooling systems for building air conditioning depending on time of construction or remodel. The original portion of the high school, refurbished in 1985, has a chilled and heating hot water system that routes to ten centrally located AHUs (air handling units), eight enclosed in mechanical closets within the main building and seven in two mechanical penthouses. The chilled water system is made up of two 300-TON rotary screw chillers tied to a pair of 284-TON cooling towers. The heating hot water is supplied by two 4,000 MBH gas to hot water boilers (installed in 2016), and one 1,812 MBH gas to hot water boilers (installed during the main building renovation). The existing building cooling is supplemented by split system condensing units feeding five AHUs installed in mechanical closets on the south side of the building. The science laboratory addition, constructed in 2010, utilizes a series of 13 vertical blower coil units (similar to a fan coil unit) located in mechanical closets throughout the addition. The capacity of the vertical blower coil units vary between 2,000 and 800 CFM and have chilled water and heating hot water coils for temperature control. The chilled water system for the blower coil units comes from a single 90 TON air-cooled scroll chiller mounted on the roof of the expansion, while the heating hot water is supplied by the main building boiler system. Building exhaust is provided by 23 roof and wall mounted exhaust fans.</p> <p>The HVAC system is in average condition as the rotary screw chillers are charged with R-22 refrigerant; the majority of the AHUs were original to the mid 1980's remodel. CU-MDF is a condensing unit located on the main roof and is operationally in good condition. However, the unit is charged with R-22 refrigerant with is in the process of being phased out of production by the year 2020. The chilled water piping that is original to the main school remodel is showing significant signs of corrosion. Chilled water pumps CHP-1 &amp; CHP-2 have considerable condensation buildup on the pump housing. The moisture is causing the pump housing and piping to rust prematurely and is reducing the expected life span of the equipment. Exhaust fan EF-22 is missing its input shaft shroud creating a life safety issue. Located just outside of the art studio is a split system heat pump tied to a fan coil unit mounted within the structure of the facility. The system is not functional and leaves the art studio space unconditioned. There are six roof mounted condensing units that appear to be original to the main school remodel. At the time of the survey, it was unclear if the units are functional or if they are abandoned in place. AHU-9, in the North Mechanical Penthouse, has excessive vibration in the supply fan section of the unit. The cooling tower for the condenser water system has rust forming at the belly pan of the housing that is beginning to penetrate all the way through to the filter media. There is a split system condensing unit, located on the exterior of the building, which connects to AHU-11 located in the boiler/mechanical room. The condensing unit is charged with R-22 refrigerant, which is in the process of being phased out of production. The boiler for the heating hot water system has a heavy gas odor around the</p>		Average

System	Subsystem	Condition and Deficiency Overview	System Condition Rating
		equipment. It is unclear where the gas odor is leaking from within the equipment. The building roof and wall mounted exhaust fans were in various levels of condition.	
Fire Protection	Fire Alarm	<p>The building has a fire alarm system that consists of alarm and signaling devices such as bells/horns/annunciators, strobes, horn/strobe combos, pull stations, and detectors. The fire alarm system is controlled by several fire alarm control panels located throughout the building.</p> <p>The fire alarm system was in good condition. The building staff indicated the system was operating properly, but the control panel labeled IFP-1000 in the AHU 7 Mechanical Room indicated a bad horn and non-functional strobe on the inspection tag.</p>	Good
	Fire Protection/Suppression	<p>The building does not have a sprinkler system and is instead served by multiple dry-chemical fire extinguishers. The laboratory expansion; however, is equipped with a wet pipe fire sprinkler system added in at the time of the expansion. Within the kitchen, there is a dedicated "Range Guard" chemical fire suppression system designed for grease fires.</p> <p>There were multiple locations where fire extinguishers were missing. Existing fire extinguishers contained up to date inspection dates. The laboratory expansion sprinkler system is in good condition. The kitchen chemical fire suppression system is in good condition.</p>	Good

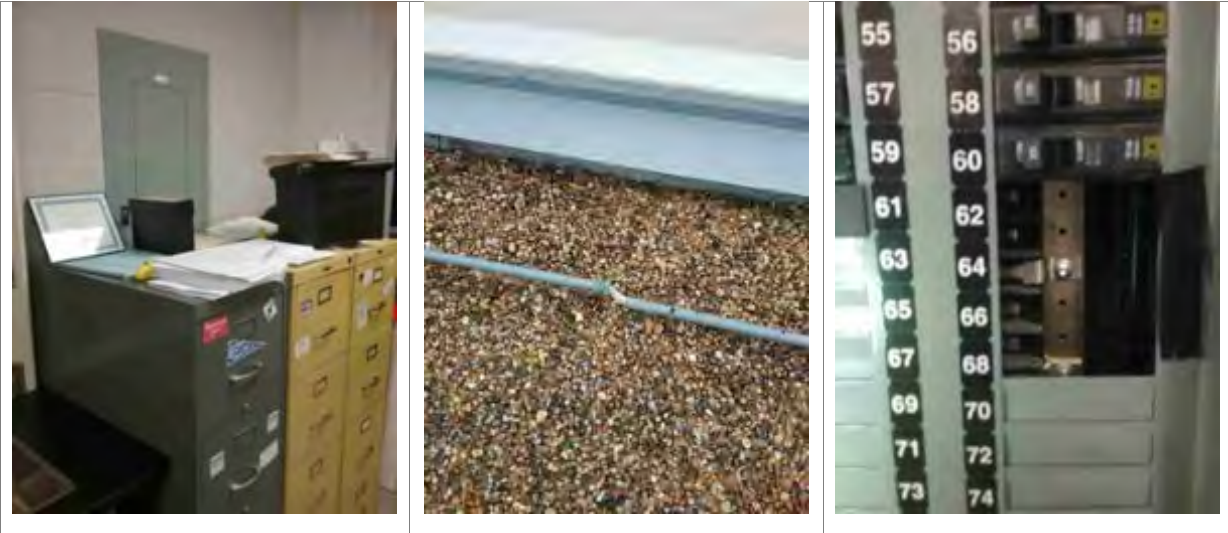
### Electrical Distribution

Electrical	Electrical Distribution	<p>The electrical utility service enters the building at the main switchgear with a capacity of 5000 amps at 480v. The switchgear is located in the main electrical room and delivers power throughout the building. There are several transformers that step down 480-volt primary to 120/208 volt secondary that feed power to 120/208 volt panelboards. These transformers and distribution panelboards are primarily located in mechanical rooms, electrical rooms, and custodial closets.</p> <p>The electrical distribution equipment is in average condition. The building has had several upgrades over the years and the electrical equipment age ranges from the mid 1970's to 2015. Most of the original equipment is beyond its useful life. Many access issues and deficiencies were found during the assessment. A panelboard in Chemistry Room 271 was blocked by several filing cabinets. Stored materials blocked access to panelboard Panel 1SP in the Art Room. A table and other equipment blocked access to panelboard Panel</p>	Average

System	Subsystem	Condition and Deficiency Overview	System Condition Rating
		1P in Office 116D. Transformer 11T was blocking access to the two panelboards in the Pease Theater Electrical Room. Stored materials blocked access to the transformer in the West Gym Electrical Room. An uncovered junction box was on the back exterior of the building near the roof. Broken and unsupported conduits were observed on the roof. There was a missing cover plate in panelboard HA in the fire sprinkler riser room. A loud hum was heard from Transformer 1 in AHU Room No. 7. A loud hum was heard from Transformer 6T located in the Book Storage. When the microwave is used in Café Austin, it trips a breaker that powers receptacles in Room 209. There was an exterior unprotected receptacle on the back of the building. The building staff also indicated that the portable classrooms are not connected to the fire alarm, paging, and security systems.

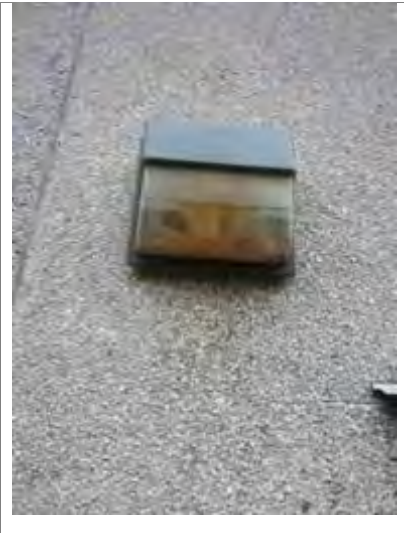
### Lighting

Lighting	<p>The building's exterior lighting consists of wall pack high-intensity discharge (HID) lights, HID floodlights, and soffit mounted fixtures that are located near the exterior doors, under the first story soffits and along the roofline at the top of the building. The interior lighting primarily consists of recessed, pendant, and wall mounted fluorescent fixtures, decorative column fixtures, and pendant mounted HID fixtures.</p> <p>The lighting for the building is in average condition. The floodlights at the top of the building appear to be in good condition. The exterior soffit mounted lights have yellowed and broken lenses with some covered in dirt and spider webs. The HID lights have unclean yellow lenses. The art room has pendant mounted fluorescent fixtures that are unreliable. During humid days, only half of the light fixtures will turn on and sometimes the circuit breaker will trip. The lighting in the kitchen is recessed fluorescent and has yellow lenses. The cafeteria lighting is recessed fluorescent with yellow lenses. Emergency and exit lights are located in the cafeteria, but may be insufficient as there is only one emergency light and only one set of doors has an exit sign.</p>	Average

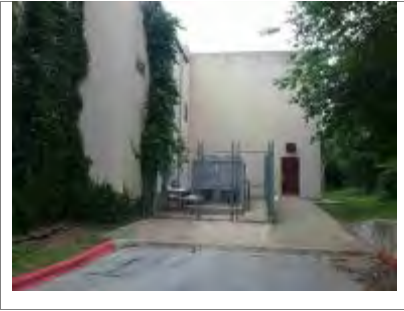
#### Exterior Walls

System	Subsystem	Condition and Deficiency Overview	System Condition Rating
<b>Exterior</b>	Exterior Walls	The Austin High School Theater Building exterior walls consist of concrete with exposed aggregate, clad with strips of metal paneling originating from the roof elevation. The exterior over the stage area is clad with metal paneling. There are two awnings on the south side of the building.  The exterior façade is in good condition. Vine and plant growth was observed on the façade along the northeast corner elevation and encroaching upon the gutter system.	Good
	Exterior Windows	The exterior windows are metal framed. These windows are in good condition.	Good
	Exterior Doors	The lobby entrance of the theater has two pairs of metal doors with glazing. The remaining doors around the facility are metal. There is a manual roll-up metal door at the rear of the stage.  The lobby doors are in good condition. The exterior door located at rear of the stage does not close properly exposing the stage flooring exposed to the elements and pests. The remaining building exterior doors appear to be in good condition.	Good

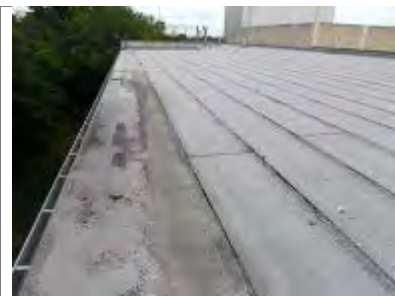
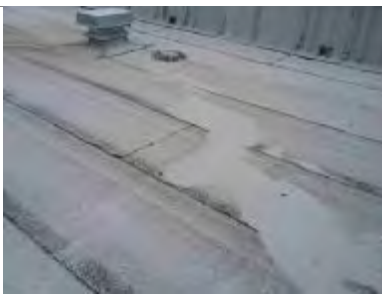
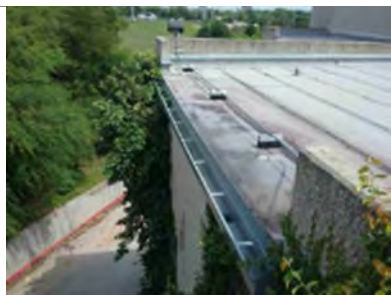
### Roofing Deficiency Examples

<b>Roofing</b>	The low slope roof sections are modified bituminous; there are two cantilever roofs over the sidewalks at the south elevations.  The low slope modified bituminous roof sections and the two cantilever roofs over the sidewalks at the south elevations are beyond their useful lives. Standing water was observed along the north roof sections. There was noticeable granule build up from the roof cover system near the gutters and roof drains.		Poor

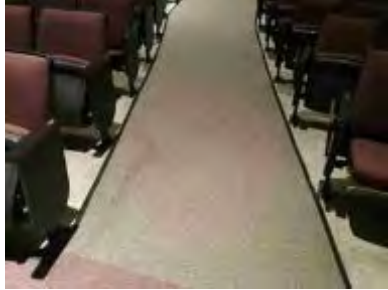
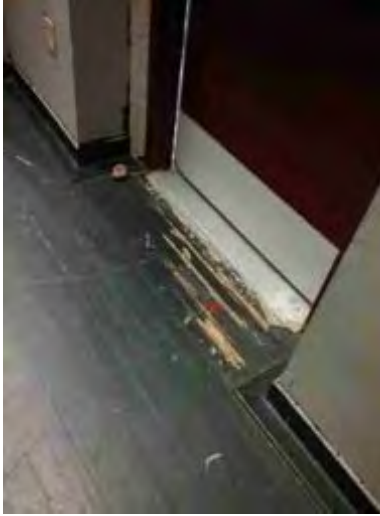
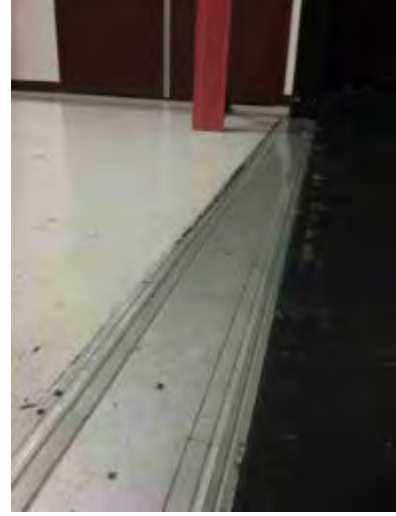
#### Interior Floor Finishes

System	Subsystem	Condition and Deficiency Overview	System Condition Rating
<b>Interior Construction</b>	Interior Walls	The interior walls are in good condition	Good
	Interior Doors	The interior doors are metal. The interior doors are in good condition.	Good
	Interior Specialties	The theater and stage is vaulted with fixed seating. The theater seating was observed to be in average condition.	Average
<b>Stairs</b>	Exterior Stairs	System not present.	N/A
	Interior Stairs	There interior stairs are concrete. The stairs are in good condition.	Good
<b>Interior Finishes</b>	Interior Wall Finishes	The restrooms are finished with wall tile with metal toilet partitions. The finishes are in good condition.	Good
	Interior Floor Finishes	The restrooms are finished with floor tile. Common areas and dressing rooms have vinyl floor tile. The theater carpet is showing signs of wear and is stained in some areas. There was noticeable deterioration of the stage flooring to the rear emergency exit door. It is suspected the deterioration was due to termites and there were other pests observed during the assessment. Staff reported that the metal threshold north of the stage makes it difficult to transport the piano from storage area.	Average

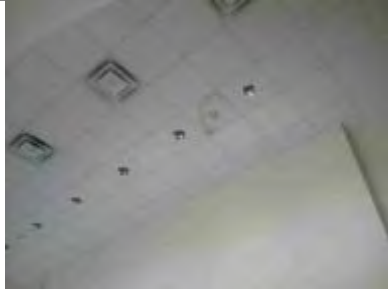
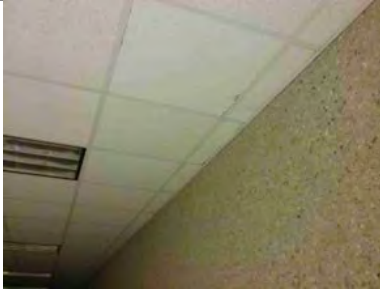
#### Interior Ceiling Finishes

Interior Ceiling Finishes	Common areas and dressing rooms have acoustic ceiling tiles. There were stained ceiling tiles in multiple areas.	Average
<b>Conveying</b>	System not present.		N/A
<b>Plumbing</b>	Plumbing Fixtures	The building has dedicated student restrooms located adjacent to the main hall. The toilets are floor mounted with manual flush valves, and the sinks and urinals are wall mounted with manual controls. All of the fixtures in the restrooms are vitreous china. The changing rooms also have single occupant showers with manual controls. The male and female locker rooms each have seven stainless steel shower terminals. One terminal in each room has a broken head. The sinks in the Preas Theater dressing rooms have significant water damage around them and there is rusting on the faucet.	Good
	Domestic Water Distribution	The domestic water and sanitary waste systems serve the student and faculty restrooms, boys' and girls' dressing rooms, janitor's closet, and wall mounted water coolers. Domestic hot water for the building is provided by a single 100-gallon, 200 MBH gas water heater	Good

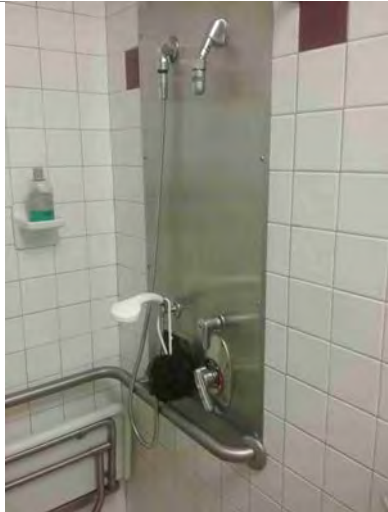
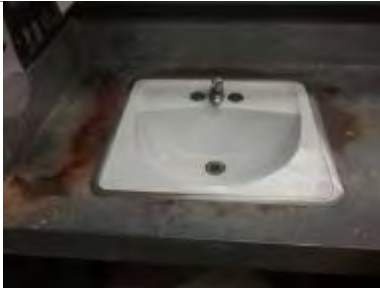
#### Plumbing Fixtures

System	Subsystem	Condition and Deficiency Overview	System Condition Rating
		located in the main boiler/mechanical room. Facility-wide, the domestic water system is in good condition with typical wear and tear associated with general everyday use.	
	Other Plumbing	The gutter system along the north wall was observed to be clear with exception of the vine and plant growth on the northeast corner.	Average
<b>Mechanical/ HVAC</b>	The Theater Building uses a four pipe system with chilled water and heating hot water feeding centralized AHUs located in the main mechanical room. There are six AHUs varying in size from an estimated 2,500 CFM to 10,000 CFM. The chilled water is provided by a single 125-TON air-cooled rotary screw chiller and the heating hot water comes from a single 1,125 MBH gas to hot water boiler. The HVAC system is in good condition with isolated areas requiring repair. The air separator for the heating hot water system is leaking from the drain valve and there is surface rust developing due to the leak.		Good

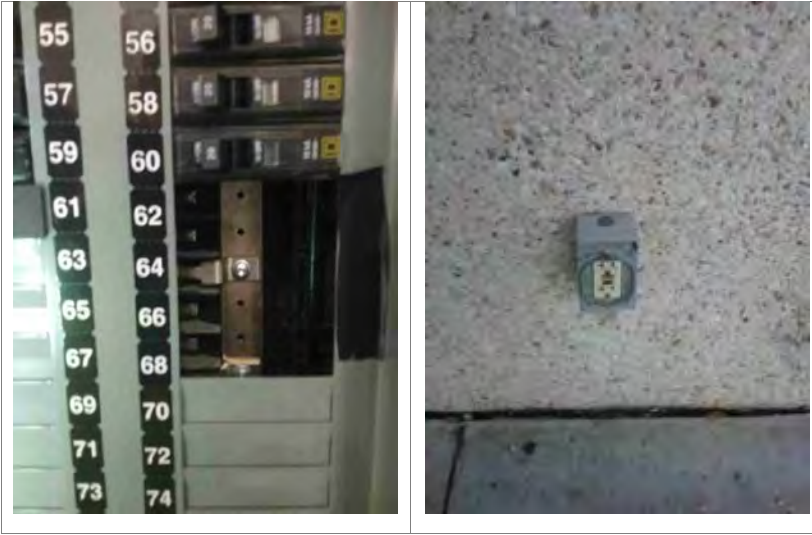
### Electrical Distribution

<b>Fire Protection</b>	Fire Alarm	The building has a fire alarm system that consists of alarm and signaling devices such as bells/horns/annunciators, strobes, horn/strobe combos, pull stations, and detectors. The fire alarm system is controlled by several fire alarm control panels located throughout the building. The fire alarm system was in good condition.	Good
	Fire Protection/ Suppression	The building is served by an ordinary hazard wet pipe fire sprinkler system. The system is in good condition. It is 15 years old and is not showing any signs of corrosion or degradation.	Good
<b>Electrical</b>	Electrical Distribution	The electrical utility service enters the building at the main panelboard in the second floor electrical room, which delivers power throughout the building. There are several 480-volt panelboards and 480-volt primary transformers that step-down to 120/208 volt secondary that feed power to 120/208 volt panelboards. These transformers and distribution panelboards are located in the second floor electrical room. The electrical distribution equipment is in good condition. There were some issues discovered during the assessment. Panelboard LB is missing a cover plate for a missing circuit breaker. A receptacle on the back side of the building is not weatherproof and not identified as GFCI protected.	Good
