Bowie High School Site Summary

Address	4103 W. Slaughter Lane Austin, TX 78749
Number of Permanent Campus Facilities	7
Original Year of Construction	1988
Total Campus Building Area (combined)	422,688 SF

Introduction

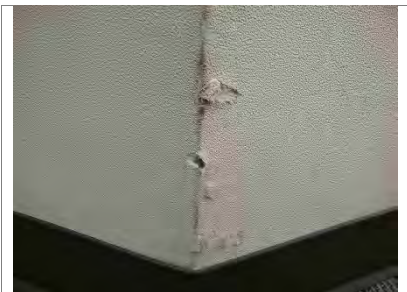
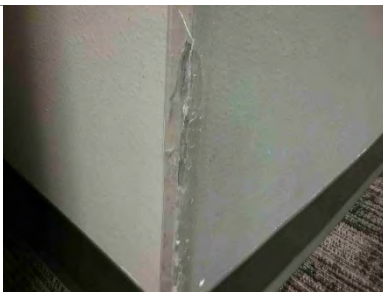
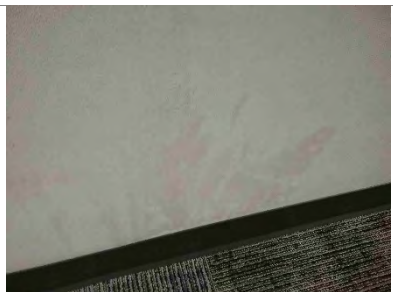
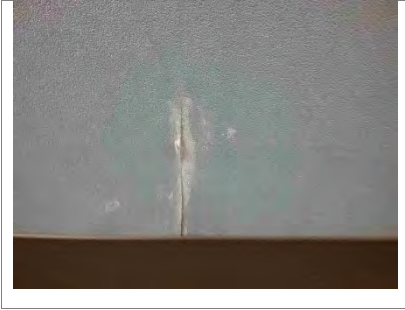
System	Subsystem	Condition and Deficiency Overview	System Condition Rating
Interior Construction	Interior Walls	The interior walls are constructed with metal studs covered in drywall. The interior walls were observed to be in good condition as the only damage observed was to the finishes.	Good
	Interior Doors	The interior doors are metal set in metal frames. Some doors have narrow side lites. The door frames were observed to be in average condition as they were excessively scratched, but the door leafs were observed to be in good condition.	Average
	Interior Specialties	System not present.	N/A
Stairs	Exterior Stairs	System not present.	N/A
	Interior Stairs	System not present.	N/A
Interior Finishes	Interior Wall Finishes	The walls are finished with painted drywall and FRP (fiber reinforced plastic) paneling. The restroom walls are finished with ceramic tile. The interior walls were observed to be in good condition except for a few areas of isolated damage. The corners of the FRP-covered walls were observed to be damaged at the base of most corners. The plastic corner guards present in the building were observed to be broken. There was slight staining observed on the wall paneling and some separation at abutting panels. The tile and drywall walls were observed to be in good condition.	Average

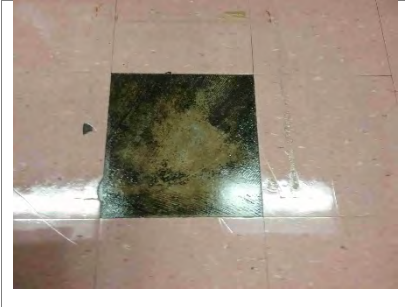
Interior Floor Finishes	The floors are finished in tile and carpet tile and rubber base. There is also VCT (vinyl composition tile) in alcoves and ceramic tile in the restrooms. The floor finishes were observed to be in good condition, though there are a few missing VCT tiles in the supply closet.	Good
	Interior Ceiling Finishes	The building's ceilings are comprised of ACT (acoustic ceiling tile) and drywall. The ceilings were observed to be in average condition with some small holes in the tiles and some popped-out ceiling tiles. Very slight rusting was observed on a small amount of ceiling tees. The drywall ceiling in the single-person restroom was observed to be damaged and peeling; two small water spots were observed.	Average
Conveying	System not present.		N/A
Plumbing	Plumbing Fixtures	The building has a male and female public restrooms as well as separate private restrooms for faculty members. The urinals are wall-hung and the toilets	Poor

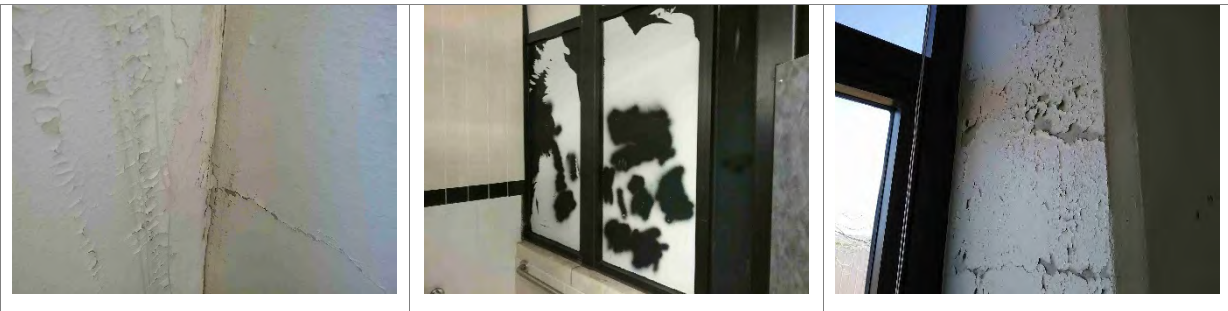
System	Subsystem	Condition and Deficiency Overview	System Condition Rating
Interior Finishes	Interior Wall Finishes	The interior walls of the corridors are finished with abuse-resistant paneling. The interior walls inside the classrooms and library are finished with painted drywall. It was observed that the paint finish inside the classrooms was beginning to crackle. A portion of the restroom walls on the first floor consist of filled-in window panes. The paint was observed to be peeled off of a large portion of the paneling. The auxiliary room between rooms 207F and 209F was observed to have excessively peeling paint on the walls. A strong odor was observed in the science rooms in the E-wing.	Average
	Interior Floor Finishes	The interior floor of the building corridors are sealed concrete. The classrooms are finished with VCT with rubber base. The restroom floors are finished with ceramic tile with a ceramic tile base. The library floor is finished with carpet. The culinary room floor is finished with a resilient epoxy flooring. The rubber base in many classrooms was observed to be dented and discolored. A portion of the ceramic tile base in a female restroom was observed to be broken. Some VCT was observed to be broken. A few tears and stains were observed in the library carpet.	Average

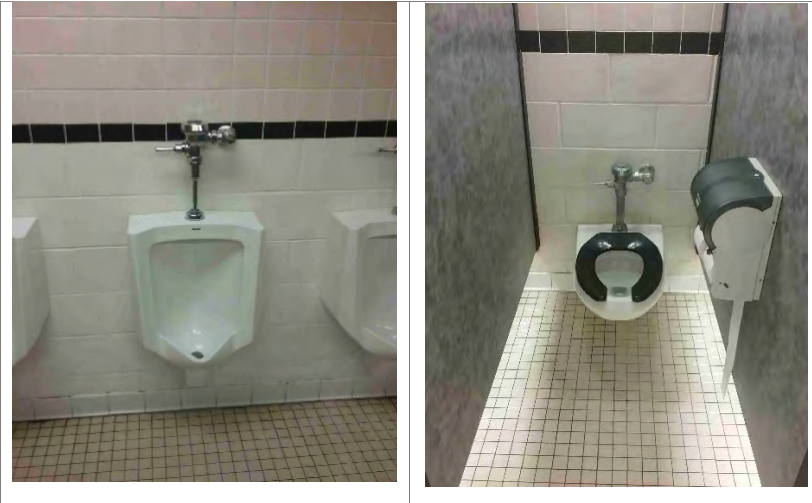
System	Subsystem	Condition and Deficiency Overview	System Condition Rating
Conveying	System not present.		N/A
Plumbing	Plumbing Fixtures	<p>The building has a male and female public restrooms as well as separate private restrooms for faculty members. The urinals and toilets are mainly wall-hung, vitreous china. The sinks are stainless steel with manual faucets, and the toilets and urinals have manual flush valves.</p> <p>The plumbing fixtures in wing A were observed to have low water pressure. There was also a toilet that had a malfunctioning flush valve. Many of the urinals did not flush properly.</p>	Poor
	Domestic Water Distribution	<p>There is a gas water heater and an electric water heater on the second floor of the building.</p> <p>The GWH (gas water heater) near AHU 610 was rusted on the exterior. The distribution piping associated with the unit appeared to be new and well maintained. Many of the faucets in the building were not receiving hot water at the time of the assessment. The unit appeared to be past the design service date. The system as a whole was given an average rating.</p>	Average

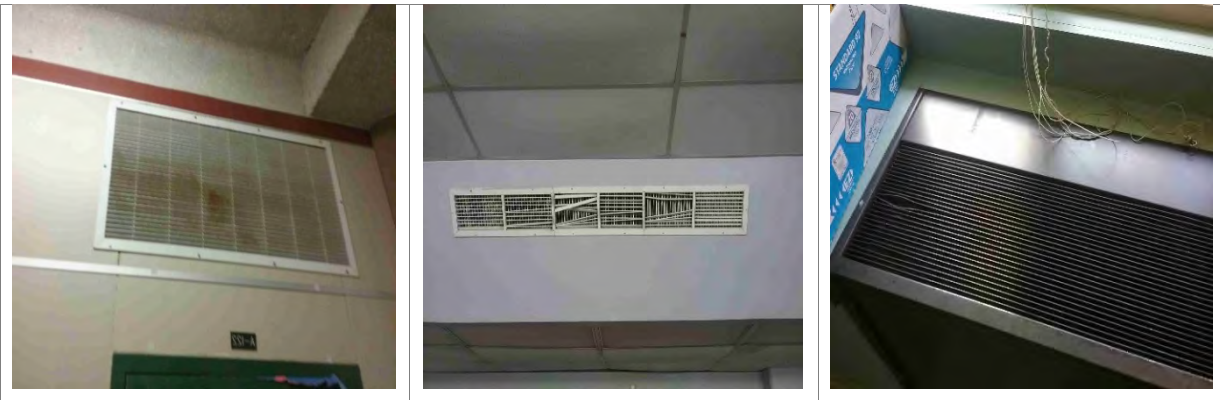
Mechanical/HVAC System Deficiency Examples

Other Plumbing	<p>There are floor drains located throughout the building near the plumbing fixtures.</p> <p>The floor drains that were observed, did not have any observed water collection near the fixtures. They were not excessively damaged or rusted. The floor drains throughout the building were observed to be in good condition.</p>	N/A
Mechanical/ HVAC	<p>The main mechanical equipment in this building consists of draw-thru AHUs, heat pumps, and vertical FCUs in each classroom. The main corridors were not air-conditioned.</p> <p>The vertical FCUs located in the classrooms throughout the building were in poor condition. They appeared to be aged and past their service dates. Classroom E105 had two horizontal water source heat pumps. Only one of the heat pumps was operational. The sidewall grilles in the main corridors were damaged and rusted. The supply diffusers in the classrooms in wing B were damaged.</p>		Poor

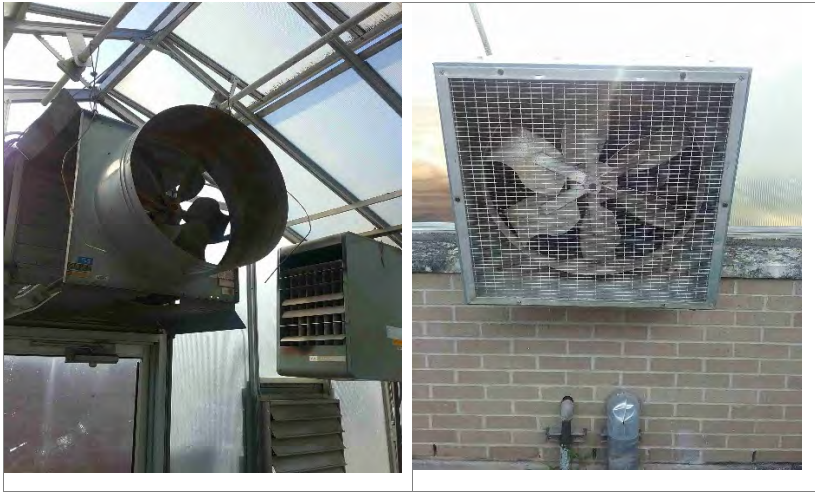
Mechanical/HVAC System Deficiency Examples

System	Subsystem	Condition and Deficiency Overview	System Condition Rating
Interior Construction	Interior Walls	System not present.	N/A
	Interior Doors	System not present.	N/A
	Interior Specialties	System not present.	N/A
Stairs	Exterior Stairs	System not present.	N/A
	Interior Stairs	System not present.	N/A
Interior Finishes	Interior Wall Finishes	System not present.	N/A
	Interior Floor Finishes	The interior floor of the building is comprised of gravel. The floor was observed to be in good condition.	Good
	Interior Ceiling Finishes	System not present.	N/A
Conveying	System not present.		N/A
Plumbing	Plumbing Fixtures	System not present.	N/A
	Domestic Water Distribution	System not present.	N/A
	Other Plumbing	System not present.	N/A
Mechanical/ HVAC	The mechanical equipment consists of two fans, a fan tube jet, and a unit heater. The mechanical equipment in this structure was observed to be aged and in poor condition. The exterior housing of the fan tube jet was damaged and corroded. The unit heater was corroded and needed to be replaced. The fan tube jet did not have a membrane, and the two fans supplying outside air to the space appeared to be aged.		Poor

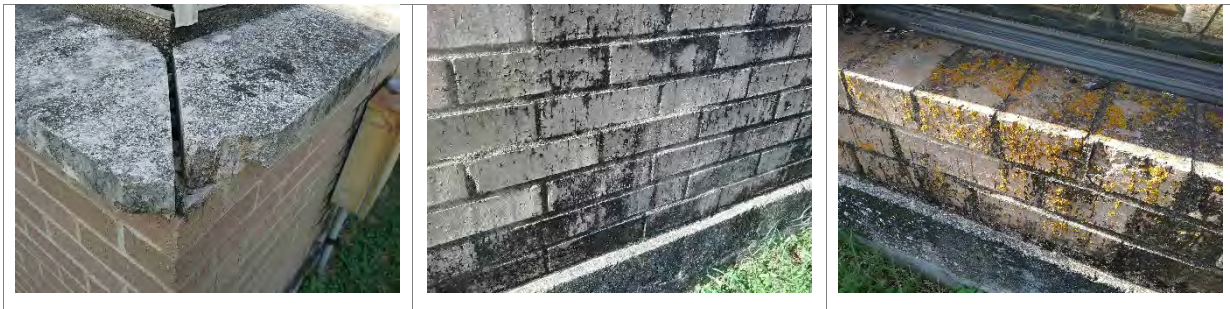
System	Subsystem	Condition and Deficiency Overview	System Condition Rating
Exterior	Exterior Walls	<p>The lower half of the exterior wall is brick on the concrete foundation. The remaining half of the exterior walls are comprised of exterior windows.</p> <p>The wall was observed to be in average condition with broken concrete sills at three of the four corners. Discoloration was observed, as were small amounts of organic growth.</p>	Average
	Exterior Windows	<p>The top half of the walls and the roof are comprised of windows. The windows are channeled acrylic, single pane, and are set in metal frames. There are also sliding windows in the base of the brick wall. These windows are glass. There are also metal louvers at the backside of the building. Corrugated cardboard is being used as a filter set over the louvers.</p> <p>Some of the metal louvers were observed to be broken or missing, and the filter paper was observed to be askew and torn. The weather stripping on some of the sliding windows were observed to be falling. The paint was observed to be in good condition, as were the metal frames.</p>	Average

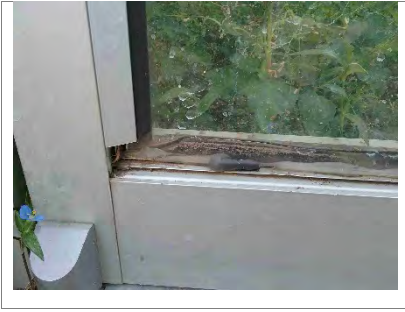
Exterior Doors	<p>There is one exterior door to the building. It is fully glazed in a metal frame.</p> <p>The door was observed to be in average condition as portions of the frame were missing.</p>	Average
Roofing	The exterior windows turn to become the roof. A roof system is not present.		N/A

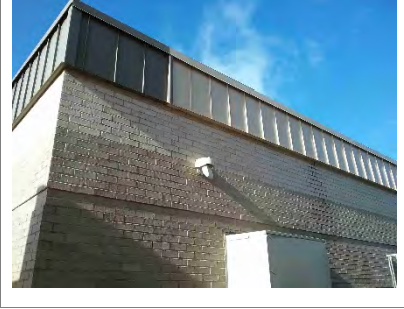
System	Subsystem	Condition and Deficiency Overview	System Condition Rating
Exterior	Exterior Walls	The exterior walls of the building are finished with brick. Where the roof reaches its peak, a metal fascia extends over the edge of the wall to a maximum of ten feet. The exterior walls were observed to be in good condition with only a few areas of discoloration due to water.	Good
	Exterior Windows	System not present.	N/A
	Exterior Doors	The main exterior doors to the building are comprised of metal double doors that are fully glazed. The doors are set in a system of transom windows and side lites. The remaining service doors are metal, and there is another set of glazed double doors with transom windows above them. The building has ten exterior overhead roll up doors; eight are found in the weight room. Some of the overhead doors are blocked and appear to be out of use. The exterior doors were observed to be in average condition due to chipped finishes and minimal rusting. The metal stripping at the door thresholds were observed to be broken. The weight room overhead doors appeared to have been installed to be electrically operated but were observed to be manually operated. The weather stripping at the base of each door was observed to be loose, and the doors were not weather-tight; water damage was noted on the ceiling around the art room overhead door.	Average

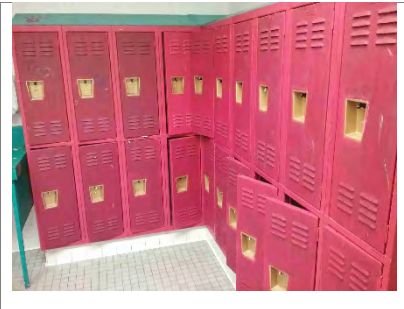
Interior Specialties	<p>There are a small number of lockers in the male and female restrooms of the art classroom.</p> <p>The lockers were observed to be in average condition because some did not open.</p>	Average
Stairs	Exterior Stairs	System not present.	N/A
	Interior Stairs	System not present.	N/A
Interior Finishes	Interior Wall Finishes	<p>The interior walls are finished with painted CMU and painted drywall. The restrooms walls are finished with glazed ceramic tile.</p> <p>The wall finishes were observed to be in average condition as much of the paint was observed to be crackling and peeling.</p>	Average
	Interior Floor Finishes	<p>The floors in the school include VCT, ceramic tile and athletic rubber flooring. The dance studio has a VCT floor made to resemble wood. The veterinary classroom has a ceramic tile floor. Two of the classrooms have sealed concrete floors.</p> <p>The VCT was observed to be in average condition, with isolated broken tiles and cracked VCT flooring near the wall edges. Some VCT were observed to be separated at the joints. The rubber base in the corridor was observed to be aged, and the rubber base in the agricultural classroom was observed to be peeling from the wall completely. The concrete floors were observed to be in good condition. The floor finish in the veterinary room was also observed to be in good condition.</p>	Average

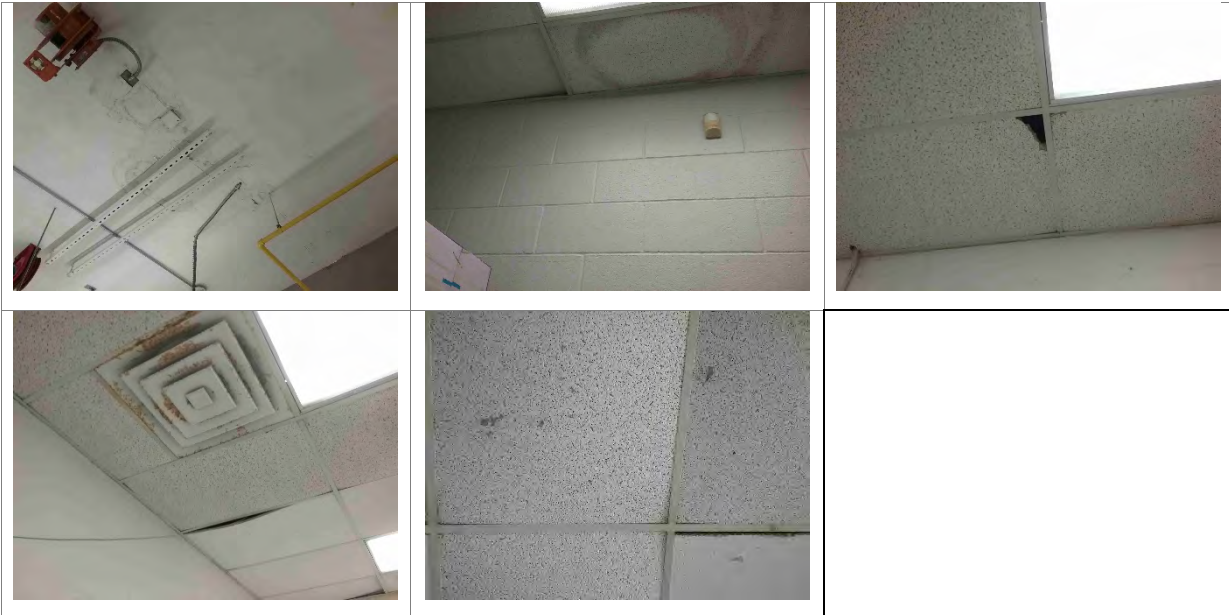
System	Subsystem	Condition and Deficiency Overview	System Condition Rating
	Interior Ceiling Finishes	<p>The ceilings in the weight room, its auxiliary rooms, and the agriculture room are painted dry wall. The rest of the building ceiling is finished with ACT.</p> <p>The ceiling finish was observed to be in average condition as much of the paint was observed to be crackling and peeling from the drywall ceilings. The ceiling in the agriculture classroom was observed to have water damage. Some ACT was observed to have holes or cracks. Water-damaged and bowing tiles were observed in the computer lab office. There were many small tears observed in the ACT ceilings.</p>	Average
Conveying	System not present.		N/A
Plumbing	Plumbing Fixtures	<p>The building has separate male and female restrooms in the weight room and near the laboratory area. The plumbing fixtures in this building consist of vitreous china wall-hung urinals and floor-mounted toilets. The hand sinks are stainless steel with manual faucets. The urinals and toilets have manual flush valves as well.</p> <p>The fixtures in this building were observed to be in poor condition. The faucets in the male and female restrooms near the gymnasium were loose. The hot water was not operating at the time of assessment, and the toilets did not flush well. The water pressure was observed to be low for various faucets and water fountains throughout the building.</p>	Poor

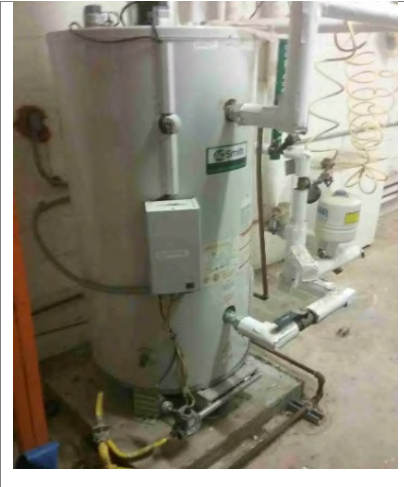
Domestic Water Distribution	<p>The classrooms in this building are serviced with hot water.</p> <p>The gas water heater in this building appeared to be operational and had new distribution piping. Although the fixtures were not getting hot water to them, the water heater itself appeared to be in good condition.</p>	Good
	Other Plumbing	System not present.	N/A
Mechanical/ HVAC	<p>The major mechanical equipment in this building consists of exhaust fans, indoor AHUs, and heat pumps.</p> <p>Many of the diffusers throughout the building were dirty, which could cause low air quality and health issues for students and faculty. The AHUs in the mezzanine areas were observed to be in poor condition. Some of the units appeared to be under repair or were not in use. Room G108 was warm, and the diffusers throughout the building were corroded.</p>		Poor
Fire Protection	Fire Alarm	<p>The building has a fire alarm system that consists of alarm and signaling devices such as voice/annunciators, strobes, voice/strobe combinations, pull stations, and detectors. The fire alarm system is controlled by the campus's main fire alarm control</p>	Average

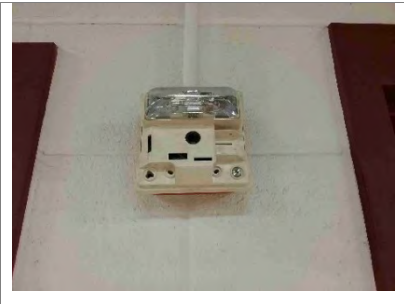
Fire Alarm

System	Subsystem	Condition and Deficiency Overview	System Condition Rating
		<p>system.</p> <p>The fire alarm system appeared to be in average condition, as 35% of the end devices were aged past their design service life.</p>	
	Fire Protection/Suppression	<p>This building does not have a sprinkler system. Fire extinguishers are placed throughout the building for protection in the event of a fire.</p> <p>The equipment appeared to be in good condition, and the observed inspection tags were current.</p>	Good
Electrical	Electrical Distribution	<p>The electrical service enters the building at the 277/480-volt 800-amp distribution panel HDP located in the theater wing mechanical room. Distribution panel HDP1 is served from the main switchboard MSB located in the mechanical building. HDP1 feeds transformers and branch panelboards located in various electrical rooms throughout the building. The building does not have a lightning protection system.</p> <p>The electrical distribution equipment appeared to be in average condition. About 40% of the assets were observed with corrosion. Panelboard 1A-LB and 1A-LV had missing breaker covers, and the bussing was exposed behind the breaker boards. This condition should be considered a life safety hazard. It was also reported that the conduits in the space were EMT and were severely corroded. Because of this, it was reported that the integrity of the electrical grounding system had been compromised, as the conduit system was the grounding system for the facility.</p>	Average

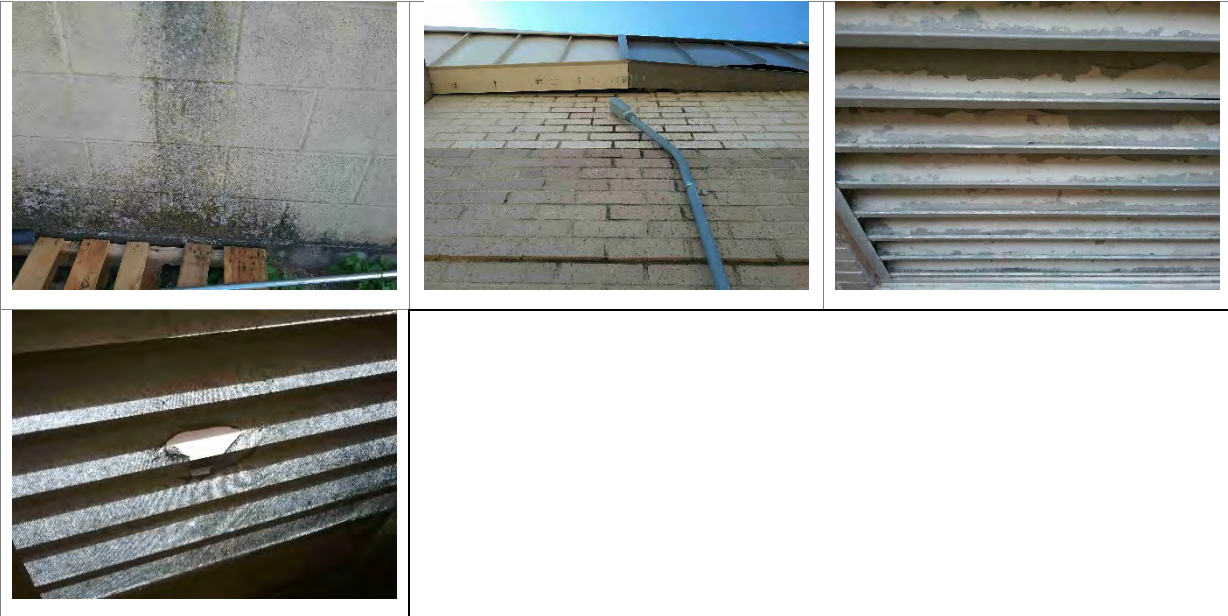
System	Subsystem	Condition and Deficiency Overview	System Condition Rating
Exterior	Exterior Walls	<p>The exterior walls are comprised of brick with a tall metal panel fascia. There are no windows in the exterior walls, but set into the walls are two large louvers with insect screens.</p> <p>The exterior walls were observed to be in good condition except for some isolated deficiencies. There was one isolated area of organic growth observed on the side of the building. There was also one isolated area of bent metal panel on the same side of the building. Additionally, the paint on the exterior louvers was observed to be extremely worn, and the interior insect screen was observed to be torn.</p>	Good
	Exterior Windows	System not present.	N/A
	Exterior Doors	<p>There is one exterior man door into the building and one overhead rolling door. There is one exterior overhead rolling door in the building, 10 feet wide and 12 feet tall. The door is segmented metal with three small vision windows.</p> <p>Both exterior doors were observed to be in average condition do to age and use. The man door was observed to be extremely scratched on the interior side of the door and the handle is broken. It appeared that the overhead door was installed as an electric door, but the chain was observed to not be present. The bottom of the door was observed to be dented and scratched, while the remainder of the door was observed to be lightly stained with calcium deposits. One pull handle was observed to be broken. The door was too heavy to</p>	Average

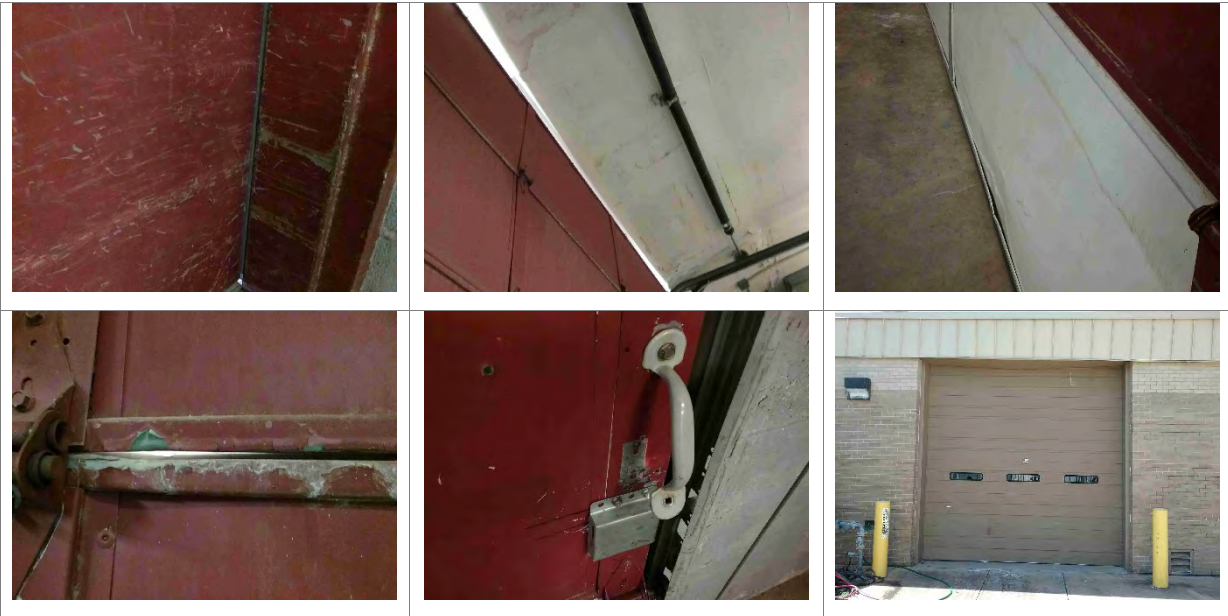
Exterior Doors

System	Subsystem	Condition and Deficiency Overview	System Condition Rating
		lift but the tracks appeared in operable condition. The top of the door frame paneling was observed to be dented.	
Roofing	The roof is a standing seam metal roof. The roof was inaccessible due to its steep slope. The roof was observed to be in good condition from ground level.		Good
Interior Construction	Interior Walls	The interior walls are constructed with CMU construction. No deficiencies were observed in the interior walls. They appeared to be in good condition.	Good
	Interior Doors	The interior doors are metal in metal frames. The doors and frames were observed to be in average condition due to use; the paint was observed to be scratched and worn. One door frame was observed to be deteriorating at the base from rust.	Average
	Interior Specialties	System not present.	N/A
Stairs	Exterior Stairs	System not present.	N/A

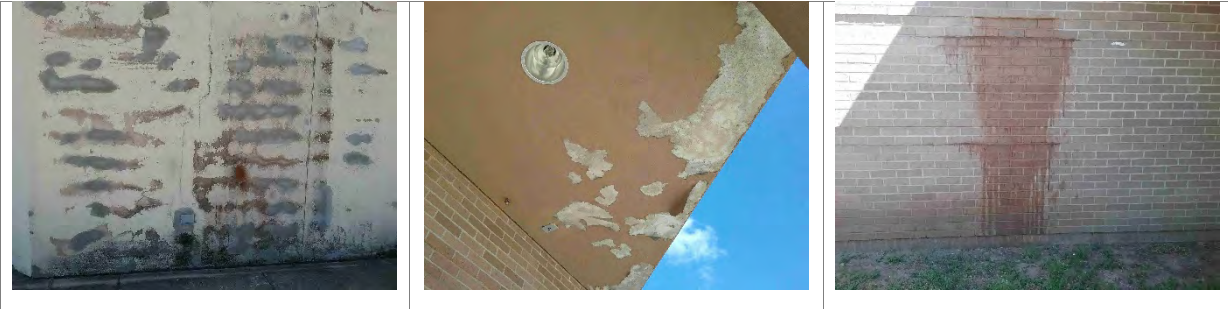
System	Subsystem	Condition and Deficiency Overview	System Condition Rating
Exterior	Exterior Walls	<p>The exterior walls of the building are finished with brick and plaster. Where the roof reaches its peak, a metal fascia extends over the edge of the wall to a maximum of seven feet.</p> <p>The brick exterior walls were observed to be in good condition with very little damage visible. The plaster portions of the exterior walls were observed to be in poor condition with worn and peeled finishes. Additionally, the painted plaster soffits were observed to be peeling. One large stain was observed on the south wall from a spill.</p>	Average
	Exterior Windows	<p>The exterior walls of the corridor are comprised entirely of a metal frame window system. The frames are painted, and the glazing is single pane. The bottom half of the system is infilled with metal panels.</p> <p>Exterior windows were observed to be in good condition as little damage was observed. The damage that was observed consisted of worn paint finishes on the corners of the frames.</p>	Good

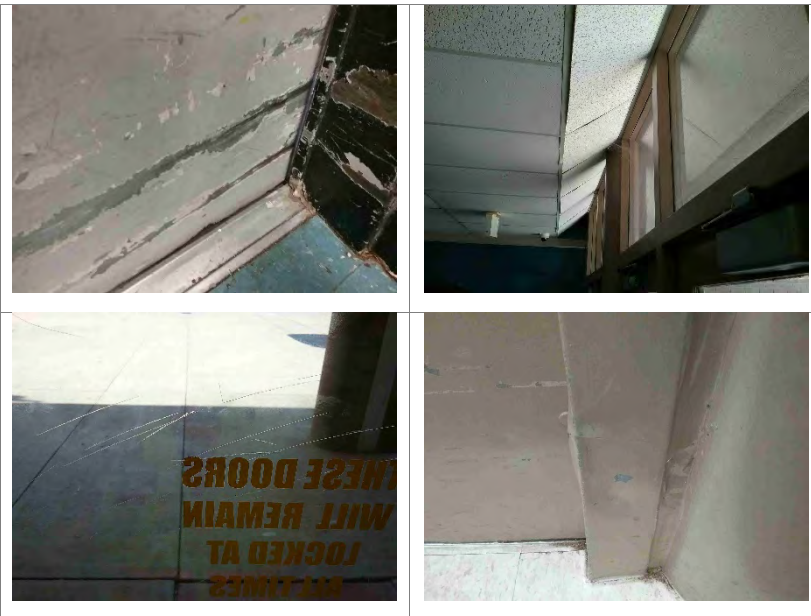
Exterior Doors	<p>The entry exterior doors exist on two corners of the building. There are three sets of glazed double doors with transom windows above them. Doors are painted metal as are the frames. The remaining service doors are also metal. There two aluminum overhead rolling doors leading into the building. One is at the backstage of theater, and one leads to a storage room.</p> <p>The exterior doors were observed to be in average</p>	Average

System	Subsystem	Condition and Deficiency Overview	System Condition Rating
		condition from daily use. Much worn paint was observed on the frames and door leafs at areas of high use. Cobwebs were observed between the door and ceiling. Some of the glazing was observed to be scratched. Some of the door frames were observed to be dented. Both overhead doors appeared to be in good condition and be operable.	
Roofing	<p>The roof of this building is standing seam metal. There is also a significant permanent canopy system providing coverage for the walkways between buildings. These canopies are set on large columns and are clad in plaster.</p> <p>Evidence of water damage was observed on the metal overhang on the south side of the building. Some of the gutters were observed to be rusted. Additionally, the large permanent canopy, which is finished with plaster, was observed to have significant water damage both near the columns and in the field of plaster.</p>		Average

1. Refinish all window frames with peeling paint.
2. Clean exterior of all windows and doors.
3. Refinish damaged and rusted metal doors and frames.
4. Replace rusted door frames.

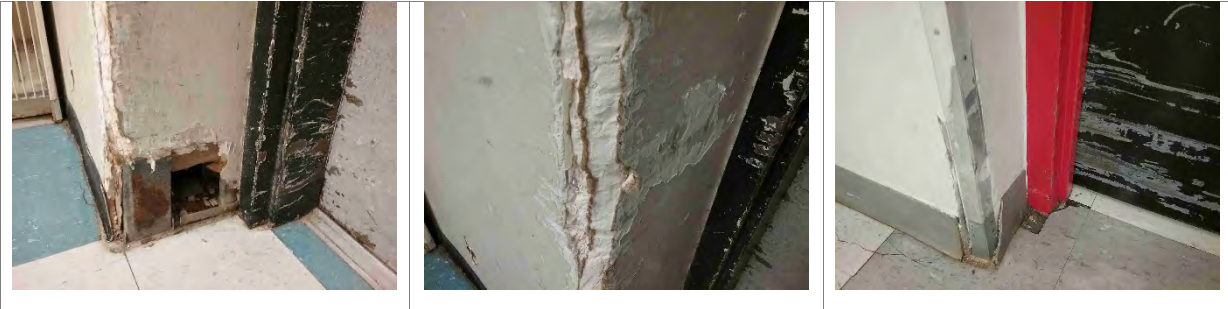
Interior Construction	Interior Walls	<p>Interior walls are constructed of metal studs covered in one layer of drywall.</p> <p>A wall near the exterior door from the music room was observed to be extremely damaged with destroyed drywall and exposed middle studs. The metal stud was observed to be displaying some evidence of rust. A similar condition was observed at the cafeteria entrance doors.</p>	Good
	Interior Doors	<p>The interior doors are metal in painted metal frames. Some doors have narrow side lites.</p> <p>The doors were observed to be in average condition from normal wear and tear. The paint was observed to be heavily scratched from the door frames. The closers on the female locker room doors do not engage.</p>	Average
	Interior Specialties	<p>There are general lockers in the corridor of the building and athletic lockers in the locker rooms.</p> <p>The general lockers were observed to be in good condition, and the locker room lockers were observed to be in average condition; the locker room lockers were observed to be dented and scratched.</p>	Average

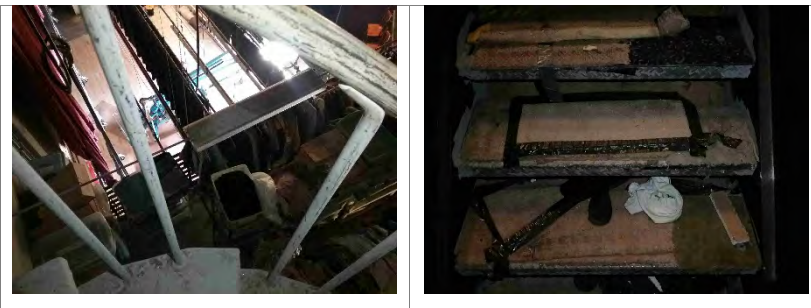
Stairs	Exterior Stairs	System not present.	N/A
	Interior Stairs	<p>There are two open metal stairs leading to the fly space of the theater. There is an additional metal spiral staircase leading to the theater mezzanine.</p> <p>The stairs were observed to be in good condition except for the balusters of the spiral staircase; every other baluster is 8 inches apart. The lower steps of the stairs are cushioned with piles of carpet posing a tripping hazard.</p>	Good

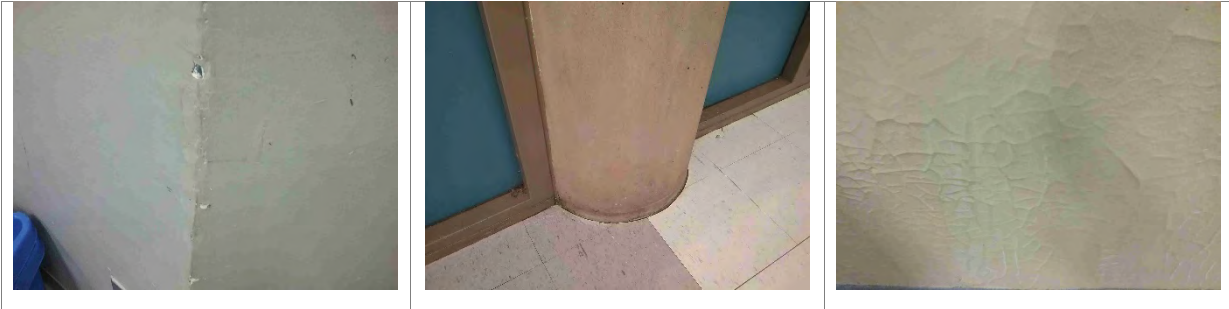
System	Subsystem	Condition and Deficiency Overview	System Condition Rating
Interior Finishes	Interior Wall Finishes	<p>The interior walls of finished with painted drywall and fiber reinforced plastic panels. Acoustical panels are present in the music rooms. The gymnasium walls are finished with painted CMU, brick, and unpainted wood wool panels. The kitchen walls are finished with ceramic tile.</p> <p>Many of the walls are damaged at the corners. The acoustical panels were observed to be in excellent condition. The gymnasium walls were observed to be in good condition. The paint finish on the base of the columns was especially dirtied. Some painted drywall was observed to be crackling. The kitchen tile was observed to be in good condition.</p>	Average
	Interior Floor Finishes	<p>The interior floor finishes include finished with VCT. The theater audience floor is finished with carpet, and the stage is wood. The gymnasium floor is finished with varnished wood. The kitchen floor is finished with ceramic tile. The locker rooms are floored with ceramic tile.</p> <p>The flooring finishes were observed to be in poor condition due to use. Door swings were observed to be scratched into the VCT floor from dragged door stops. Some of the VCT was chipped or stained, especially near the wall base. Extensive cracking was observed in the VCT in the corridor. A ridge was observed to extend north to south for the length of the east side corridor. The majority of the VCT was also observed to be pimply. The rubber wall base was observed to have been removed from the backstage corridor and aged in many of the classrooms. The floor of the choir room risers were observed to be failing. Parts of the floor were observed to be sinking, much of the VCT was cracked and the edges were observed to be broken. The wood floor of the large gymnasium was observed to be in good condition, but the floor of the small gymnasium was observed to be pocked. The kitchen tile was observed to be in good condition. Broken VCT was observed in the locker rooms.</p>	Average

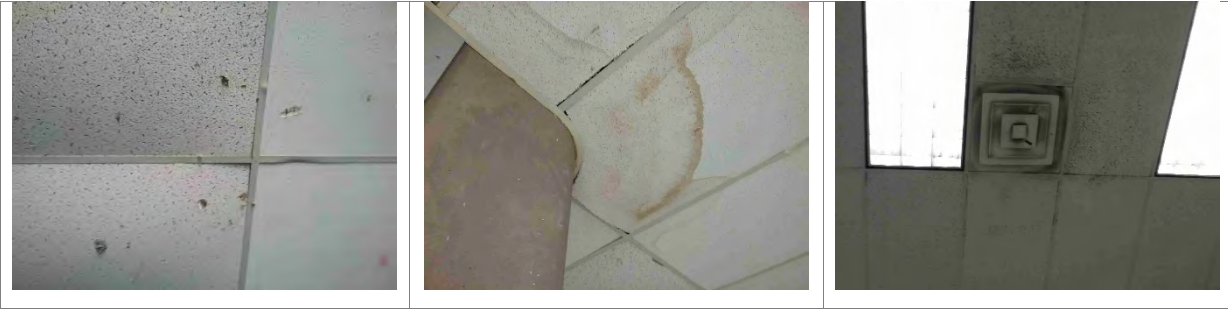
Interior Ceiling Finishes	<p>The majority of ceilings in the building are finished with ACT. The theater and restrooms ceilings are painted drywall. The main gymnasium ceiling is painted wood wool panels. The kitchen ceiling is water resistant lay-in ceiling tiles. The locker rooms and restrooms ceilings are painted drywall.</p> <p>The ACT ceilings were observed to be in average</p>	Average

System	Subsystem	Condition and Deficiency Overview	System Condition Rating
		condition. Surface damage was observed. Water damage was also observed on some tiles. Possible mold or simply heavy dust was observed on the ceiling of the music rooms. The gymnasium ceiling was observed to be in good condition. Some water damage was observed in the cafeteria ceiling, but the kitchen ceiling was observed to be in good condition. The locker room ceilings were observed to be in good condition.	
Conveying	System not present.		N/A
Plumbing	Plumbing Fixtures	<p>The building has a male and female public restrooms as well as separate private restrooms for faculty members. The urinals are wall-hung and the toilets are floor-mounted, vitreous china. The sinks are either stainless steel or vitreous china with manual faucets, and the toilets and urinals have manual flush valves. Service sinks are located in janitorial closets throughout the building.</p> <p>There were water pressure issues with the plumbing fixtures throughout the building. Many of the urinals did not flush properly. Many of the faucets did not have hot water at the time of the assessment.</p> <p>There was a faucet in the kitchen area that did not have hot water and was leaking. The kitchen faucets that did have hot water needed to be left running for a prolonged period before the water became warm.</p> <p>There was a urinal in one of the male public restrooms that did not flush properly, and one of the sinks did not have water flow. The restroom near FC-816 above the stage was under repair. The urinals in the male locker room did not flush properly. One of the faucets in the male locker room did not have hot water, while another did not have water flow. One of the faucets was also missing a valve. The showers in the male locker room did not have water flow. The water fountain outside of the male locker room was in bad condition and had low water pressure.</p>	Poor

1. Replace damaged and bowing ceiling tiles and tees. Monitor and repair roof leaks as needed on all buildings to prevent further damage.
2. Scrape peeling paint and repaint damaged finishes.
3. Refinish damaged metal doors and frames.
4. Install metal corner guards at all damaged drywall corners.
5. Replace all discolored, detached or damaged rubber wall base.
6. Replace broken VCT, and reinstall bubbling tile.

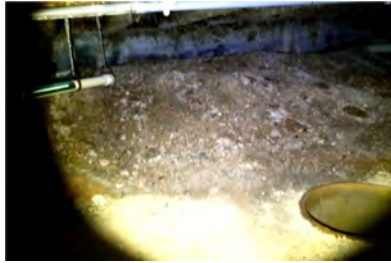
Damp soil at perimeter

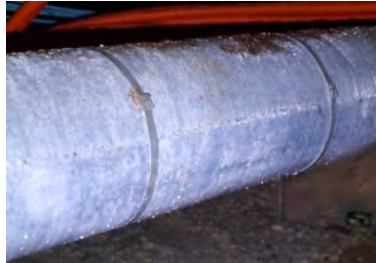
Condensation on pipe

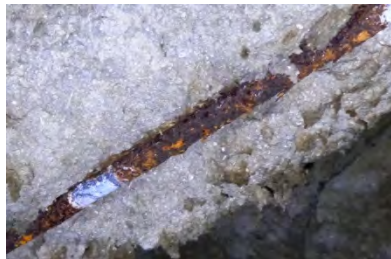
Rusted pipe under joist

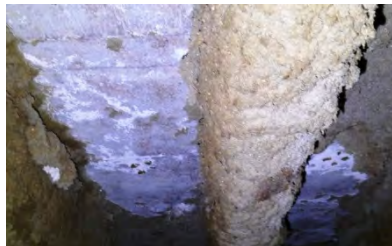
Fallen spray-on fireproofing

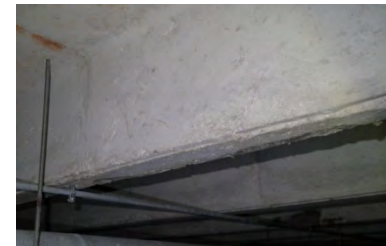
Missing/removed spray-on fireproofing

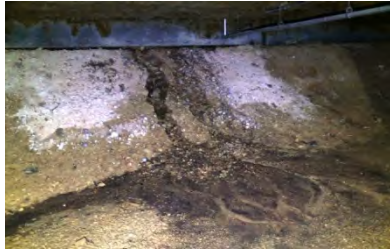
Water infiltration at perimeter

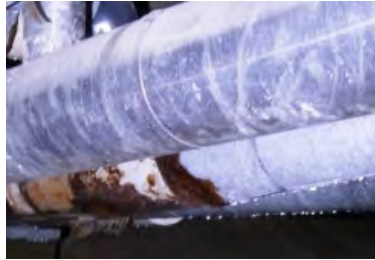
Pipe condensation

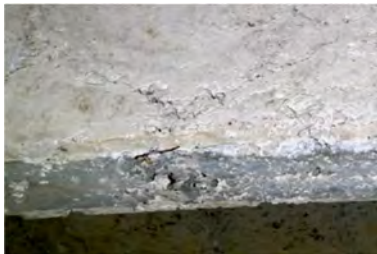
Honeycombing at bottom of pan joist

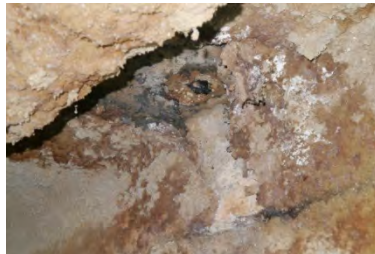
Rusted metal concealed behind fireproofing

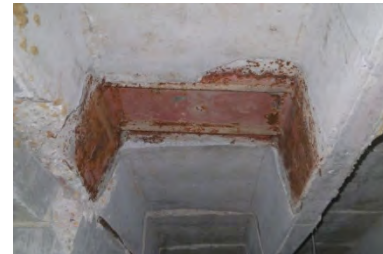
Metal pan form left in place and corroding

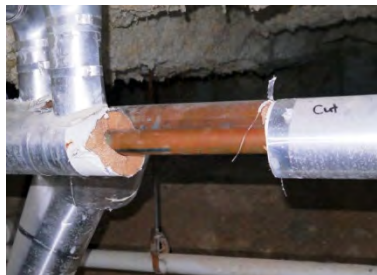
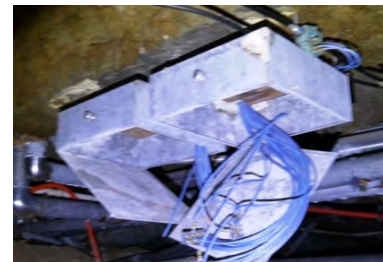
Open junction box

Missing pipe insulation	Corroded mechanical equipment

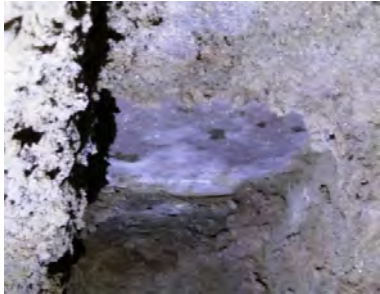
<p>Missing/degraded spray-on fireproofing</p>

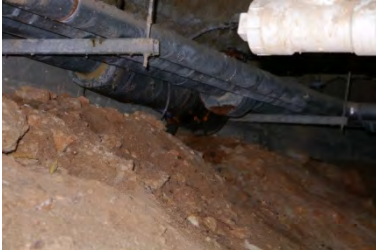
<p>Damp soil, water infiltration around perimeter of building</p>		
---	--	--

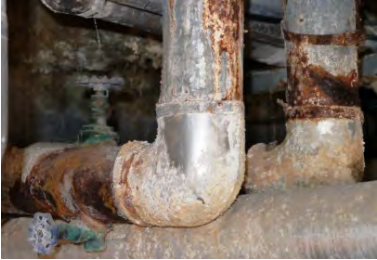
<p>Rusted pipes</p>

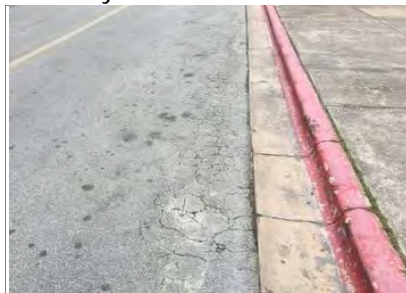
Cracking along gutter (front drop off)

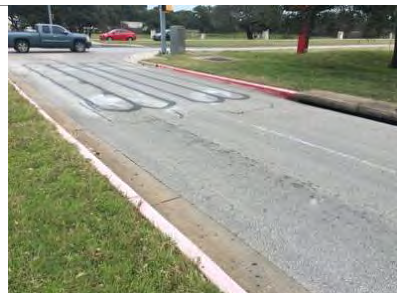
Settling at exit

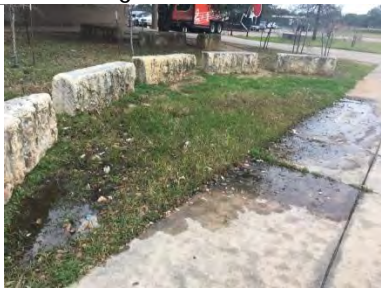
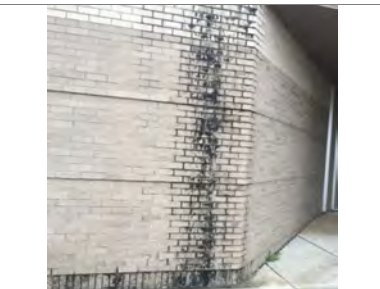
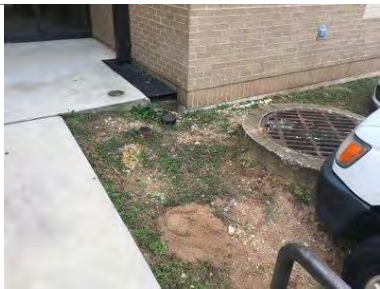
Site Drainage

Standing water-front right of main entrance	Gutter leaking	Erosion from downspout

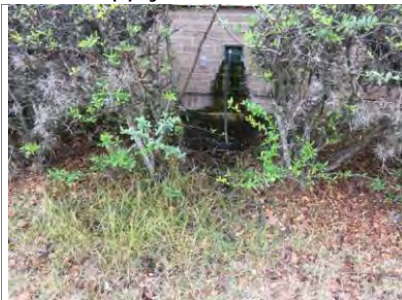
Leaking water faucet

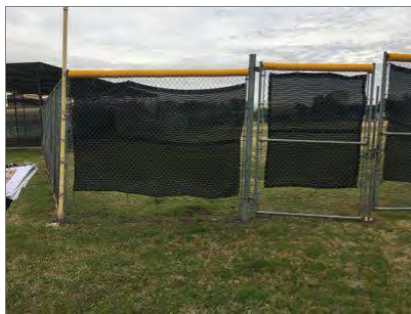
Gate slanted

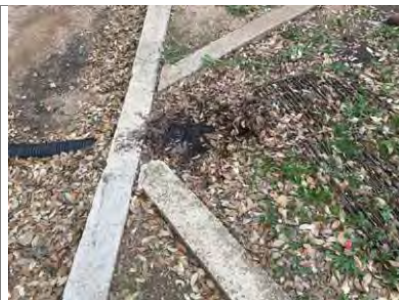
Misplaced grate cover

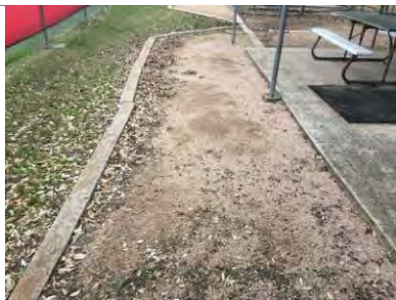
Uneven crushed granite

1. Replace grate cover
2. Even and fill crushed granite walkway

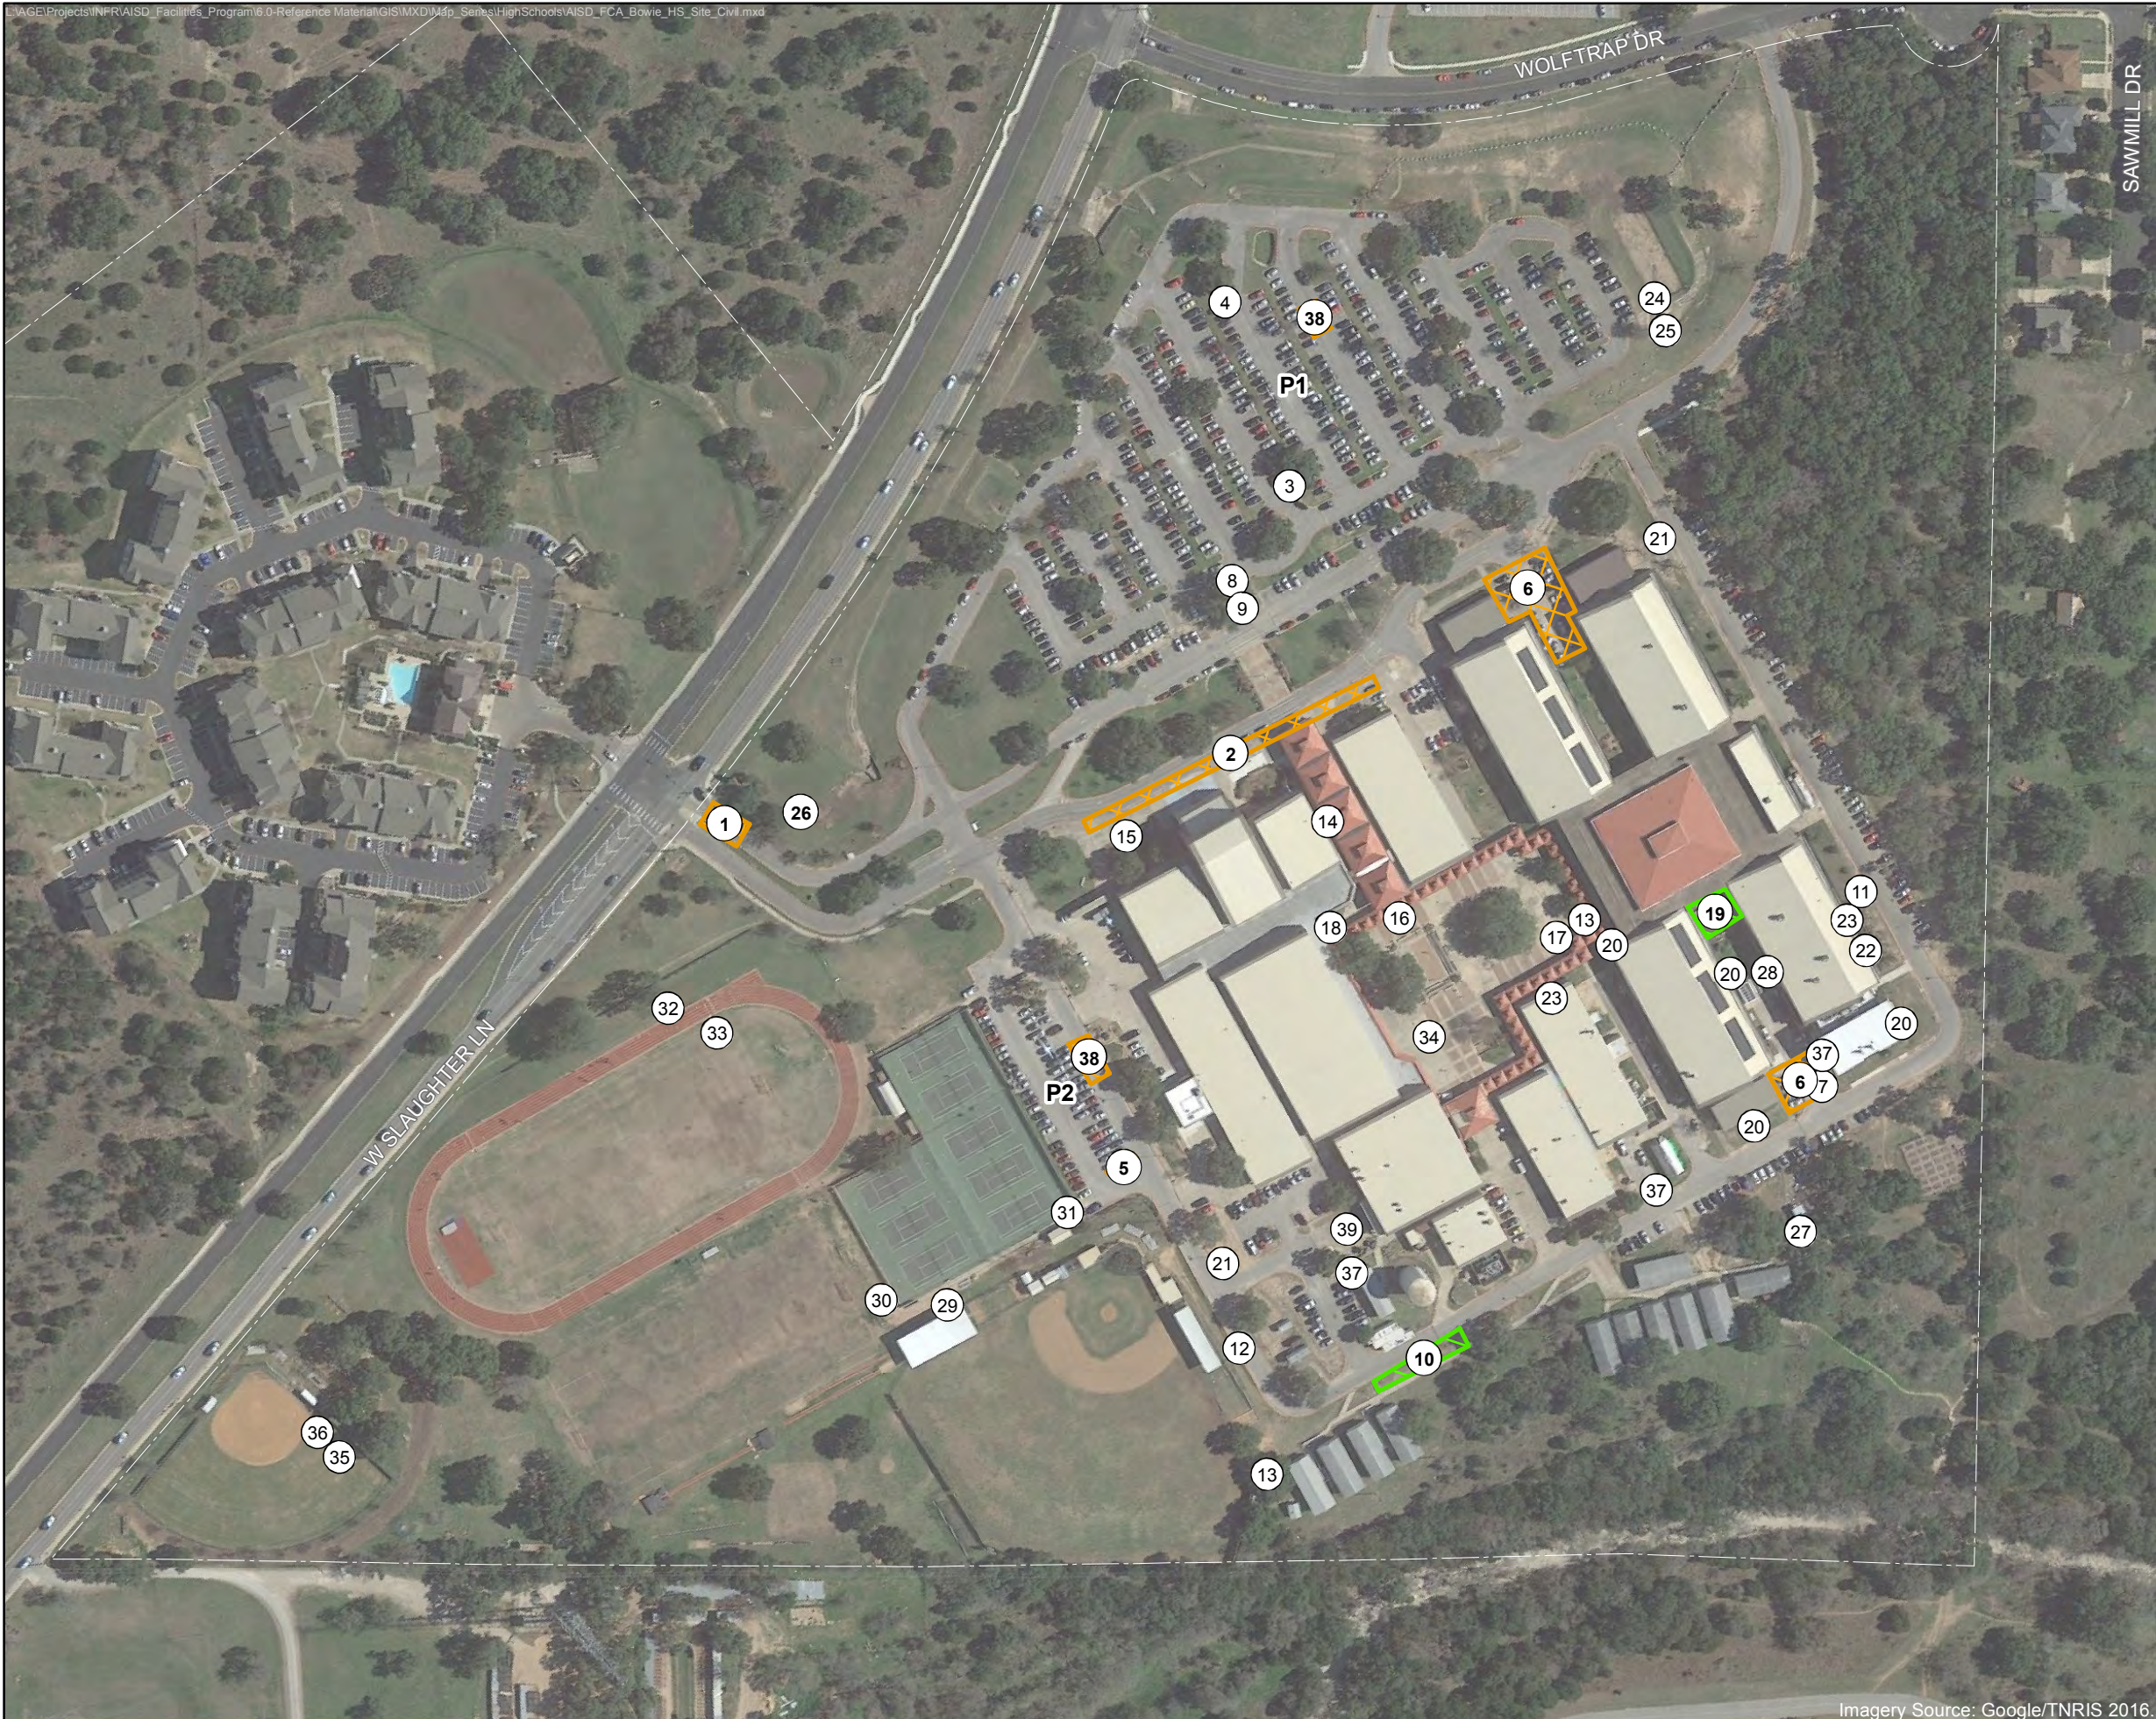
1. SETTLING/CRACKING PAVEMENT PATCH
2. ALLIGATOR CRACKING ALONG GUTTER
3. RADIAL CRACKING NEAR TREE WELL IN LOT 1 (TYPICAL)
4. CRACKED CONCRETE AROUND MANHOLE

5. BROKEN CURB STOPS
6. CARS PARKED ON GRASS/DIRT
7. POTHOLE
8. CRACKED CONCRETE AROUND TREE WELL
9. LOW SPOT IN CONCRETE
10. EROSION ALONG SIDEWALK
11. CONCRETE SUNK AROUND INLET

12. TOP OF FENCE DAMAGED
13. STONE RETAINING WALL DAMAGE
14. INTERIOR ROOF DRAINS, WATER DOWN SIDE OF BUILDING (VARIOUS LOCATIONS, ONE EXAMPLE SHOWN)
15. STANDING WATER

16. BRICK PAVERS DEPRESSED/GRASS GROWTH(VARIOUS LOCATIONS IN COURTYARD)
17. CONCRETE SLAB CRACKING AT PILLAR BASE
18. CONCRETE PILLAR CRACKED
19. UNEVEN GROUND

20. PESTHOLES (VARIOUS LOCATIONS)
21. ERODED GRASS AREA
22. OVERGROWN THORNY VEGETATION (VARIOUS LOCATIONS)
23. LEAKING WATER FAUCETS (TYPICAL AROUND THE BUILDINGS)

29. DETERIORATED AREA
30. BROKEN TARP
31. DRINKING FOUNTAIN
32. SINK HOLE
33. EROSION AROUND INLET
34. SLANTED GATE
35. MISPLACED GRATE COVER
36. UNEVEN CRUSHED GRANITE
