Crockett High School Site Summary

Address	5601 Manchaca Road Austin, TX 78745
Number of Permanent Campus Facilities	2
Original Year of Construction	1969
Total Campus Building Area (combined)	336,603 SF

Main School Building – BLDG-008A

Theater Building – BLDG-008B

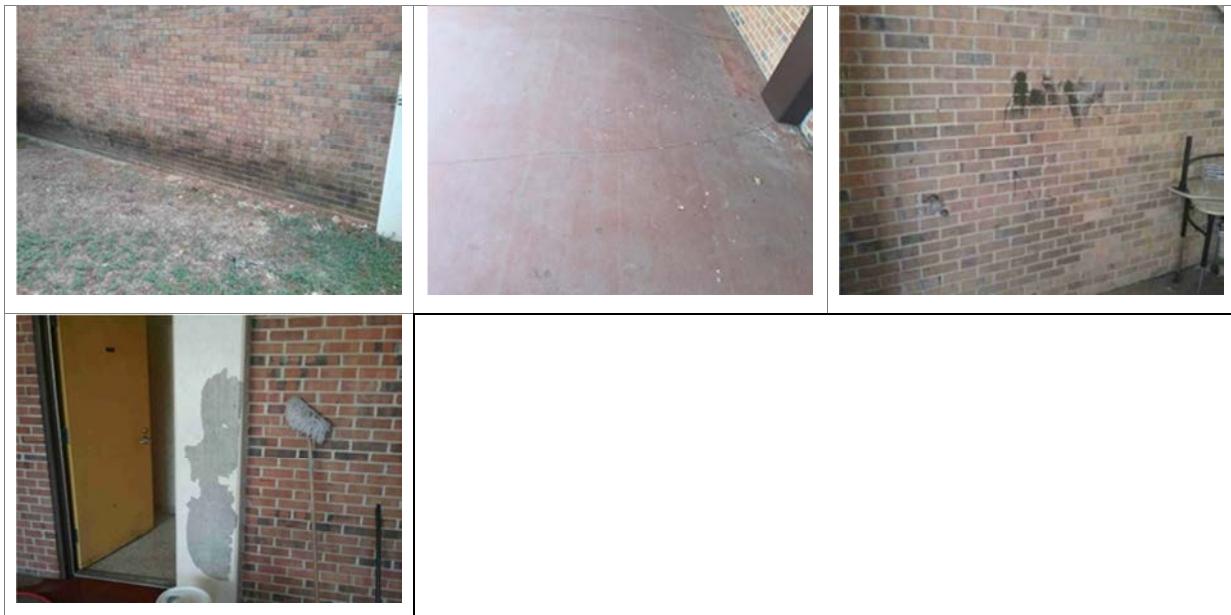
System	Subsystem	Condition and Deficiency Overview	System Condition Rating
Exterior	Exterior Walls	<p>The exterior walls are brick with horizontal and vertical accents of concrete.</p> <p>The exterior walls were in good condition with several observed deficiencies. There were instances of staining and organic growth on the sides of walls, specifically along the base. There was minor staining on the concrete at the top of the building where water flows from the roof. There were cracks in the concrete flooring under the covered walkways. Chipped paint and spalling was observed on several of the concrete columns in the covered walkways.</p>	Good
	Exterior Windows	<p>The exterior windows are single-pane glazing and acrylic, varying throughout the school. The windows along the outer perimeter have plastic panel infill on the bottom portion, metal mesh behind acrylic on the middle portion, and acrylic as the top portion.</p> <p>The windows were in average condition. A window in a courtyard stairwell had a hole and missing weatherstripping. There was a broken pane and several panes with scratched surfaces. It was reported that the gym lobby windows were cracked and in poor condition.</p>	Average

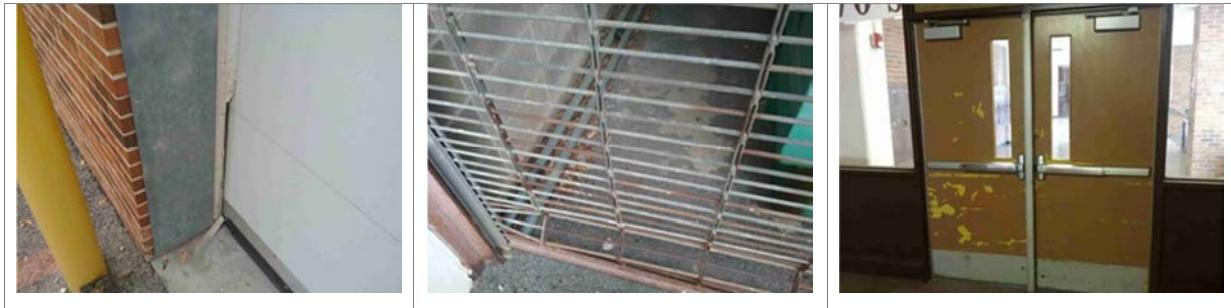
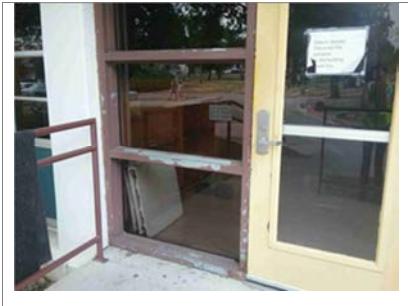
Exterior Doors	<p>The exterior doors are primarily metal with metal frames. One of the main entry doors was ADA (Americans with Disabilities Act) accessible with a push button to open the door.</p> <p>The exterior doors were in average condition showing</p>	Average

System	Subsystem	Condition and Deficiency Overview	System Condition Rating
		typical wear and tear. An exterior overhead door on the southwest wall had deteriorated weather-stripping. A metal overhead door along the southwest wall was aged past its typical design service life and difficult to operate. There was significant wear and tear to the door paint on the doors separating the covered walkway and the interior portions of the building. Chipped paint was observed on the metal framing of a storefront entryway. It was reported that there was a gap in the roll-up door at the kitchen and pests were able to access the building.	
Roofing		The roof material covering the building varies between modified bitumen, built-up asphalt with a granular topping, and metal standing seam roof deck. There is also a covered walkway through the courtyard with a corrugated metal roof. The roof surfaces were observed to be in average condition with some staining, moderate cracking, and isolated areas of blistering and rust. The majority of the roof is covered with modified bitumen, which is stained and slightly cracked over large portions of the roof. Some areas of the modified bitumen, particularly in roof sections A-04 and A-08, were observed to be severely blistered over small areas. The standing seam metal roof over roof section A-33 appeared to be in good condition. The corrugated metal roof deck covering the courtyard walkway was observed to be rusted in some areas. In addition, facility occupants reported that the roof leaks at some expansion joints, at the STOMECH2 room, and above the serving line in the cafeteria.	Average

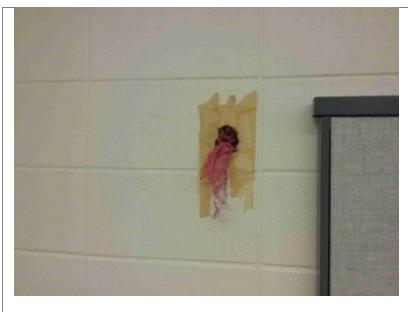
Interior Construction	Interior Walls	The interior partitions of the building are predominately constructed of CMU (concrete masonry unit) and gypsum wallboard. In addition, fully-glazed walls, brick walls, and moveable partitions were observed. The interior partitions appeared to be in average condition throughout the building. Some small holes were observed, specifically in the CMU walls.	Average
	Interior Doors	The vast majority of interior doors are wood with a metal frame. Some of the wood doors have glass view windows, metal louver panels, and/or metal kick plates. Some painted metal doors were also observed. There were two overhead doors in the cafeteria. There are pocketed steel gates in the corridors. The interior doors and frames were observed to be in average condition given the age of the system and typical signs of wear and use. The overhead doors were in good condition, but showed minor rusting at the base. The pocketed steel gates were recessed at the time of assessment, but the tracks were observed to be in average condition with minor rusting.	Average

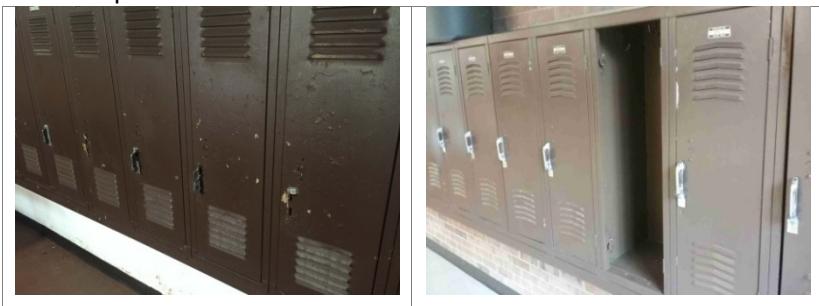
**Interior Specialties**

System	Subsystem	Condition and Deficiency Overview	System Condition Rating
	Interior Specialties	<p>Painted metal lockers line many of the school's corridors, both inside the building and outside within the covered walkways.</p> <p>The lockers were aged, but most appeared to be in average condition. However, the insides of some lockers were unclean, approximately one third had chipped paint, a locker door was missing, and several of the locks were broken.</p>	Average
Stairs	Exterior Stairs	<p>Several concrete exterior stairs were observed. Stairs within the courtyard space have a red cementitious topping, metal handrails, and metal nosing strip. Stairs along the perimeter of the building are unfinished concrete with painted metal handrails.</p> <p>The stairs were in average condition with several deficiencies observed. The paint on the handrails of the perimeter stairs was peeling. The concrete stairs leading to a utility room is stained, unclean, and rusting.</p>	Average

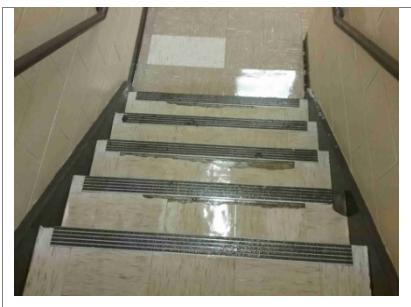
**Stair Deficiency Examples****Interior Stairs**

Interior Stairs	<p>Several different types of interior stairs were observed. The larger, monumental stairs in main occupant flow areas are concrete with metal nosing strips and metal hand rails. These stairs are similar to the exterior stairs, but do not have the red cementitious topping. Stairs in side corridors are metal pan stairs with VCT (vinyl composite tile), metal nosing guards, and metal hand rails. There is a concrete stairwell in the auto shop with metal railings. Small stairs on grade were also observed, with a rubber covering and metal handrails.</p> <p>The interior stairs were in average condition. Some delamination of the VCT was observed at one interior stair.</p>	Average
Interior Finishes	Interior Wall Finishes	<p>CMU walls and gypsum wallboard walls are primarily painted, while some wallpaper was also observed. Several of the classrooms and corridors have a painted plastic panel attached to the face of the wall. Wood paneling is also present in some rooms, particularly in the administration wing, and ceramic tile lines the walls in most restrooms.</p> <p>The interior wall finishes were in average condition. Some paint was chipped on various walls, and some wood paneling was observed to have wear and discoloration consistent with the age of the building.</p>	Average

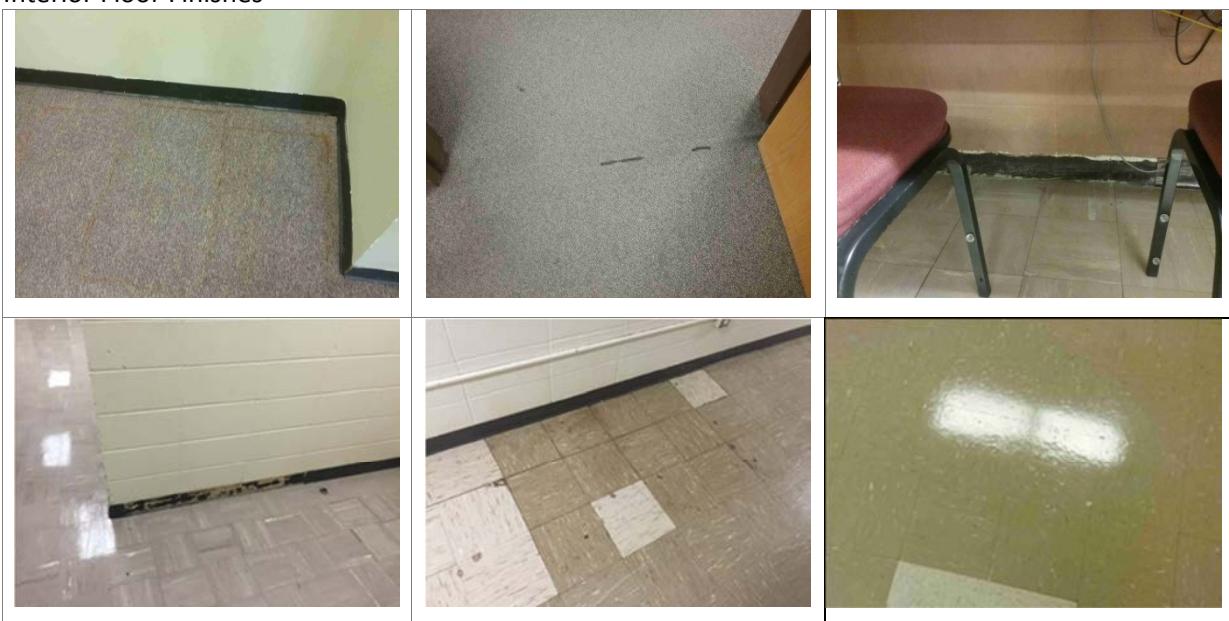
Interior Floor Finishes

System	Subsystem	Condition and Deficiency Overview	System Condition Rating
		The floor finishes were in average condition. There were instances of carpet stains, torn and damaged carpeting, stained VCT, loose rubber baseboards, and missing rubber baseboards. The cafeteria VCT had divots covering a majority of the flooring. Facility staff reported loose floor tiles in the auto shop, cracked ceramic tile in the kitchen, and cracks in the floor of the MRRGYM room.	
	Interior Ceiling Finishes	<p>The majority of the interior spaces are finished with ACT (acoustic ceiling tile). The restrooms are finished with gypsum board. The janitorial closets do not have a drop ceiling, and are open to the structure above. Rooms 13 and 19 were observed to have no drop ceilings, and were open to the structure above.</p> <p>The interior ceiling system was observed to be in average condition showing signs of age and deterioration. The ACT was observed to be stained and buckling in some areas. More staining was observed in the administration wing than in the classrooms.</p> <p>During the time of the assessment, mechanical equipment was being installed. As a result, several ceiling tiles had been removed in various places within the building. In the library, many ceiling tiles were missing, the ceiling support grid was damaged, and one tile was hanging down from a piece of electrical conduit.</p> <p>Facility occupants reported that the locker rooms have a deficient ceiling and that the ceiling grid is in poor condition near the band hall.</p>	Average

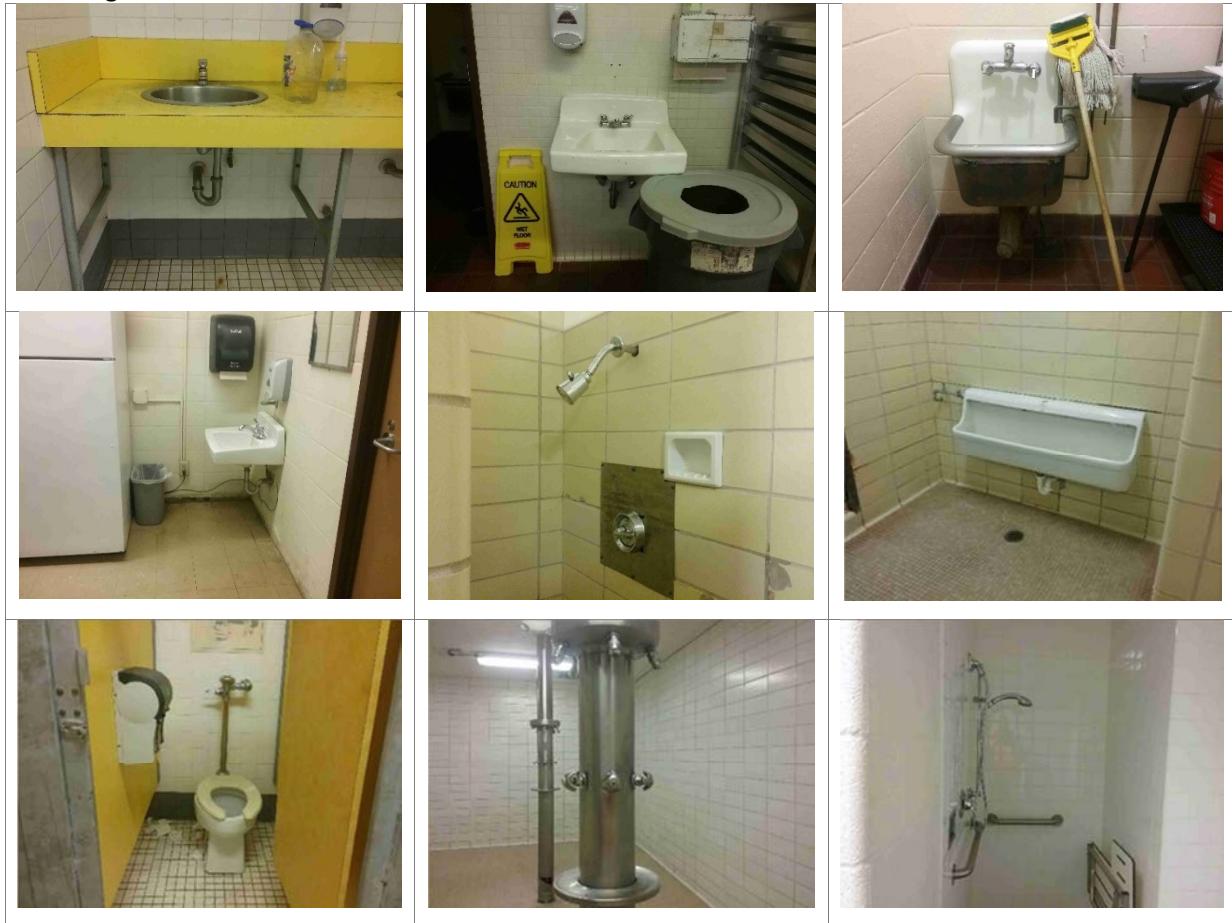
Conveying	The building is equipped with a hydraulic passenger elevator to service two levels. This elevator was observed to be in good condition and no operational issues were reported by the facility staff. Access to the elevator machine room was not possible due to floor waxing.		
Plumbing	Plumbing Fixtures	<p>The building has public restrooms for men and women, students, and separate staff restrooms located throughout the facility. These restrooms have a variety of lavatories including stainless and vitreous china sinks in counters with manual faucets, as well as molded lavatory units with sensor style faucets. There are vitreous china, floor-set toilets with manual flush valves, and vitreous china, wall-hung urinals in the men's restrooms with manual flush valves.</p> <p>The male and female locker rooms consist of group showers, individual showers, floor set water closets with manual flush valves, a trough style urinal in the male locker room, and vitreous china lavatories. P-trap style</p>	Poor

System	Subsystem	Condition and Deficiency Overview	System Condition Rating
		<p>service sinks are found in the janitorial closets.</p> <p>There are single-level electric water coolers located throughout the facility, typically near the public restrooms. There are wall-hung vitreous china hand sinks and faucets in the kitchen.</p> <p>The restroom plumbing fixtures were observed to be in poor condition, as the fixtures were typically aged beyond their typical design service life though still operational. Some of the manual faucets had extremely low flow and pressure. Several flush valves were temperamental when operating, requiring multiple flushes to properly function.</p> <p>The group shower Bradley shower pole units are out of date and replacement parts can no longer be ordered. The thermostatic mixing valves, which supply the tempered water to the showers, are failing. One mixing valve in the male locker room has been replaced, but there is one more in the male locker room and two in the female locker room that have not been. The remaining plumbing fixtures in the locker rooms have exceeded their typical design service life. Many of the fixtures have parts that are failing.</p> <p>P-trap style raised sinks make it difficult to empty buckets by staff and can result in physical harm, as well as spilled water on the floors.</p> <p>The electric water coolers were in good condition.</p> <p>The kitchen equipment appeared to be well maintained. The wall-hung vitreous china hand sinks and faucets were aged and in poor condition.</p>

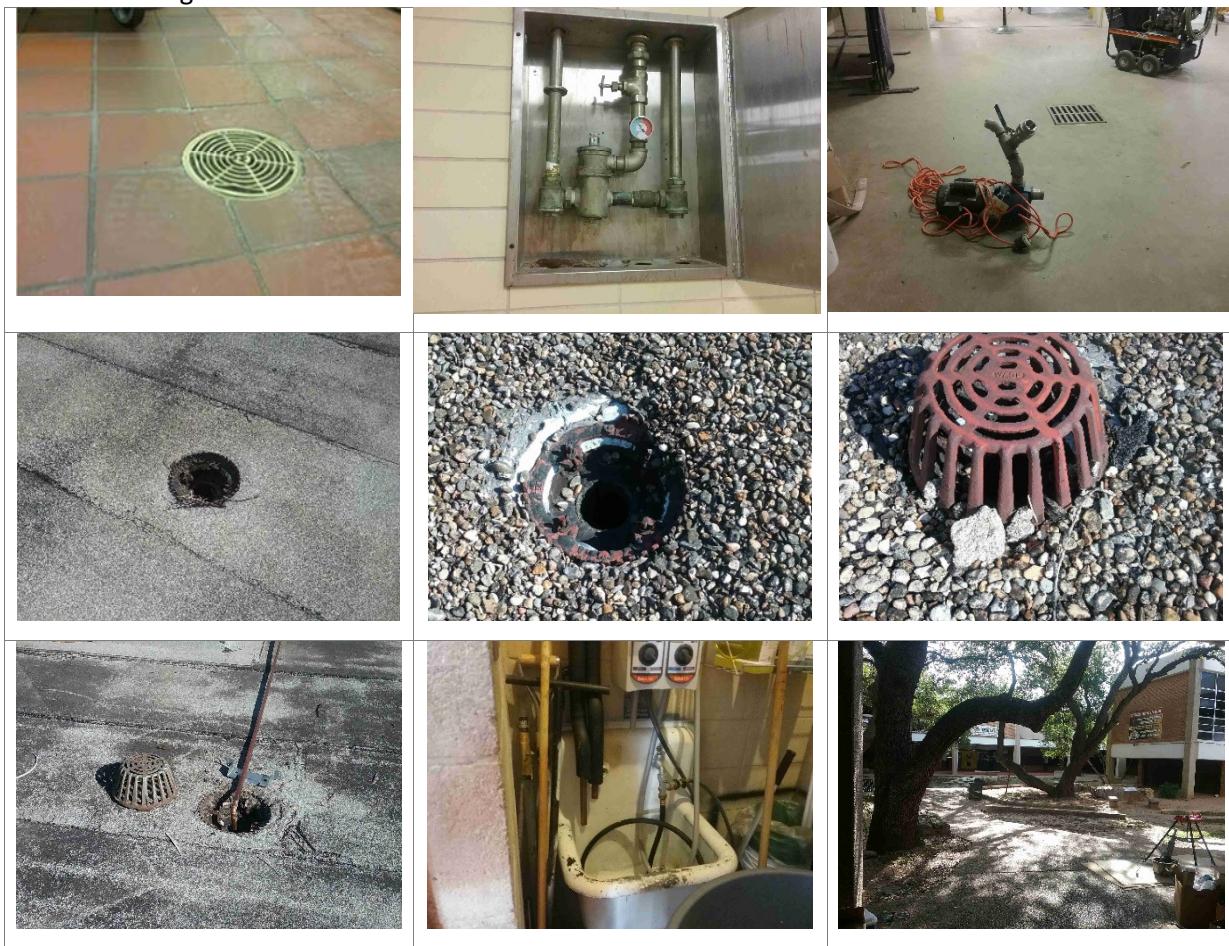
System	Subsystem	Condition and Deficiency Overview	System Condition Rating
		75-gallon gas-fired water heater serving the home economics and cosmetology classrooms showed signs of corrosion and rust. The Raypak hot water boiler reportedly takes 30 minutes to deliver hot water to the locker rooms. Most likely, this is due to undersized or poor hot water recirculating system. The kitchen water heating system was in good condition with the exception of one (B-3) that had some corrosion and rust along the bottom and was in average condition. Water heaters in rooms 140 and 121 were nonfunctioning. This was believed to be due to pressure fluctuation and lack of pressure regulating or relief valves. The water heaters also showed signs of corrosion.	
	Other Plumbing System	<p>There are roof and floor drains present in the building. The storm drainage system was in poor condition. Debris was observed in many of the roof drain bodies. Storm drain system blockages have been reported by maintenance staff. The roof drain domes were not secured or set onto the drains properly. There were some drain domes removed to allow RTU (roof top unit) condensate to spill into them which also allows debris to collect into the system causes blockages.</p> <p>Maintenance staff reported exterior storm drainpipe and roof drainage pipe blockage due to collapsed pipes near and around the auto shop areas. This caused flooding in the auto shop areas, as rainwater backed up through the floor drains and required the maintenance staff to utilize a portable pump to remove the water from the system and area.</p> <p>Central courtyard drainage was reported as undersized and to cause backups in ground level mechanical room floor drains when it rains. The mechanical room floor drains surrounding the courtyard had been plugged and the AHU (air handling unit) condensate was pumped to utility sinks.</p> <p>Some of the kitchen floor drain grates were loose and some were damaged. The damaged grates had parts protruding upwards causing a tripping hazard.</p>	Poor

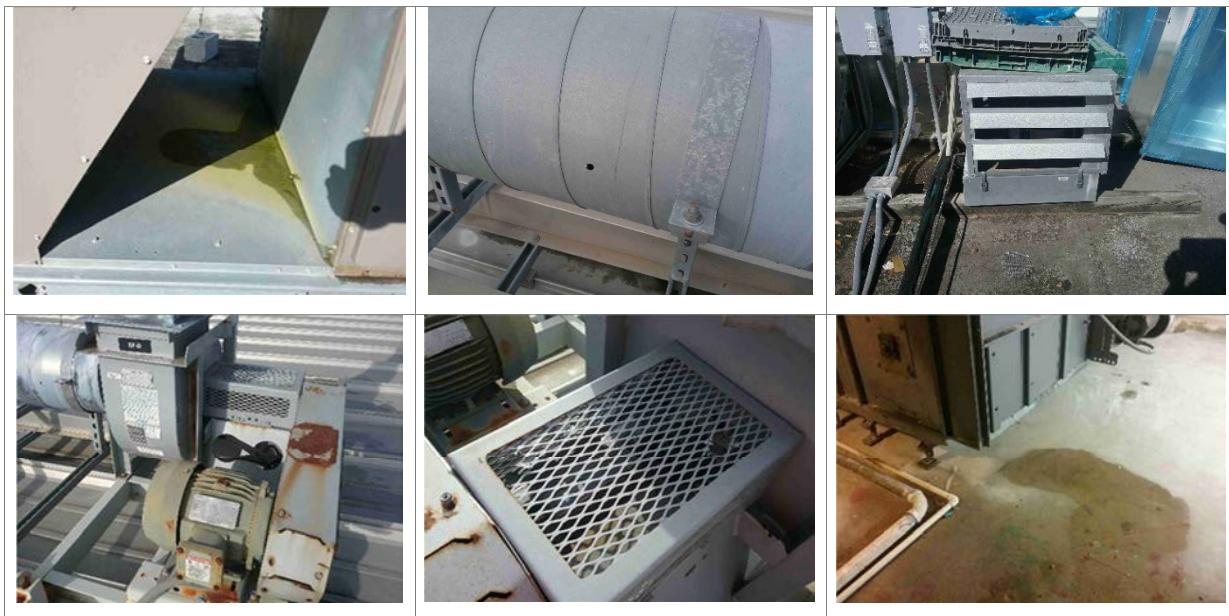
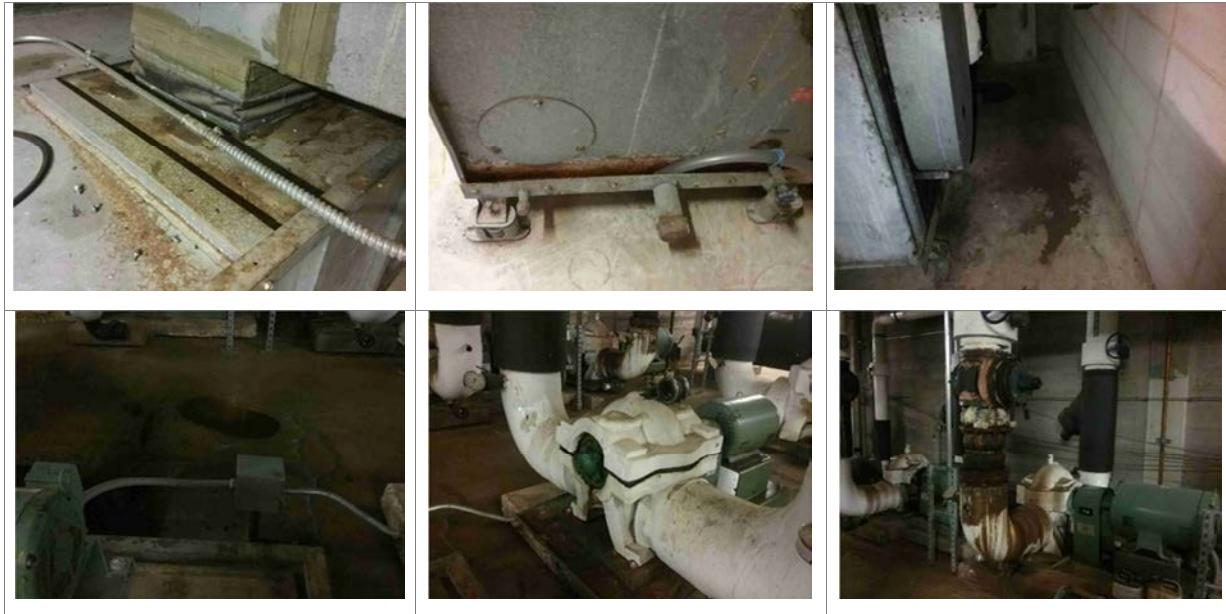
Mechanical/HVAC System Deficiency Examples

Mechanical/HVAC		<p>The major mechanical equipment consists of modular AHUs and RTUs located primarily on the roof or in mechanical spaces inside the school, boilers, chillers, and cooling towers. These serve the HVAC (heating, ventilating, and air conditioning) system throughout the building.</p> <p>There are 44 AHUs located on the roof or inside mechanical rooms. Fifteen AHUs are located on the roof and the other 29 AHUs are located throughout the interior of the facility. These AHUs serve different zone locations throughout the facility.</p> <p>The roof has 12 newer AHUs. These were either installed in the past several</p>	Average

System	Subsystem	Condition and Deficiency Overview	System Condition Rating
		<p>years or are currently being installed and have no visible issues. The AHU's that are older are AHU-1, AHU-2, and RTU-MDF-2.</p> <p>There are four mezzanine level AHUs, AHU-18, -19, -23 and -24. These were not accessible at the time of the assessment. Based on the equipment information provided prior to the assessment, AHU-23 and 24 had been recently replaced. Maintenance staff indicated AHU-19 was recently refurbished.</p> <p>The second floor has seven AHUs. Four of the AHUs were new and in the process of being installed. AUH-8, AUH-10, and AUH-31 had reached the end of their typical design service life.</p> <p>The first floor has 11 AHUs. Ten of the AHUs showed signs of age, and corrosion or rust and were at the end of their typical design service life. AHU-6 was new and in the process of being installed.</p> <p>The ground floor has seven AHUs. AHU-21 and AHU-25 were new and installation needs to be completed. FCU's FCU1 and FCU2 were installed within the last several years and were in good condition. AHU-20, AHU-28, and AHU-29 were in average condition but were reaching the end of their typical design service life. Leaks, corrosion, and rust were observed.</p> <p>The AHUs were observed to be in either excellent condition due to being new or average condition with the most typical deficiency being corrosion on the housing enclosure and/or the piping associated with the AHU. Additional deficiencies observed include general aging of the equipment, several with excessive noise and vibration and several leaks. Out of the 44 AHUs, 23 were new or were recently replaced. The three chillers were original to the building and were in average condition. Corrosion and rust, as well as leakage were noted at the system. The system pumps all showed sign of wear with evidence of leaks.</p> <p>Cooling tower CT-2 was rebuilt approximately two years ago. Cooling tower CT-1 was in the process of being rebuilt during the time of the assessment. They were not accessible beyond viewing from ground level. There was minor surface rust on the piping. The two cooling towers were in good condition.</p> <p>The hot water boiler system was installed in 2000 and was in good condition. The system consists of four 1,950,000 BTUH RBI boilers and one 1,250,000 BTUH RBI boiler. Boiler B-3 was the only boiler that showed signs wear with rust and corrosion along the bottom.</p> <p>The roof top condensing units CON-1 and CON-2 are located above the kitchen area and are believed to be serving the kitchen walk-in refrigerator and freezer. They were nearing the end of their typical design service life.</p> <p>Supplemental mechanical equipment for the HVAC system also includes EFs (exhaust fans). Roof top EFs were observed to be original to the building and in average condition based on their age. Many were observed with excessive noise and vibration.</p> <p>Based on the amount of new equipment installed relative to the older existing equipment and systems that are nearing the end of their typical design service life, the HVAC system was in average condition.</p>

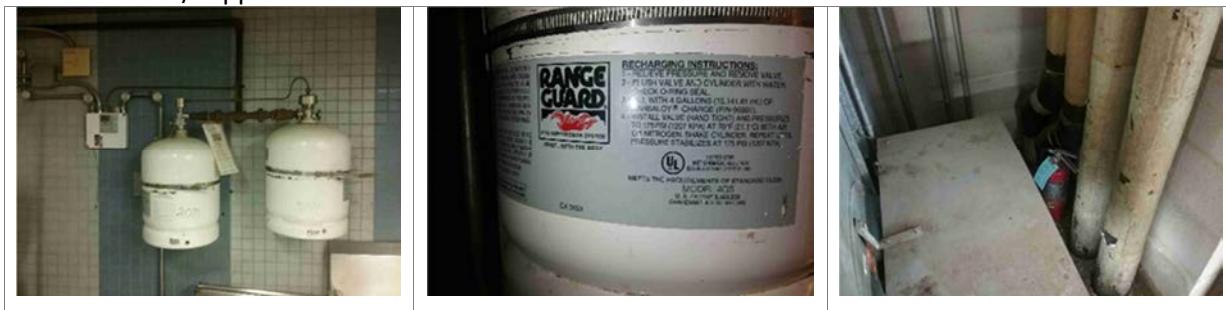
Fire Protection/Suppression

System	Subsystem	Condition and Deficiency Overview	System Condition Rating
Fire Protection	Fire Alarm	<p>The building has a fire alarm system that consists of alarm and signaling devices such as horns, strobes, horn and strobe combination devices pull stations, and smoke detectors. The fire alarm system is controlled by a Silent Knight control panel.</p> <p>The fire alarm system was observed to be in good condition. The faculty reported no fire alarm system deficiencies.</p>	Good
	Fire Protection/ Suppression	<p>The majority of the building is not protected by a fire suppression system. This portion of the building is protected by portable fire extinguishers. An automatic wet pipe sprinkler system protects the auto shop areas. The kitchen exhaust hood is equipped with a Badger Range Guard system.</p> <p>The auto shop sprinkler system was installed in 2007 as indicated on the hydraulic information tag on the system valve. This system appeared to be in good condition with no deficiencies observed or reported by the maintenance staff.</p> <p>There was no evidence of inspections or testing of the kitchen hood suppression system, which would ensure the system, is operating properly.</p> <p>Although the fire extinguishers were up to date on inspections, the fire extinguishers that were located in the mechanical rooms were not mounted to the walls. There fire extinguishers were observed to be sitting on the floors, behind equipment and storage, and on mechanical equipment.</p>	Average

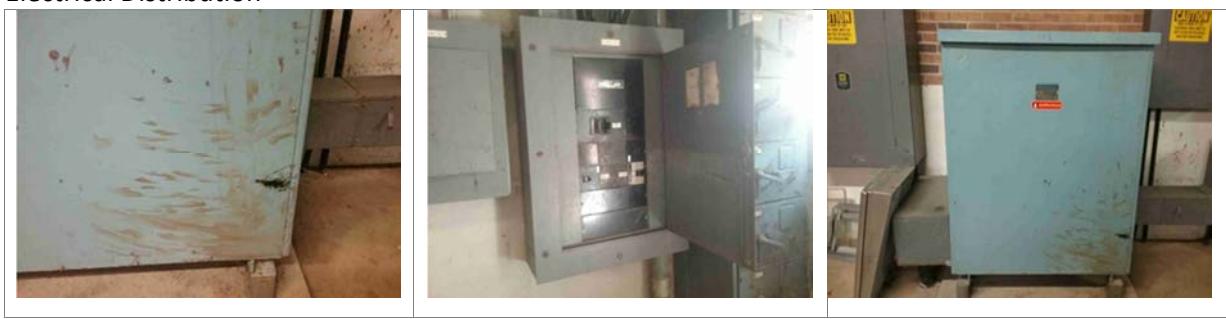
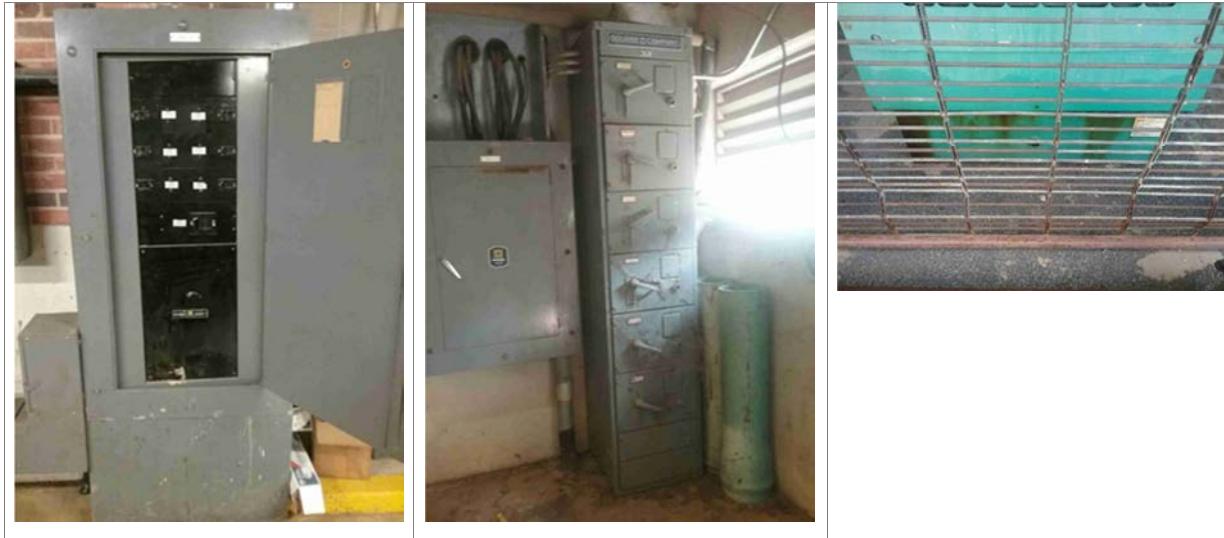
Electrical	Electrical Distribution	<p>The electrical service enters the building at 480 volts from a utility transformer into the main electrical room. The service entrance equipment in this room is a 480/277-volt, 2000-amp main, 3-phase switchboard. The utility transformer is located in the yard next to the main mechanical and electrical rooms. There are two power factor correctors in a nearby electrical room which appeared to be in good condition. The service entrance switchboard feeds downstream distribution equipment including switchboards, transformers, and panelboards located in mechanical and electrical rooms throughout the building. It appeared that the service switchboard was installed during a renovation and back-feeds equipment which once was original service gear, so the age of the electrical equipment varies. There are distribution transformers rated at 480-volt primary that step-down to 208/120-volt secondary feeds power to 208/120-volt panel boards. Branch panelboards are</p>	Poor

System	Subsystem	Condition and Deficiency Overview	System Condition Rating
		<p>typically located in mechanical or electrical rooms to serve general purpose circuits and utilization equipment.</p> <p>Much of the electrical distribution equipment was observed to have exceeded its typical design service life of 20-25 years and was found to be unclean with signs of rust and corrosion. Several items were installed in 2007 and were observed to be in good condition. Several distribution equipment items, particularly transformers, were missing enclosure screws and had handwritten warning signs acknowledging housing issues with the equipment. Some of the panelboards were unable to close due to faulty latches. This condition reduced the integrity of the enclosure, particularly in the event of an arc flash, which is a safety concern. The electrical room located adjacent to the choir room was inaccessible due to storage of non-electrical items; the NEC (National Electric Code) working clearance for all equipment in this space is violated by storage of materials.</p> <p>A generator is located in room STOMECH1 which serves two ATSs (automatic transfer switches) located in the main electrical room. The generator was missing its nameplate and was found to have rust along the base. Both automatic transfer switches are rated at 150A, are located in the main electrical room, and are in excellent condition having been installed in 2007. The size of the ATS's suggests that the generator is only serving life safety and critical loads; this survey could not validate the type of loads that are connected to the generator. The facility is also equipped with a portable generator connection point and a manual transfer switch.</p> <p>Facility staff reported frequent brown and black outs as well as overloaded and tripping circuit breakers in the kitchen panel and the breaker serving room 230.</p> <p>No modern grounding equipment was observed in the facility. In addition, no lighting protection was observed.</p>

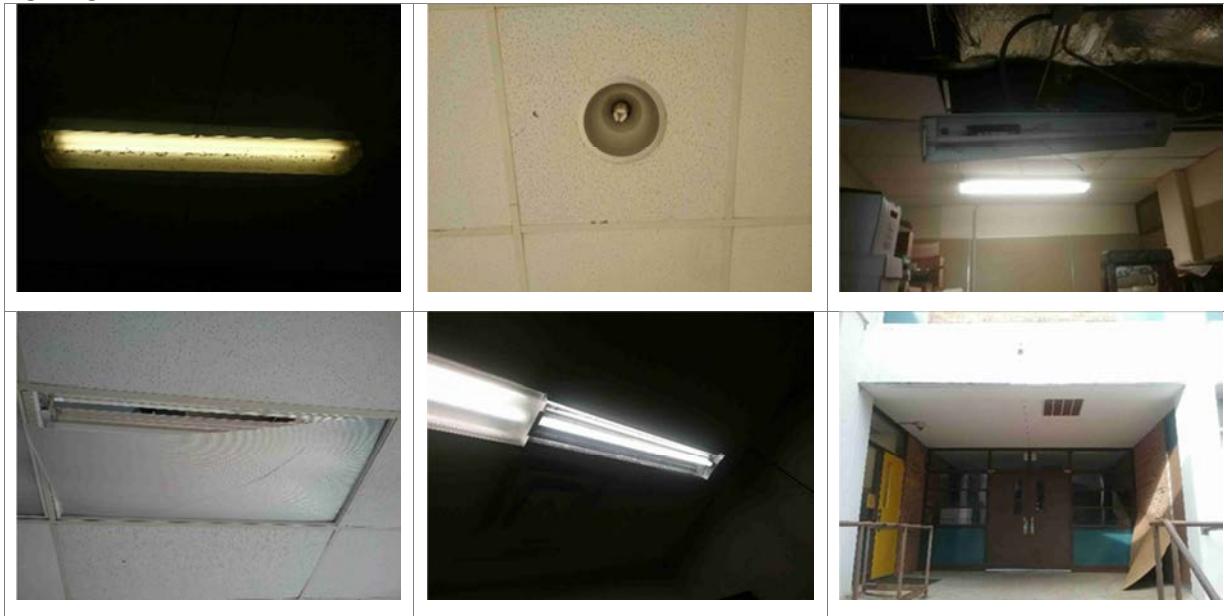
Lighting

System	Subsystem	Condition and Deficiency Overview	System Condition Rating
		<p>use of retrofitted T8 and compact fluorescent lamps. The fixture lenses throughout were found to be discolored resulting in diminished light levels. In addition, some lenses were found to be cracked or missing and lamps with noticeably different color temperatures have been utilized. The fixture spacing in the classrooms provides adequate lighting levels; however, the lighting in the interconnecting courtyards which serve as corridor connections for the students is insufficient. The facility staff reported that the courtyard lighting is a persistent maintenance issue. Numerous non-functional lighting fixtures were observed throughout as well as exposed wiring in the ceilings and switch locations of the library, several classrooms, and storage rooms.</p> <p>The building's exterior lighting consists of wall-mounted area lighting. The older fixtures are HID; however, some locations have been retrofitted with LED (light-emitting diode) fixtures. Limited lighting has been installed at the building entrances, so emergency egress lighting is insufficient at these locations. Facility staff reported that the lighting levels at the loading dock and gymnasium entrance are insufficient and not functioning properly.</p> <p>A limited number of exit signs were located in the facility. Those present were in good condition; however, the quantity and location did not meet life safety requirements. Emergency lighting wall packs were observed in the courtyards. The spacing of the fixtures was not consistent and did not appear to meet life safety requirements. No battery powered emergency lighting was observed in the remaining portions of the facility. It is assumed that those areas have emergency lighting powered from the generator.</p>

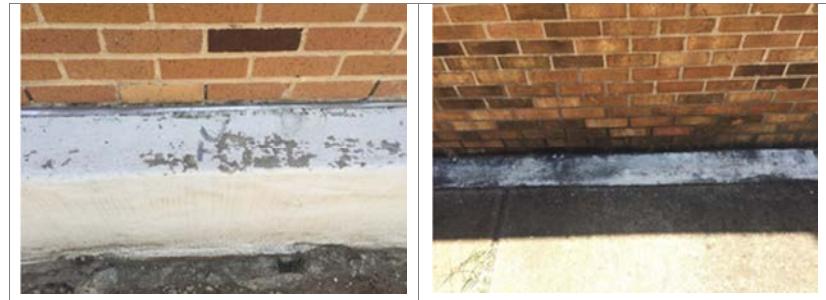
System	Subsystem	Condition and Deficiency Overview	System Condition Rating
Exterior	Exterior Walls	The exterior walls are brick with horizontal and vertical concrete panels. There are two panels of storefront glazing with metal framing on the southwest wall. The exterior walls were in good condition with few instances of deterioration. There was minor spalling on the foundation wall. Staining was observed on the brick at the base of the building.	Good
	Exterior Windows	The single exterior window is a ticket pass-through in the box office room at the entry to the Theater building. It is surrounded by a metal frame. The window was in good condition.	Good
	Exterior Doors	The exterior doors are primarily metal with metal frames. The exterior doors were in good condition.	Good
Roofing		The roofing system was modified bitumen. There are two metal canopies covers the north west entry. The metal canopies were in good condition. The roof was in good condition. There were no reported or observed deficiencies at the time of the assessment.	Good

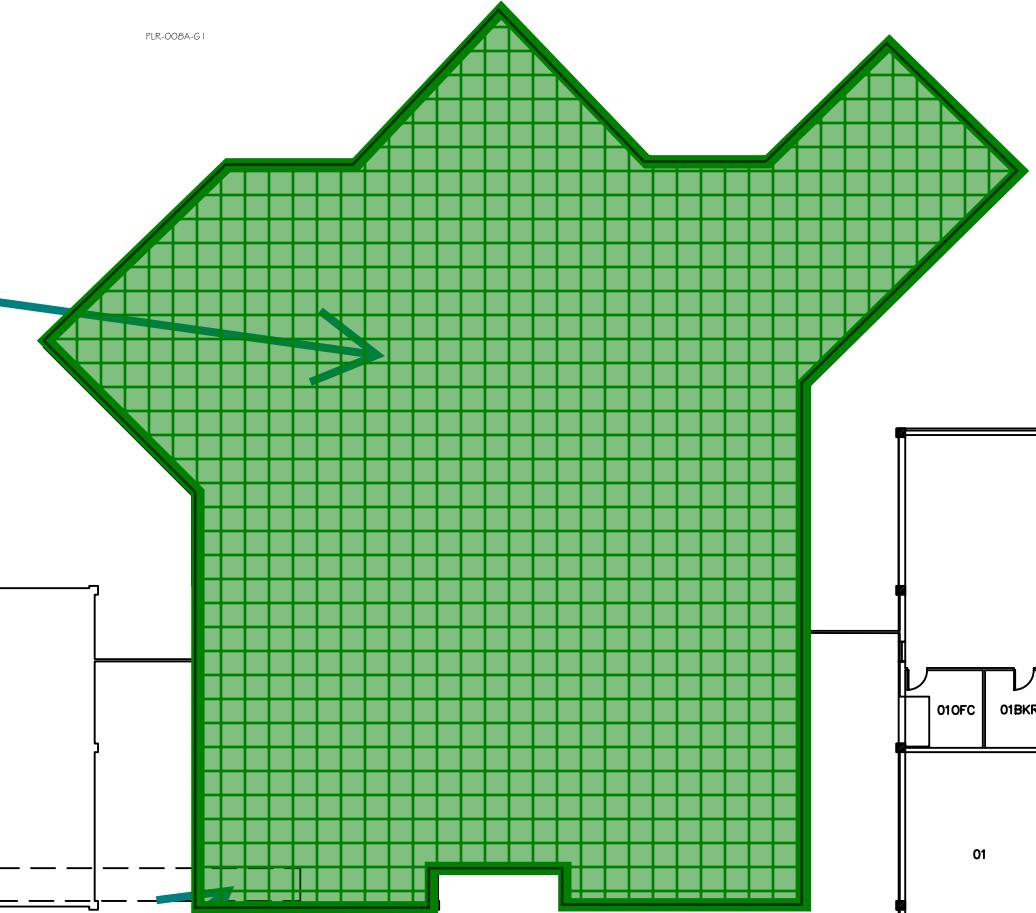
A

- 1) DAMP SOIL
- 2) BUCKLED AND SHIFTED SOIL RETAINERS; MINOR TO SIGNIFICANT SOIL INTRUSION
- 3) HUMID AND STAGNANT AIR, CONDENSATION ON PIPES & CONCRETE, POOR VENTILATION
- 4) VENTS PARTIALLY CLOGGED
- 5) VENTILATION FAN NOT OPERATIONAL (MISSING BELT)
- 6) EXPOSED REINFORCEMENT AT WALL OPENING TO ADDITION
- 7) HONEYCOMBING IN PERIMETER & INTERIOR BEAMS
- 8) MODERATELY TO ADVANCED SPALLING AND EXPOSED/RUSTED REINFORCEMENT IN FLOOR BEAMS AND SLAB SOFFIT
- 9) MILD RUST AND CHIPPED PAINT ON STEEL BEAMS
- 10) EXPOSED SLAB REBAR AT PIPE PENETRATIONS
- 11) RUSTED PIPES AND HANGERS
- 12) DEGRADED/MOLDY/MISSING PIPE INSULATION

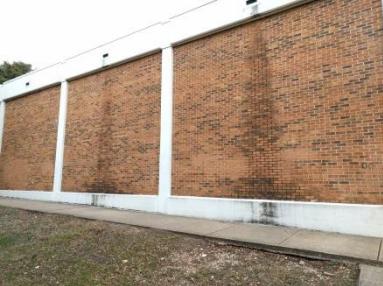
Mildew on wall from roof	Ponding water at SW corner of the school	Ditch with erosion and obsolete culverts

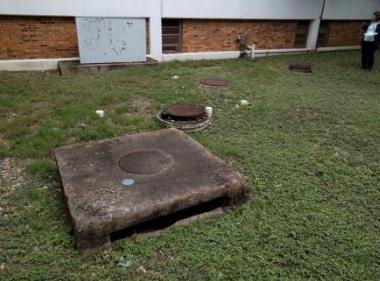
Inlet and sanitary manhole with erosion and infiltration	Hole from removed light	Loose conduit

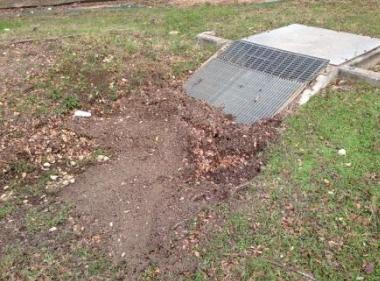
Clogged outfall structure grate	Outfall structure bent and loose	Outfall structure with demolished fence.
